Bulle Clock Serial Number 53995

*Restoration of Bulle Clock
Serial Number 53995*

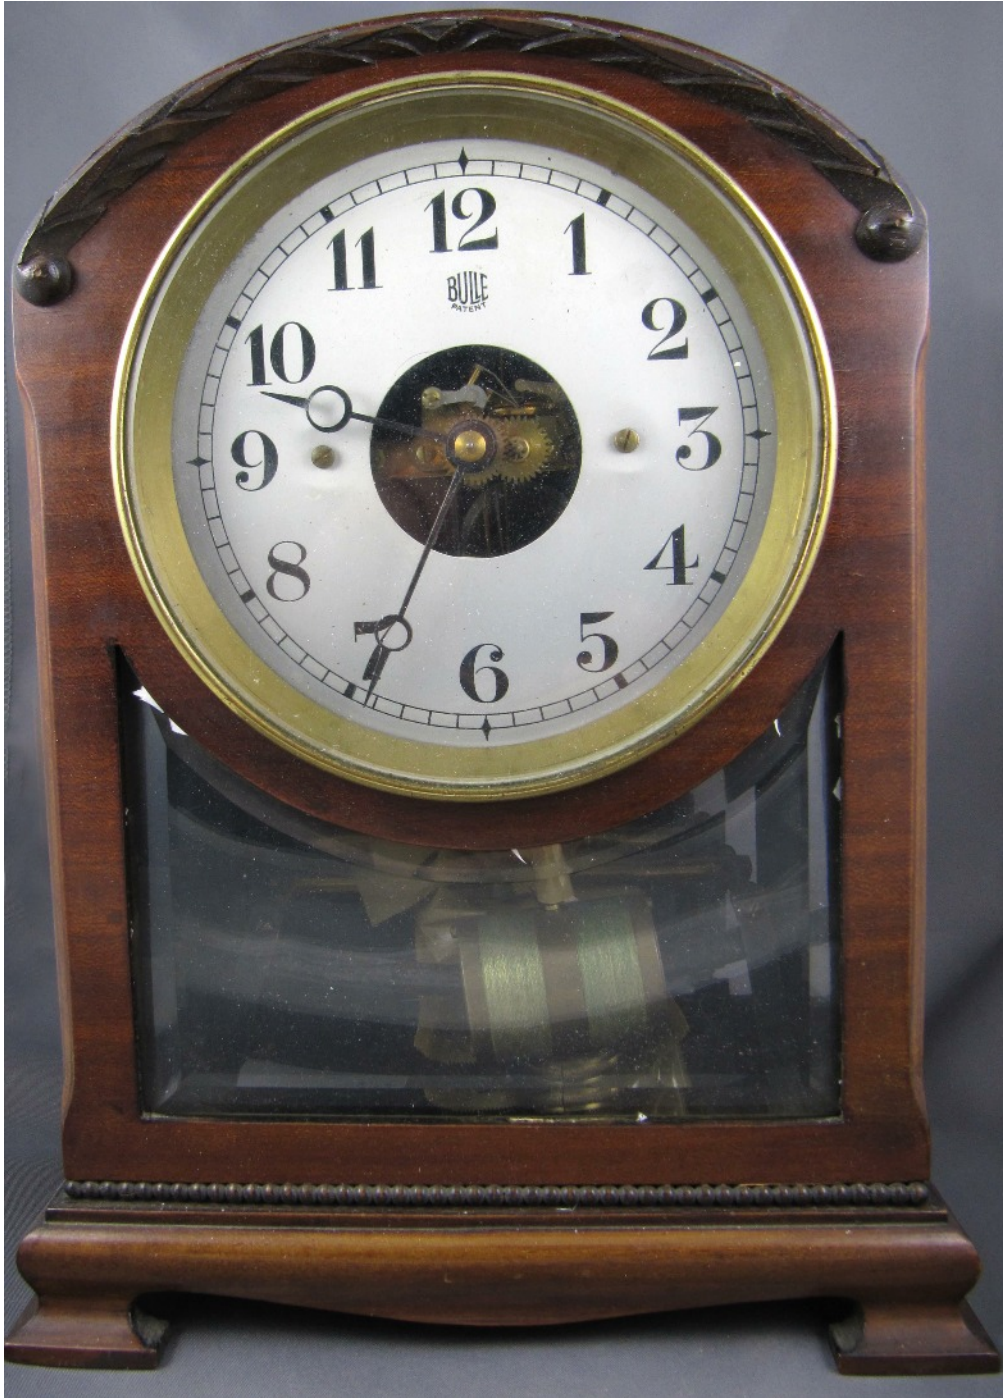
Photos by kind permission of the owner. A medium movement Bulle with a 0.44 beats per second pendulum in a mahogany veneered case with opening bezel, bevelled glass panel and rear door. Overall the clock looks in good condition with the case just needing a good wax polish although there is an old stress crack on the top of the case.

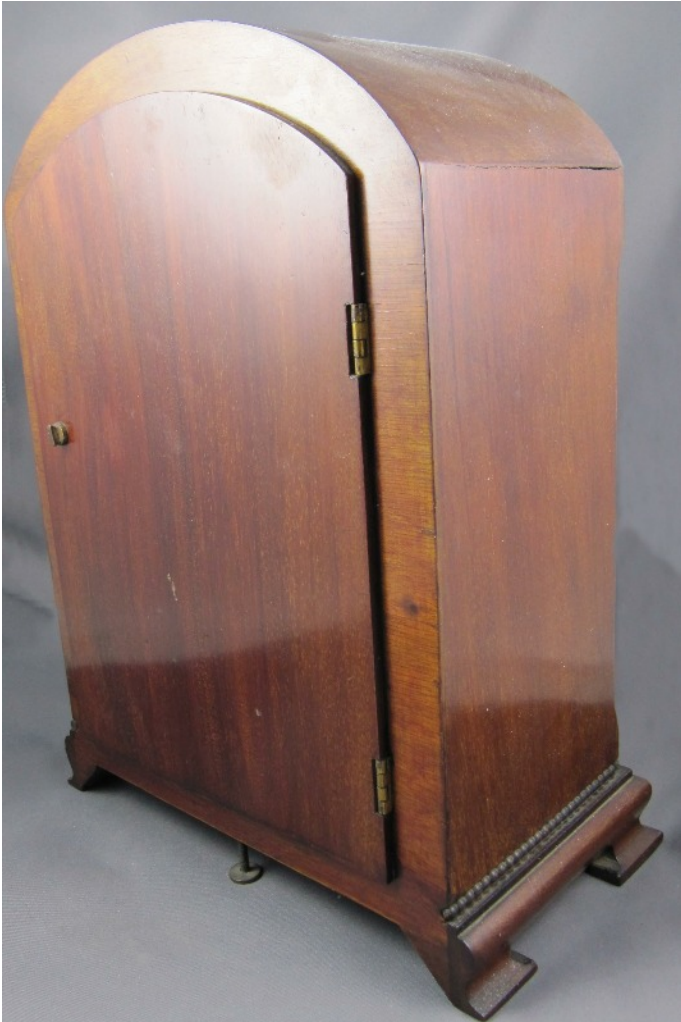
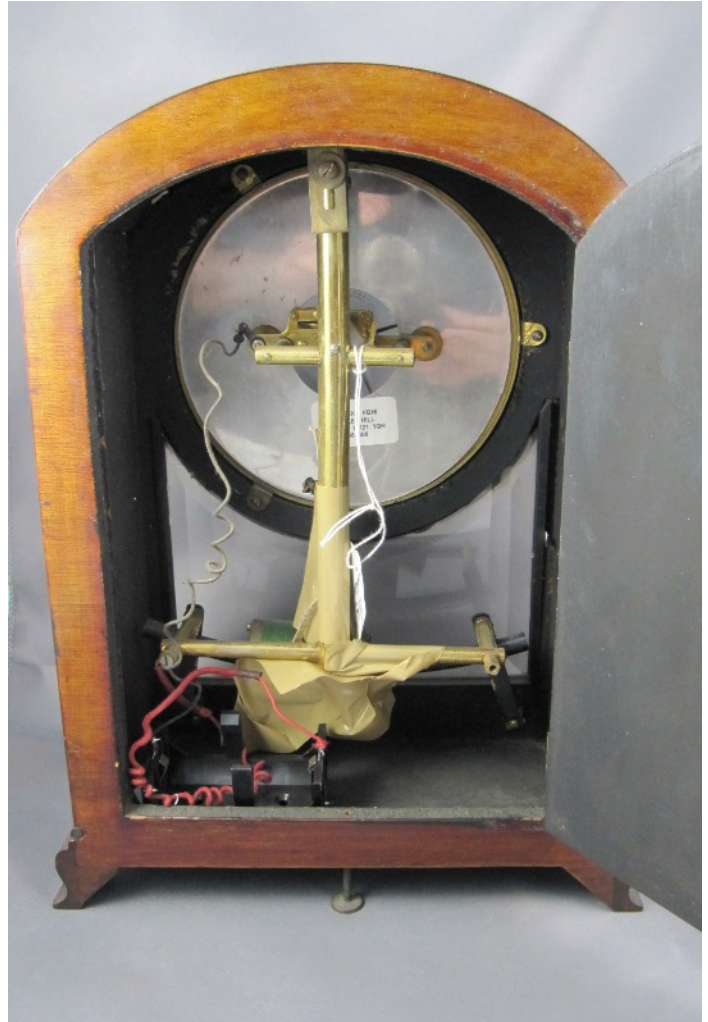
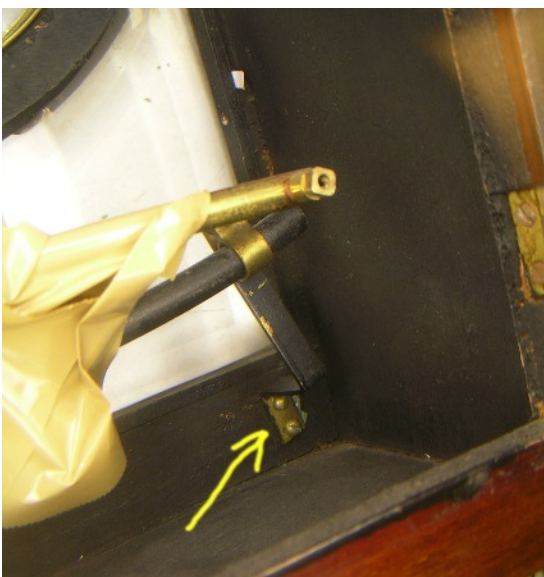
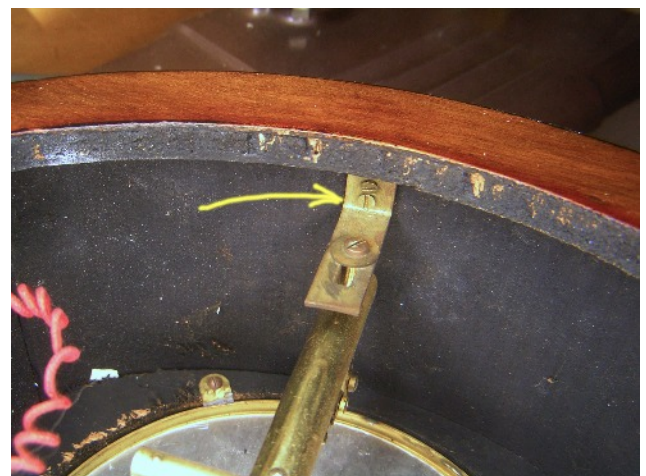
This group of photos show the casework and the method of securing the movement frame in the case. This same movement can be found in many different case styles and is often found secured to the rear of cases.

This movement though is secured to the front of the case to allow access from the rear.

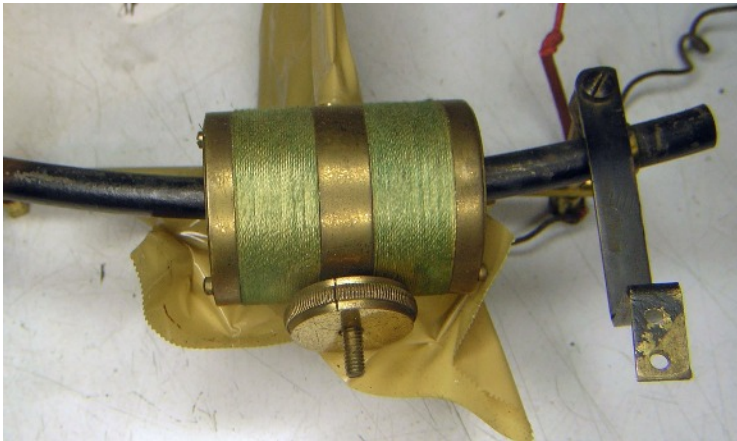
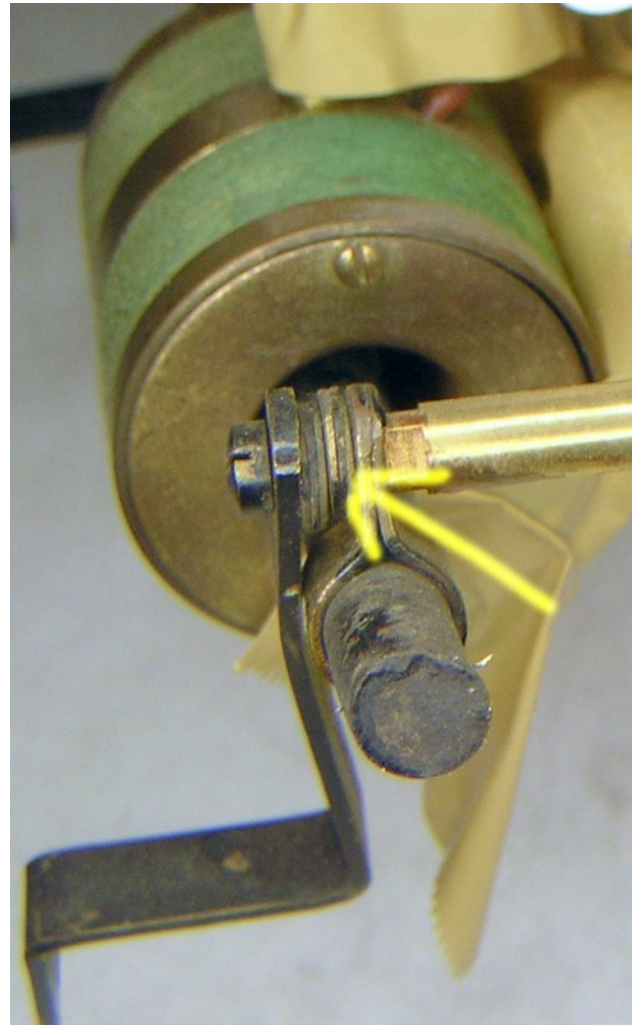
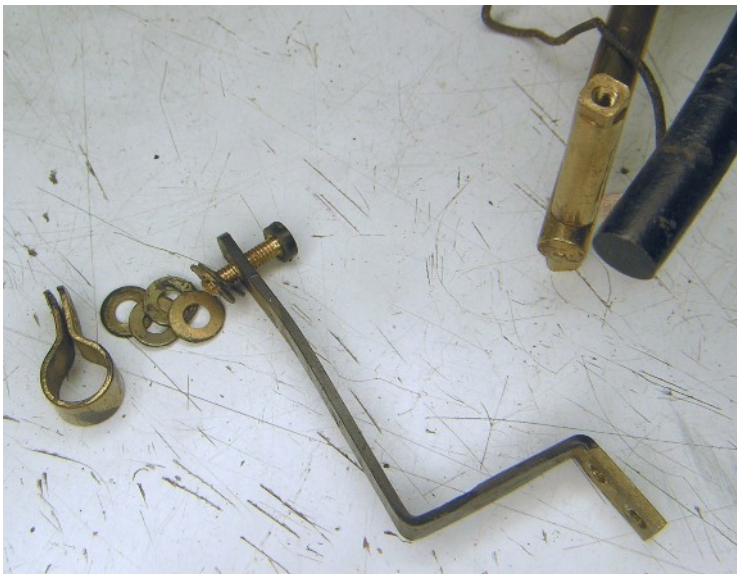
The photos above show the method of attaching the frame to the case. Note the number of washers needed for packing the bent brass strap. This has been painted black to try and hide it from view through the front glass panel.

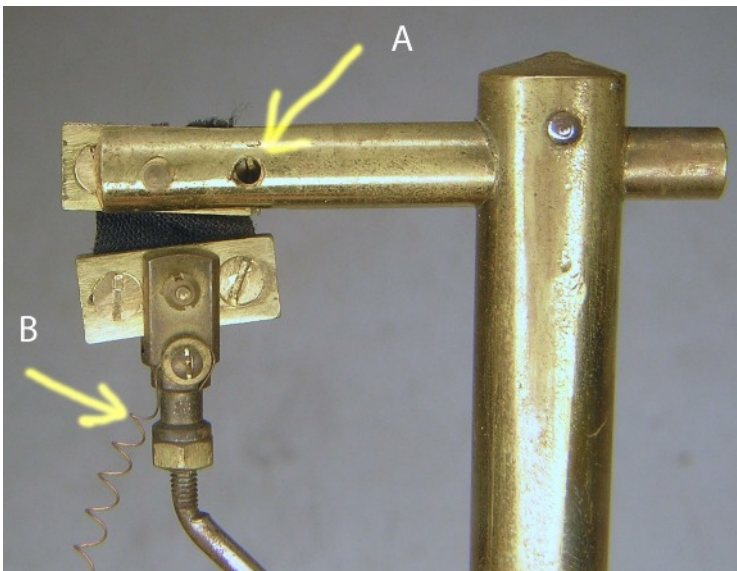
The photo at left shows the made up suspension and missing screws that secure the suspension in place. These will have to be made.

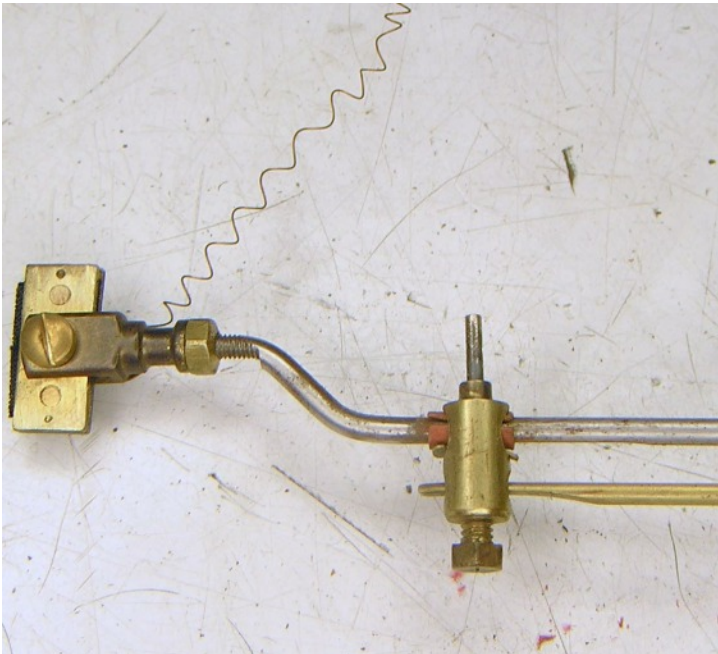
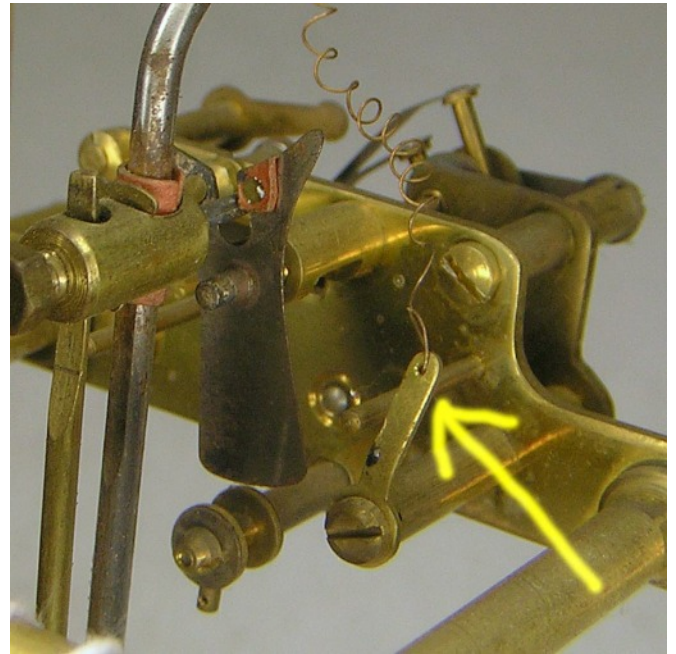
These two photos show the wire which has been connected (wrongly) from the pendulum to the movement. This would never have worked. The wire from the top of the pendulum should be connected to the frame where the suspension is secured. The arrow shows where a silver contact spring should be. This spring connects to the rear of the fork arbour in a large looped end.

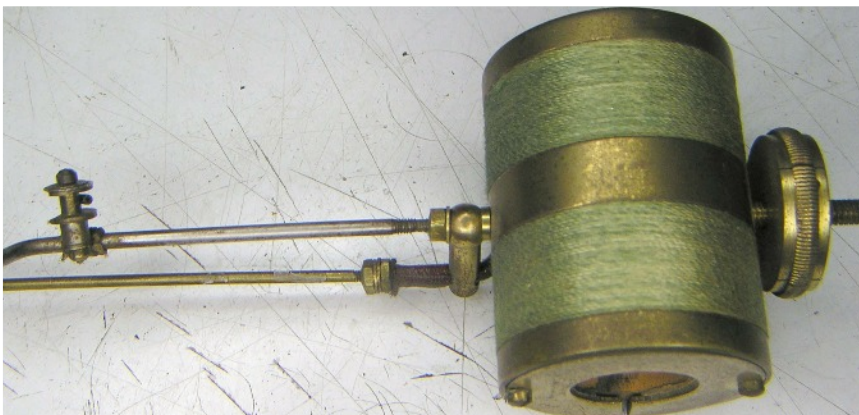
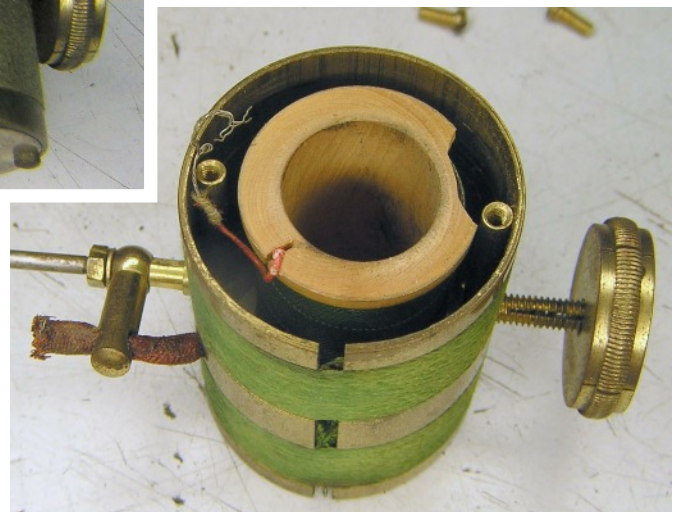
The pendulum and coil casing. The cord is covered in some sort of sealer and will be replaced. The last photo shows the coil inside the casing. The wooden bobbin has a broken cheek but this will not make any difference to the performance and will be left as is. The lead out wires though are a bit tatty. They will be tidied up and extended

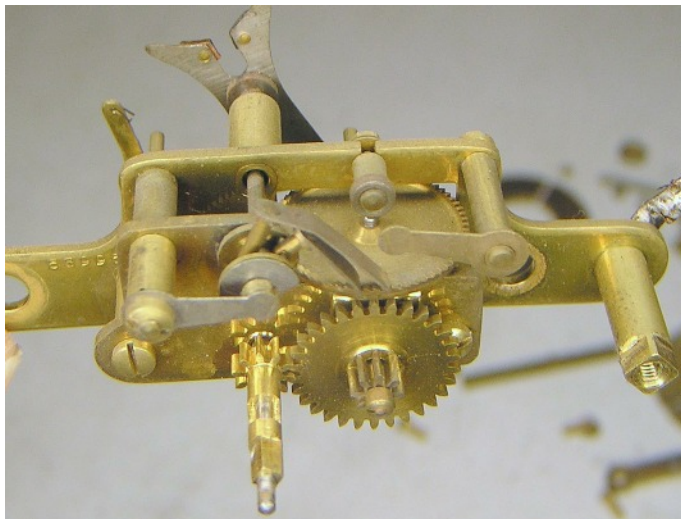
The movement look sto be in good condition with just a coating of dust. It will clean up well.

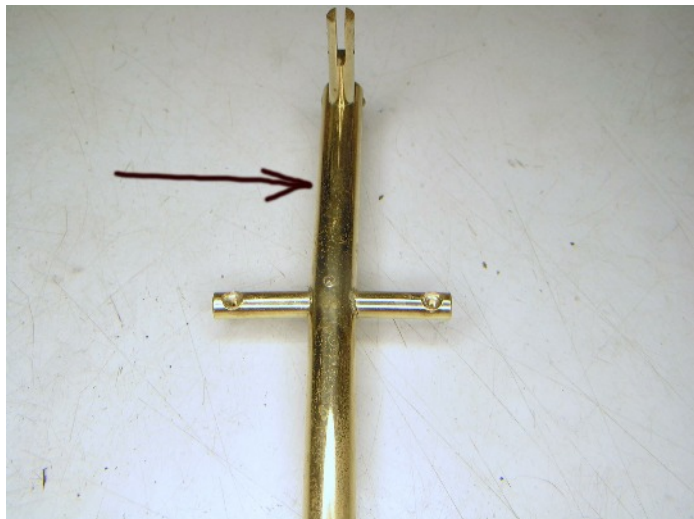
The frame has a nasty bend in it which is relatively easy to correct. I hold the top of the frame in fibre jaws in the vice and apply gentle pressure until the frame is straight.

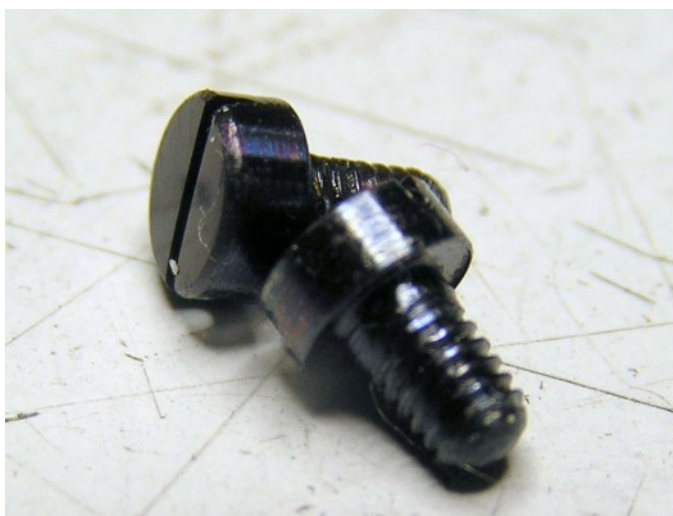
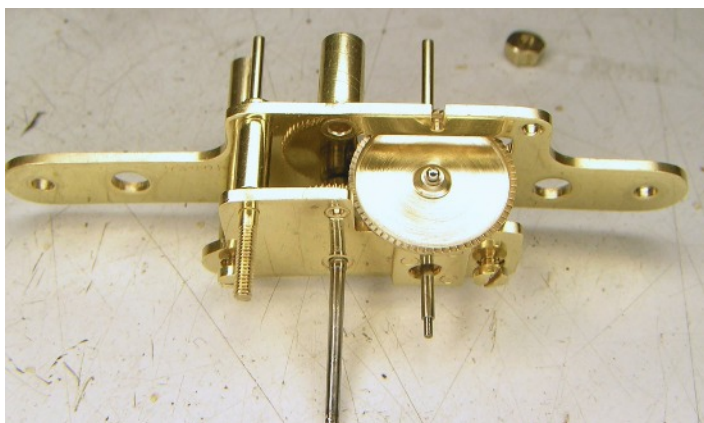
At top left are the new screws made to secure the suspension in the frame. Above is the partially reassembled movement.

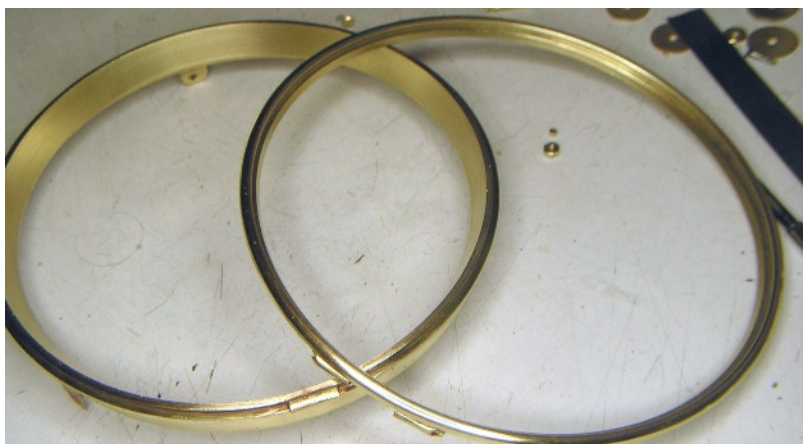
At left is the bezel split apart ready for a new hinge pin. The bevelled glass is easily removed from the front by applying a little heat to the bezel to expand it whilst applying finger pressure to the glass until it pops out. The reverse procedure is used to re-insert the glass. A hair dryer provides more than enough heat for the job.

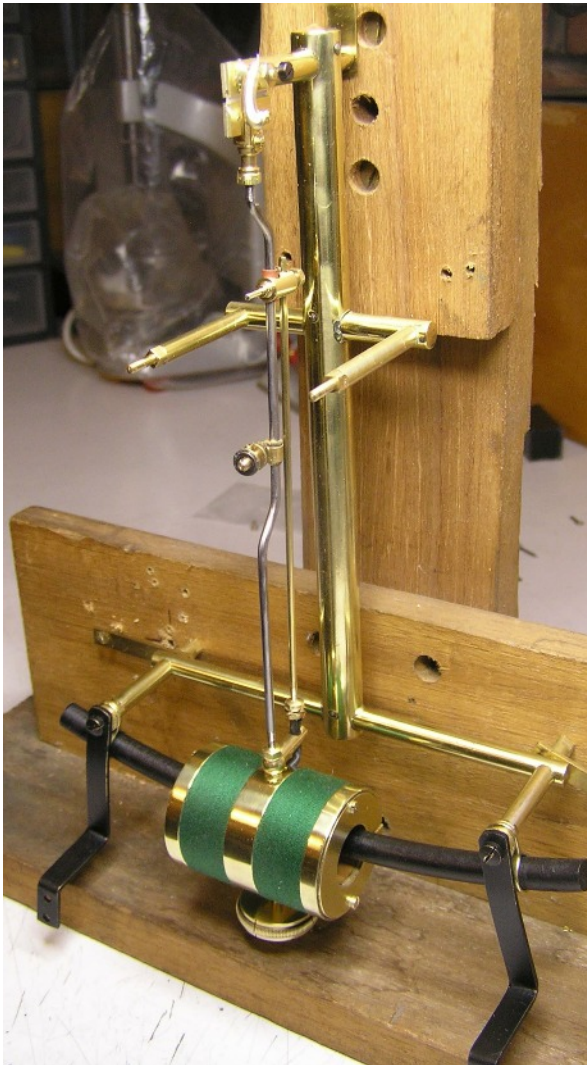
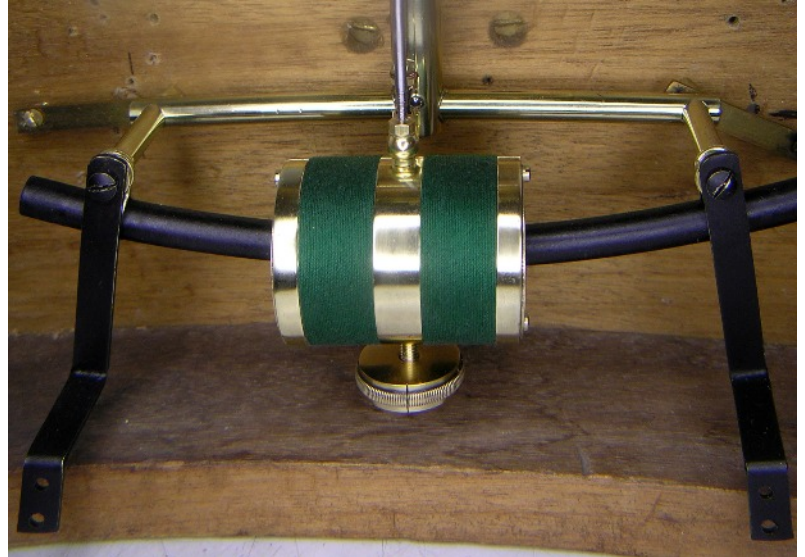
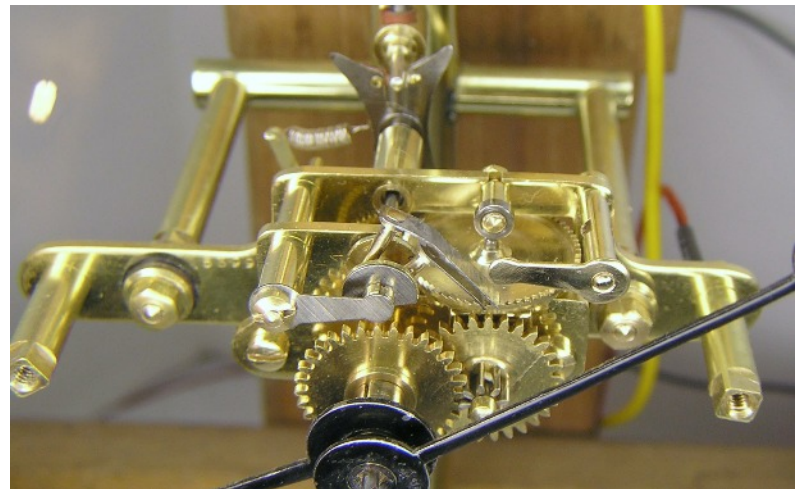
These photos above show show the pendulum and frame tack together ready for testing the function of the coil and magnet. There is a short video on the website showing how to test the pendulum and magnet without having the movement in situ. The last photo shows the movement back in place.

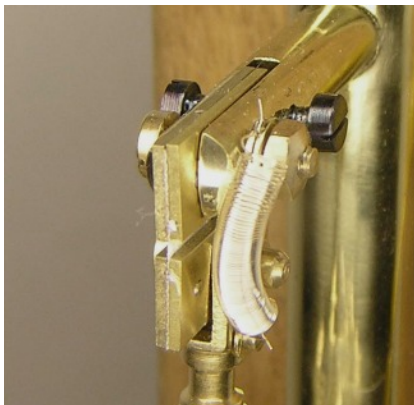
The photo on the left shows the suspension and screws with the contact wire as it should be placed. This wire carries the current from the frame across the suspension and down to the pendulum.

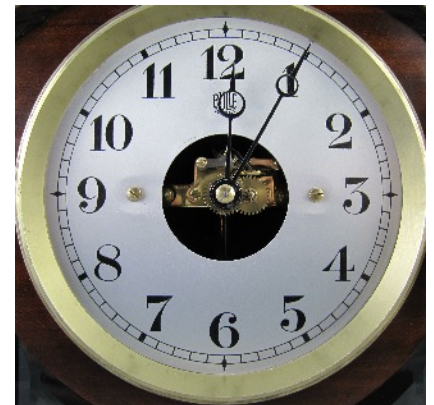
The photo on the right shows the finished dial, bezel and hands all back in place. The hands were in good condition and only needed cleaning and buffing

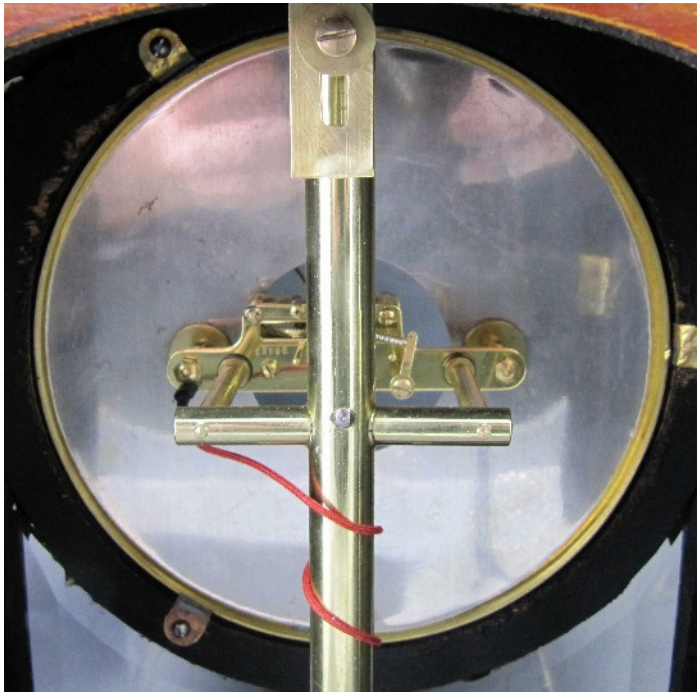
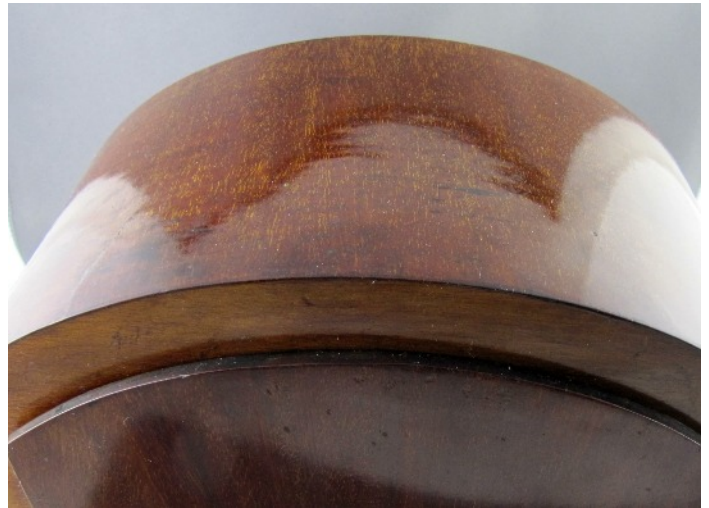
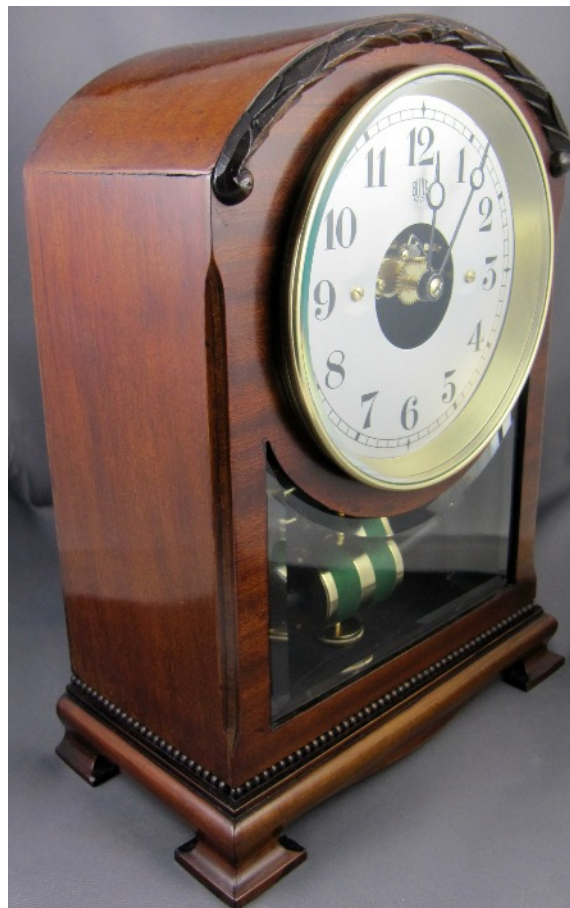
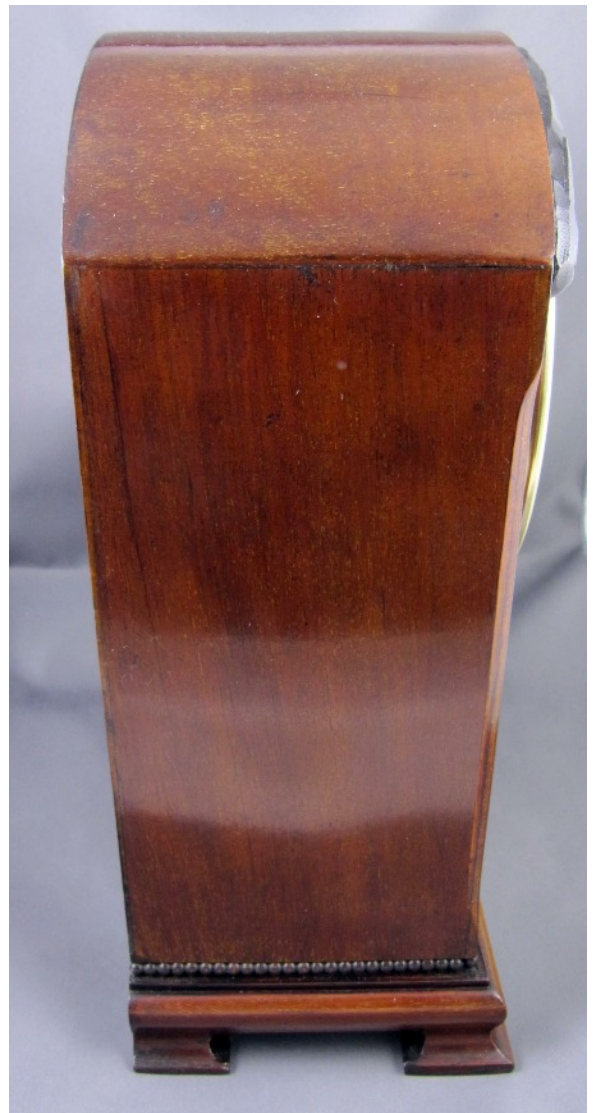
The photo at top left shows the rear of the clock with the movement and dial back in place. The other photos show the wood case which has come up nicely with a gentle buff with beeswax polish.
