Horologix

Bulle Clock Serial Number 5407

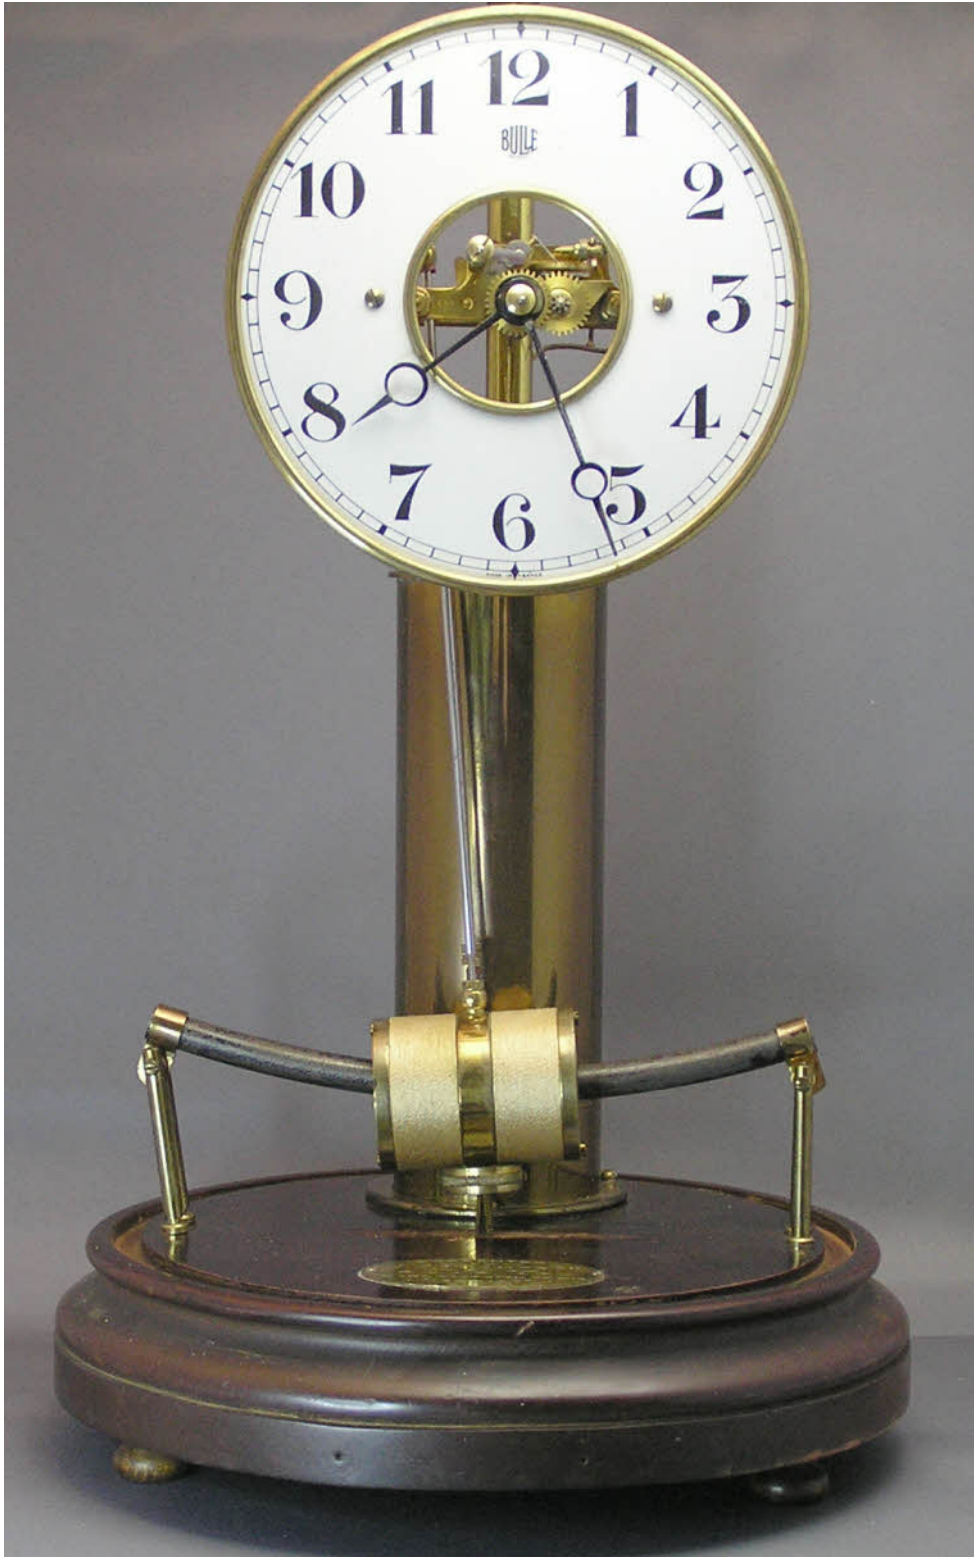
A tall "A" type Bulle clock with tubular column for the battery. This is a relatively early example from the first year of production. At first glance it appears to be in a reasonably good condition. Note the magnet support arms are thrusting out on the left though. This may mean its had a hard knock at some time. The dial looks to be almost perfect with no large marks or scrapes. The oblong labels from the front is missing and will be replaced with an Horologix original part. You can just spot the two mounting holes for the label at the bottom of the wooden base. The distance between the two holes proves that it is the earlier oblong labels rather than the shorter oval type.

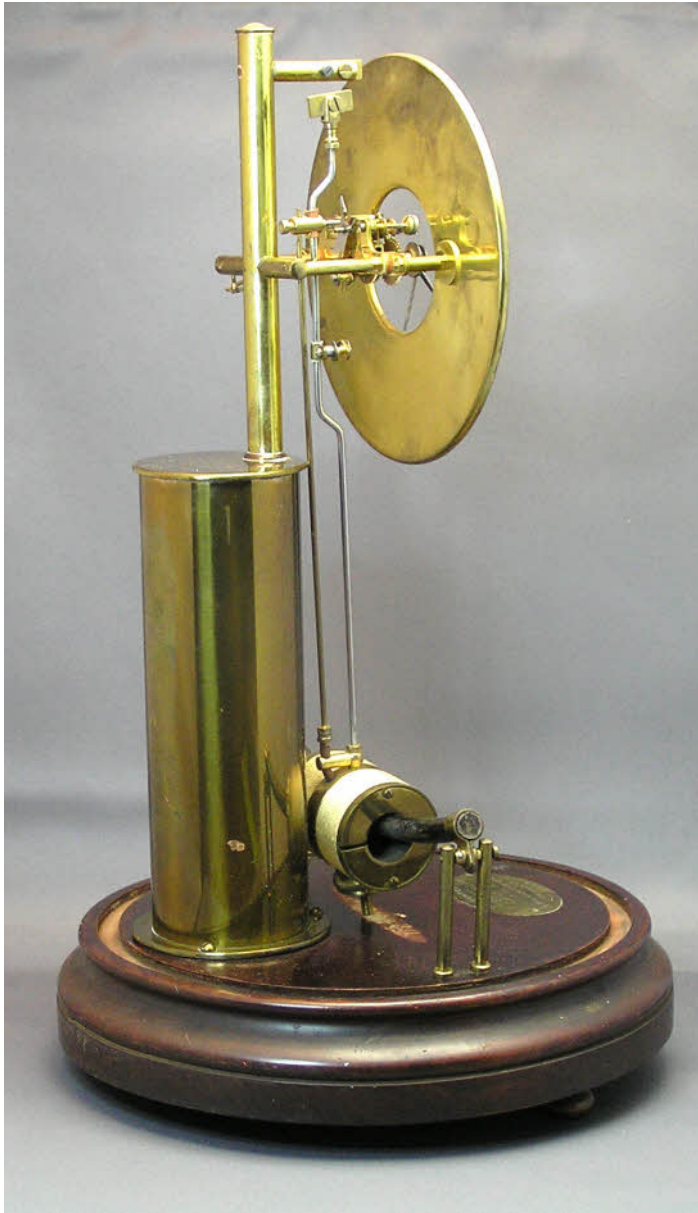
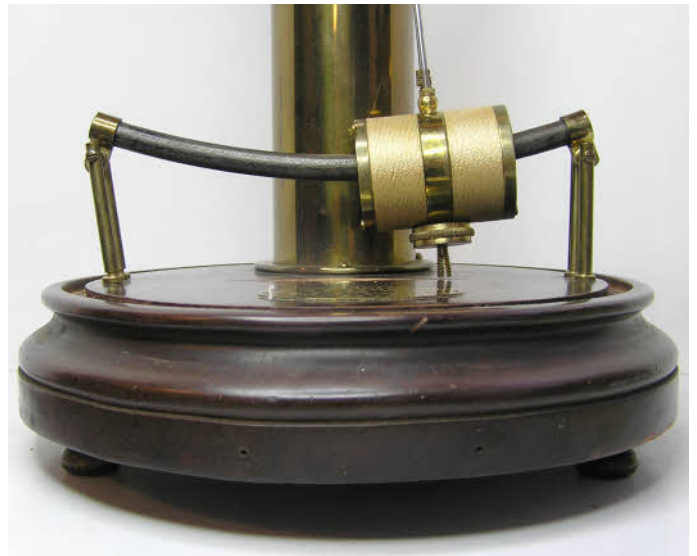
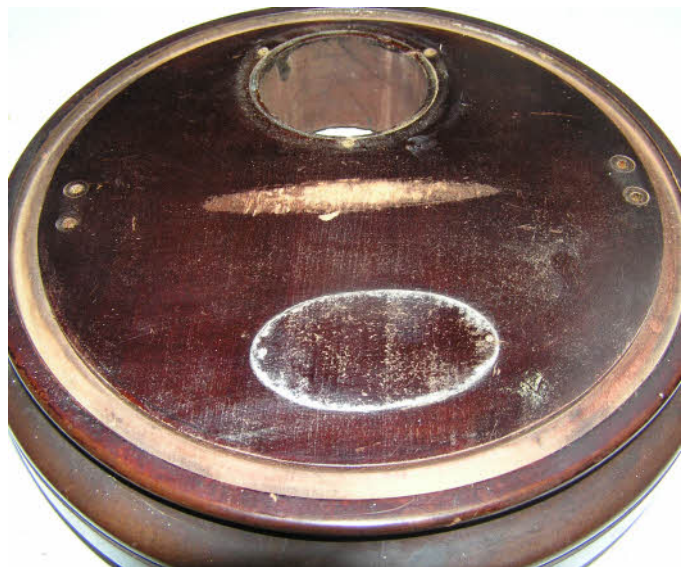
The photo above shows the side and rear of the clock with perhaps an acid burn low down on the tube. The photo top right shows the left hand magnet support pillars are pushed heavily to the left. The last photo shows the bad scoring caused by the pendulum which has been hanging free because the suspension has been broken. This is going to take a fair amount of work to recover.

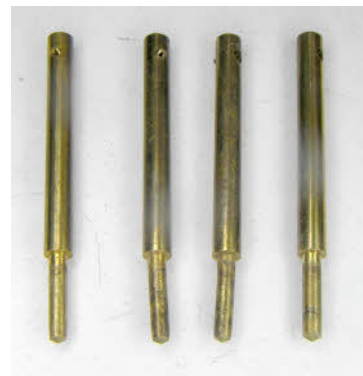
The magnet support pillars after removal, confirming that they have received a hard knock at some point. They are easily straightened.

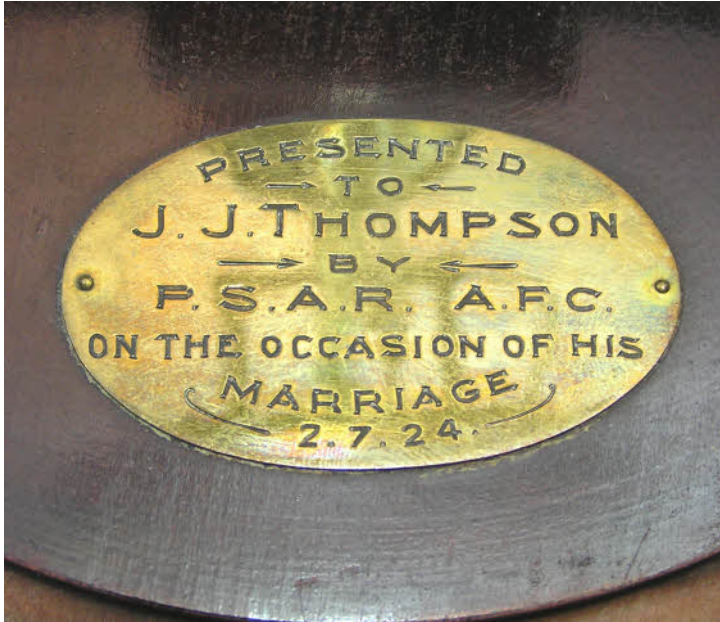
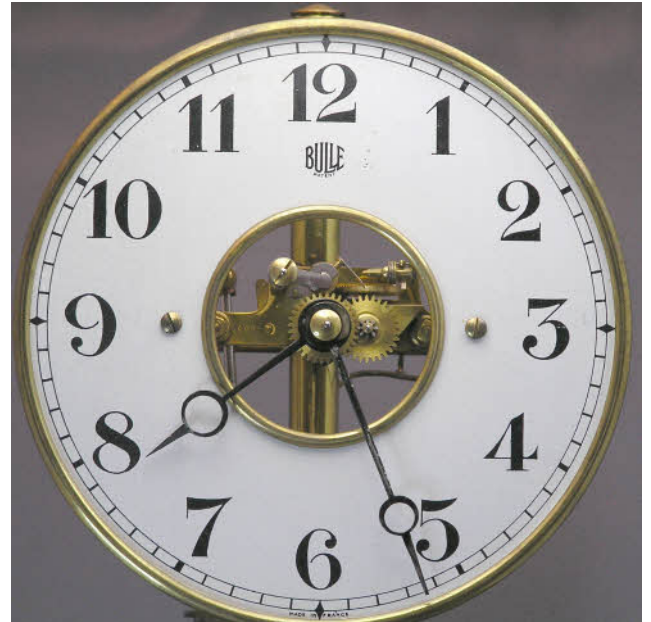
The presentation plaque provides good dating evidence. This close up of the dial shows it to nice and clean and will not require any major work.

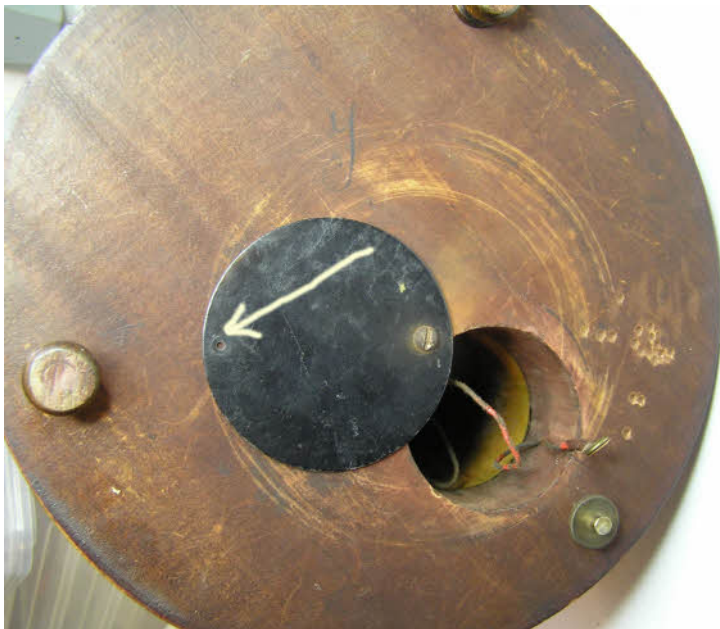
The underside of the base shows the steel door still in place albeit with the small brass knob missing. A replacement will be turned up on the lathe.

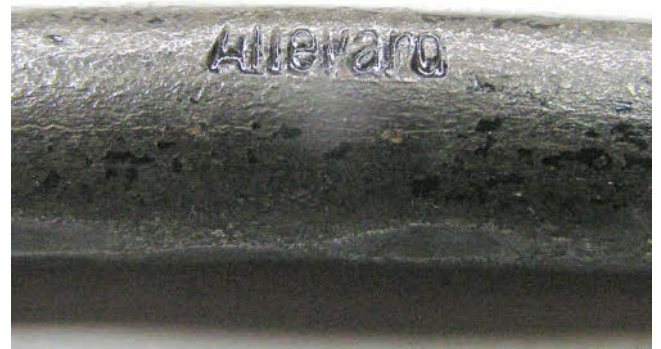
The magnet is one of those rare ones with the manufacturers name "Allevard" punched into the side. Evidently this is a famous area of steel manufacture in Southern France.

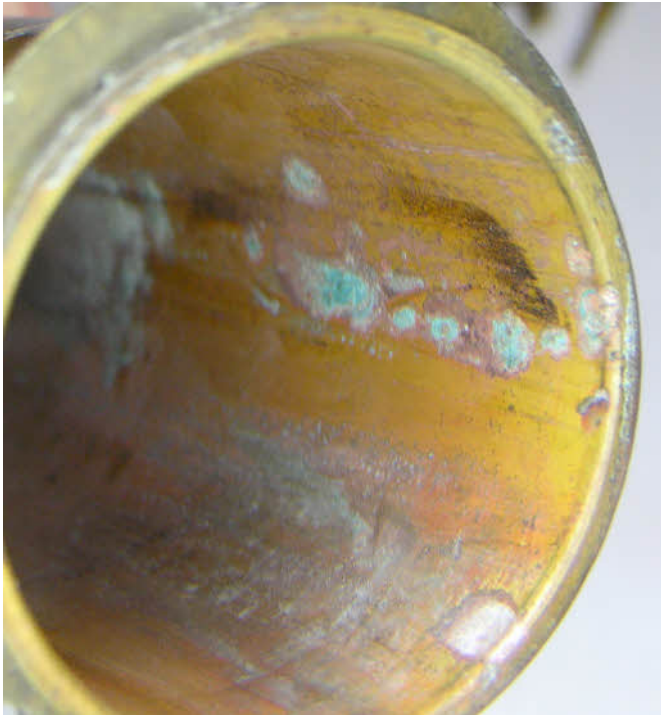
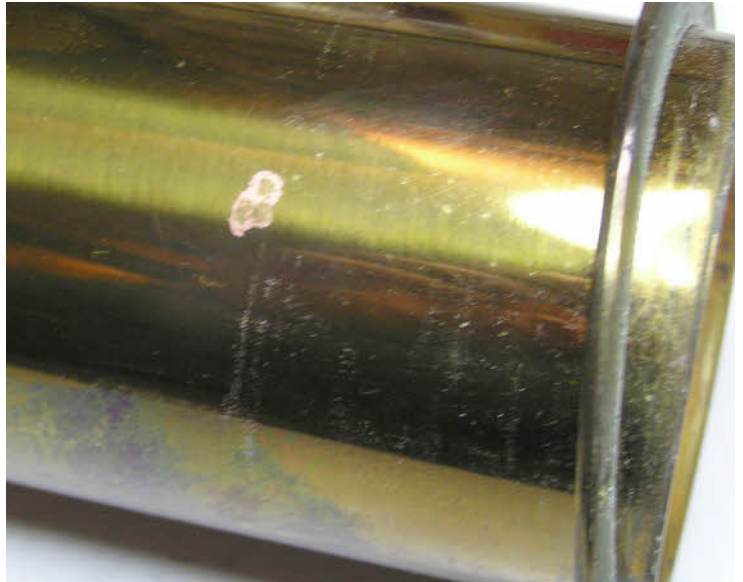
These two photos show the small amount of damage caused by leaking battery acid. The burn through should polish out OK.

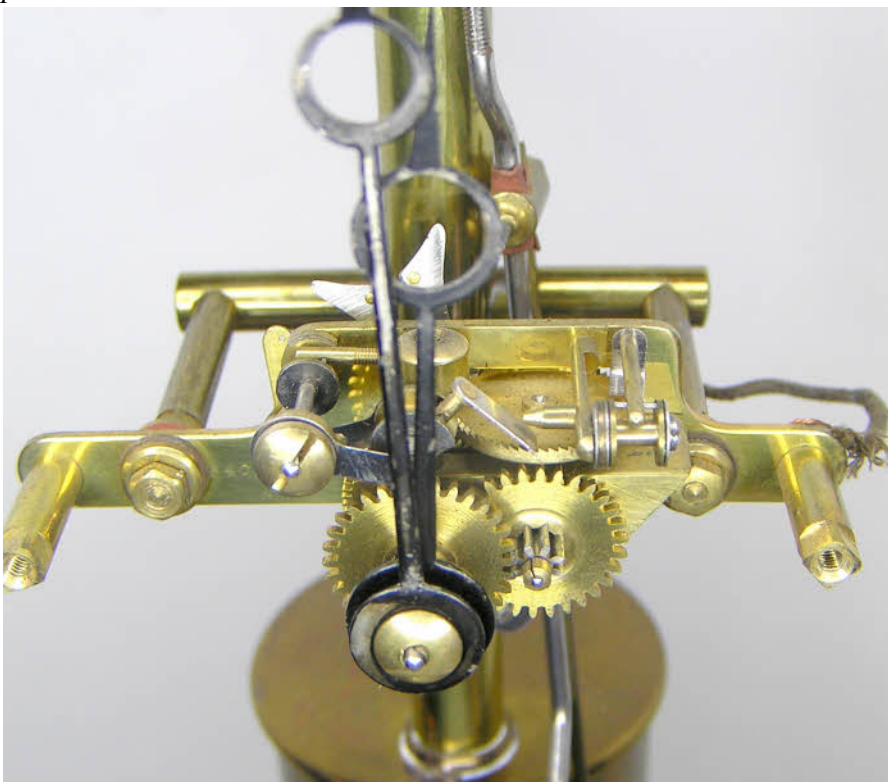
The movement shows no signs of any major faults or missing parts

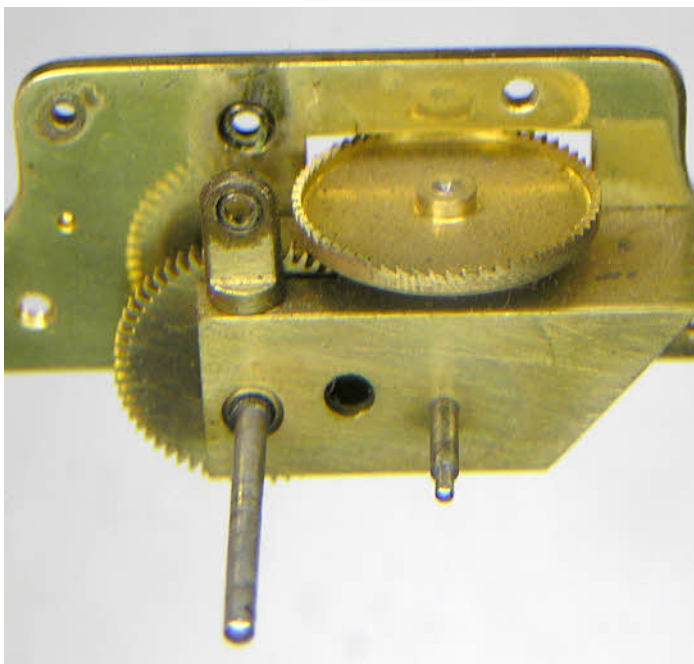
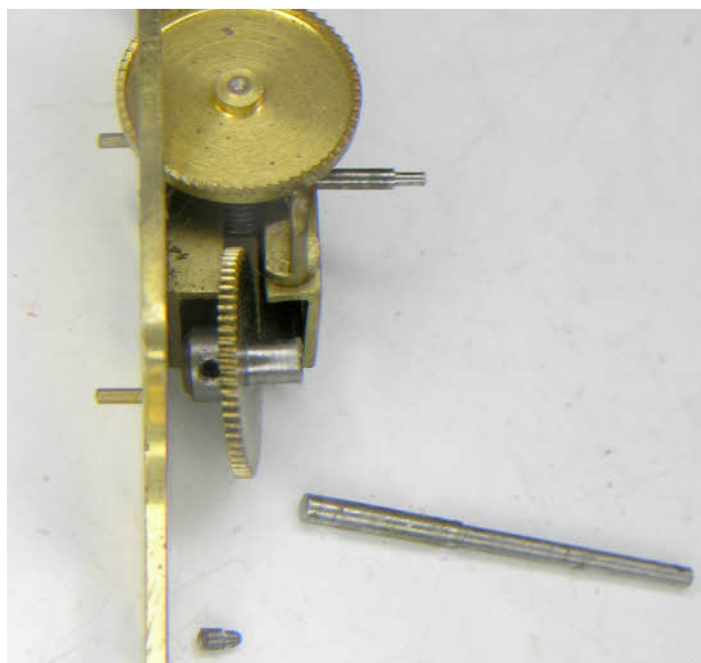
The partially disassembled movement showing the "Plate and Box Tube" movement. The second photo shows the method of securing the centre wheel by means of the small set screw. The wheel and arbour must be removed before the screw holding the box to the main plate can be removed.

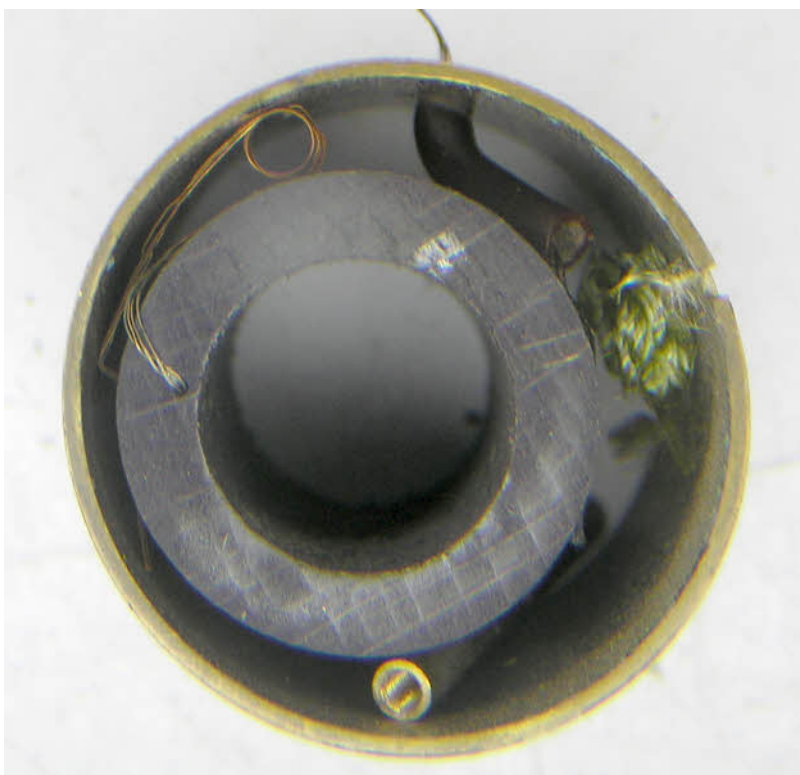
The photo at left shows the contents of the casing. The coil is still in place with the two lead out wires. One is coiled to fit around the cap spacers while the other is seen protruding through the casing at the top. This wire needs to be insulated from the casing and runs through a piece of tube. In this case the tube has completely hardened into a brittle biscuit like structure and disintegrates into dust when touched. It is the reason many of these early clocks fail when the insulation crumbles leaving the lead out wire to touch the case. The cord covering the casing is also flakey and fragile and will be replaced.

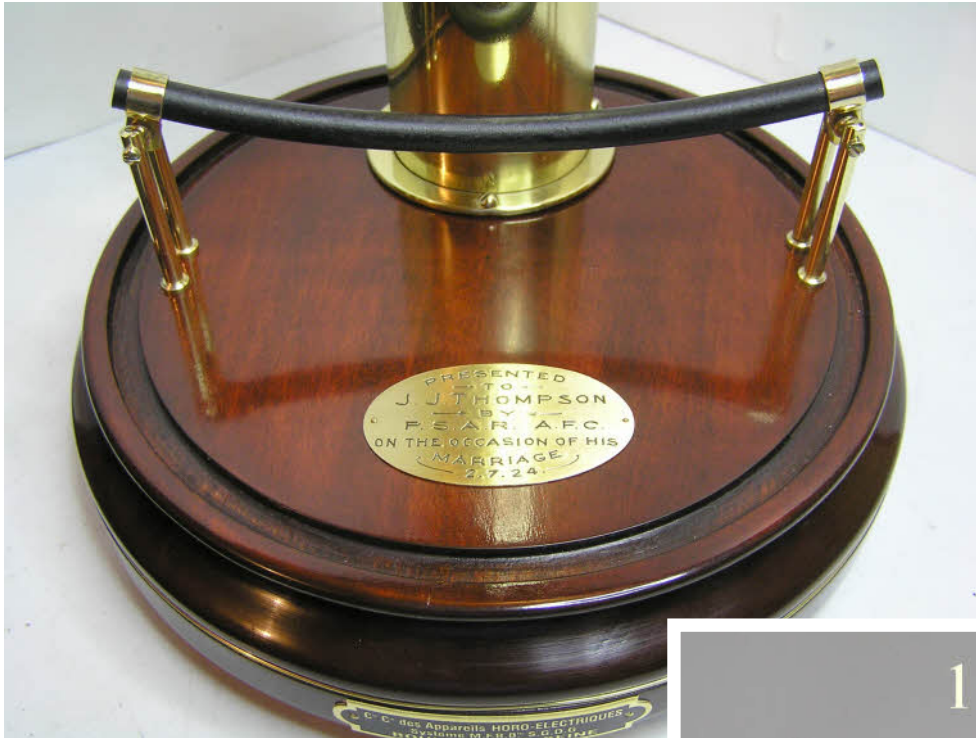
The photo left, shows the presentation label polished and back in place on the wooden base. All the marks in the wood have been removed and the whole then stained and French Polished.

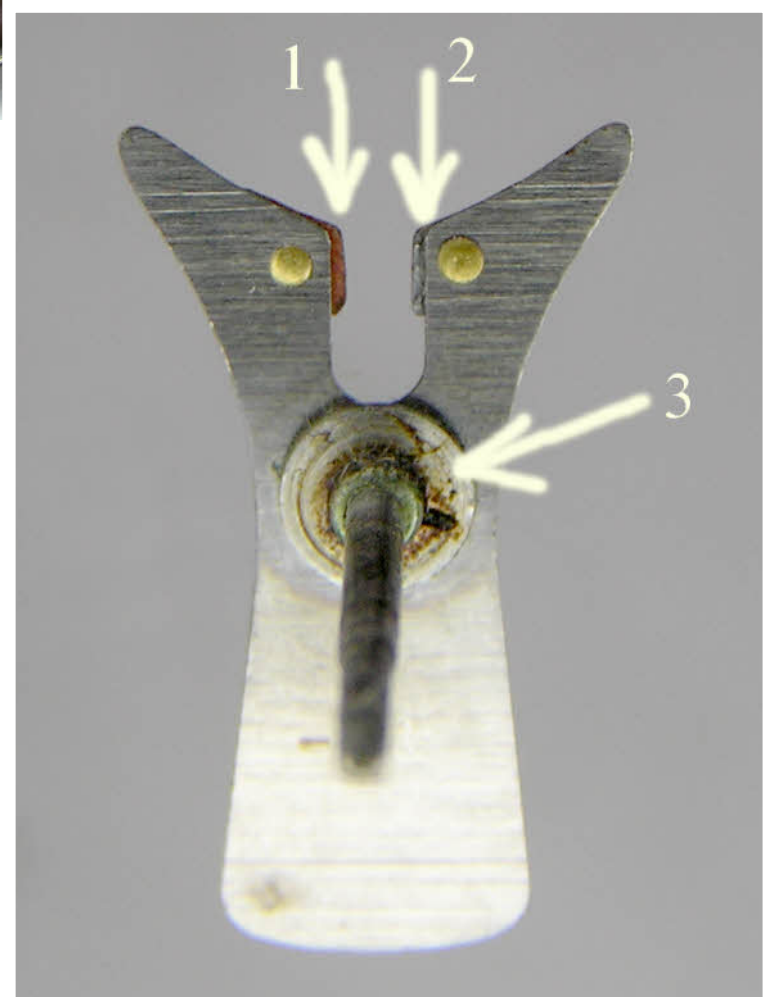
The fork is in excellent condition with only some old gummed oil (3) around the arbour.. This will be cleaned off with some Methylated spirit. The fibre (1) and the silver contact (2) show no signs of wear at all and will last for another 20 years or so.

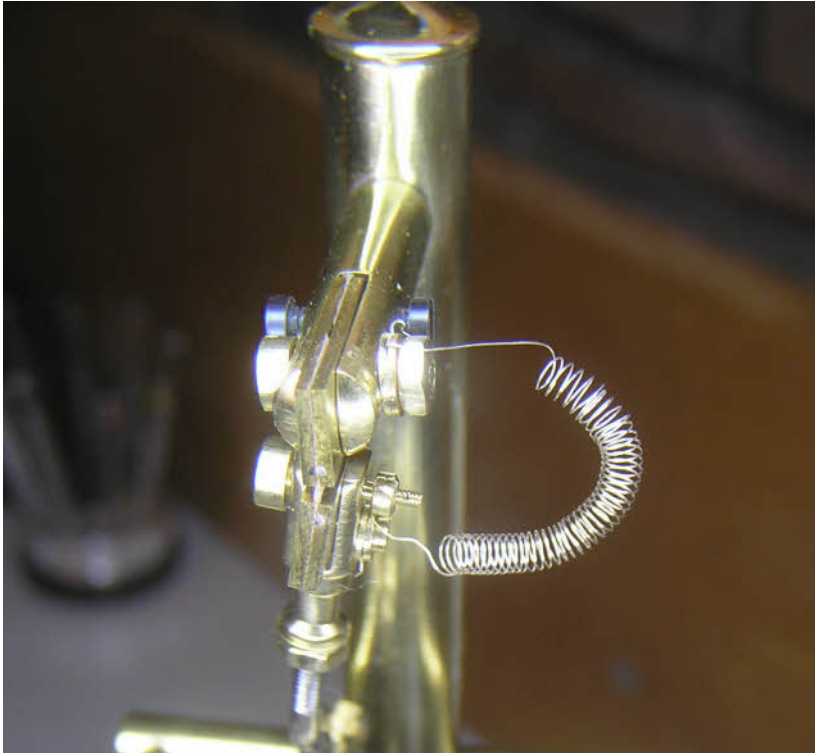
The photo top left shows the suspension assembly with the new contact spring.

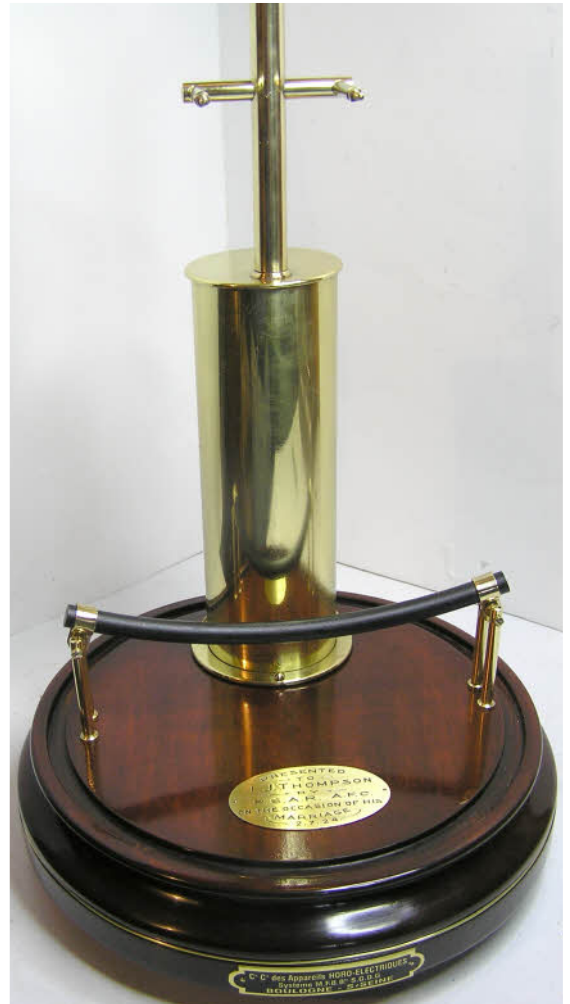
The photo above shows the base, magnet and column in position awaiting the pendulum and movement. Note the magnet pillars have been straightened. This clock also originally had 1.00 mm brass stringing which has also been replaced as can be seen immediately above the label.

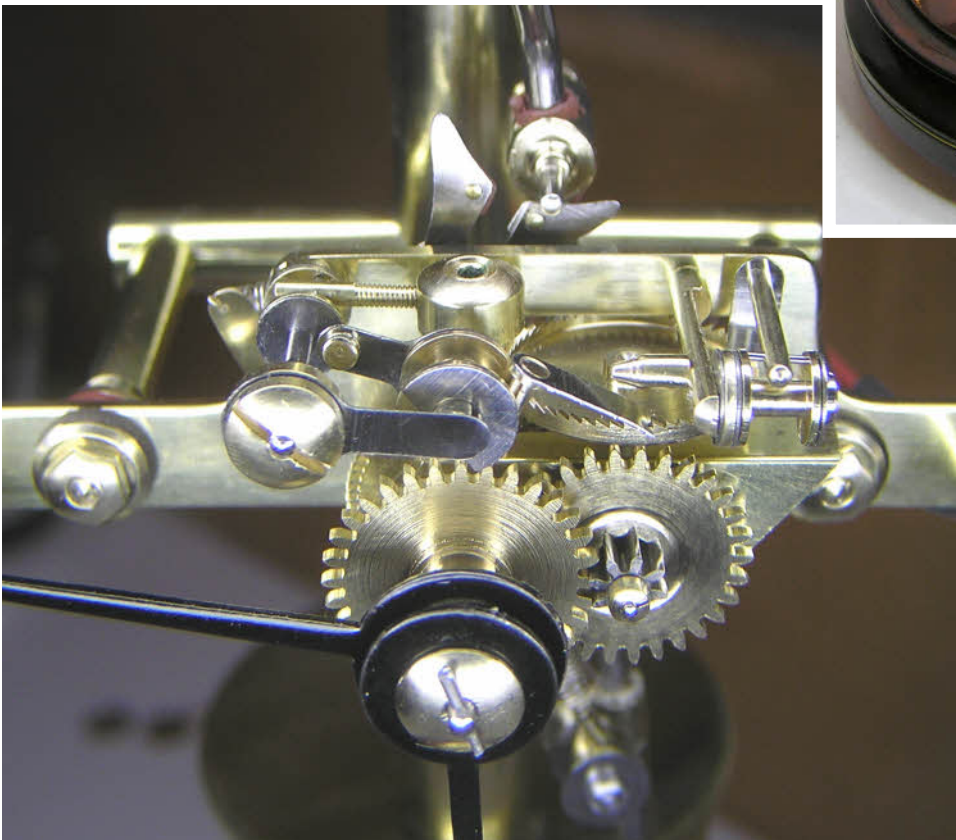
At left is the finished movement back in position.

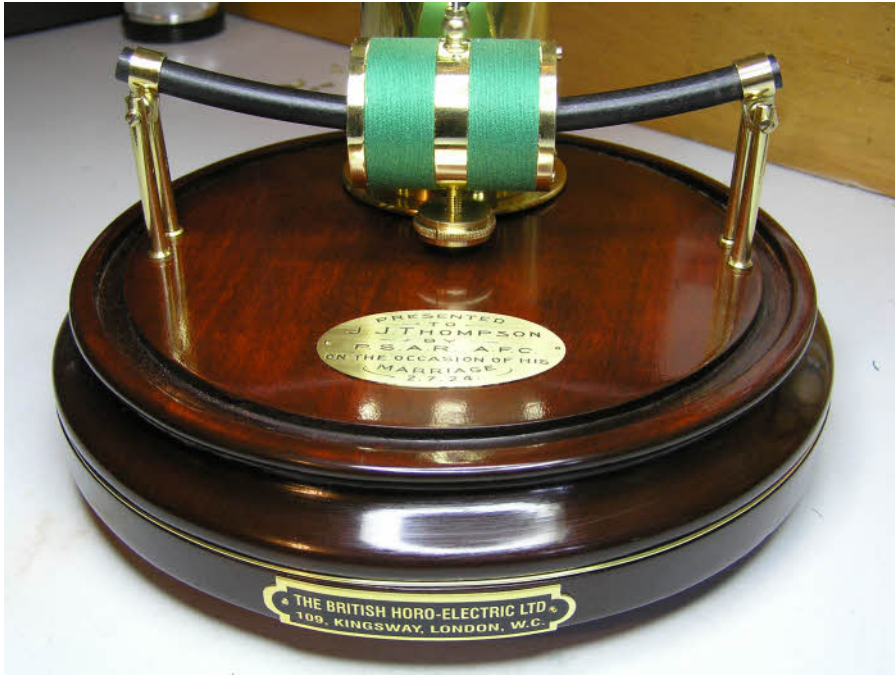
Below we see the base, column, magnet and pendulum all in position and being checked for length and alignment. This is a good time to check the coil and magnet (see video).

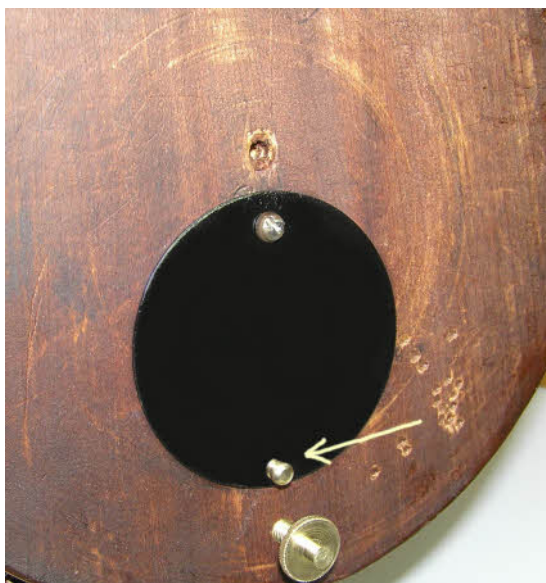
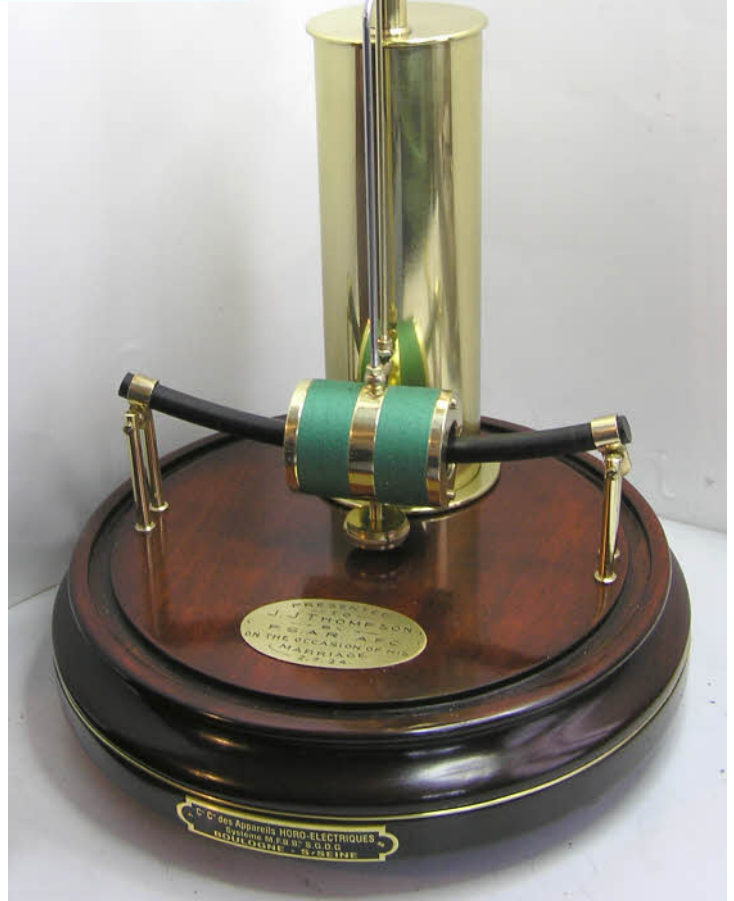
I initially thought that the clock was a French version, but on digging out the dial (which was put away safe until the rest of the clock is finished) I realised that it was an English version and so used the "British Horo-Electric" label instead. Below can be seen the battery cover cleaned and sprayed with the new brass "Button" handle in place.

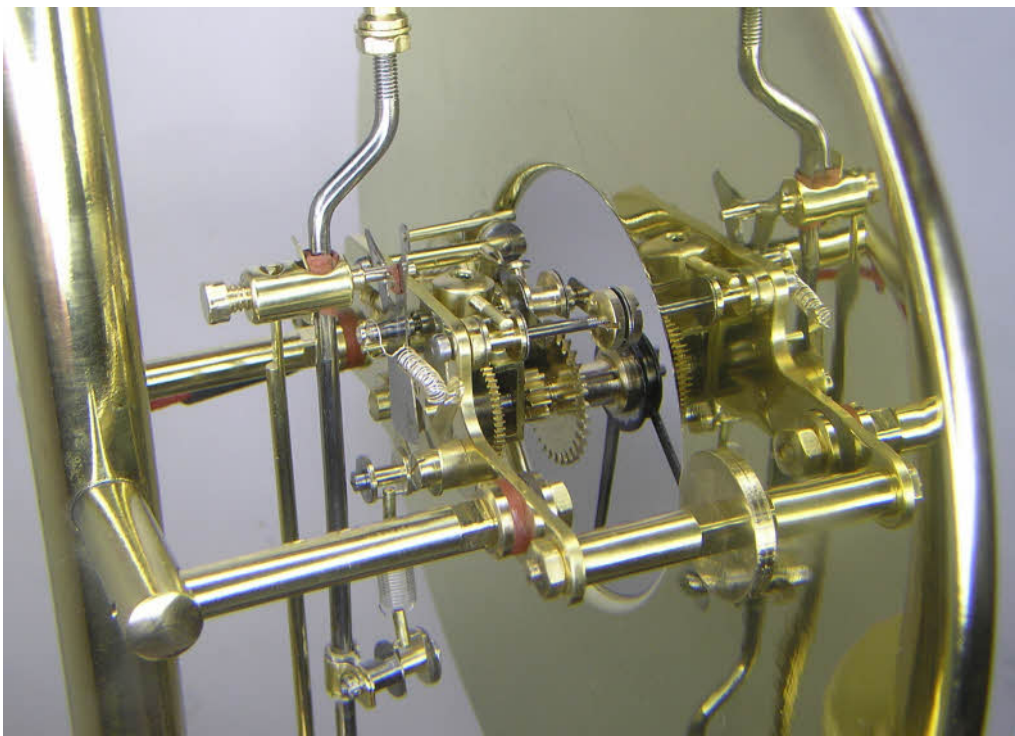
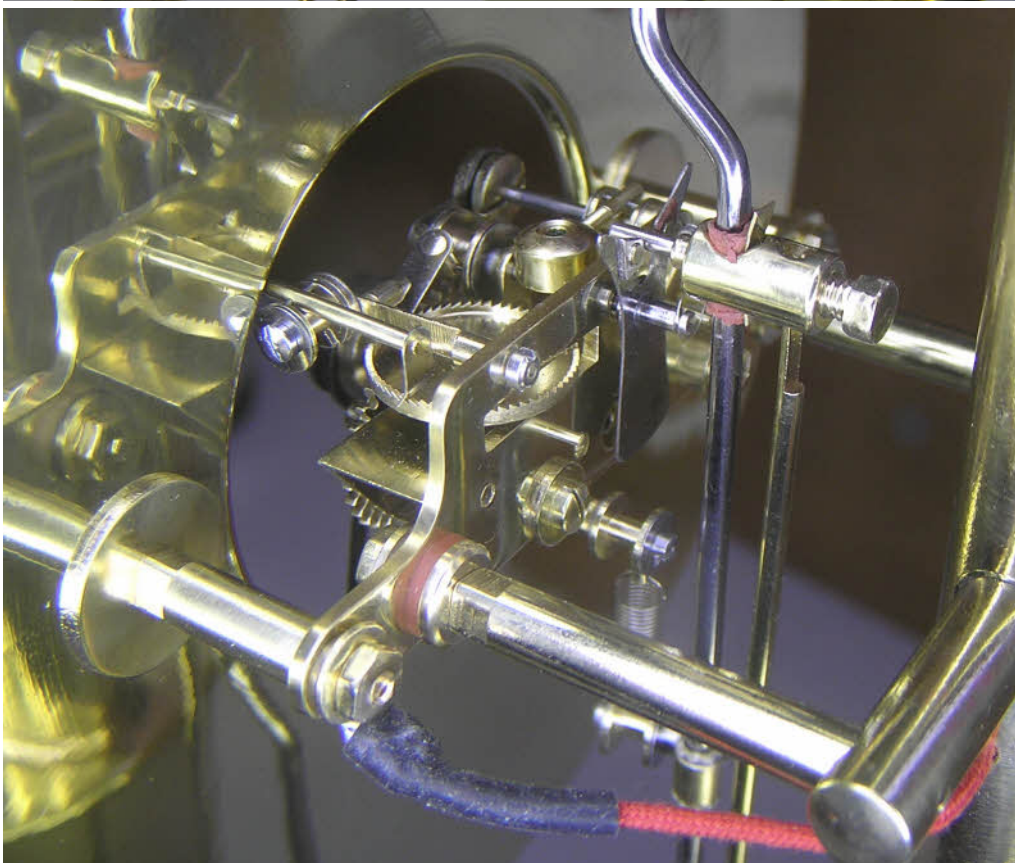
*A couple of photos of the
finished movement in place
behind the cleaned dial.*

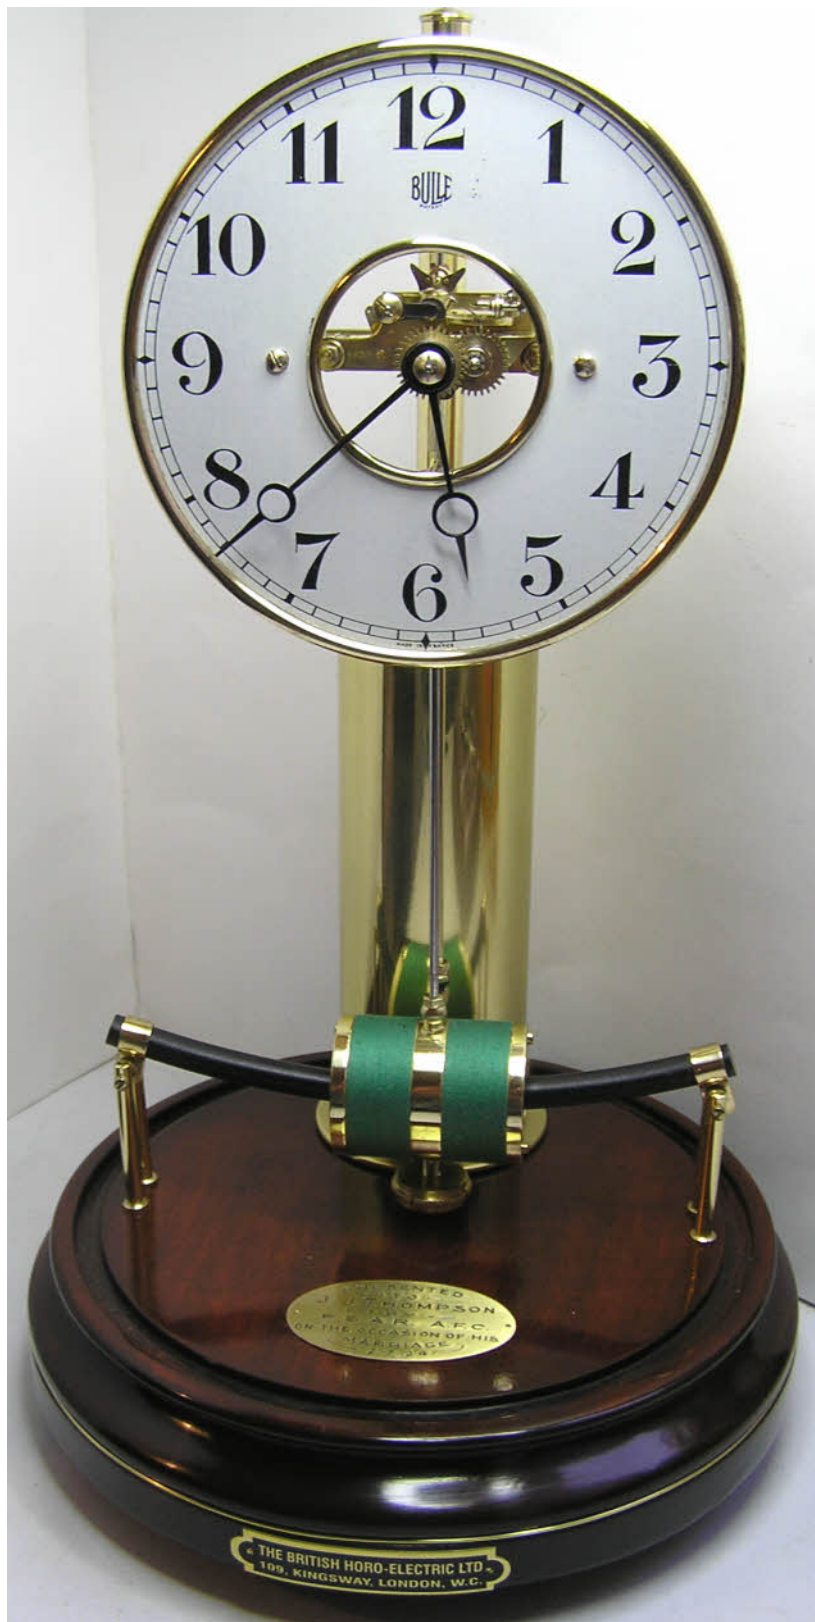
The finished clock

The hands have been sprayed black as per original. .
