Bulle Clock Serial Number 57561.

Early Battery Clock Parts & Restoration

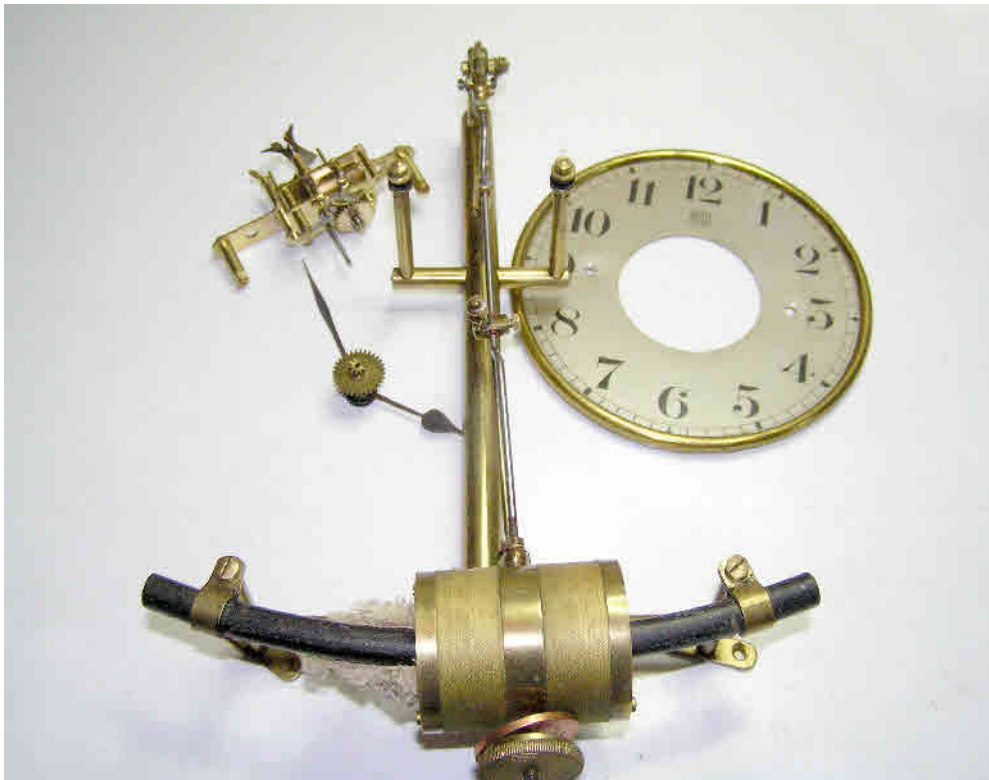
The clock as delivered. It came without a case and the owner would like it mounted on a round wooden base under a glass dome in a similar fashion to the tall Bulle movements with a 29cm pendulum (Type A). This movement has the slightly shorter 24cm pendulum normally associated with a cased clock. The magnet though is the same length so it should fit OK on the same type base. The only problem will be the height of the dome.

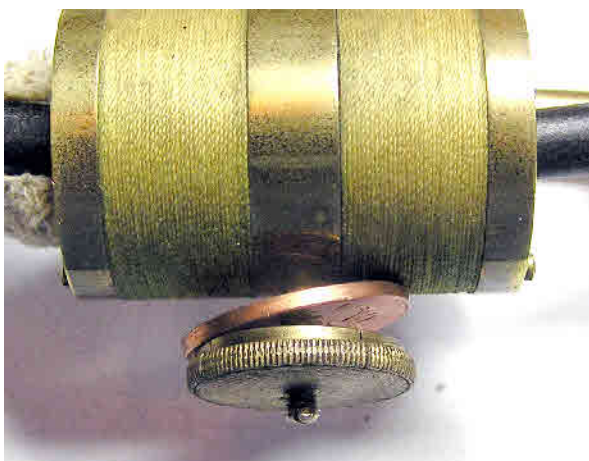
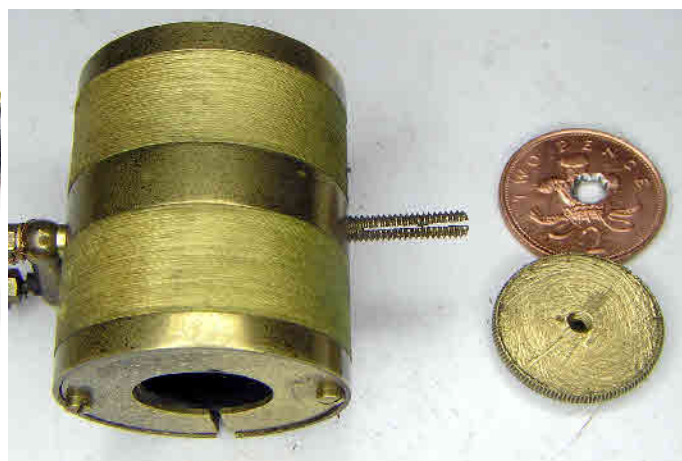
The clock has a few problems though. The two penny piece has been added because the nut has been cut down!!

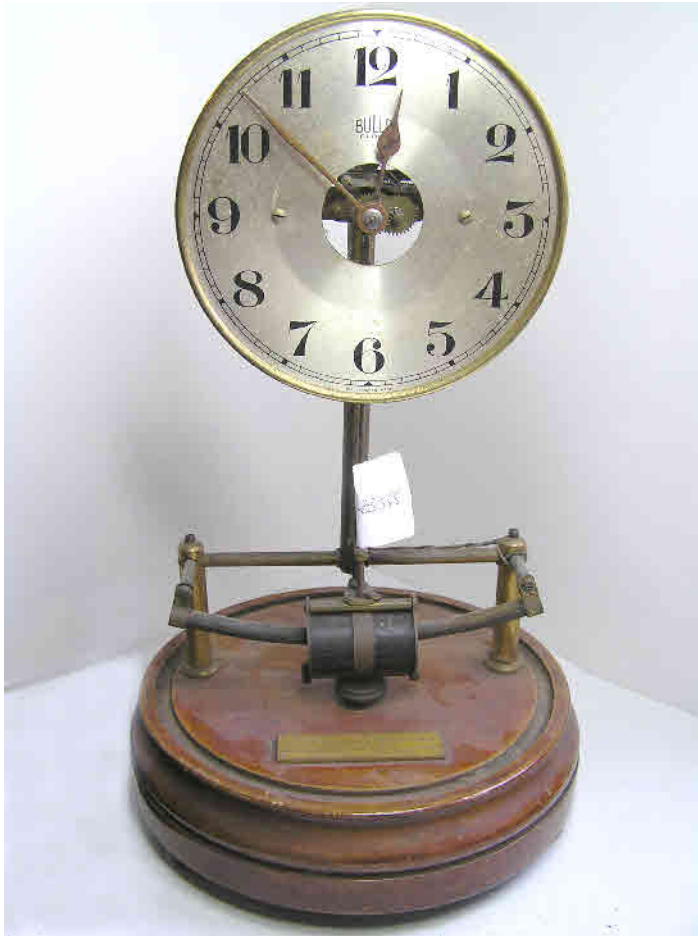
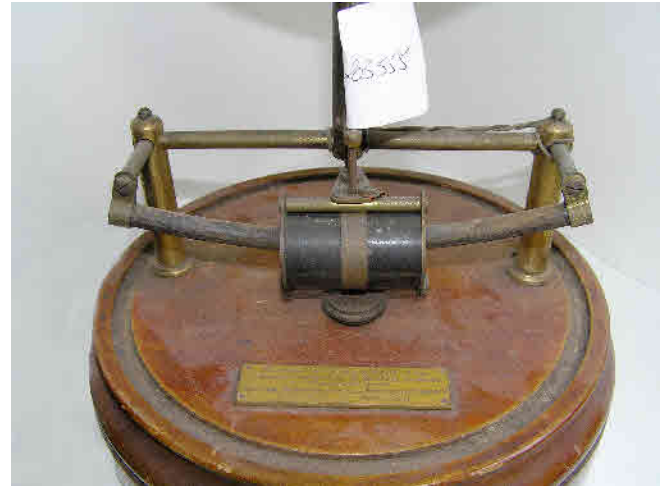
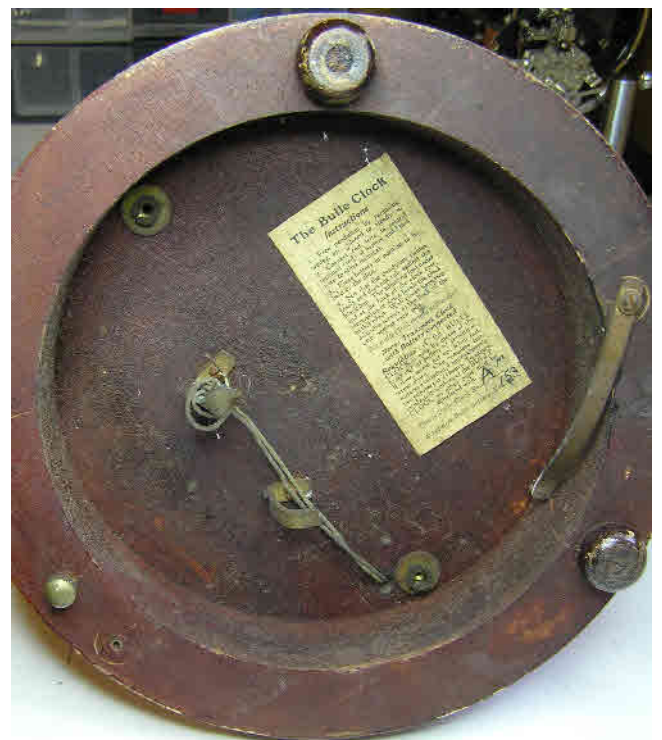
This is the type "A" clock we will be using as a template for our new frame parts. We'll need two pillars with decorative washers. These will be secured from underneath by 6mm screws. The original clock has a slightly deeper base to house the battery. Our new base is solid wood and will house the battery in a short column that will protrude through to the top as was common on the Crystal dome Bulle clocks. The new base will also require a third brass levelling foot.

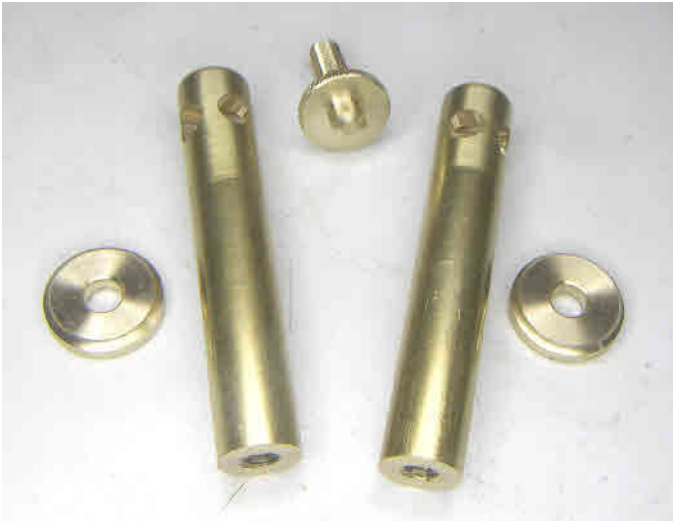
The photo above shows the new pillars and washers turned up on the lathe. Each pillar has two cross drilled holes 10mm from the top. One will take the 7mm cross bar and the other the 6mm magnet support posts. These holes have to be precisely positioned so that the frame will sit square and upright. The photo at top right shows one of the pillars in position. The lower photo shows the new third foot secured in position. This foot allows the base to be levelled so that the pendulum can swing freely over the magnet even when the table or mantle piece is not truly flat. I never liked the way these just screwed into the wood on the original model so I have upgraded this clock with a machined brass insert. I must make the point here that I am not trying to pass this clock off as an original. I am solely concerned with making a useable timepiece that will save the movement from being scrapped.. I am adding enough changes so that it is obviously not original.

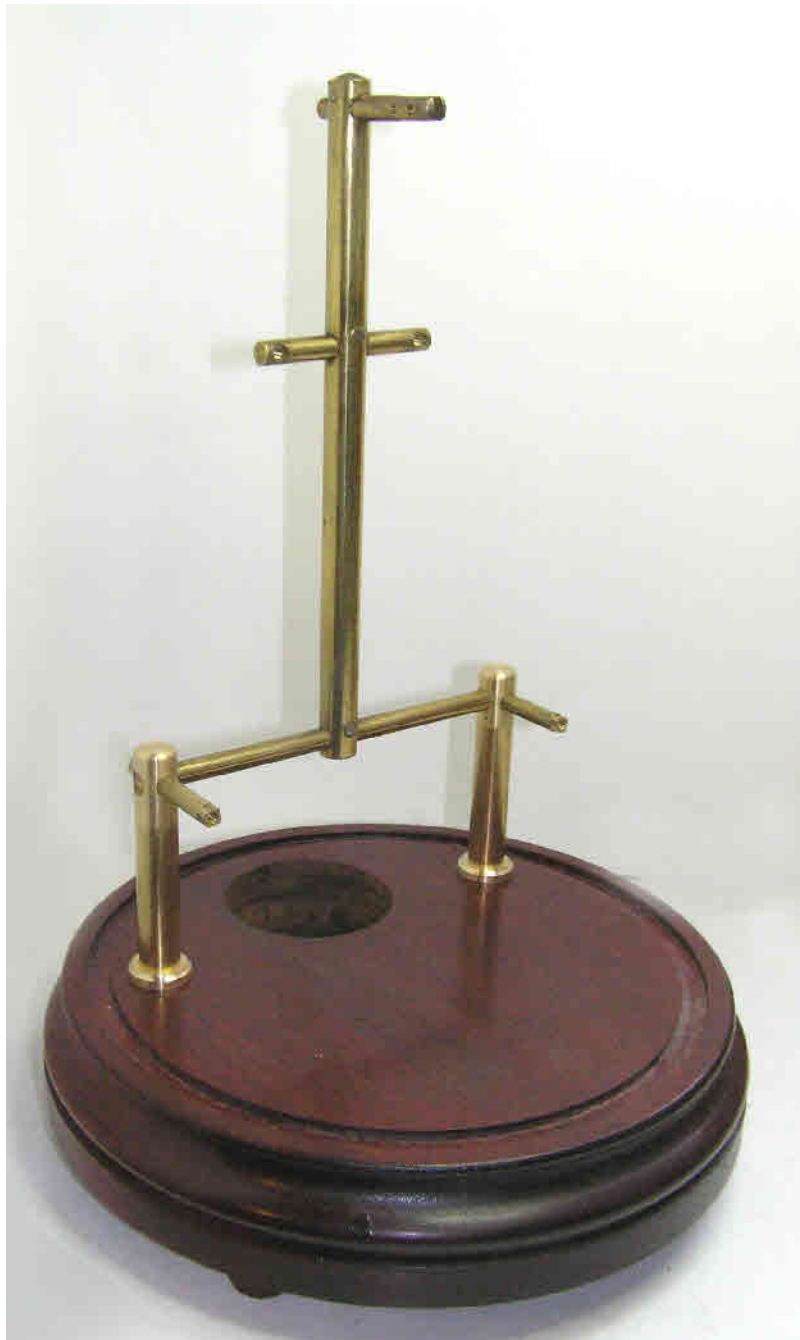
The new parts in place on the new base. The frame stands straight and solid so we can now progress with restoring the rest of the clock. I'll leave the battery column until later.

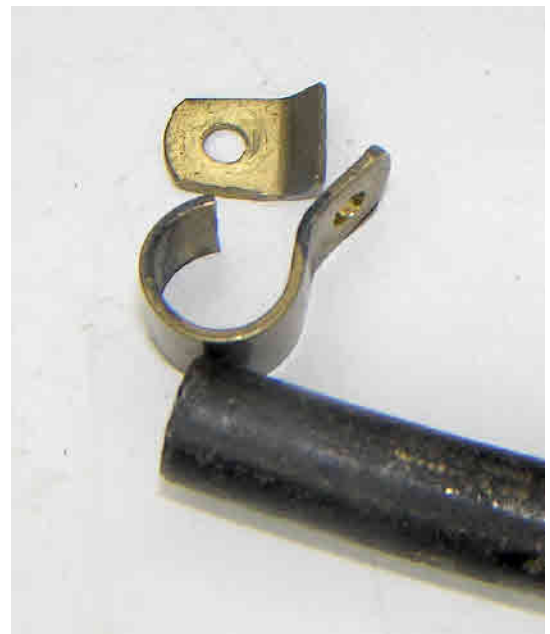
The magnet retaining loop is broken and will need to be replaced. I will either use a spare one or silver solder this one up. The magnet itself was a little low on the magnetometer with a 140mm reading. I have therefore re-magnetised it to obtain a good reading of 180mm.

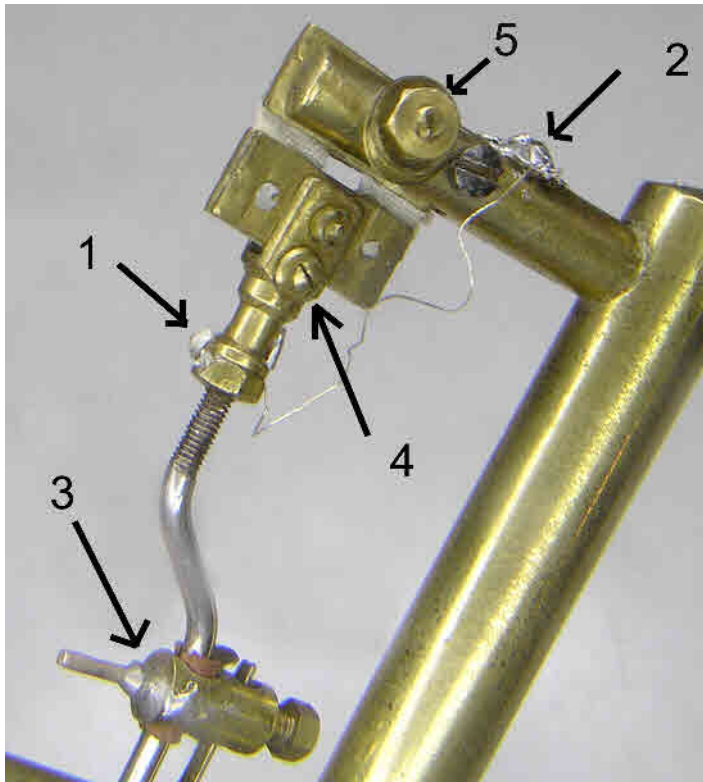
This photo shows a few more issues with the clock. At 1 and 2 you can see that the contact wire has been soldered in position. It should in fact be connected to the two terminals shown at 4 and 5. The wire should also be formed into a large loop to alleviate the problems of fatigue after millions of oscillations.

At three you can also see that the contact pin has been soldered in position. This is normally the case when the pin has been snapped off and the stub cannot be removed from the assembly. The solder will be removed and the pin inspected. If the pin has broken off then I'll either have to drill and re-tap it or make a new assembly.

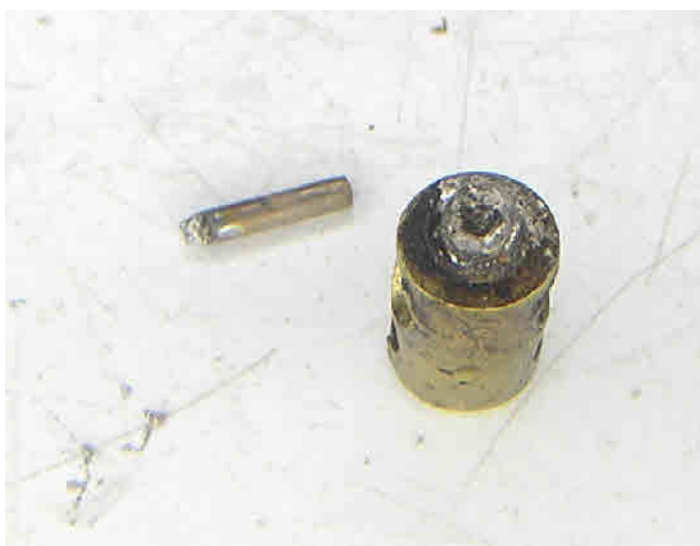
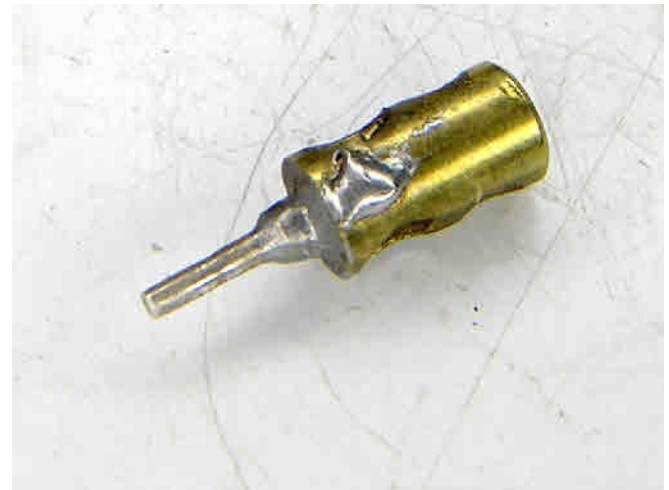
These final photos show that the pin was broken and the stub left inside the assembly which is also the worst for wear. So I think in this case I'll make a new one or replace it with a spare.

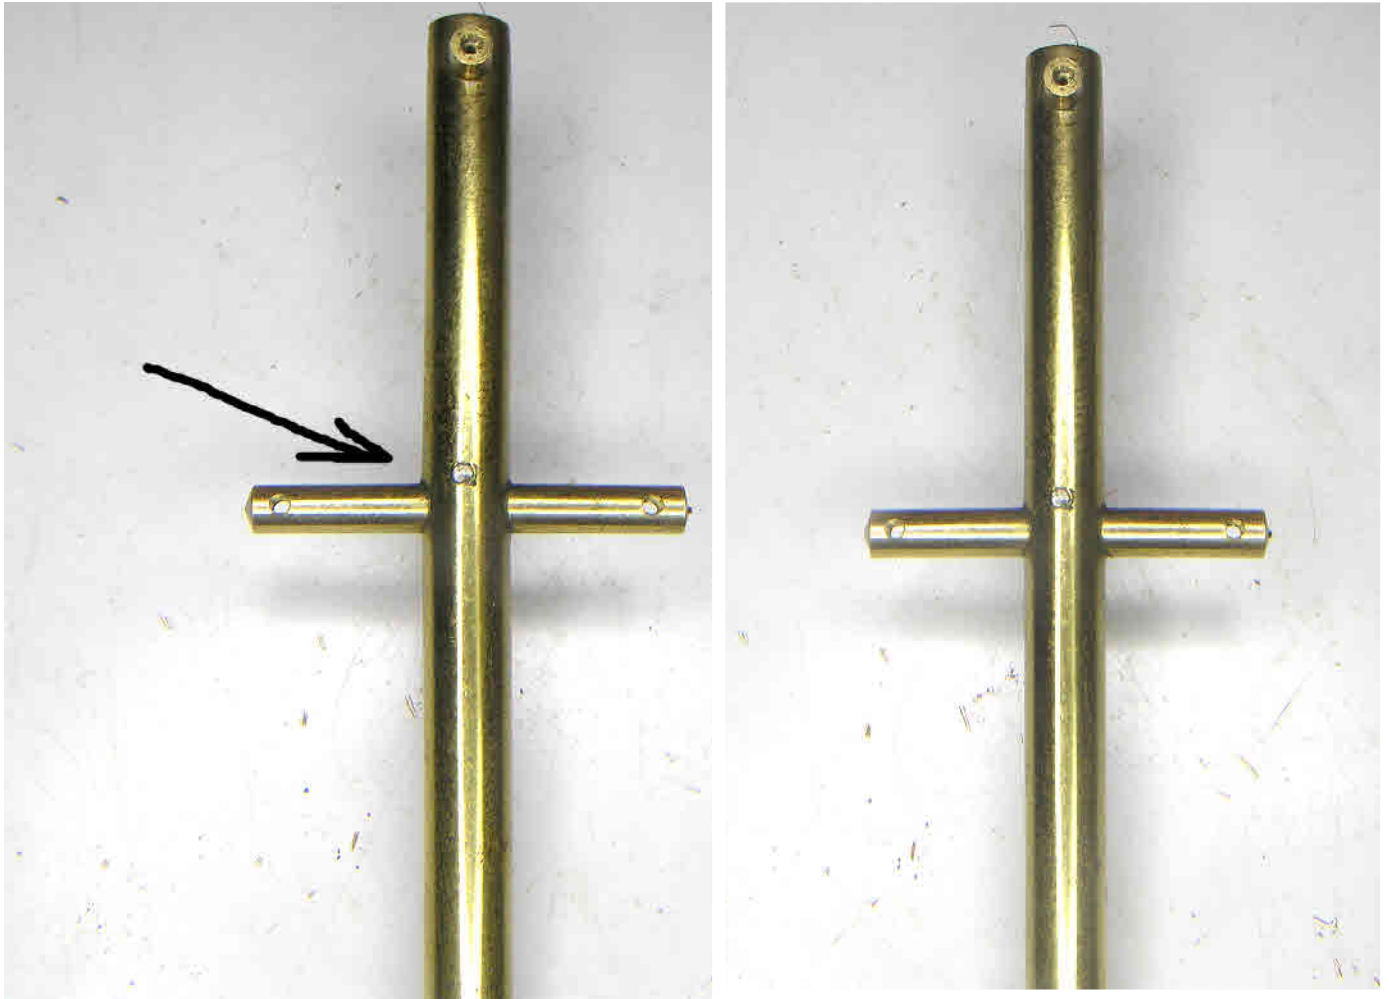
The photo on the left shows that the main frame is slightly bent at about the point immediately above the cross arm. This was an easy matter to straighten given a bit of controlled brute force. The frame was secured in the jaws of a large vice, protected by fibre inserts. Pressure was then applied slowly until the frame looked straight against a steel ruler. How it got like this we'll never know. But it must have taken one hell of a knock at some point.

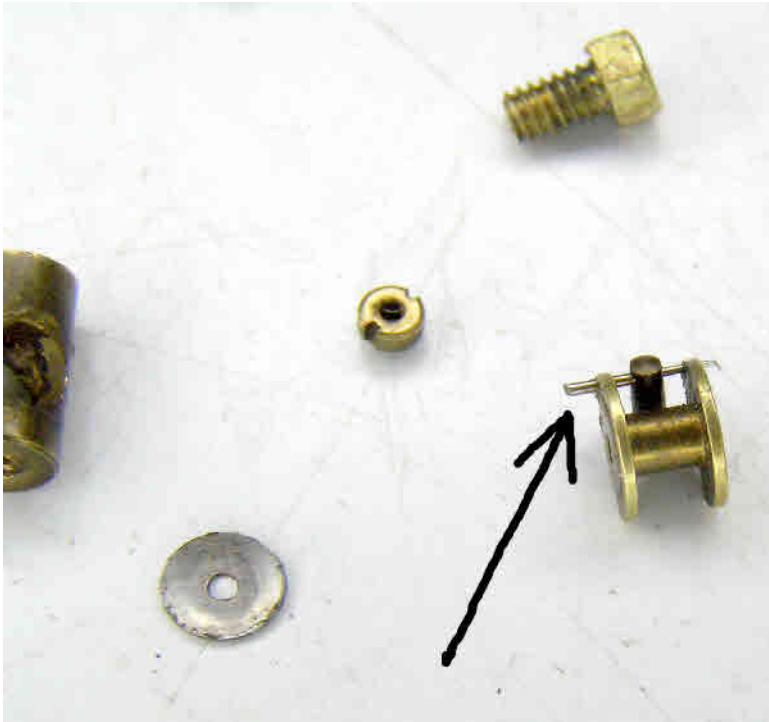
This photo shows the lower Isochron bracket found on the pendulum rod. Notice that the pin has gone missing and a taper pin has been used to replace it. This would have the tendency to jam in the holes and not allow the isochron spring to level itself correctly. So we will replace it with the correct size 0.5mm piece of piano wire.

There should also be another two steel shim washers on this bracket. Only the small domed out one is left. We will replace these.

The photo at right shows the coil assembly, which, besides being badly frayed, one of the wires is connected to the wrong place. The wire at 1 should be connected inside the coil cover and not be seen. The wire at 2 is correct but the nut shows signs of solder. This will be investigated and the solder removed.

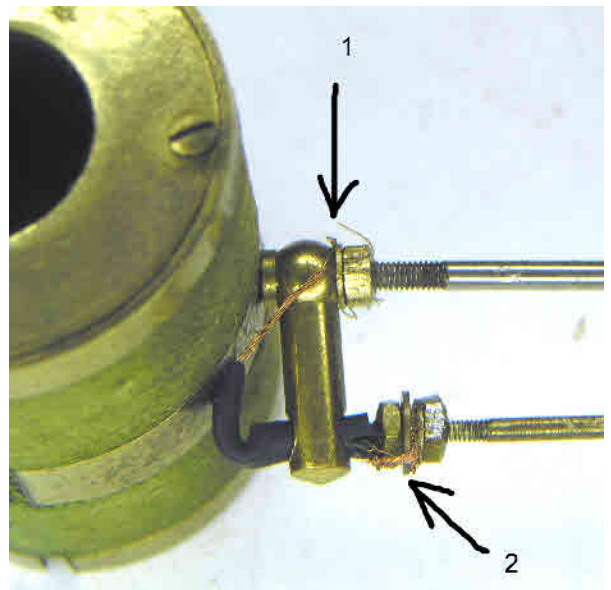
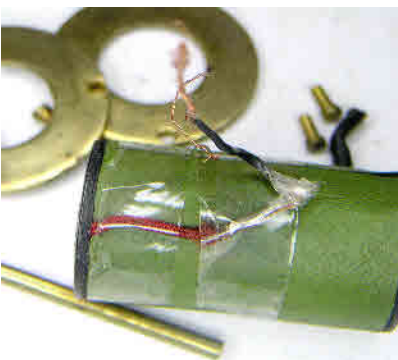
The coil itself has obviously received some attention. It looks as though a length of wire has been added and the joint wrapped in Cellotape. I wonder what the condition the coil is in..

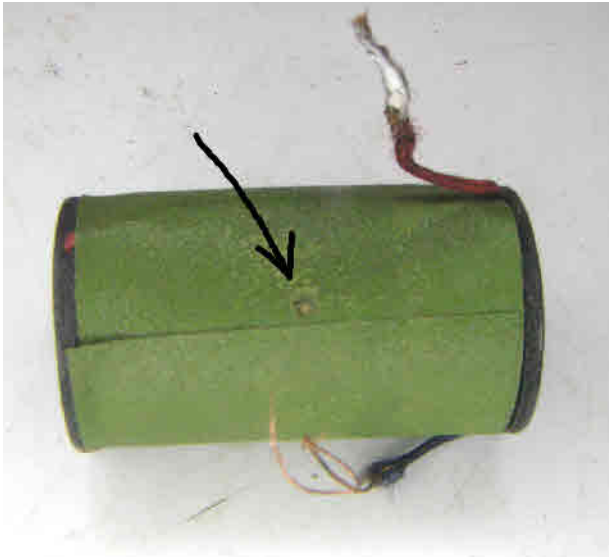
Well, the coil reads a consistent 1200 Ohms so it looks OK. But it was a near thing! The small hole you see in this photo has been formed by the pendulum rod being screwed too far down through the brass coil casing. It has then just started to penetrate the coil. Lucky it went no further. The best way to avoid this on re-assembly is the leave the coil caps off when attaching the rod. The rods progression can then be monitored as it is screwed in. It should not protrude through the spacing rods by more than a single thread.

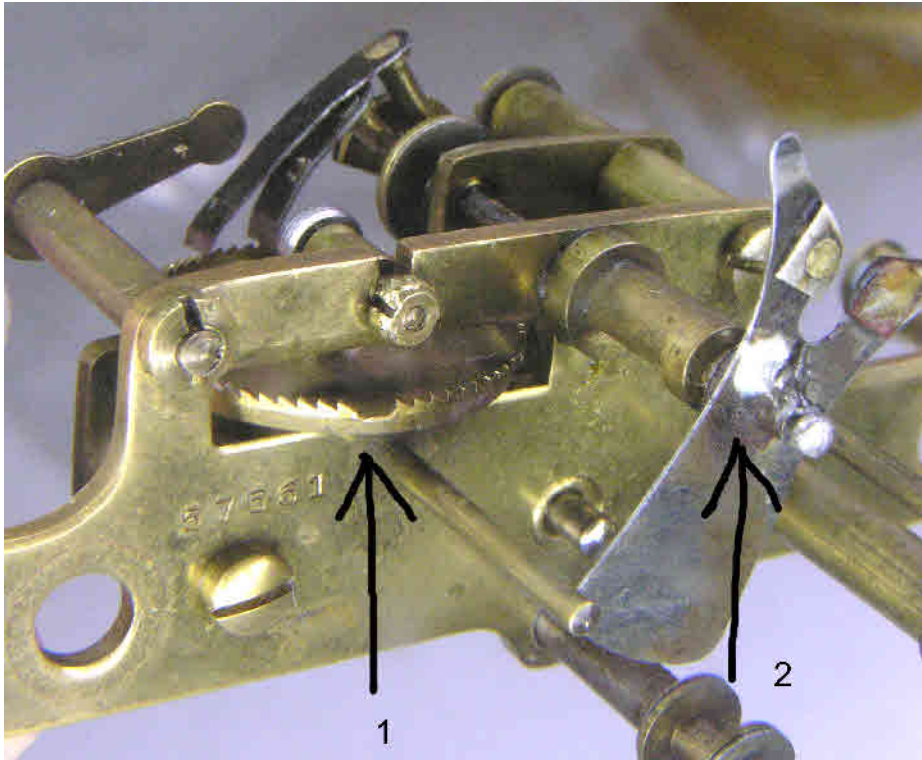
This photo shows the count wheel on the movement itself. I guess there are one or two teeth missing here (1). That'll probably need fixing???? Two possibilities are open to us. The first is to silver solder a new piece in the gap, turn it down on the lathe and then form the missing teeth with a cutter. If you're really keen then they can be formed with a small needle file and a large magnifier.

Also shown is the large lump of solder to the back of the fork arbour(2). Why? Is the fork loose? The fibre contact also has a large dab of what looks like Araldite. This little lot adds up to a large amount of work.

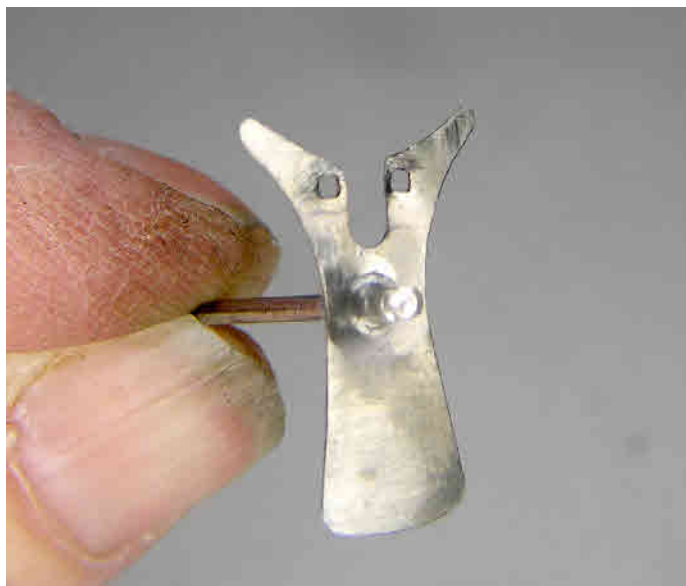
The fork arbour cleaned up ready for new contacts. The damage wasn't that bad and the fork has been riveted tightly onto the arbour. New contacts can now be made and fitted.

The photo at right shows the new rating nut to the correct dimensions. I managed to retain the original Cord around the pendulum bob by securing it with masking tape while the brass was cleaned and polished. This was then removed and the whole casing and cord washed in soap and warm water. To remove the dirt and bring back some of the colour.

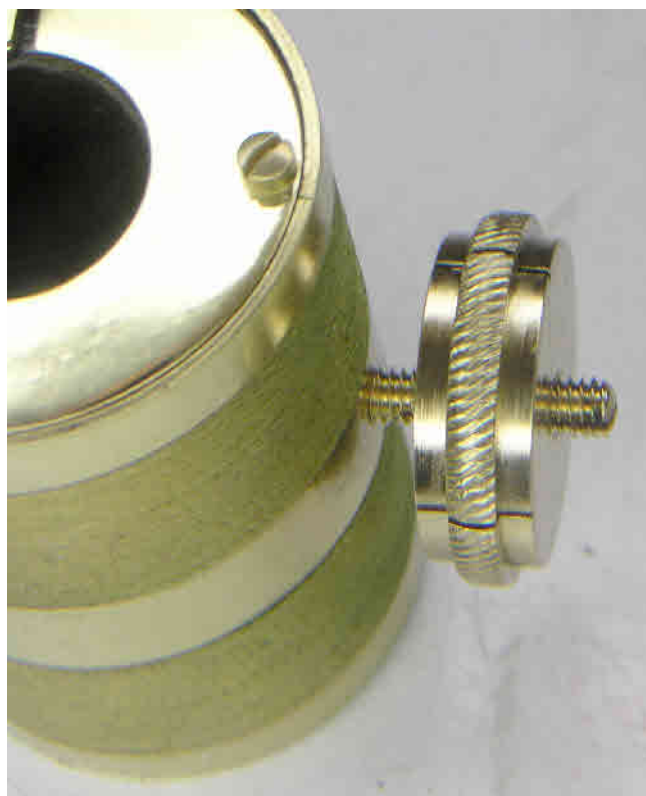
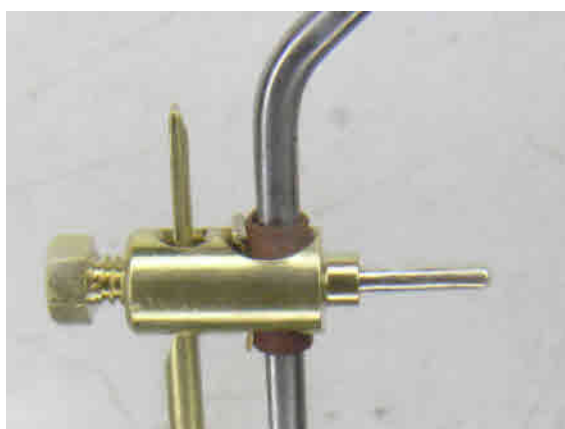
The new contact pin and assembly in position with fibre and "T-piece" spacer. It's always a good idea to check continuity at every stage of re-assembly. Especially the pendulum which has two rods that need to be electrically isolated.

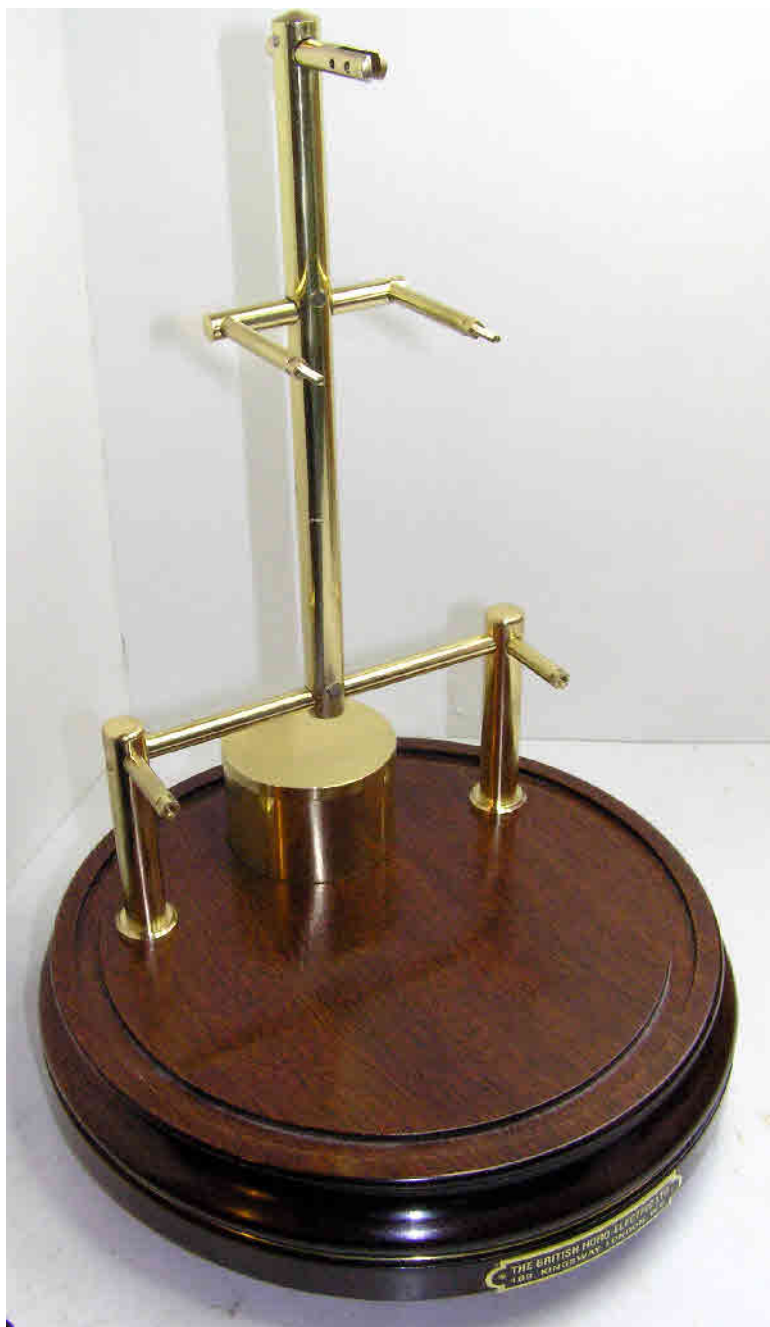
The frame and base assembled ready for the movement. The wood has been polished with about 10 layers of French Polish. Which has then been cut back with wax and 0000 gauge wire wool to present a nice restrained lustre. A new Horologix replacement metal badge has been added as well as a band of 1mm brass wire around the circumference of the base. The central battery tube has been cut from old 55mm tube and fitted. The cap has been formed by spinning. The frame and battery casing have then been lacquered. The whole, I think, is coming together quite nicely and lends an air of elegance to the old movement.

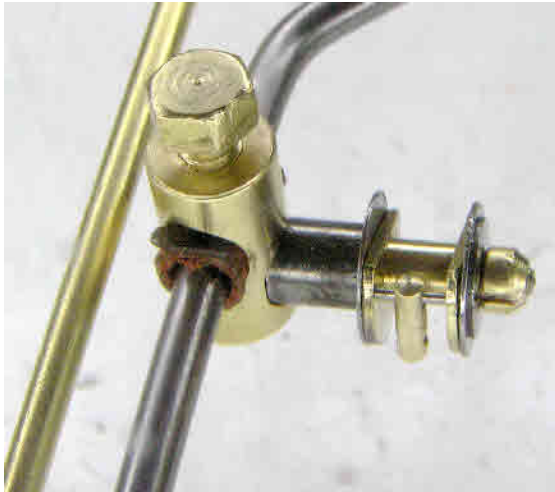
The photo above shows the new Isochron bracket in position with the new piano wire pin and washer set. The clock assembled on test while the new wiring is made up and fitted.

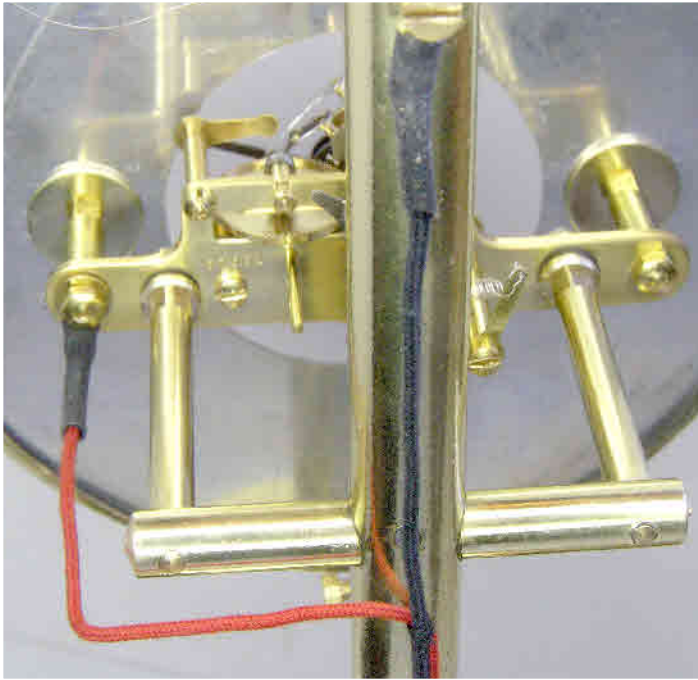
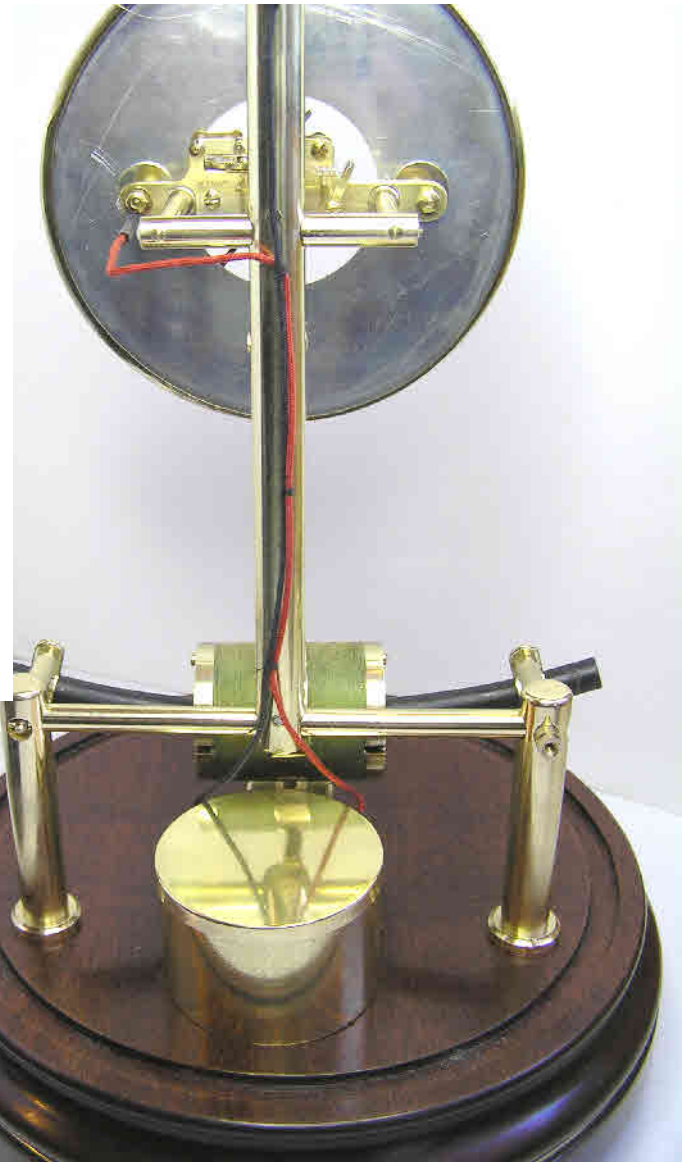
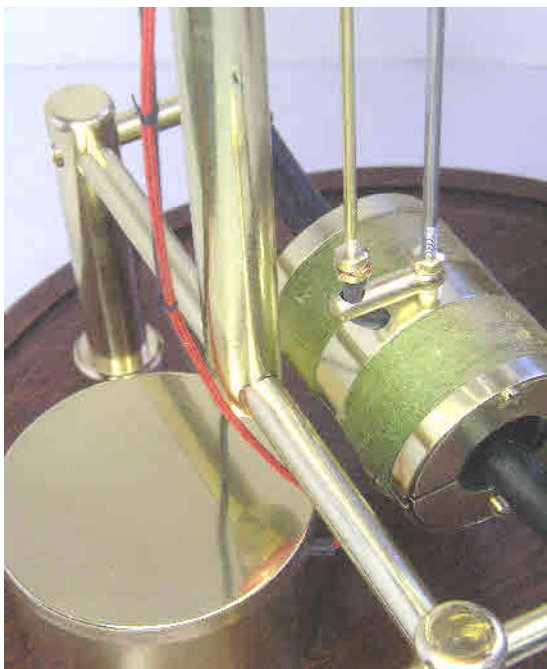
The rear of the clock with the new wiring in place.

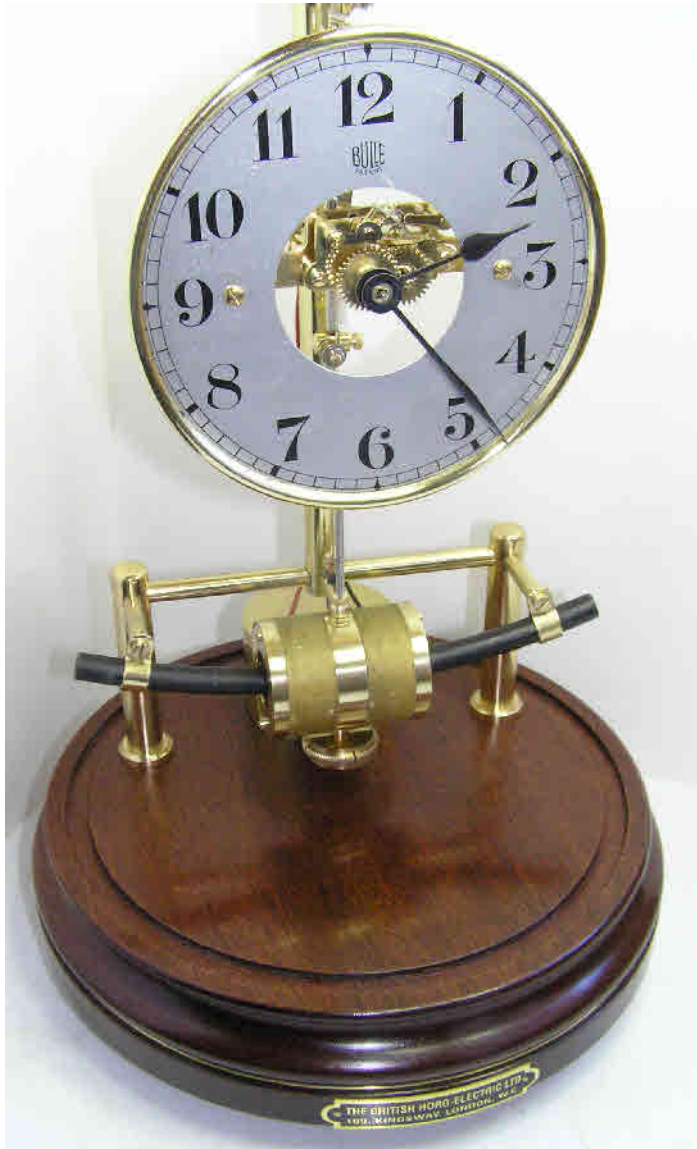
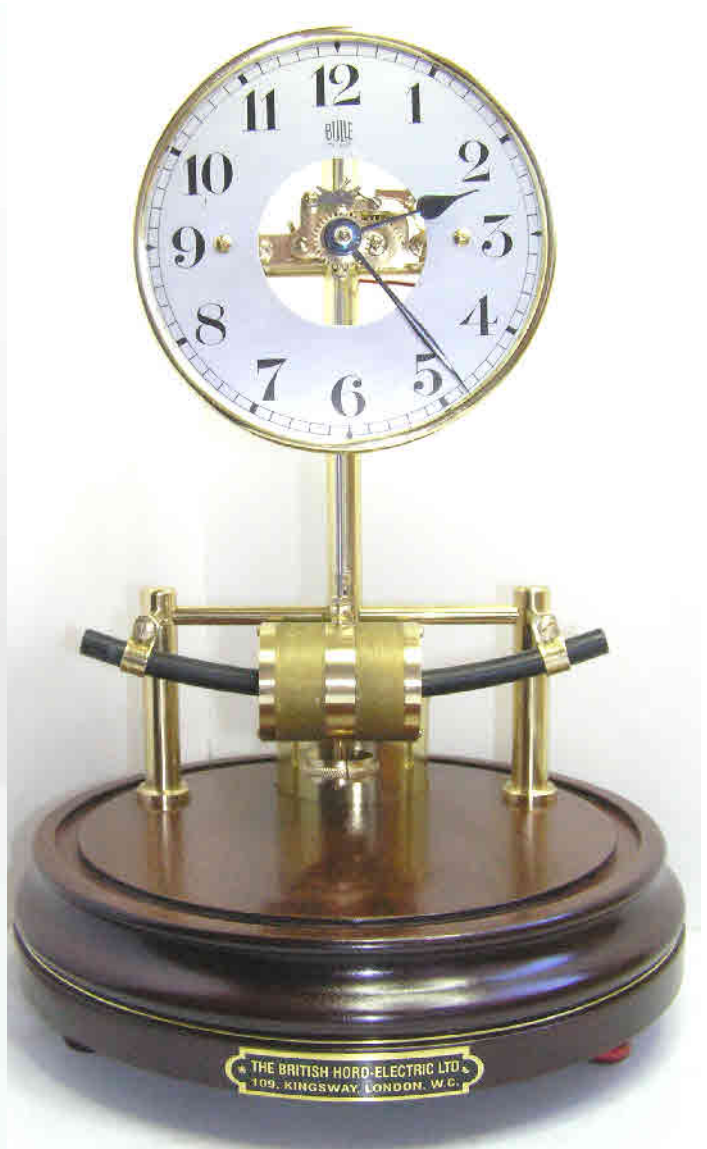
The Finished Clock.
