Horologix

*Restoration of Bulle Clock
Serial Number 58150*

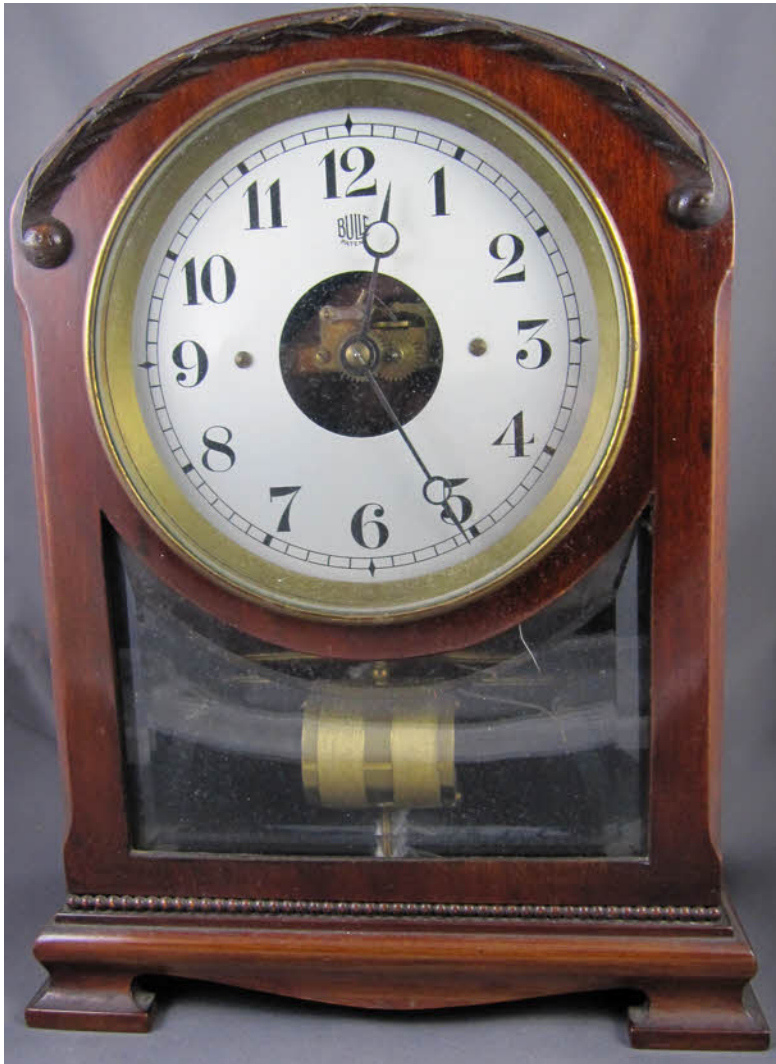
This medium sized movement with 22cm pendulum is housed in a mahogany case with bevelled glass window at the front and bevelled glass in the dial access door. The aluminium dial is in excellent condition with no discernable marks. The dial sight ring is integral to the bezel and is of thick brass. There is no sign of silvering anywhere and was manufactured with just the polished brass finish. The woodwork looks to be in good condition and will only need a good wax polish to lift the dirt. The hands are good but will need repainting. There was a small plastic bag inside the case which held a few parts that had obviously fallen off the clock over the years. The largest of which is the rating nut.

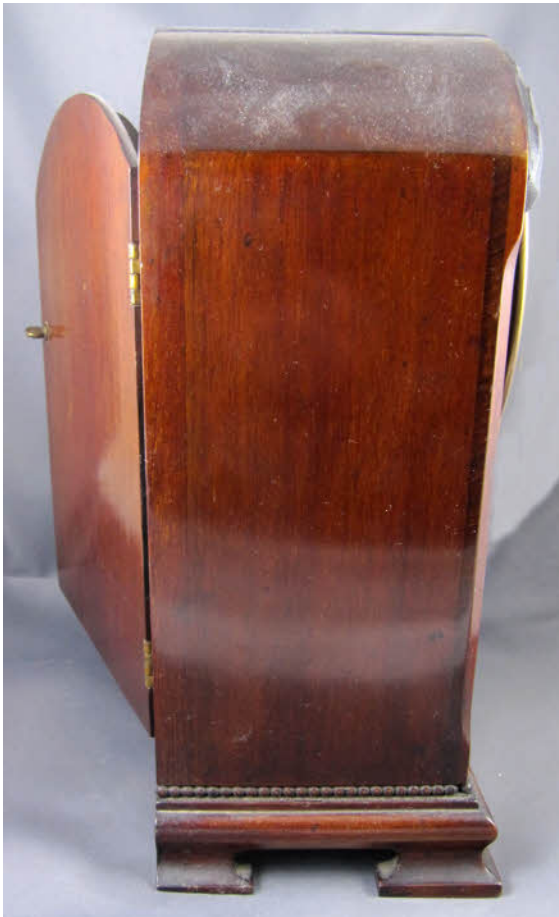
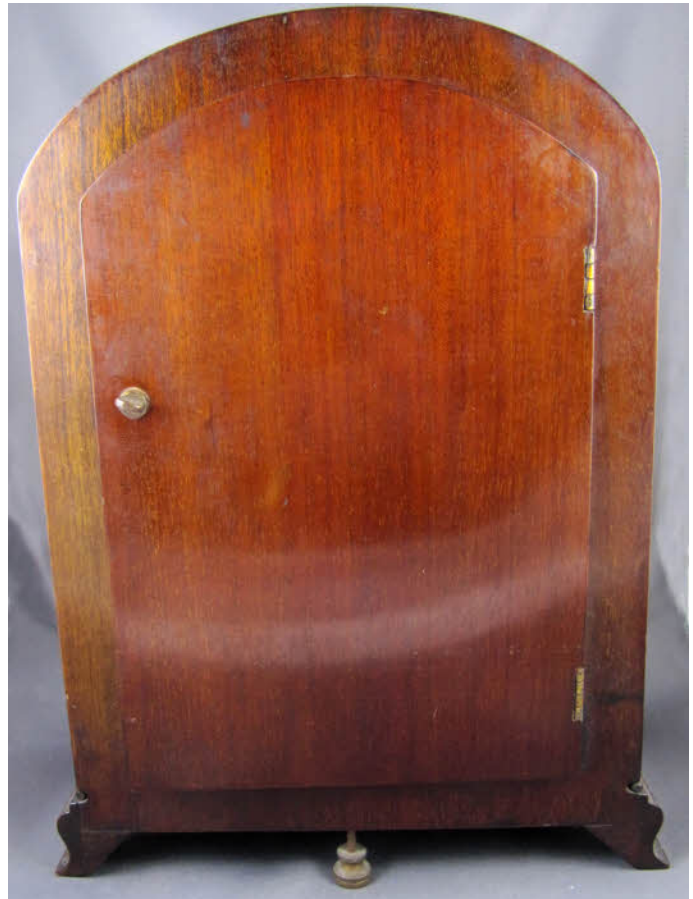
Above are photos of the back and side of the case, which other than dust and grime are in good nick.

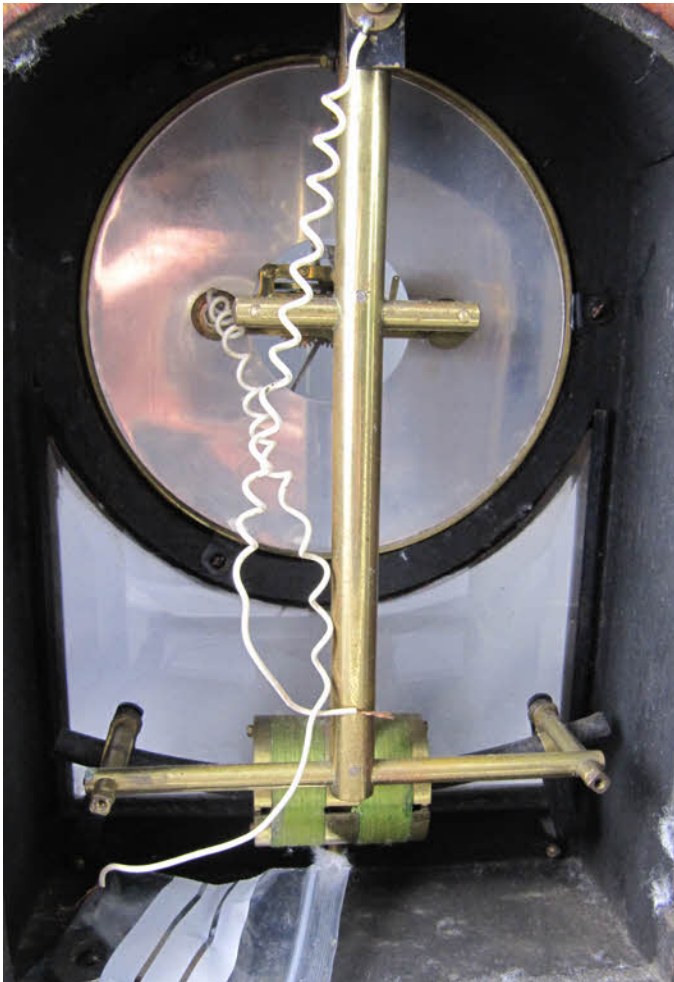
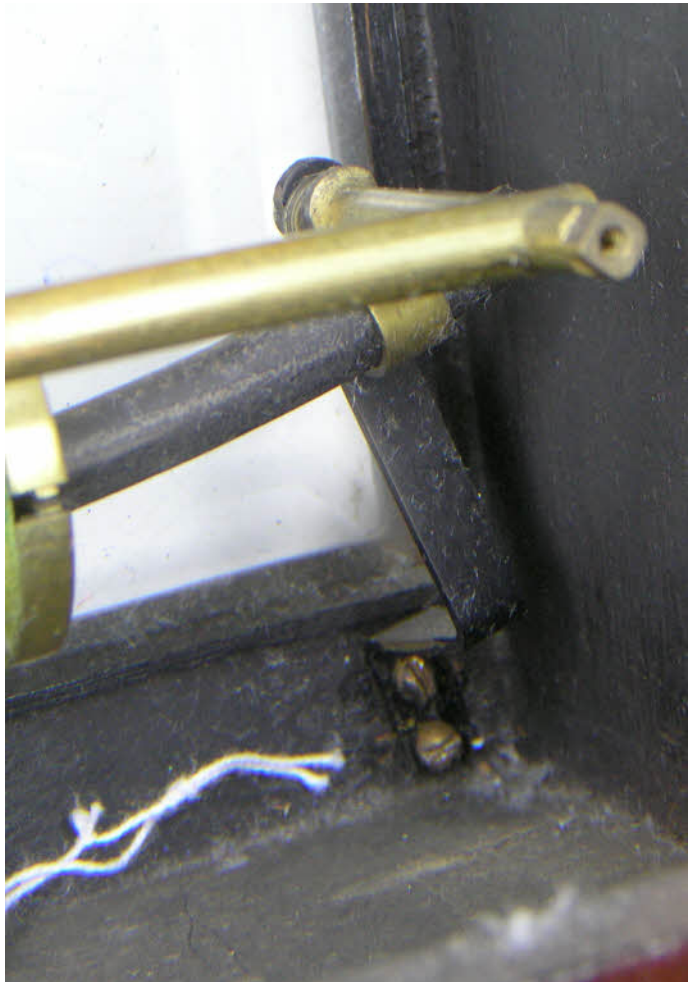
The inside of the case shows the movement which is held in place from the front via two lower brackets and one central one at the top.

The wiring is later plastic replacement.

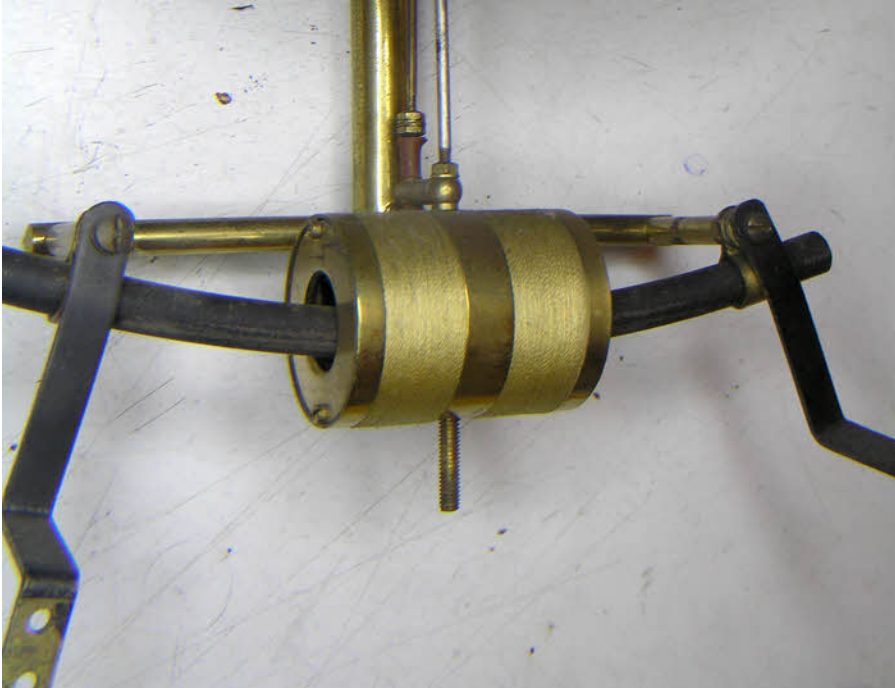
Both of the lower brackets have been bent to suit the movement and dial placing. Note also that they have been padded out with about 8 washers on each side so that the movement sits vertically in the case. Without them the movement would sit too far forward to suit the dial placing, and the coil would be scraping on the magnet.

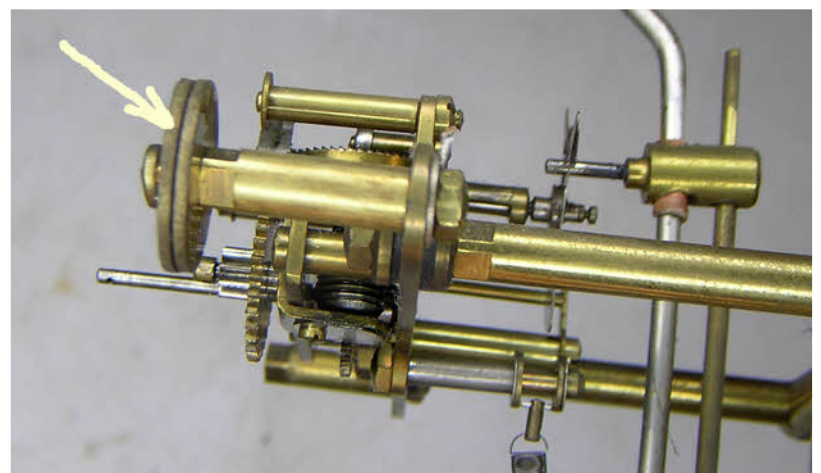
The photo below shows the extra spacer required to seat the dial in the correct place in the bezel. All in all it seems that the guy who put this clock together in the factory had a hell of a job lining it all up.

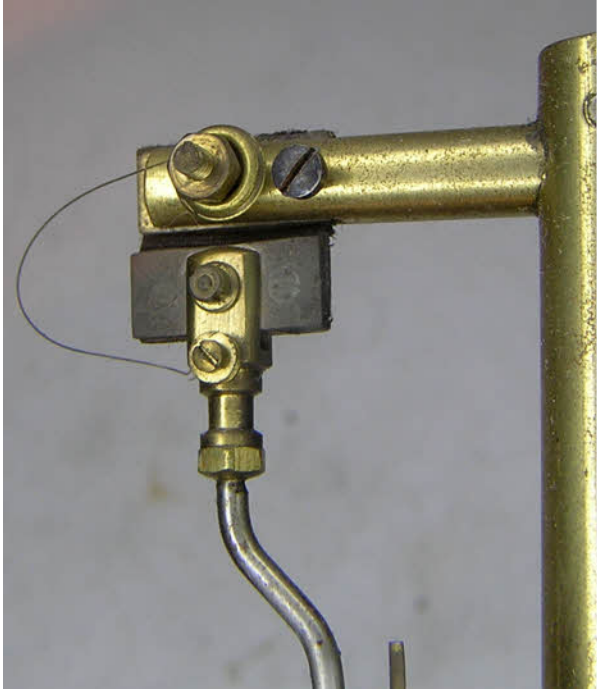
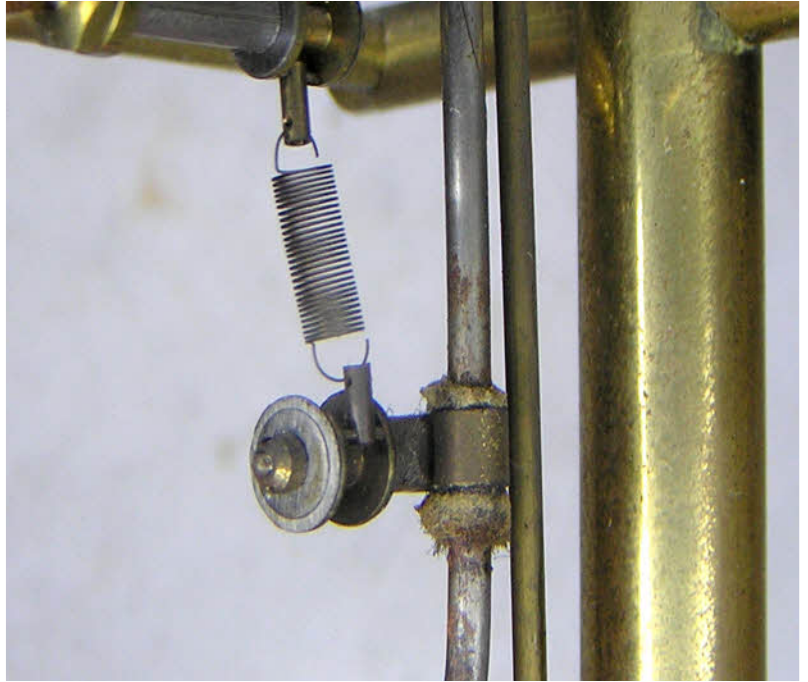
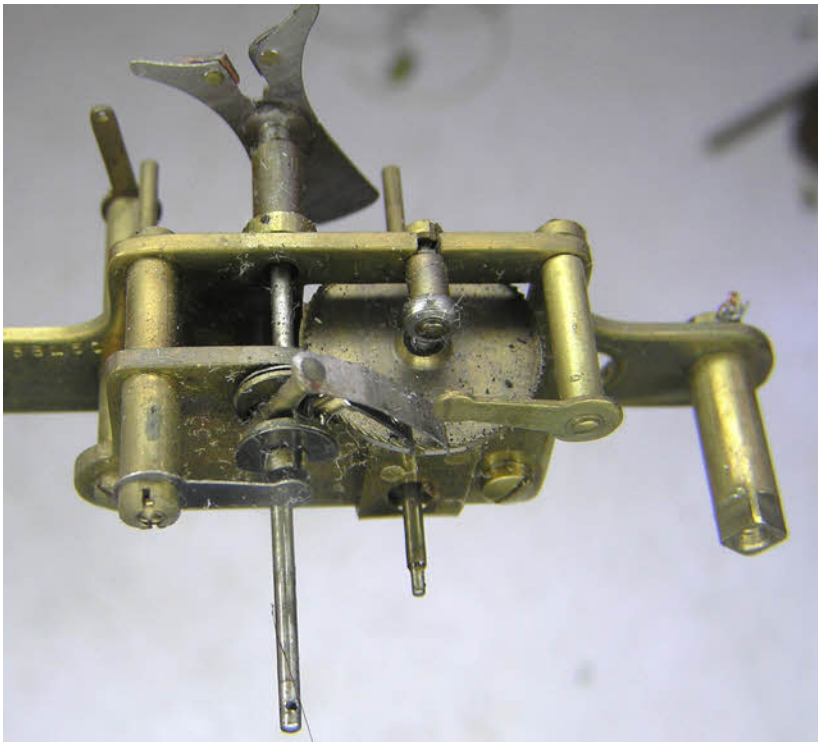
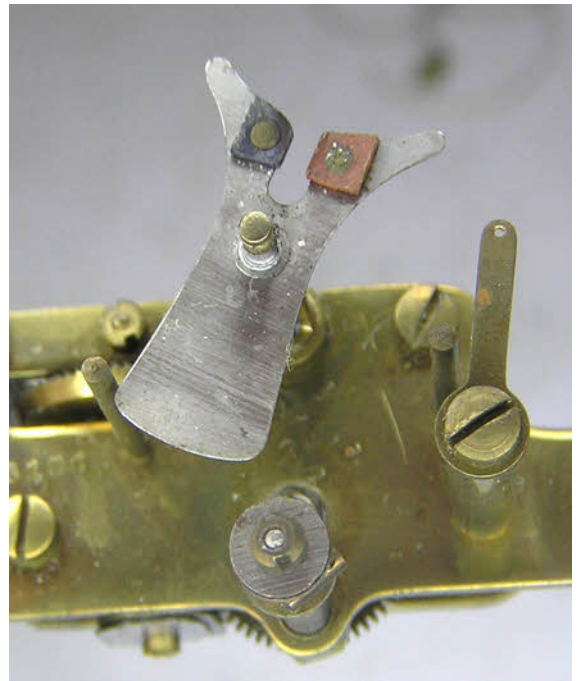
The photo at top left shows the suspension assembly which may have the original contact wire in place. The second photo shows the Isochron spring assembly and the slight rust on the steel pendulum rod. The last photos shows the movement which apart from dust and oil looks to be in good condition. The fork contacts will only need cleaning.

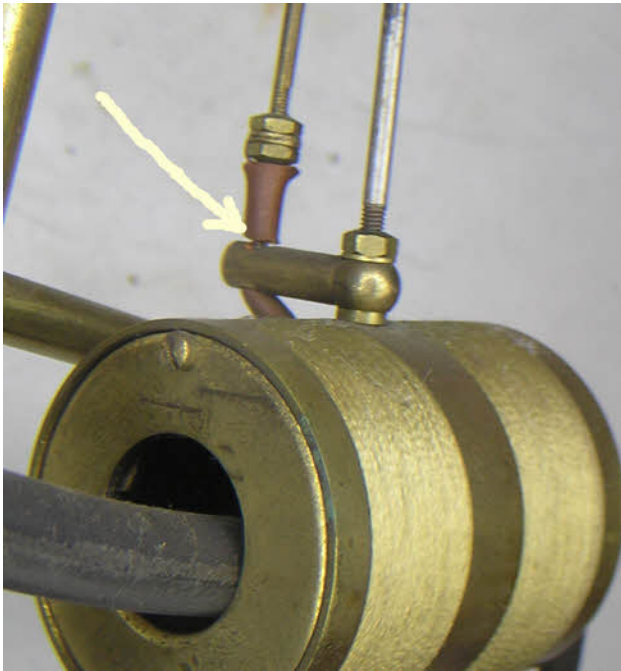
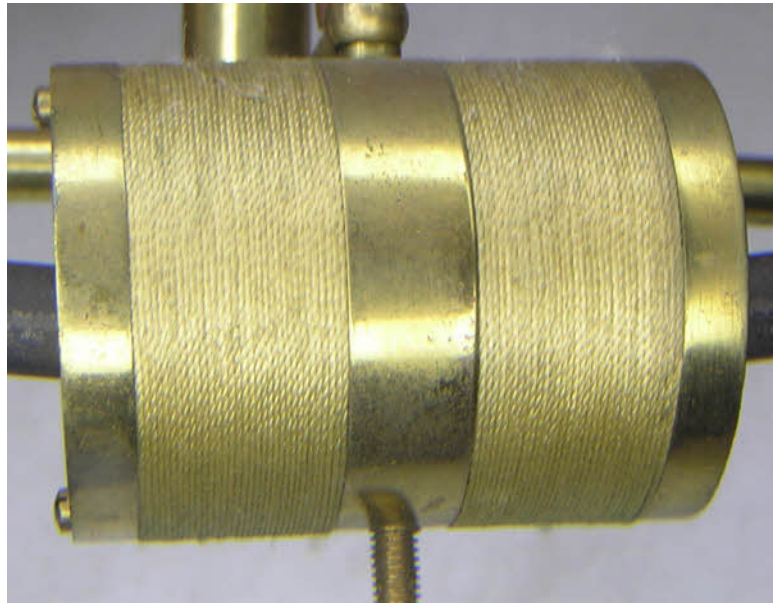
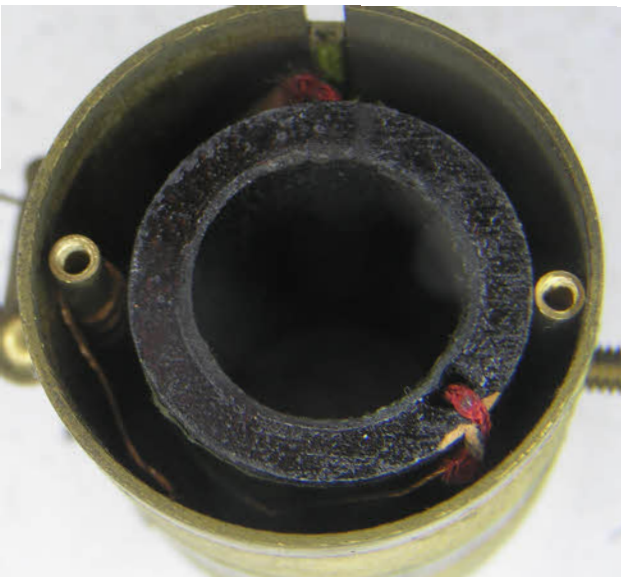
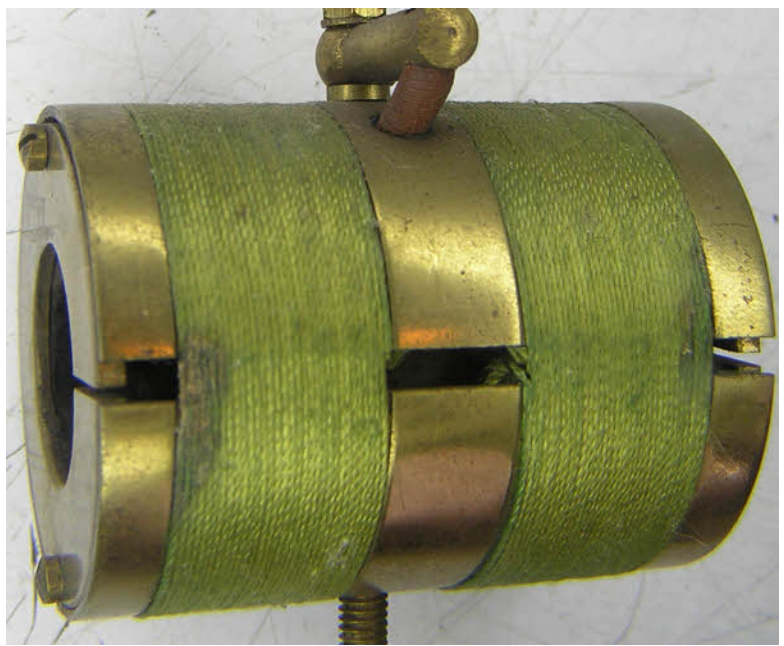
The photo at top left shows the insulation which has separated and allows an intermittent contact with the brass bracket thereby shorting the coil. The two photos on the right show the difference in colour of the cord covering the coil housing. At the front it's straw where it has been bleached by sunshine, while the back is less so as it was protected in the darkness of the case. But you can also see the two areas at each end where it seems to be partially eaten away. It is very brittle and will have to be replaced. The photo at bottom left shows the interior of the coil casing after the cap has been removed.

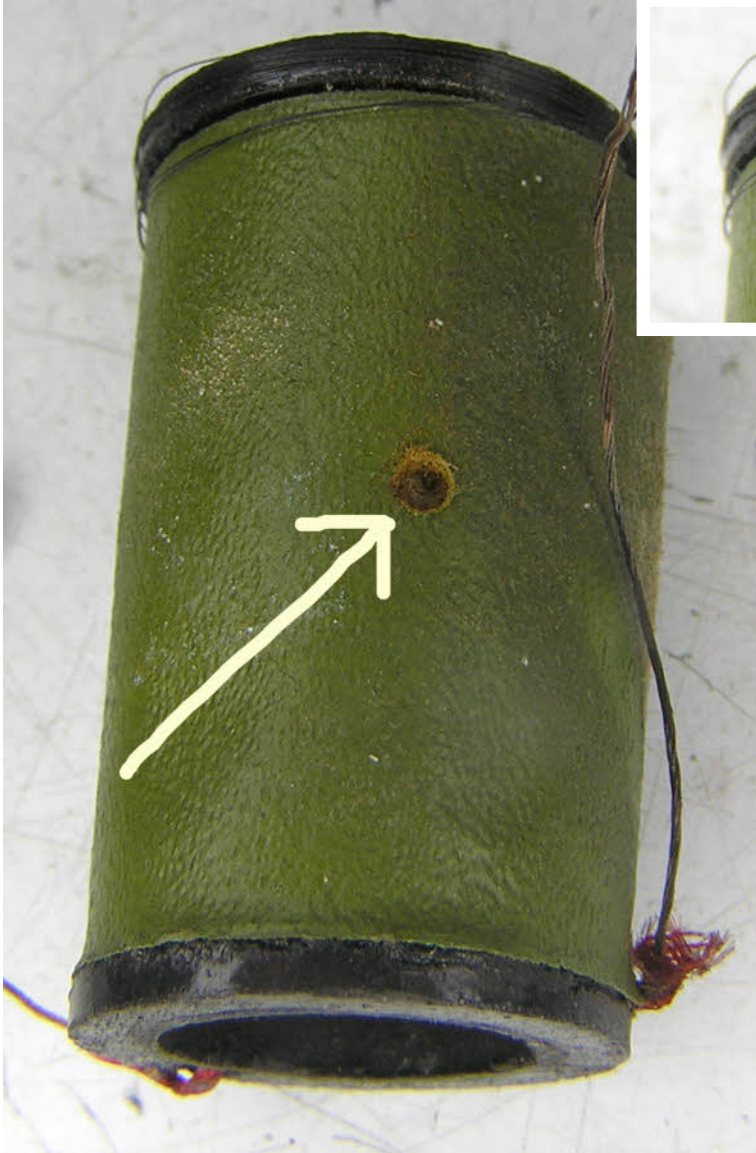
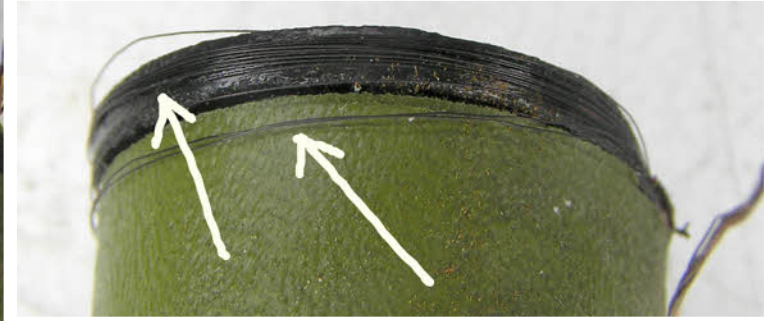
This doesn't look good. The hole in the left hand photo is caused by the pendulum rod being screwed down to far into the casing thereby cutting into the paper coil cover and maybe into the coil itself. The photo above shows the loose coil wire protruding from the paper cover. I was very surprised indeed to find that the coil was still intact and shows a good 1200 ohms on the meter. With the damage shown I was sure I would have to rewind the coil. As it is I will make good the winding and secure it all back with a paper cover before re-assembly.

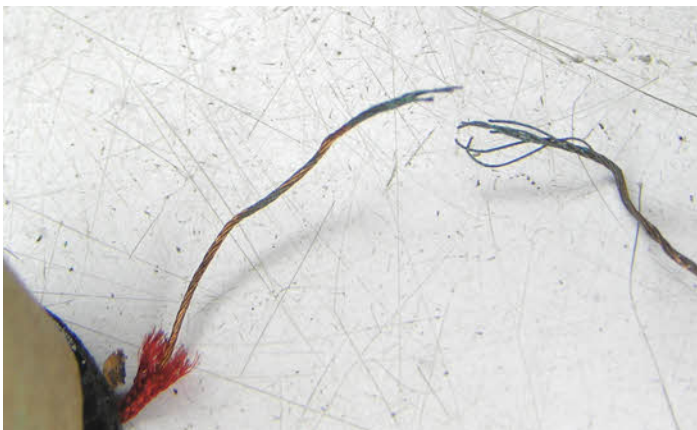
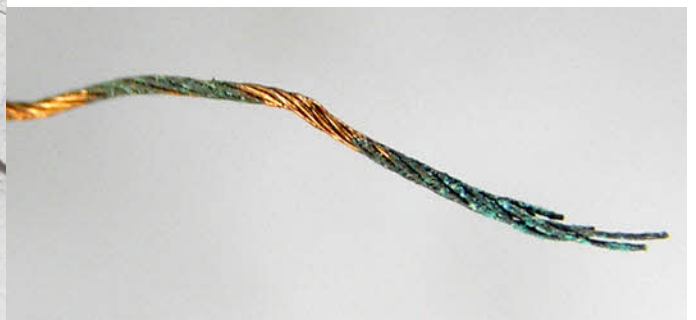
Below we can see that the coil leads are in a very bad way and in fact have been eaten through and separated completely. This just goes to show the necessity of completely disassembling a clock so that all parts can be checked for wear and tear. This wire will need to be cleaned back and new wire attached. But it looks as though there is enough left to clean rather than rewind the coil.

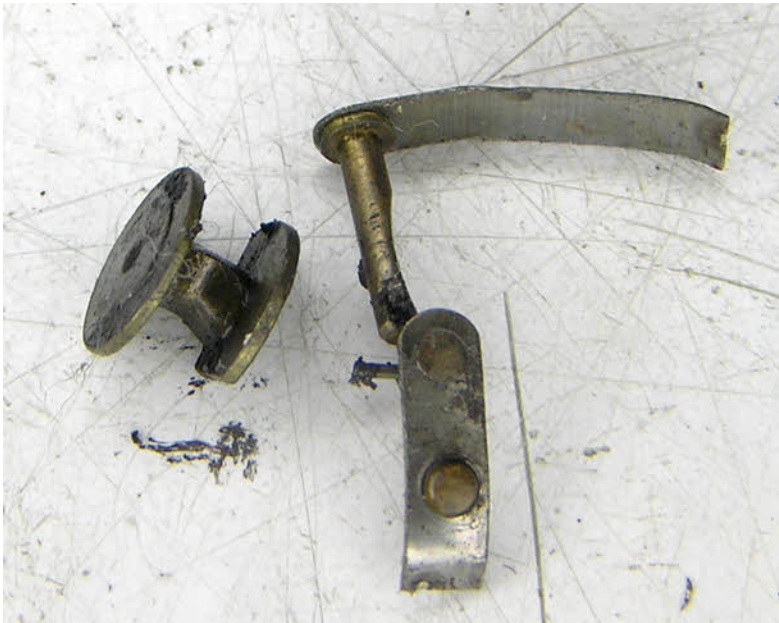
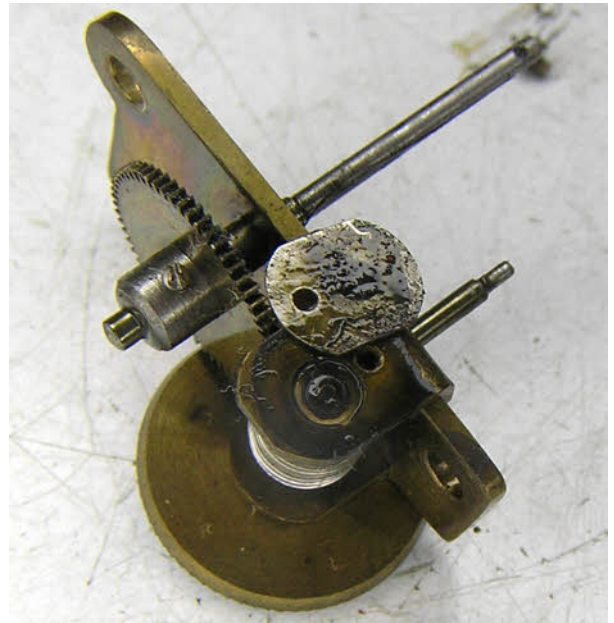
These two photos shows the amount of oil sludge present in the pawl assembly and the count wheel. But it is easily cleaned up.

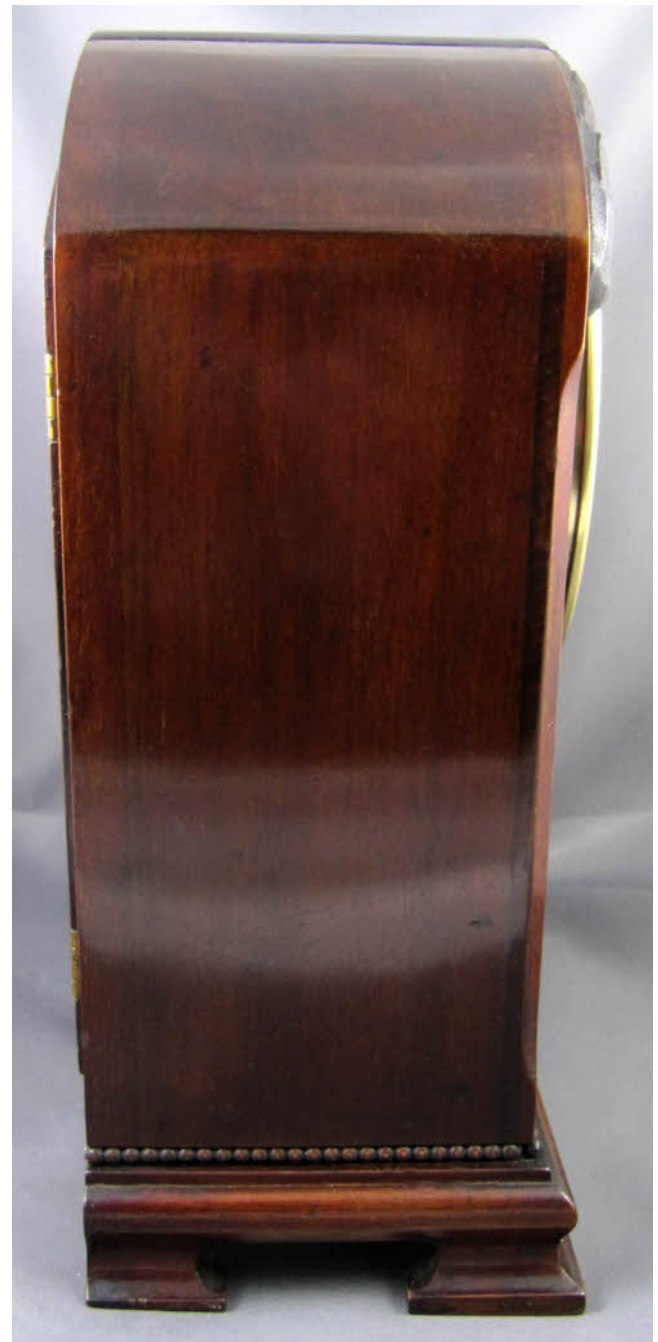
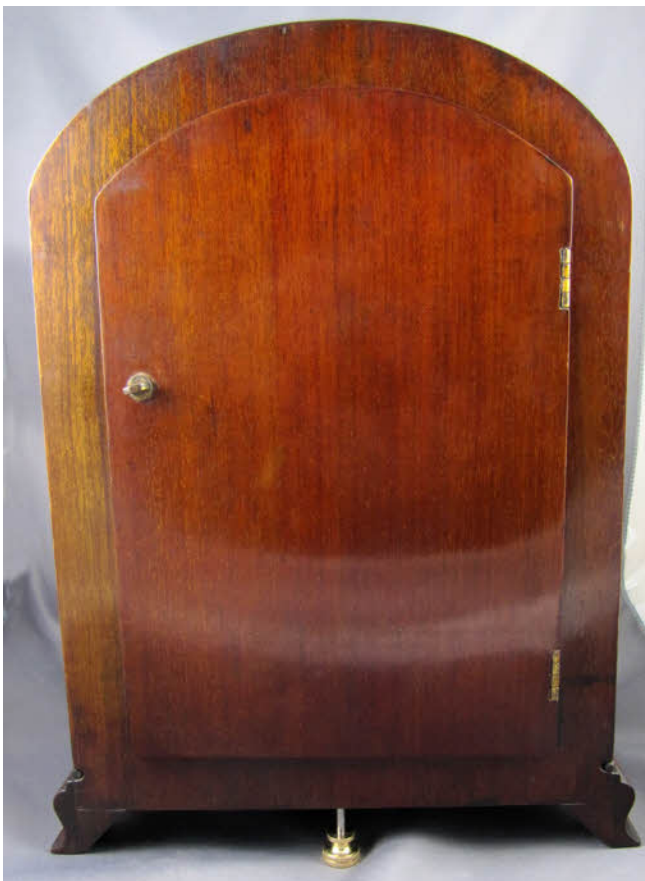
Some shots of the dial and polished case.

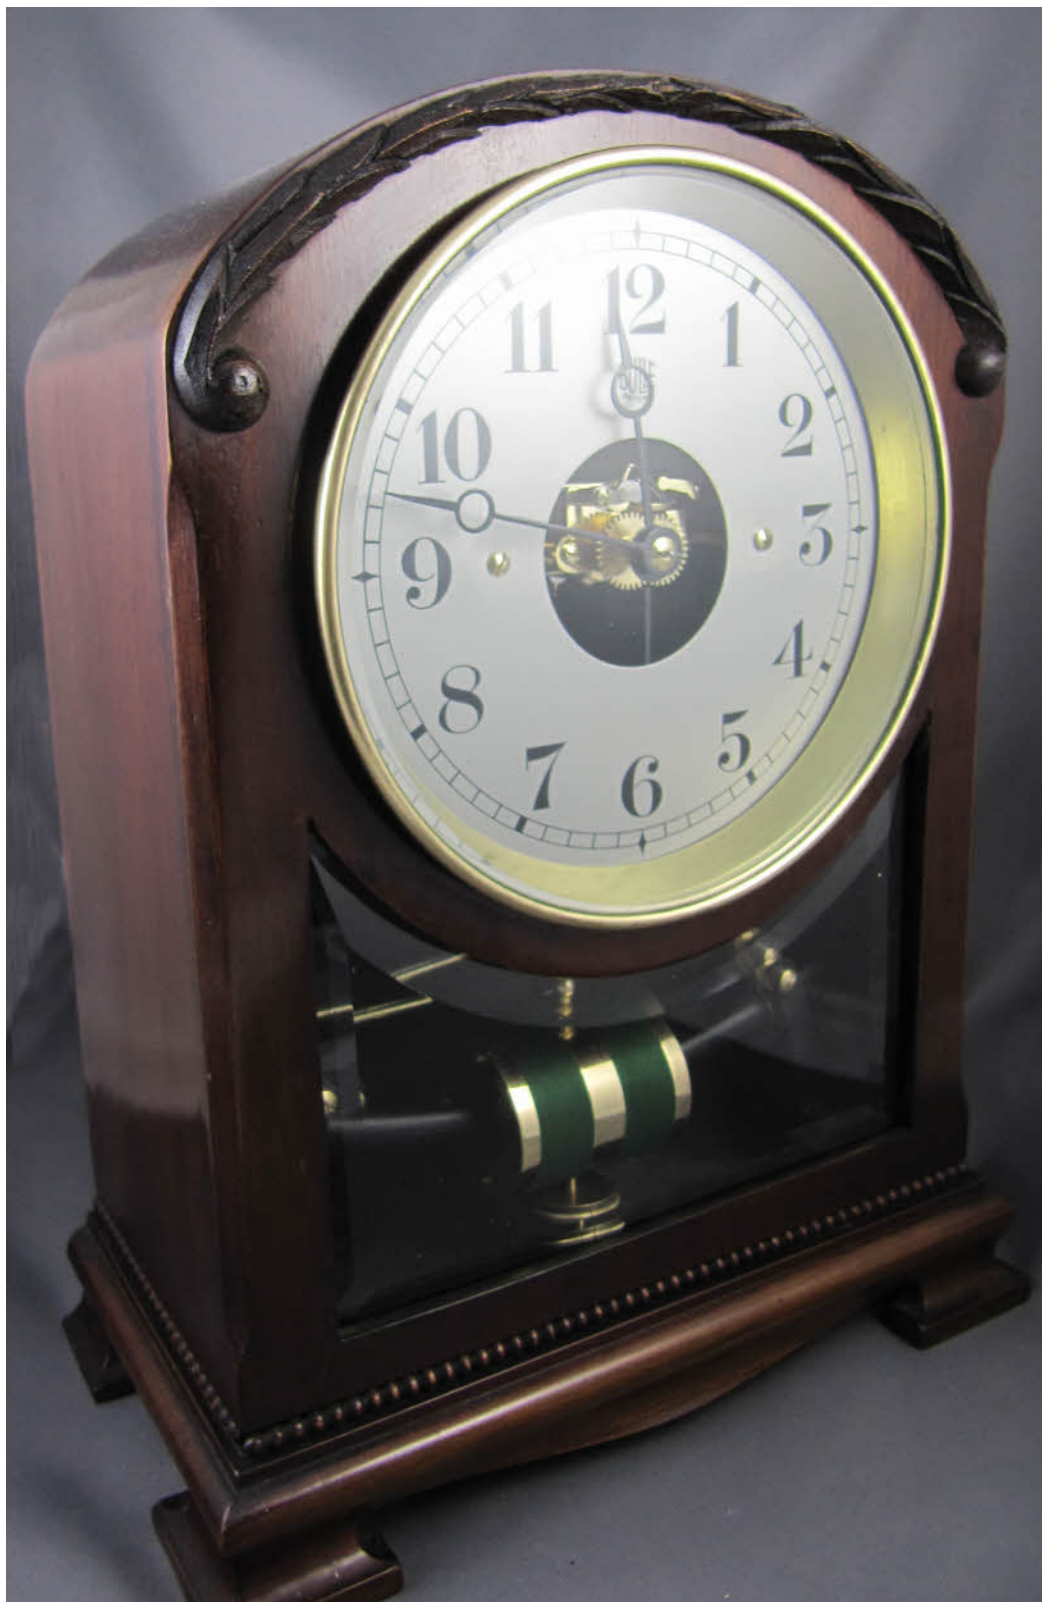
The finished clock
