Bulle Clock Serial Number 5909

*Restoration of Bulle Clock
Serial Number 5909*

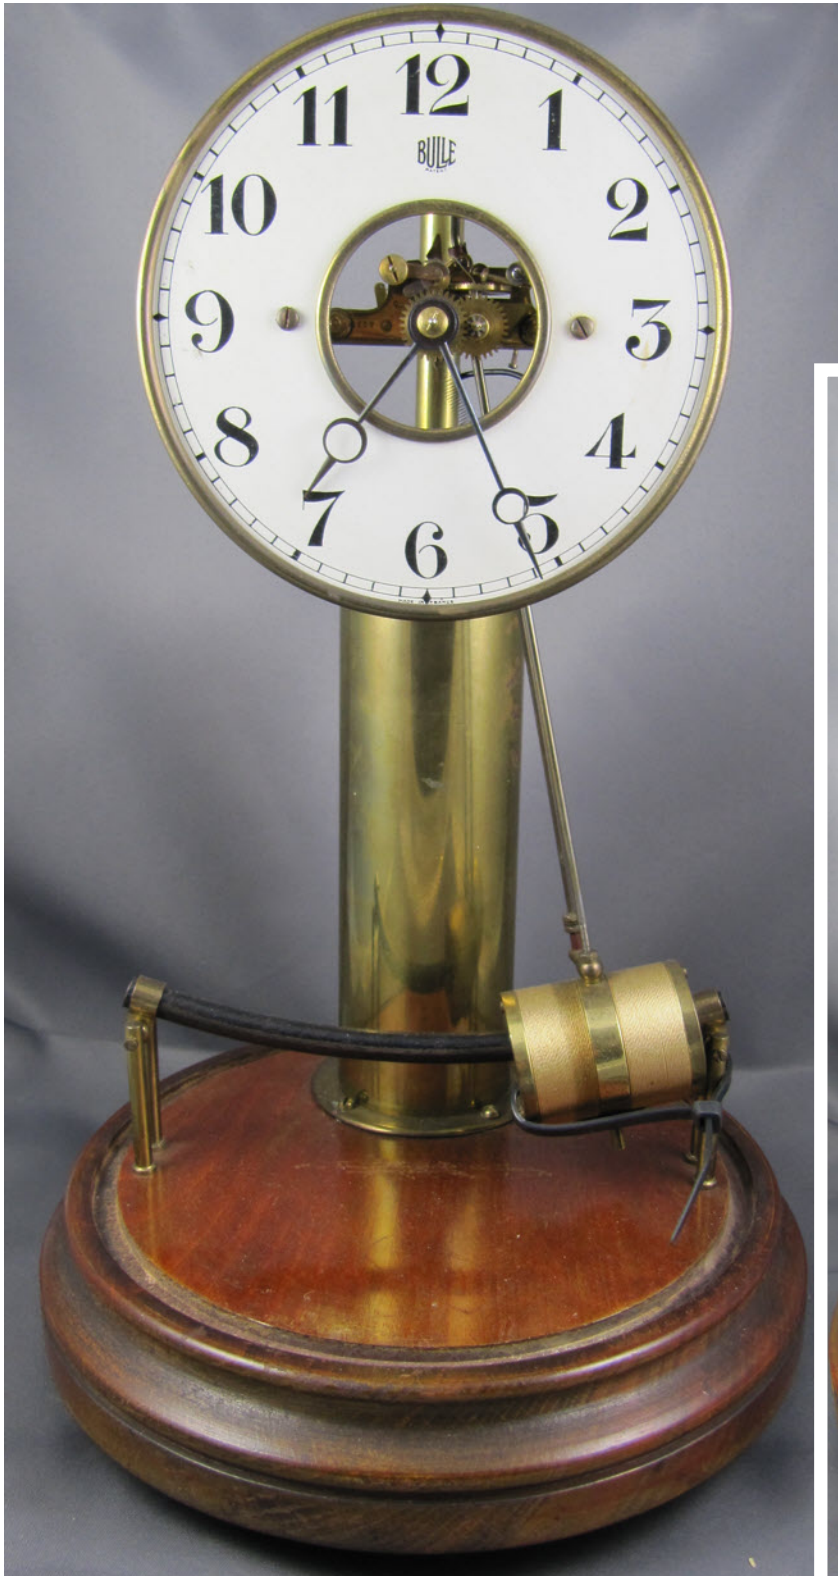
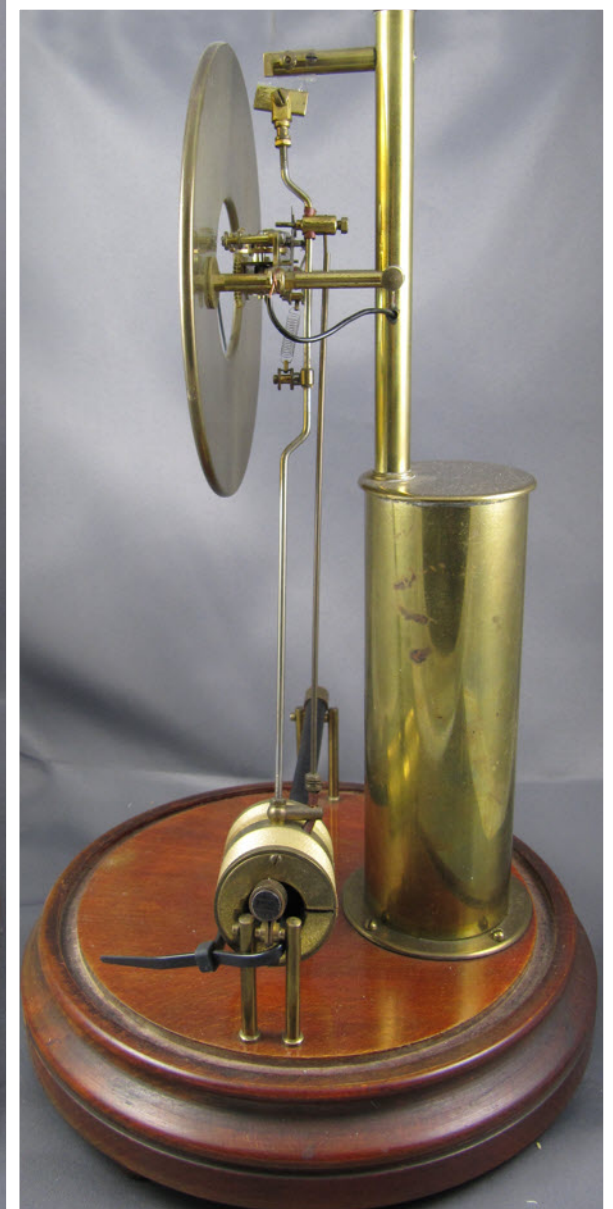
A tall early movement on a round wooden base. The dial is in excellent condition with no major blemishes. The base is a little tired and missing label and brass banding. The hands moon hands are original and just need tidying and painting.

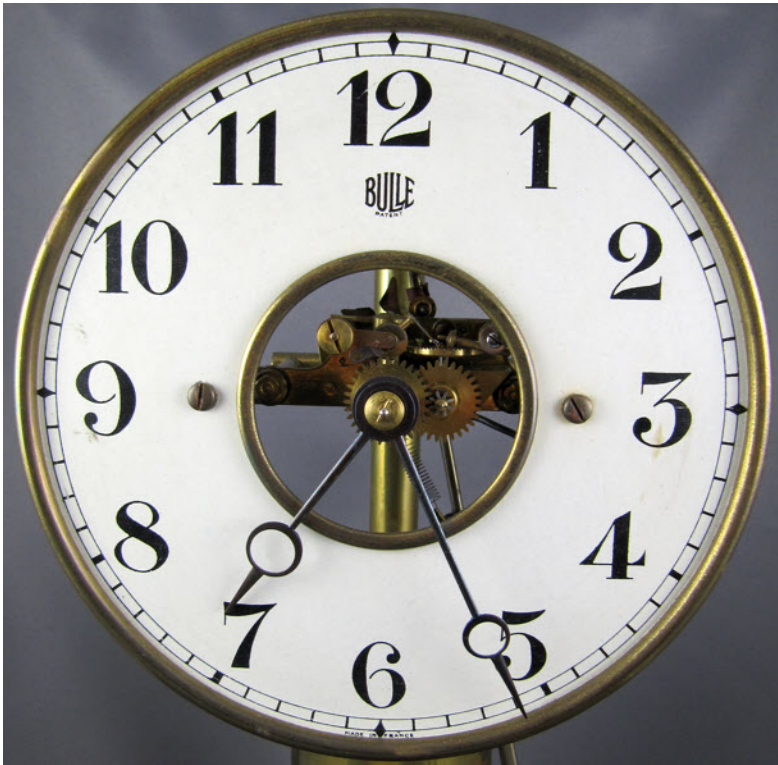
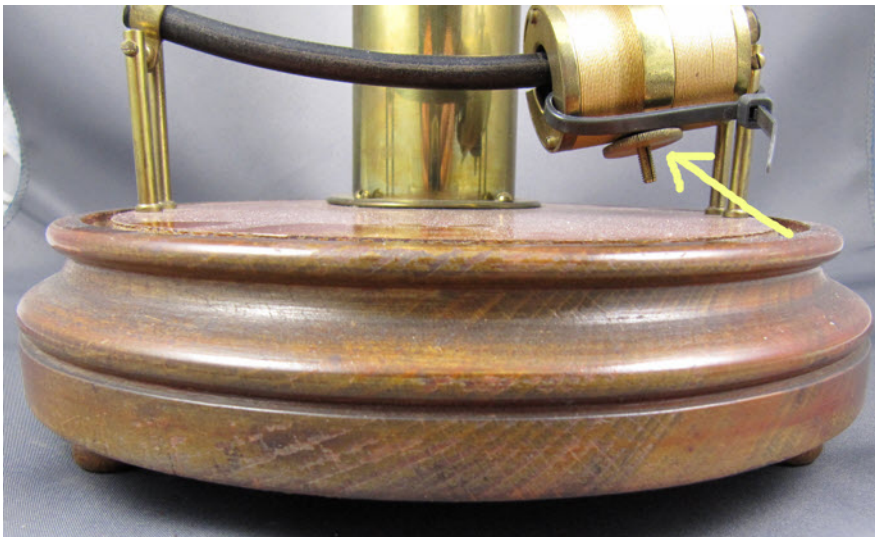
The base will need to be stripped and polished whilst the column will need to be cleaned and then the acid burns treated. There are also some marks on the outside of the tube which may not polish out. The suspension is an easy job to replace and will present no problems. But there is the old problem of the rating nut being reduced in mass to try and lighten it and thereby speed the clock up. In all my time in restoring Bulles I have never needed to adjust the weight of this nut. If the movement and pendulum are cleaned and restored correctly then the rating nut as supplied with the clock will work just fine.

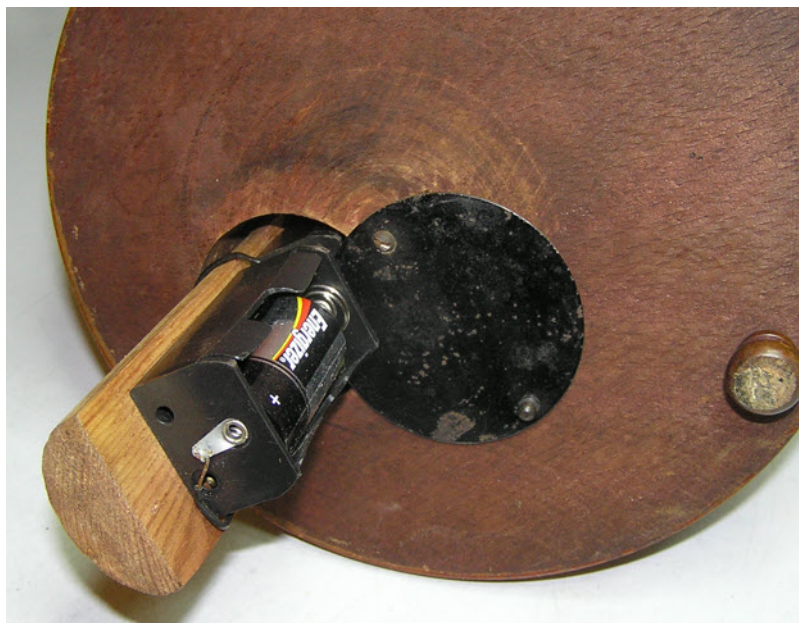
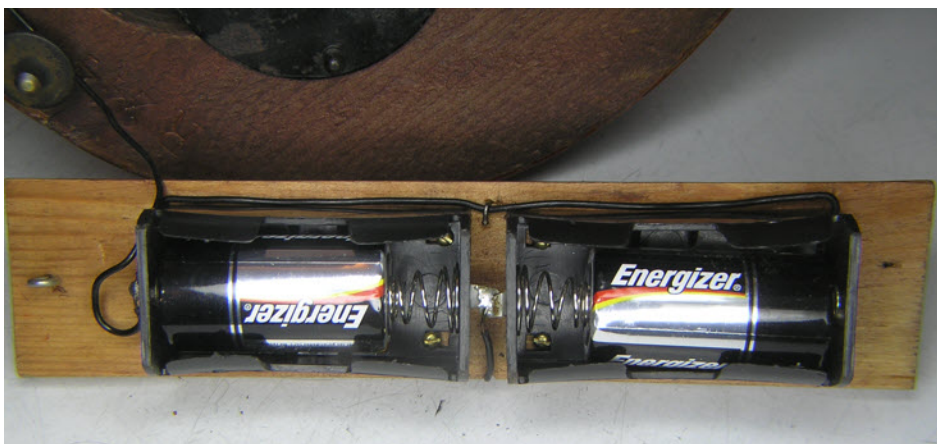
Top left is the movement behind the dial. All looks to be OK with no missing parts or damage. The next two photos show the novel, way the power is applied to the clock. The two battery holders are soldered together in parallel to provide 1.5v and then secured to a wooden block which has one of the terminals attached to a bent brass wire which is forced against the column when inserted in the tube.

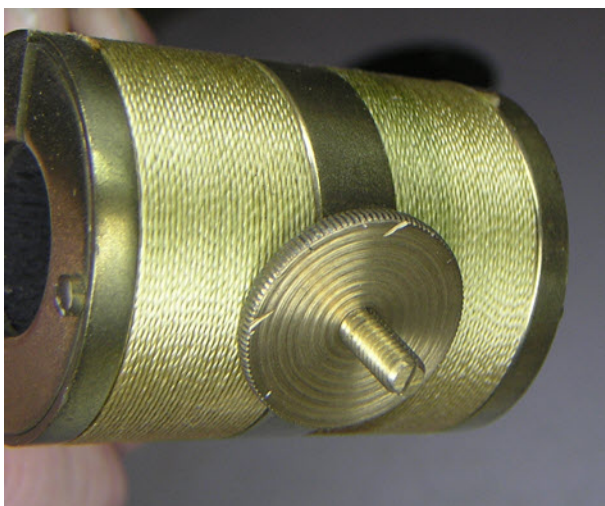
This last photo shows the reduced rating nut that will have to be replaced. It also shows the condition of the cord which although it has lost most of its colour, it is still bright and "silky" to the touch. This contrast with most of the other restorations as seen in the galleries on this web site, where the cord can normally be seen to be lack lustre, dry and very brittle. So we will try and leave the cord in situ and work around it to clean the brass casing. This take more time and effort but worth it where the cord is in such good condition.

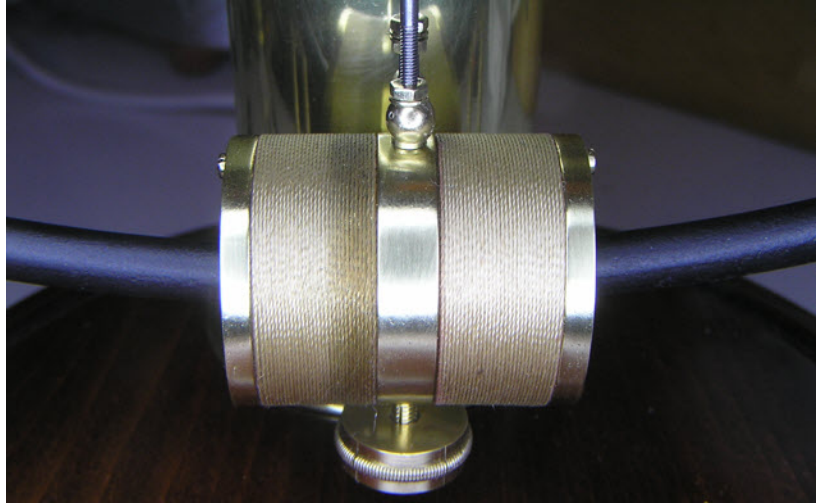
The pendulum back in place on the column. The cord was successfully preserved during the cleaning operations.

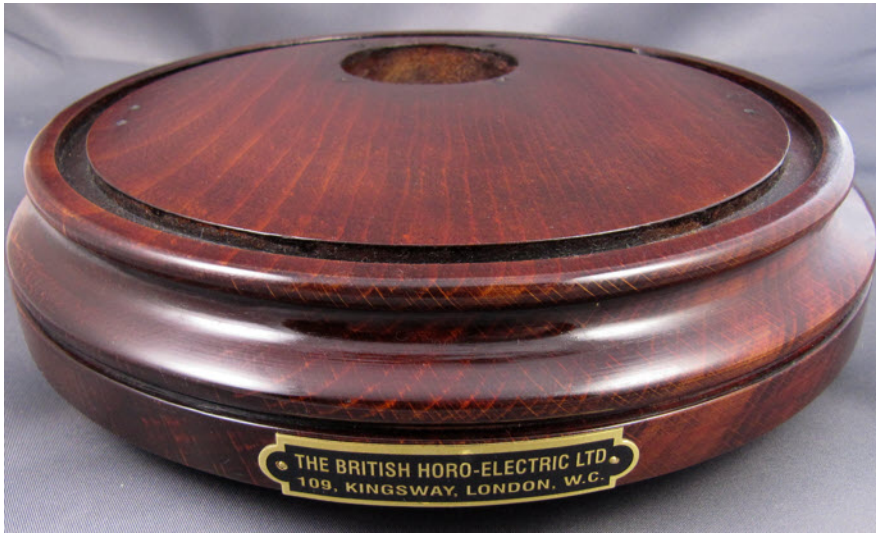
The polished base with new label and brass stringing.

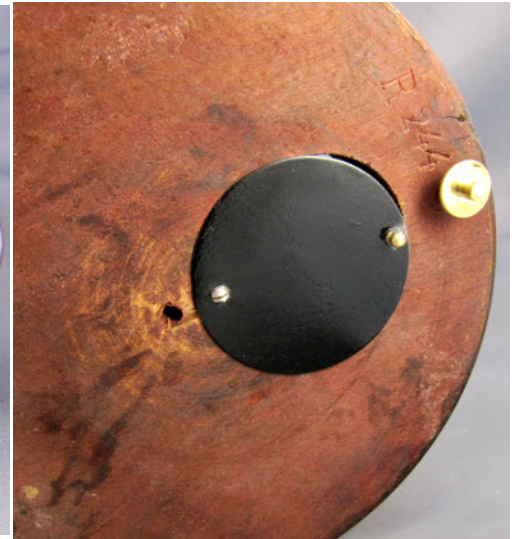
The underside of the base with re-stored cover.

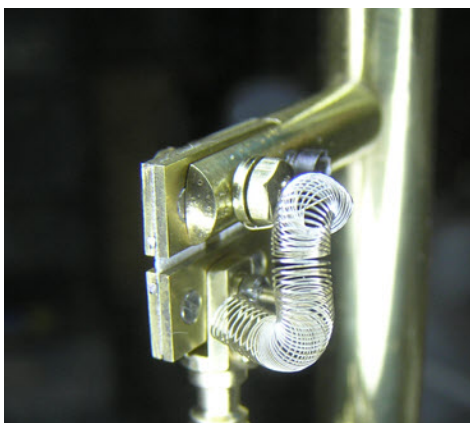
This last photo shows the silver contact spring that spans the electrical gap created by the silk suspension unit.
