Bulle Clock Serial Number 67438

*Restoration of Bulle Clock
Serial Number 67438*

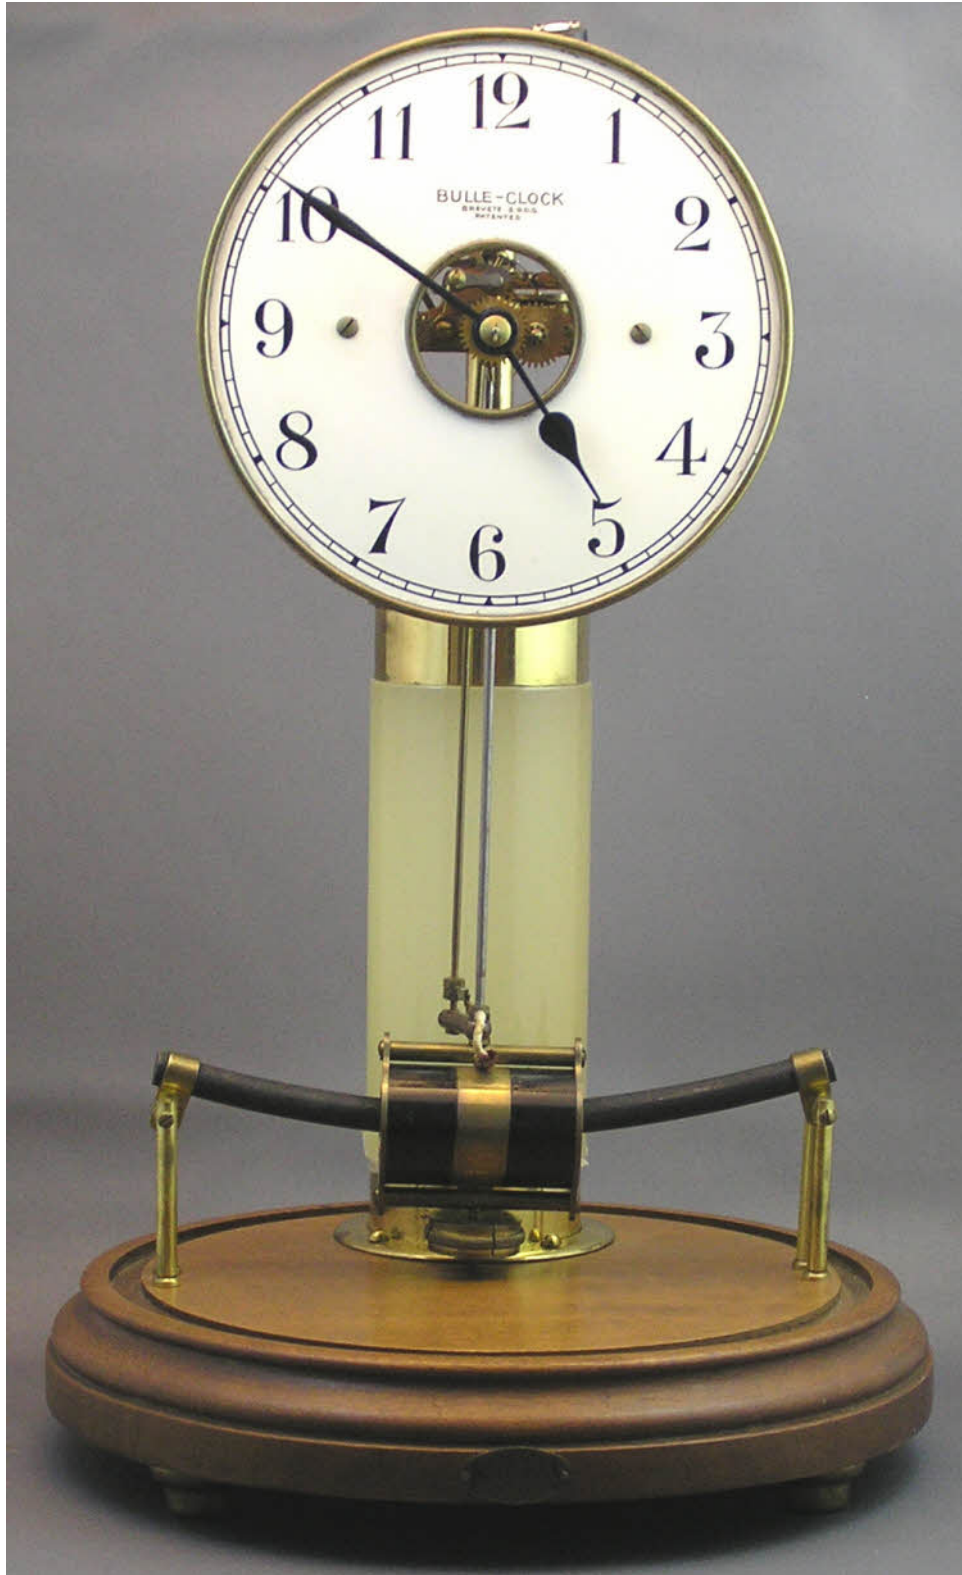
This clock is of the tall two plate, "A" type and dates from around 1926. The first thing to note is that the column looks a little strange!! The top and bottom of the column are all that's left of the original with a solid plastic type material inserted between. We can only assume that the dreaded battery acid has done its work and eaten enough of the original tube for it to be quite rotten and need replacing. The original tube was 55mm diameter and 0.5mm thick, so it is difficult to obtain. From the number that I have restored I believe them to be fabricated from plate rather than extruded. Anyway, we'll see more when we disassemble the clock. Other than that, the clock looks to be in reasonable order.

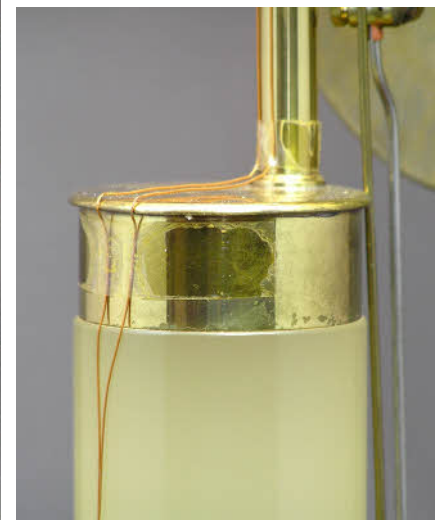
Below we see the top of the column in more detail

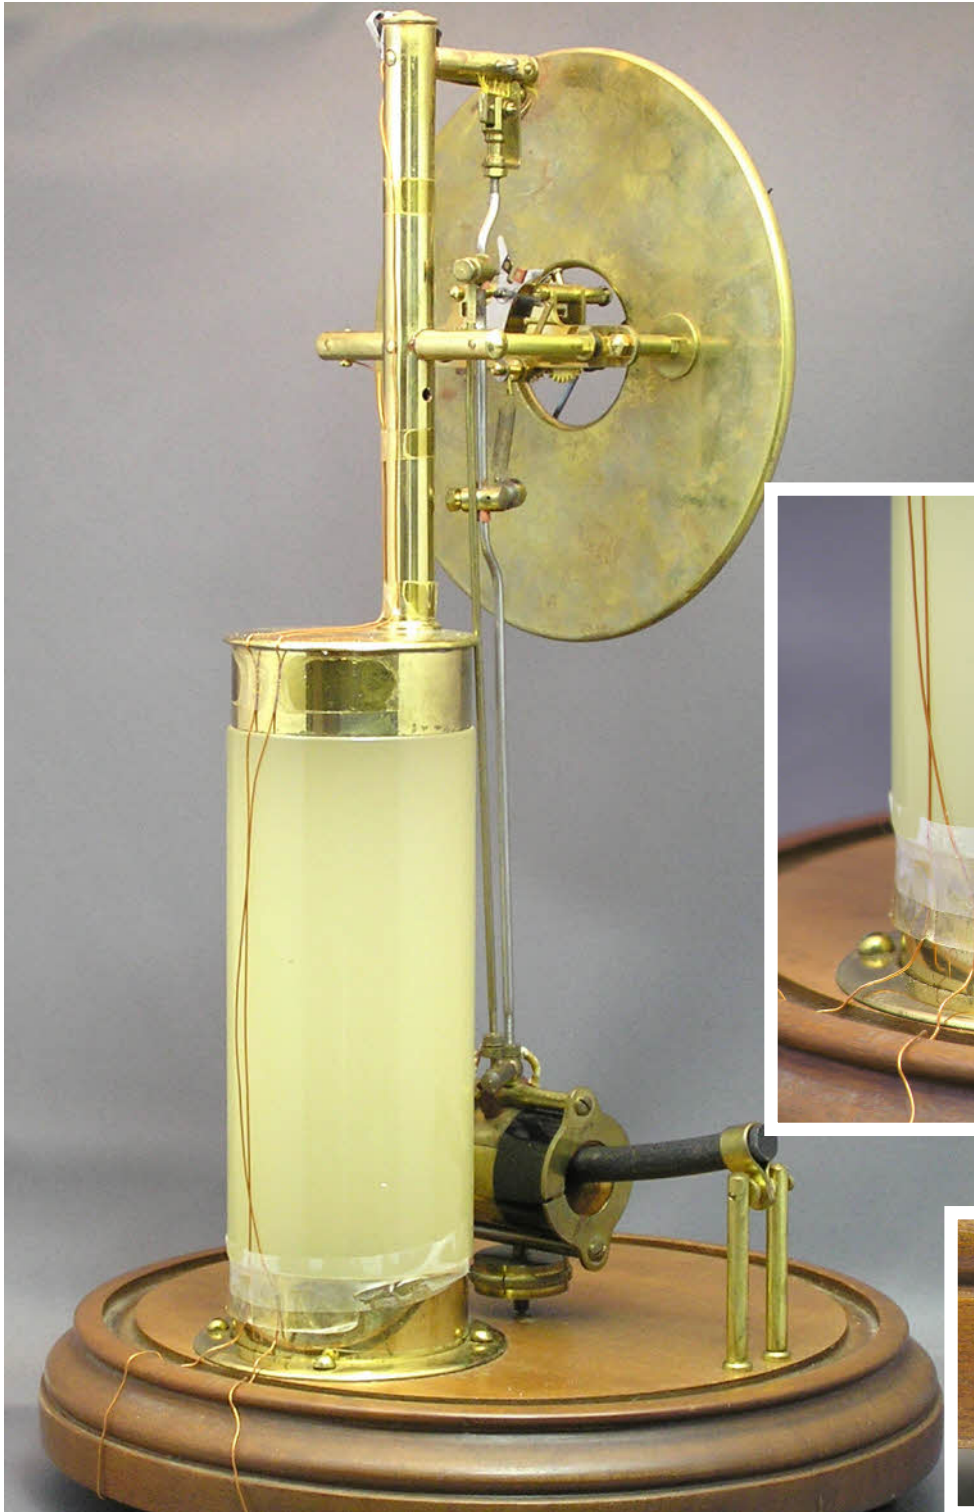
The rear of the clock. Note the two enamelled copper wires running from the movement, down the outside of the column and out under the base. This was done because the column is now solid plastic and had no where to run the wires. In this photo is much clearer that the top and bottom of the original brass column have been expertly machined to fit the plastic.

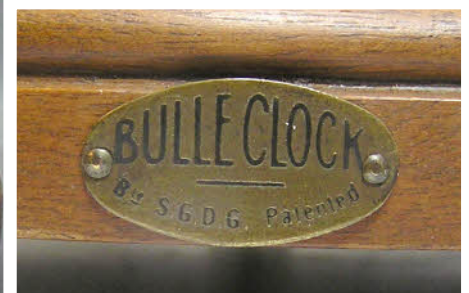
The wooden base looks clean and tidy although a little "tired". I think all we need do is cut it back a little and add a few coats of Polish to bring out the lustre. The label on the base is of the later oval type.

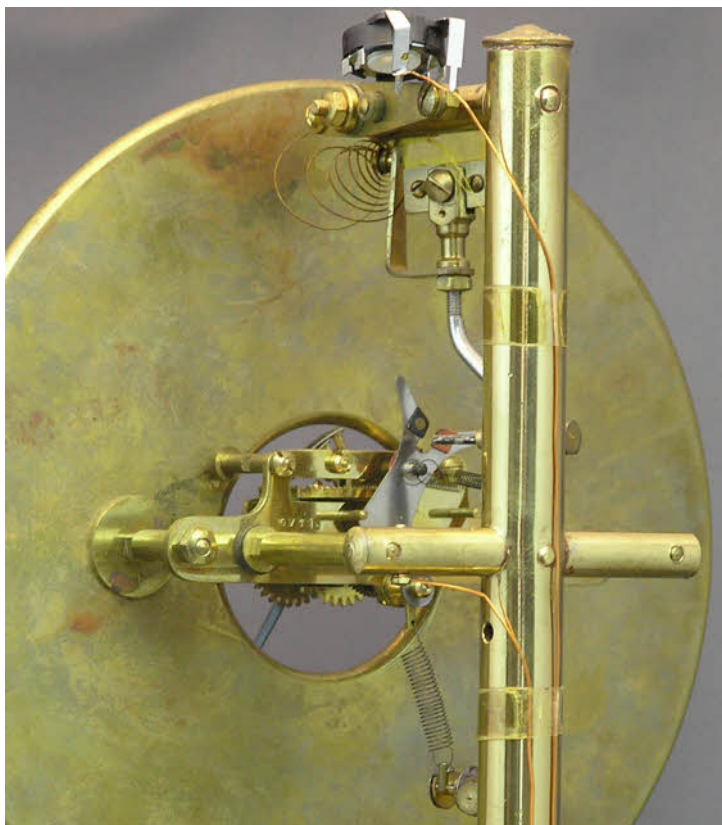
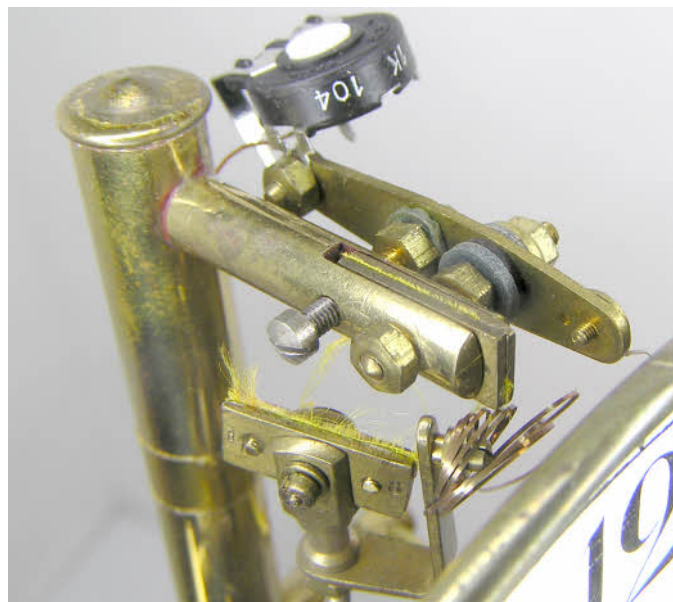
As you can see from these two photos there is a small "Pot" resistor of 1000 Ohms. I have no idea why this is here. The coil still reads a healthy 1100 Ohms so there is no need to add any extra resistance. I can only assume that this clock has been the recipient of some experimentation in the past.

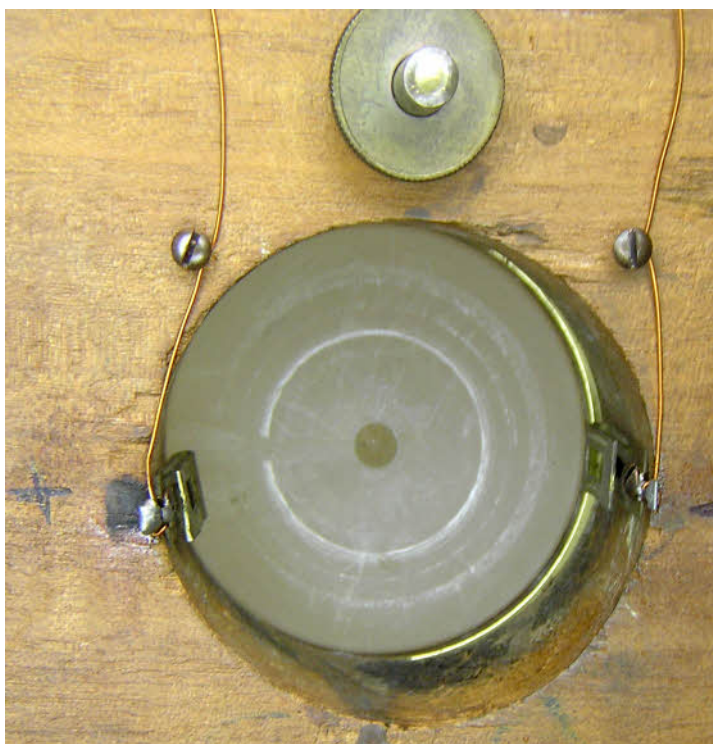
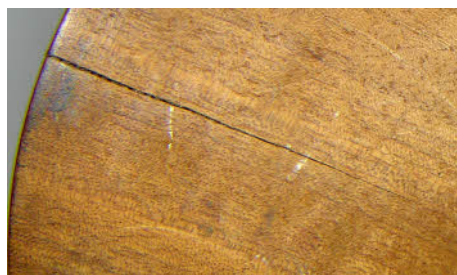
The underside of the base shows further modifications. The solid replacement column takes up the room where the battery would have fitted, so the two wires from the movement are terminated with contacts that allow a small battery to sit across the opening. This of course leaves no room for the bottom battery cover which has been removed and lost. So besides restoring the column we will have to make a replacement battery compartment cover. The last photo shows a shrinkage crack in the wood; perhaps a sign of modern home heating. It is not

that bad and will not be treated other than a good waxing.

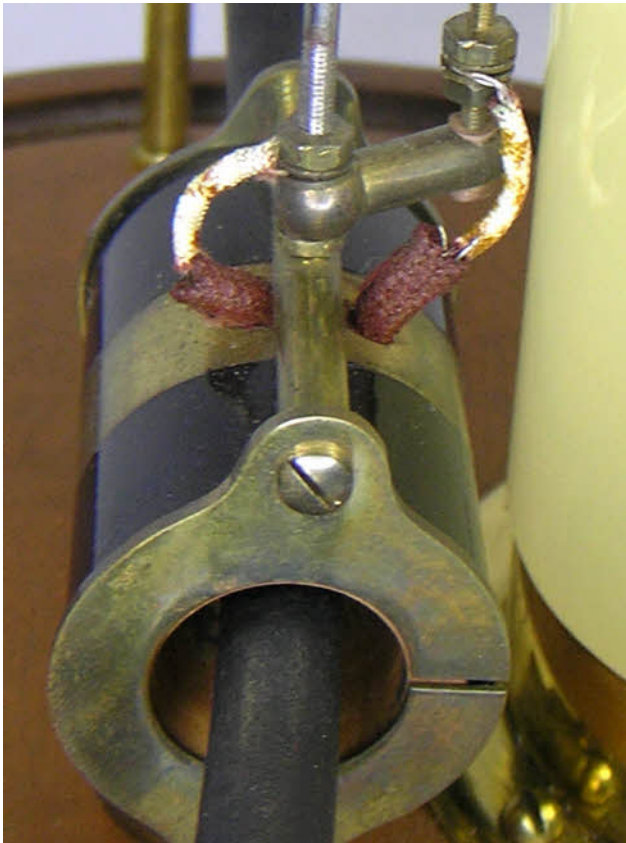
The coil looks as though it has been tampered with although the good news is that it still has a good resistance. Hopefully all we probably need to do is remake the lead out wires.

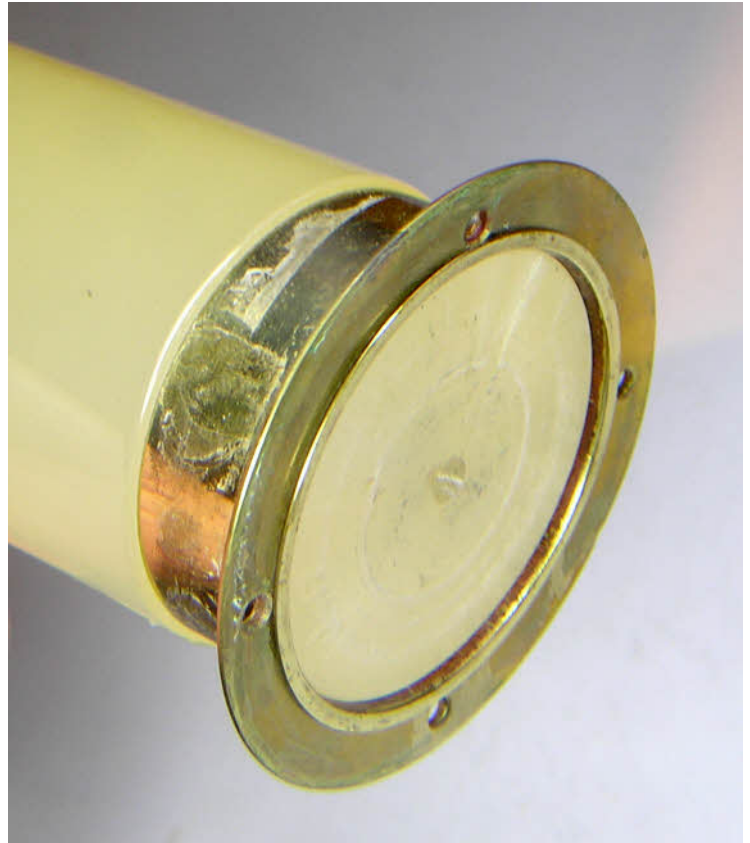
The column removed from the base shows how the plastic and column had been machined to mate together.

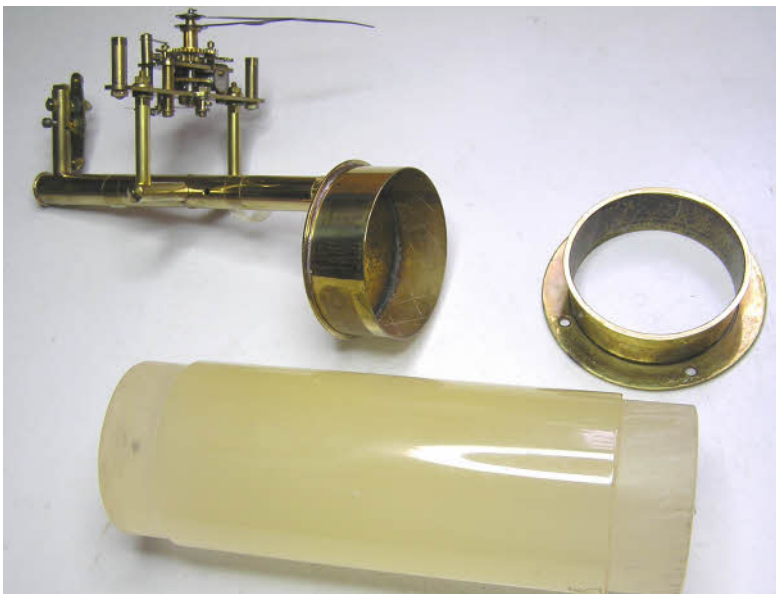
The whole column disassembled. Notice the machined ends of the plastic and original column.. We will need to remove the top of the column from the rest of the frame carrying the movement and replace it with a donor from another damaged clock. Luckily I managed to find a column with the top frame damaged leaving a good column. I'll show the donor operation a little later.

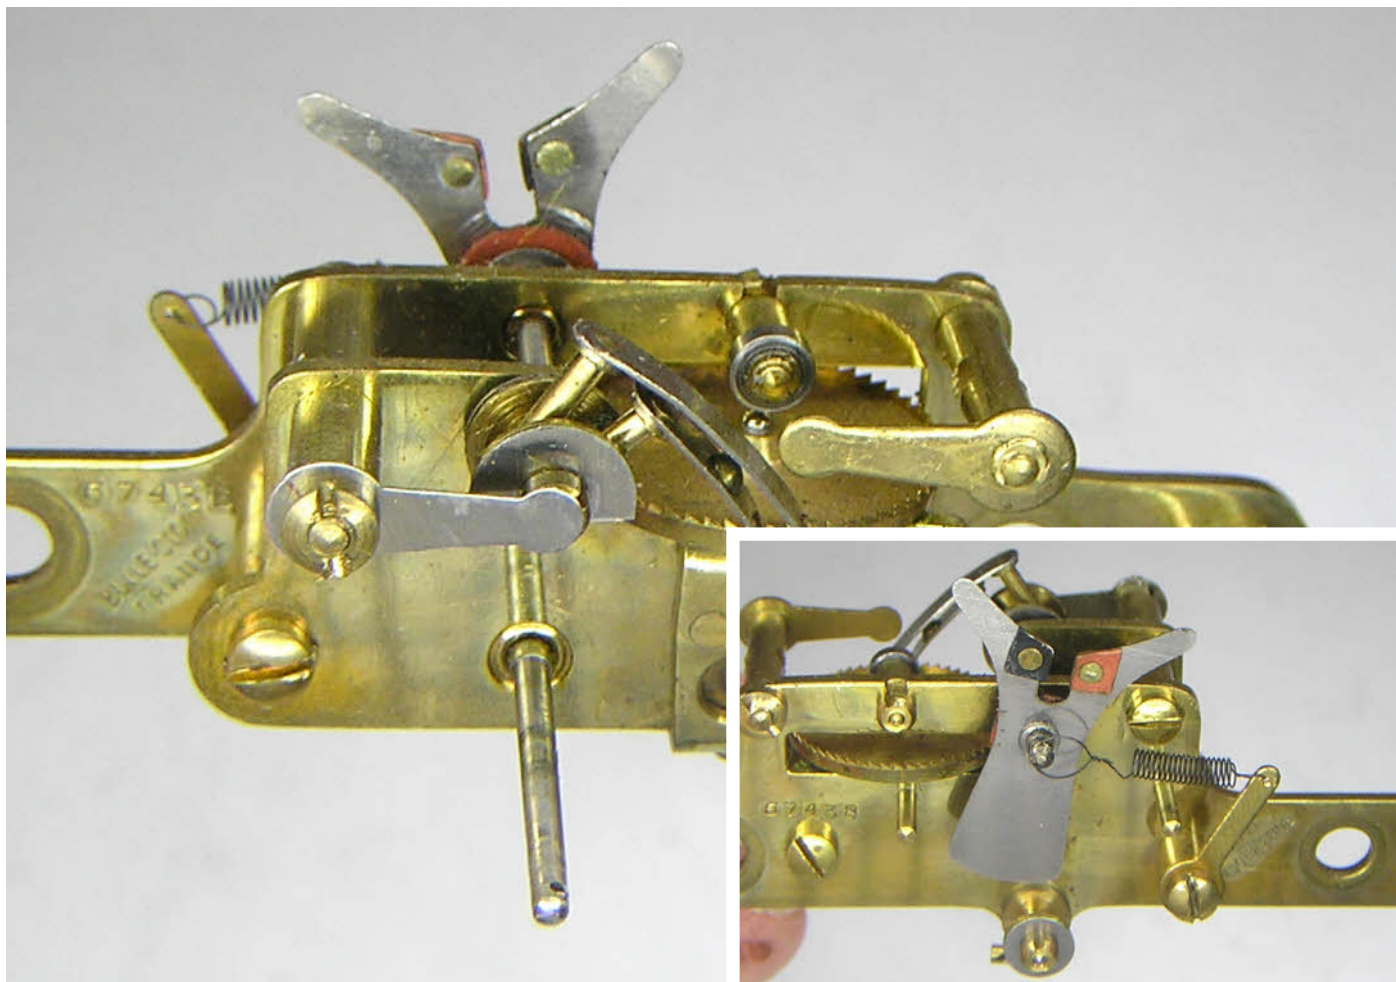
The movement itself looks to be in good condition. The fork contacts have a good presentation within the fork pin gap, and show little signs of wear. This means we can clean it up without replacement. It seems that this clock has not had such a bad life as the column would suggest. Perhaps it was left inactive for many years, with the battery left in the column to leak acid. A familiar scenario. The insert photo shows the rear of the movement with fork contacts.

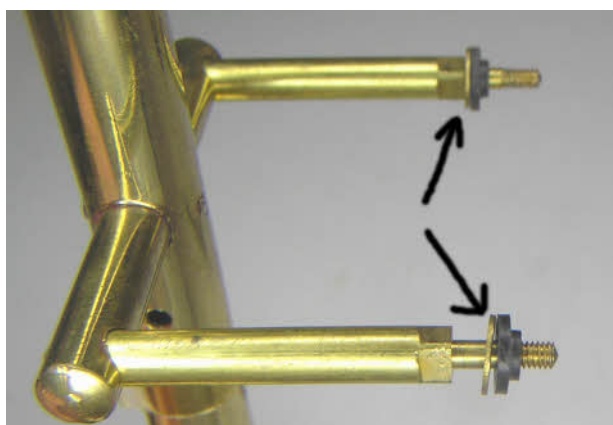
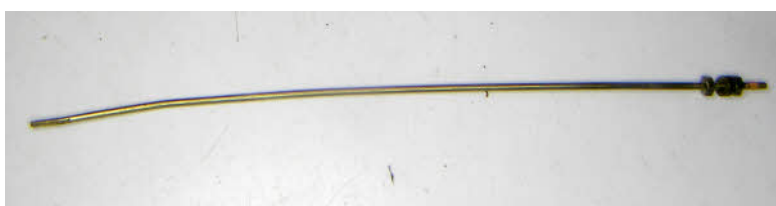
The photo at left shows the insulating washers and brass spacers. The spacers are replacements and are much too thin. New ones will be machined on the lathe. Below we see the brass contact rod from the rear of the pendulum. A little bent but easily straightened.

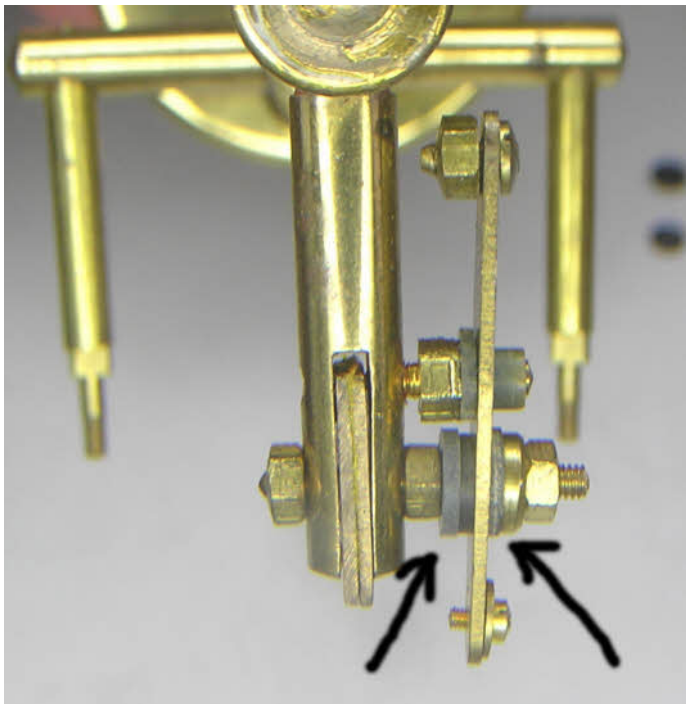
The top contact assembly also has the large brass spacer missing on the left. The right one is in position. Another simple machining job.

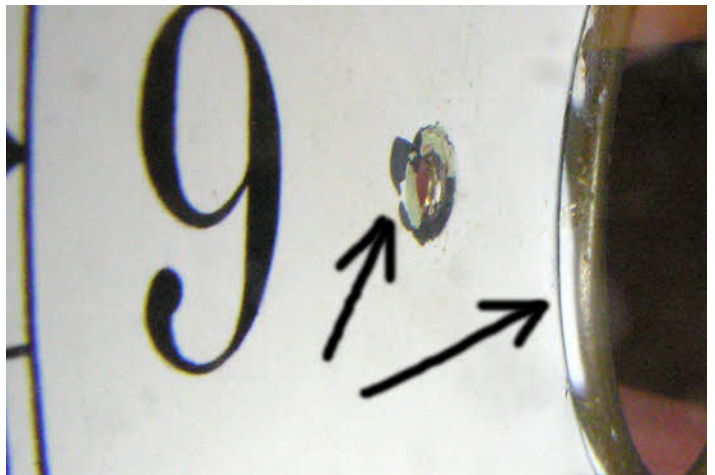
The dial has been repainted as can be seen from the over-spray marks on the brass (arrowed). The execution is excellent though perhaps a little flakey. We will have to be extra careful when cleaning the inner and outer brass rims.

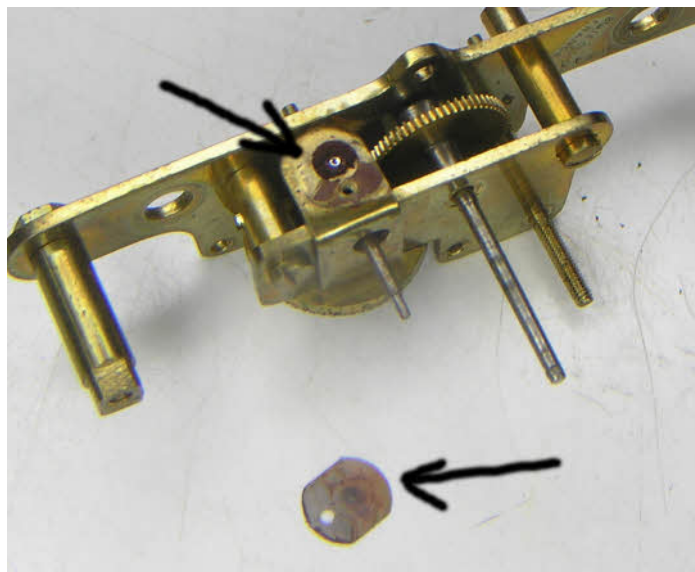
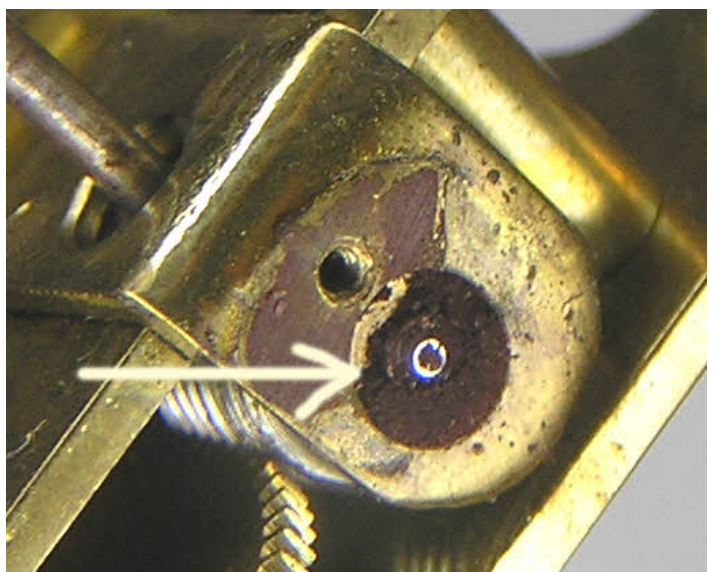
This looked a little more serious. At first sight it looked as though the count wheel arbour had rusted badly, but luckily it was the bottom plate. The arbour was in fact quite clean and smooth. The plate however is pitted with rust and may need replacing. The count wheel was, not surprisingly, stubborn to rotate which wouldn't have helped the clock to perform.

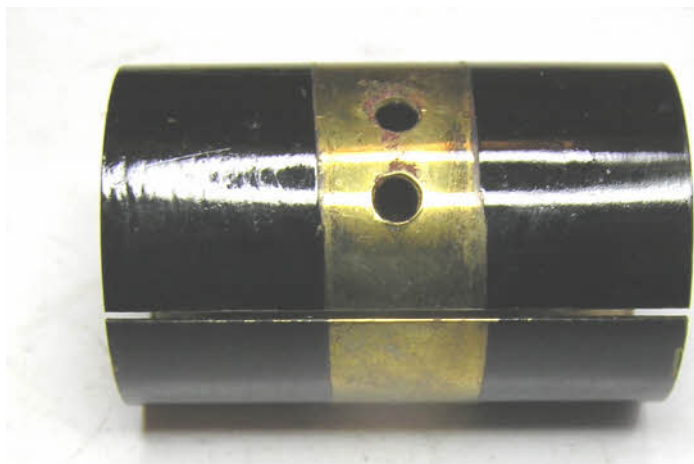
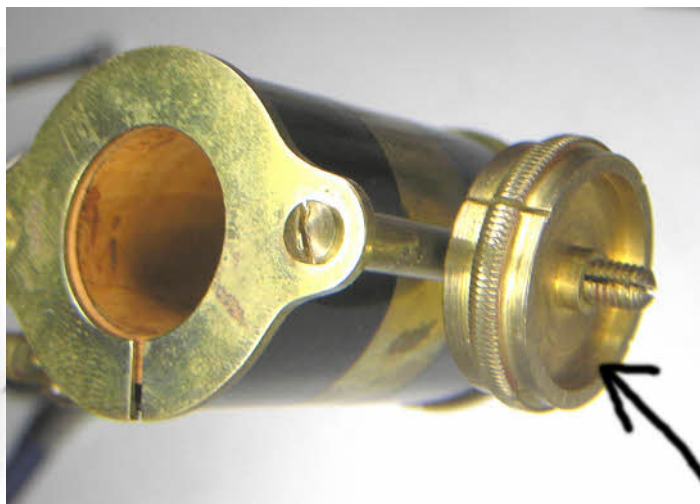
These two photos show the painted brass coil cover and the rating nut. On some Bulle clocks the coil cover is sprayed completely black with an additional brass ring that spans the middle of the cover. In this style of clock however, the cover is first polished and then the centre masked (not too straight as can be seen) before spraying. The practical upshot of which is you get the look of a brass ring but at less expense. The second photo show usual problem of "lightened" rating nut to try and speed up the going rate. The best thing in this case is to machine an insert so as to keep as much of the original as possible.

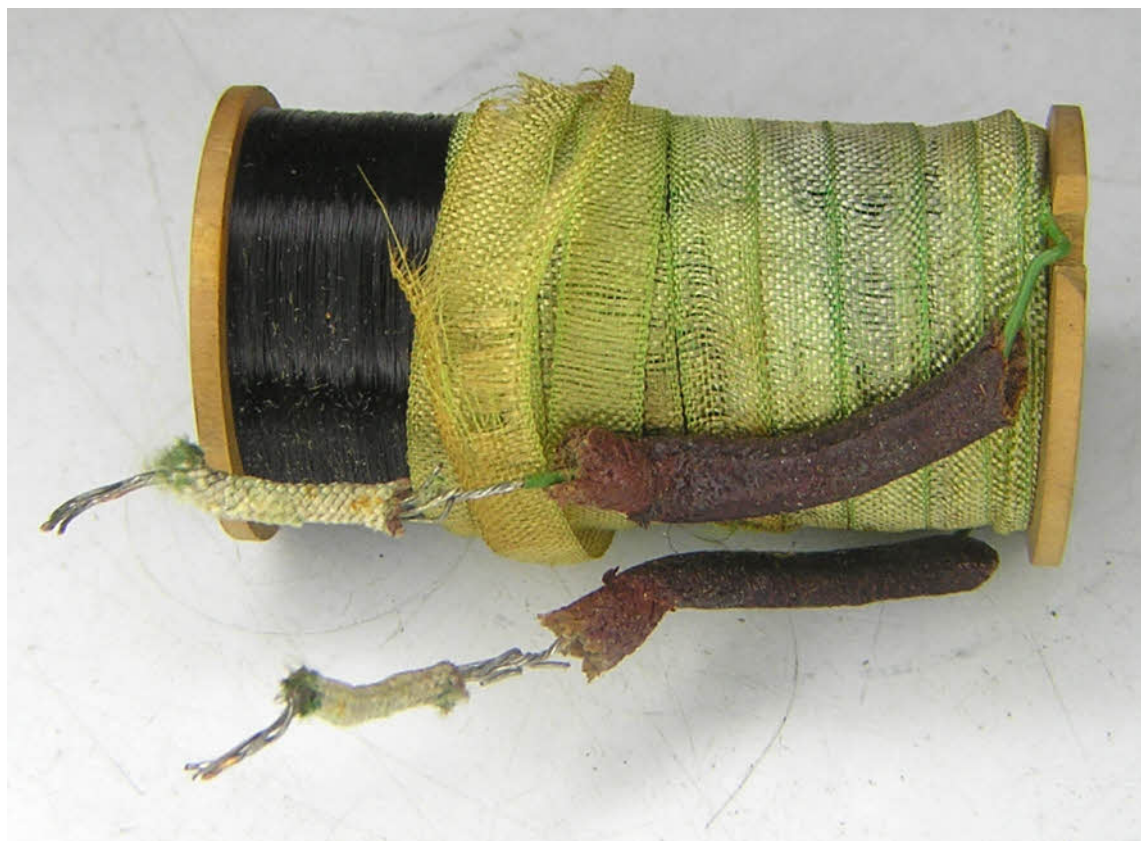
In this photo you can see the two lead out wires from the coil have been cut off and extended. The silk ribbon is also loose and uncoiling. The extension swill be removed and the silk rewound. New extensions will then be added and insulated. The coil is wound with 6500 turns of 42 swg enamelled wire.

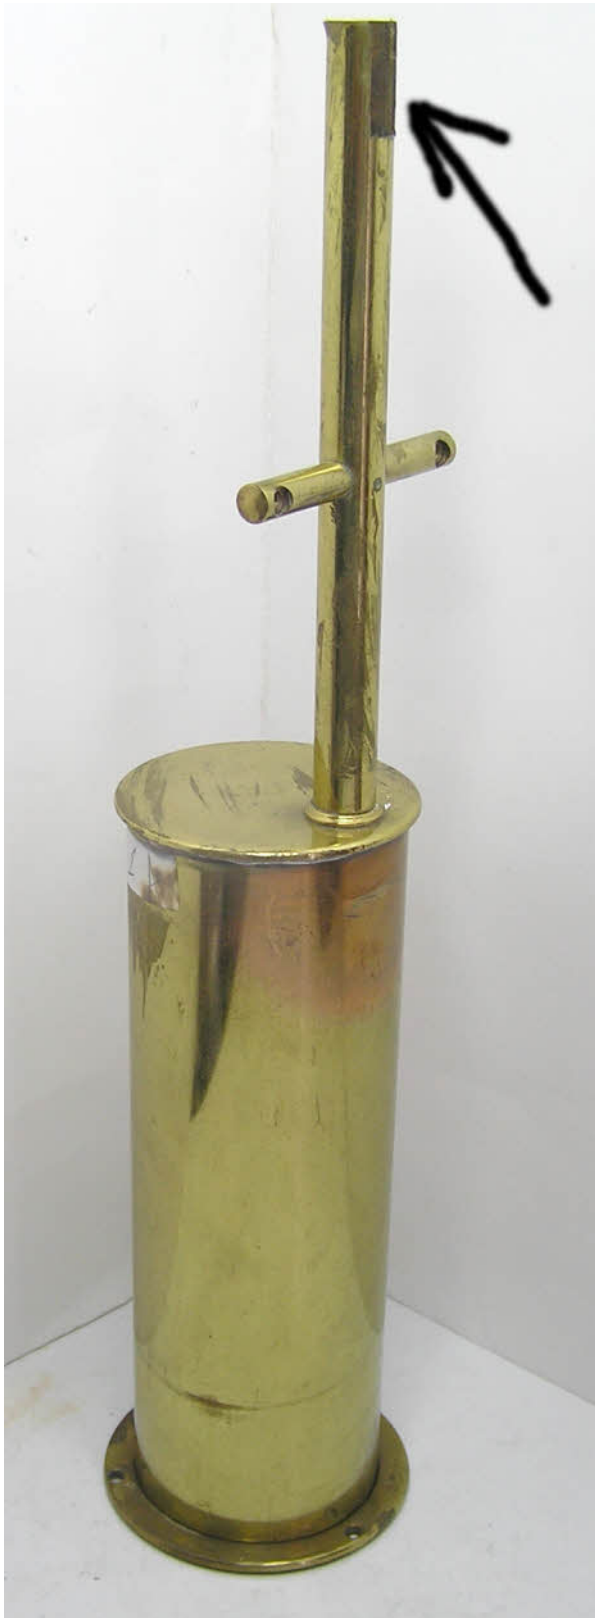
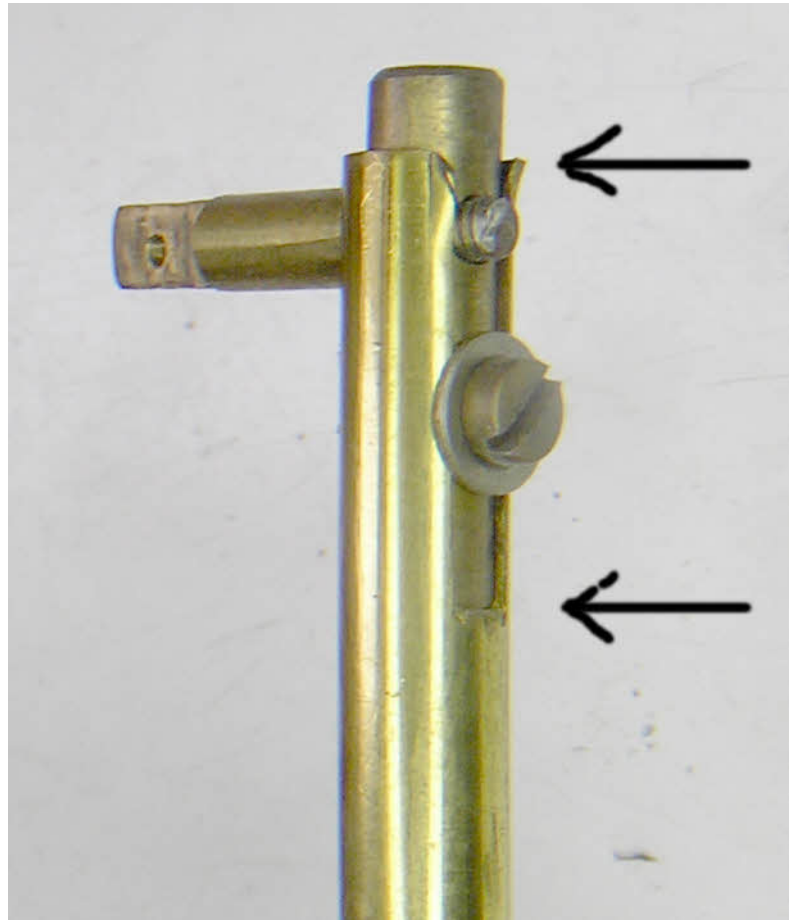
These two photos show the donor column. It had been discarded because the top of the frame had been destroyed by a "Bodger". The top cap has been removed and a long slot cut vertically (between the arrows) so that a solid brass insert could be slid up and down. This was probably to allow the pendulum length to be altered because the clock couldn't be rated through being unable to solve another problem elsewhere in the clock. This is all a waste of time really because the pendulum can only move a millimetre or two before the coil casing hits the magnet on the base. What a waste. I wonder what happened to the rest of the clock?

Anyway, all we need to do is remove the top cap from the column by melting the solder. We also need to do this on the recipient clock but this time we need to wrap a wet rag around the frame where it meets the column cap to stop the heat from also melting this joint.

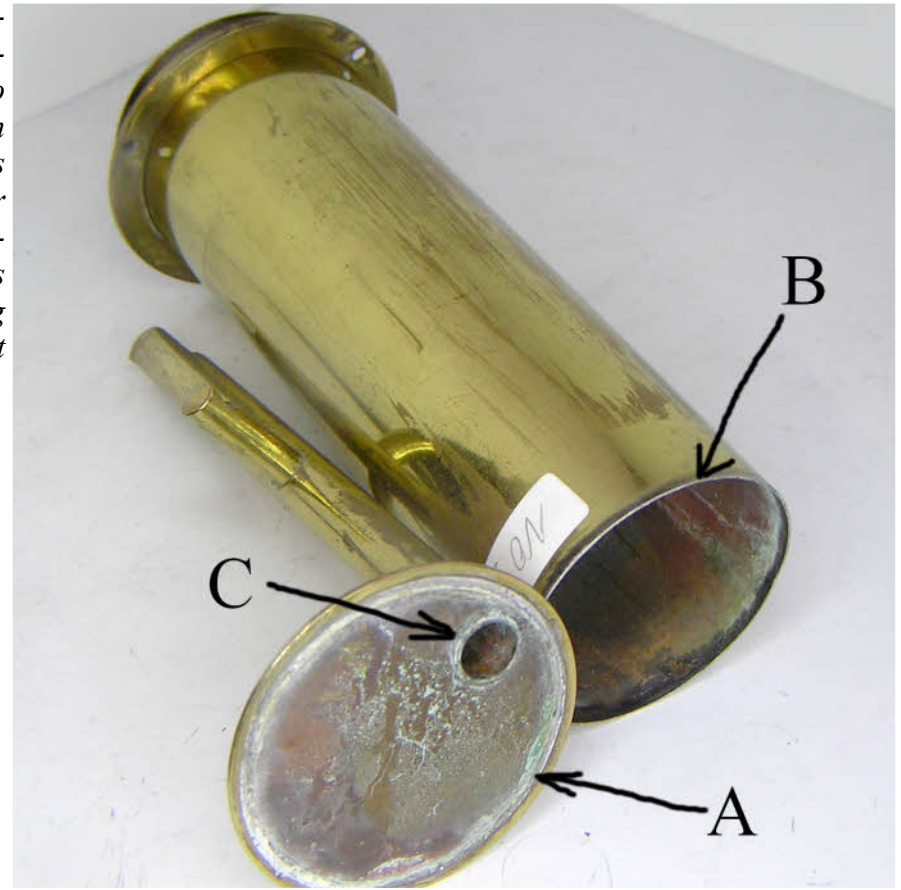
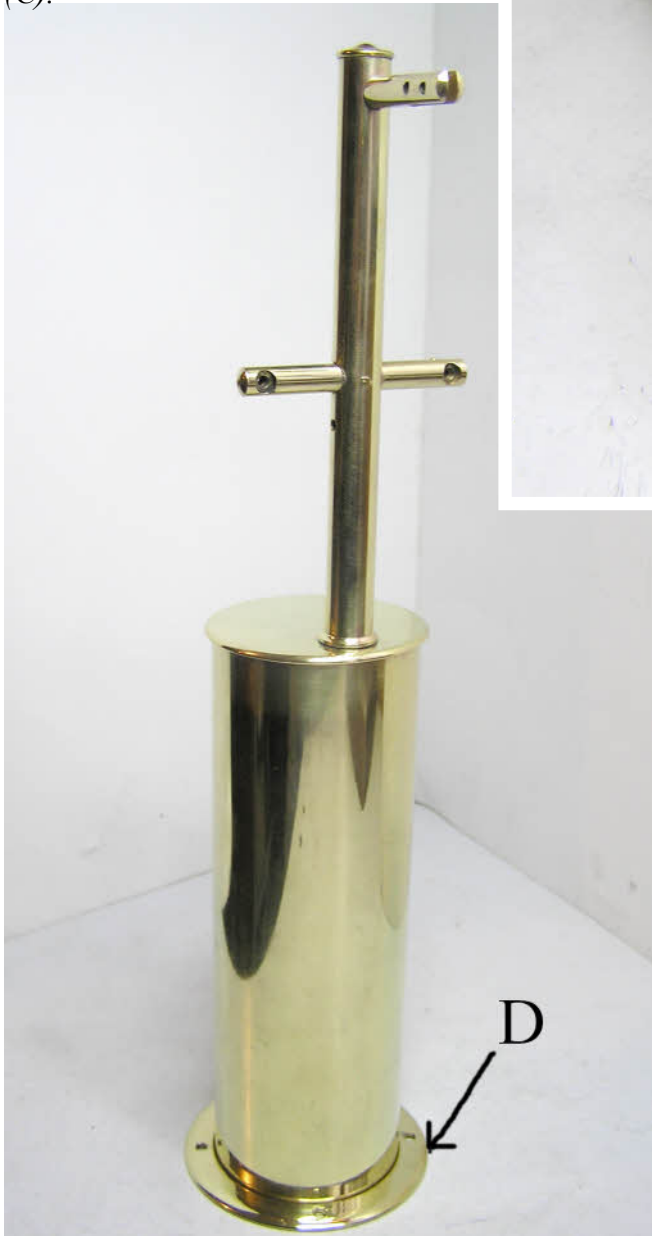
The top cap (A) removed from the column (B) by heating the solder and gently lifting. Note the groove in (A) to receive the column. The problem with the procedure is that the top frame is also mounted in the top cap by a solder joint (C) which we don't want to disturb in the recipient clock.. This is achieved by wrapping a wet rag around the frame just above the joint (C).

At left we see the donor column attached to the recipient top cap and frame. Both parts were first cleaned and degreased before attempting to re-solder the joint. Particular attention needs to be paid to the vertical posture of the top frame. It must not lean front to back or right top left. Remember, the pendulum is going to swing from here over a curved magnet! In case you do attempt this procedure, please remember to locate the loose securing collar (D) over the column before attaching the top cap (as I have neglected to do in the past).

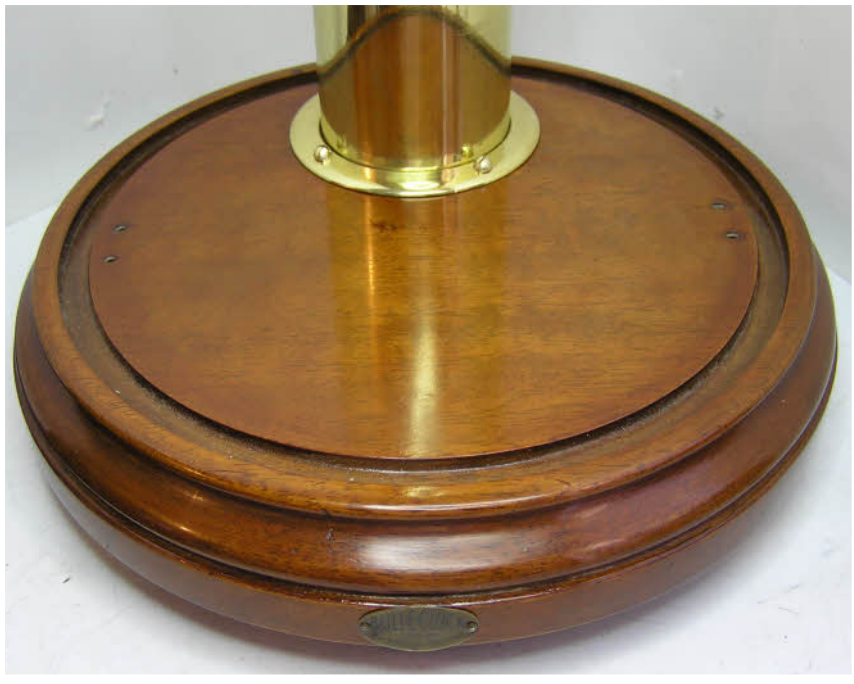
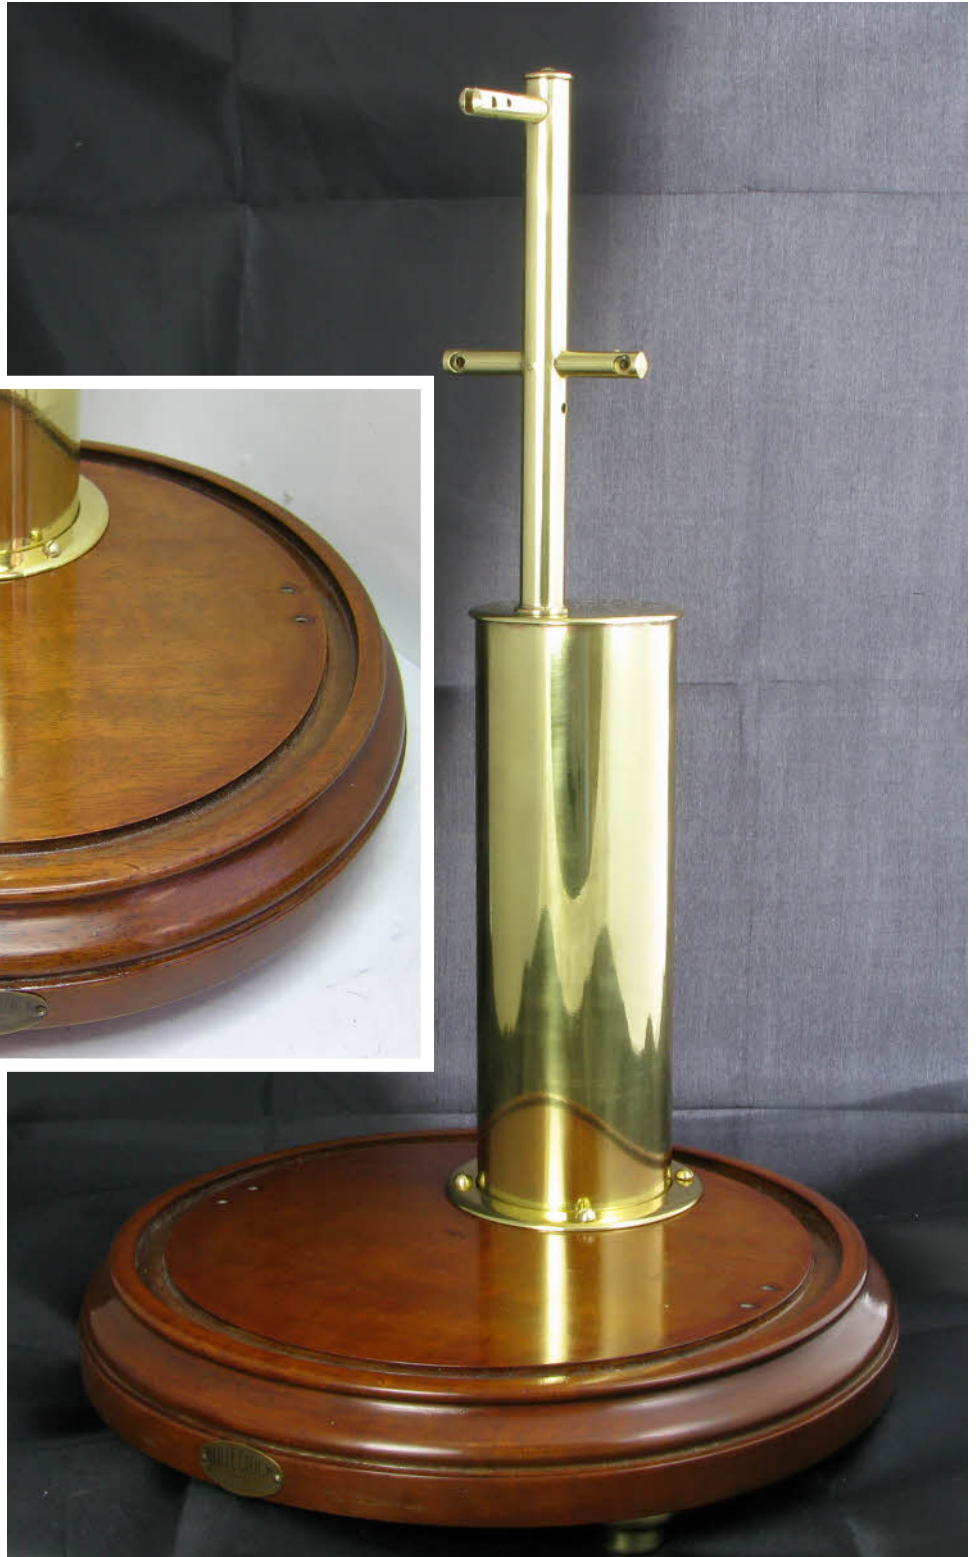
The photo on the right shows the column and polished base now reunited ready for the pendulum and movement..

Some "A" type bases have a decorative brass banding in the groove around the circumference. The give away is one or two holes at the back behind the column. In this case there are no holes present and so this clock had no banding.

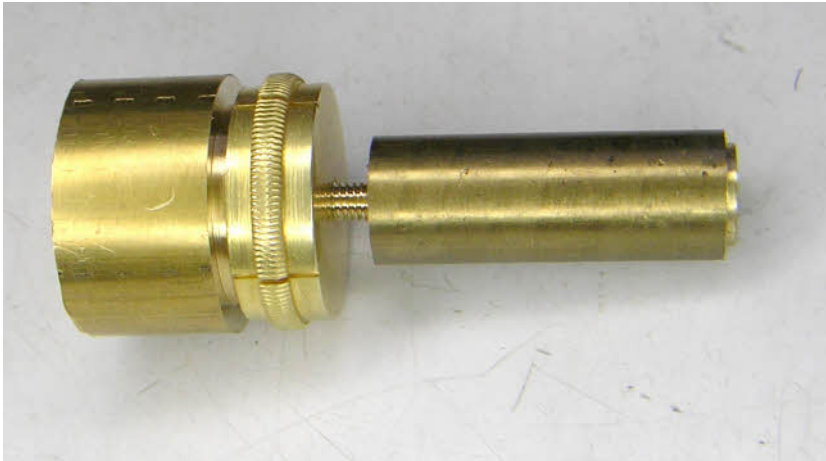
Checking the progress of machining the rating nut insert.

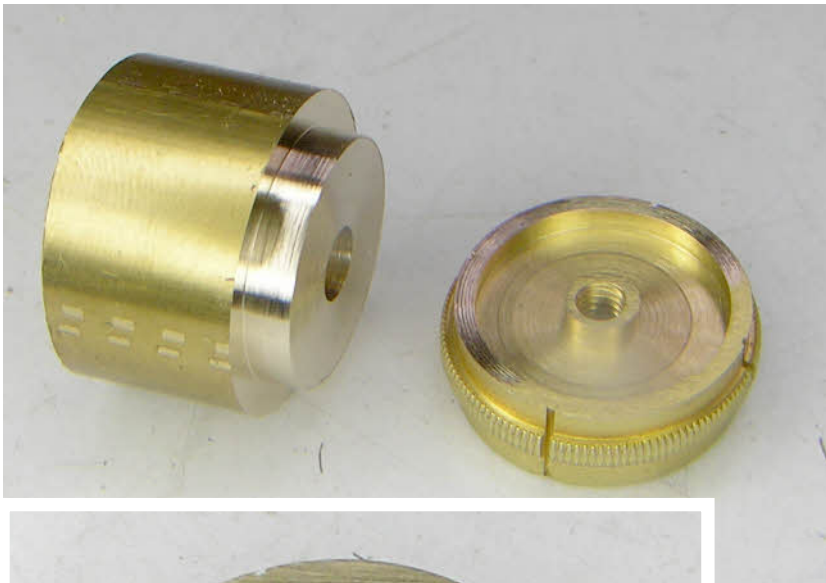
The insert ready to be inserted and machined flush.

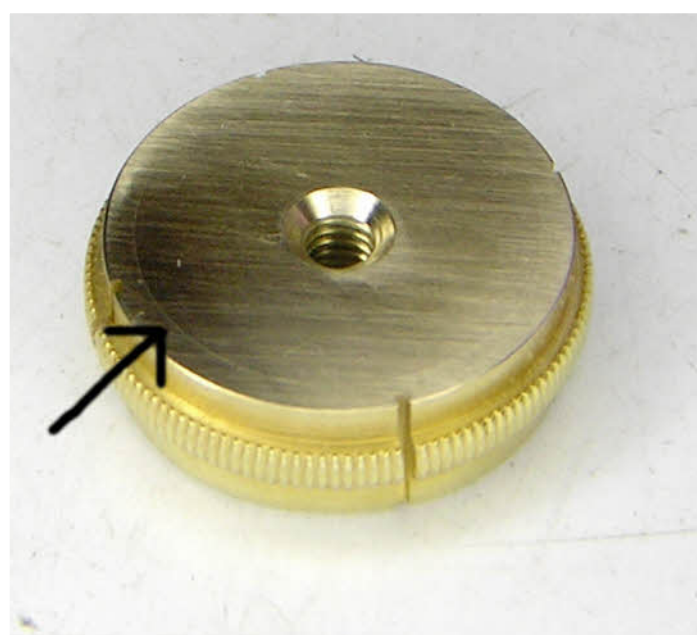
The finished nut. You can just make out the joint (arrowed) between the insert and original nut. The centre has been countersunk so the joint will not be so readily visible. Besides, this will be the underside of the nut and will never be visible. All that remains is for the whole thing to be polished and lacquered.

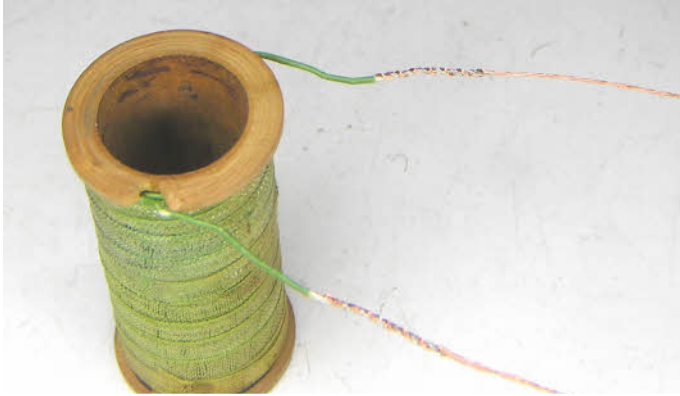
The coil with ribbon rewound and lead out wires cleaned up and extended

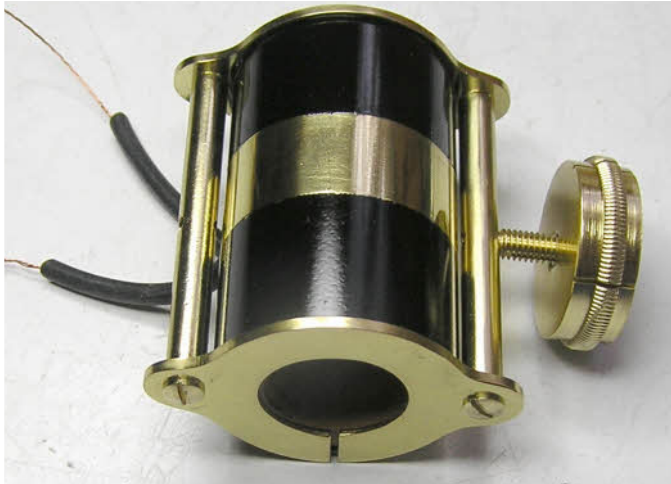
The coil back within the cover with new insulated sleeves. The cover has been cleaned, polished and re-sprayed as per original.

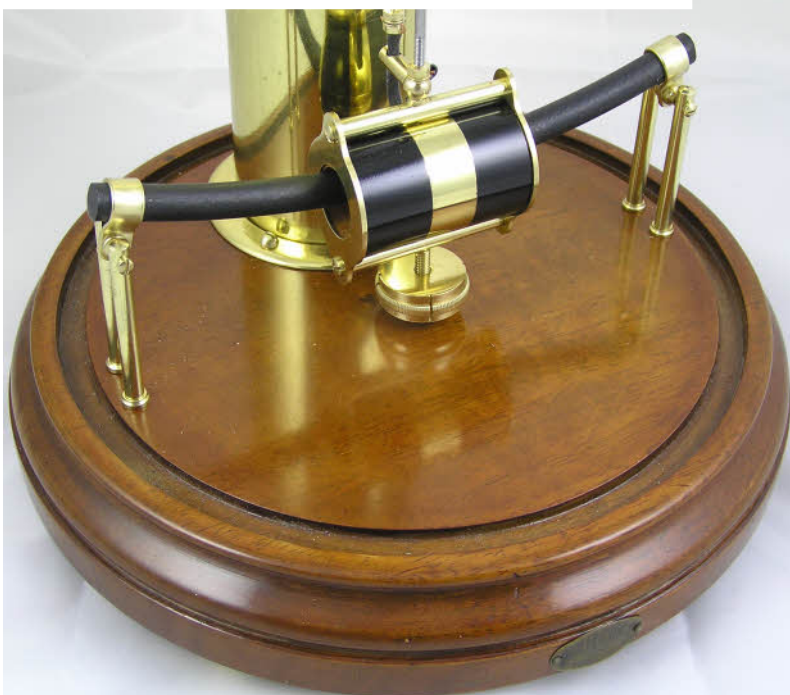
The magnet has been re-charged to read 180mm on the magnetometer and then polished with Grate Black. The pendulum and magnet assemblies have been re-mounted on the frame ready for the movement.
