Bulle Clock Serial Number 67438

*Restoration of Bulle Clock
Serial Number 67438*

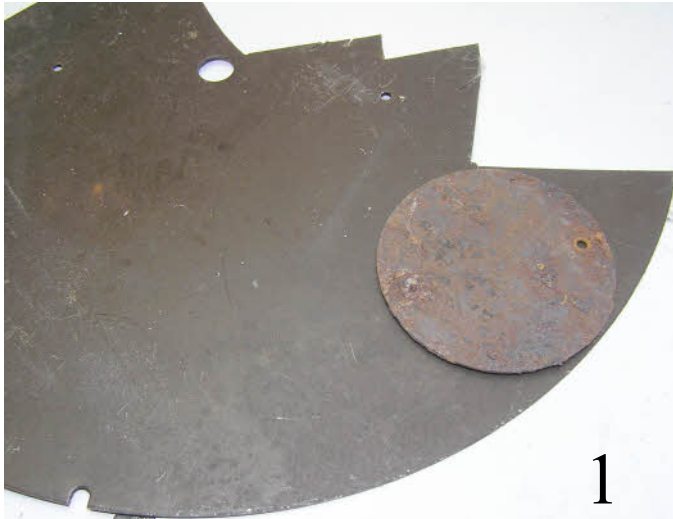
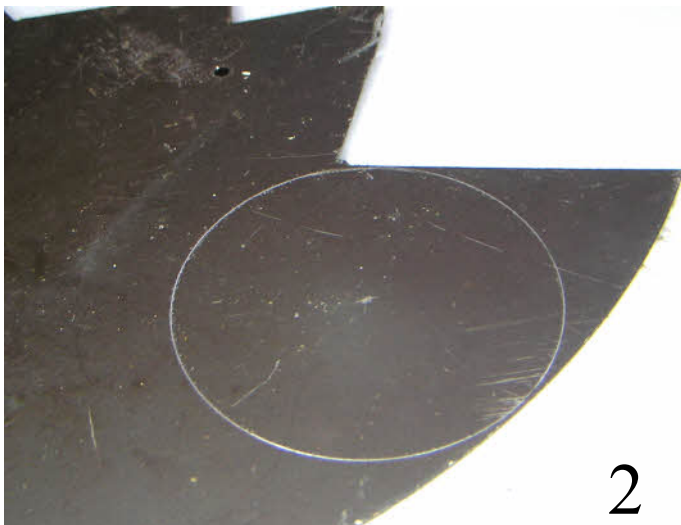
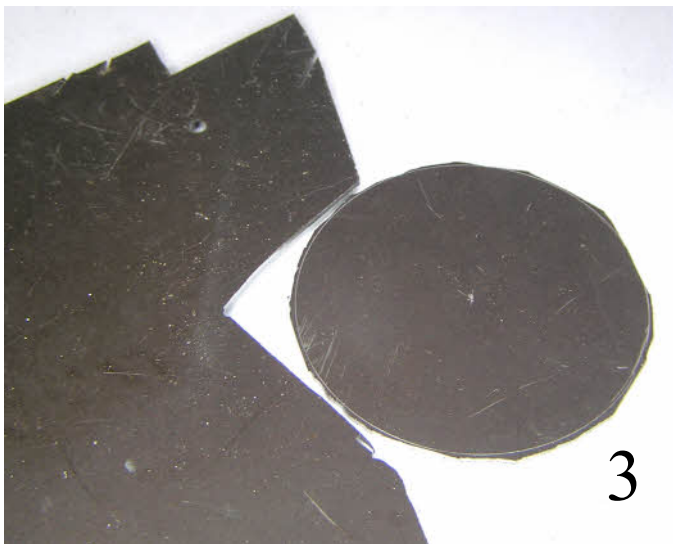
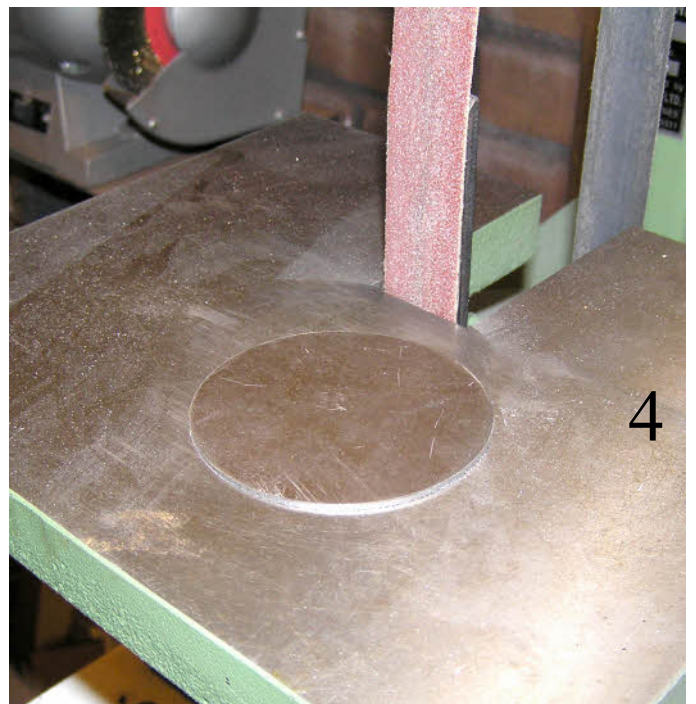
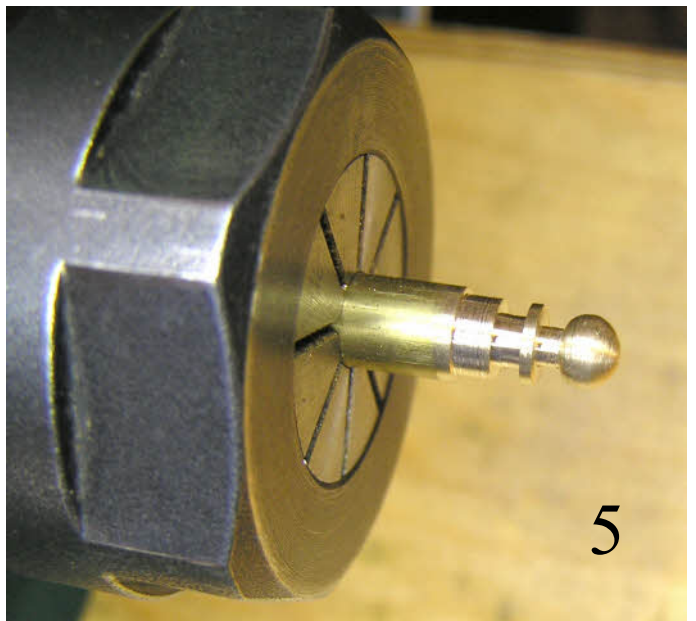
The battery cover now needs to be made. The sequence of events is shown here. I use 1.0mm steel from an old dial plate. It is the perfect thickness as per the original. An old cover is used as a template to mark out the new one. Photo 5 shows the embryo brass Knob in the lathe ready for parting off.

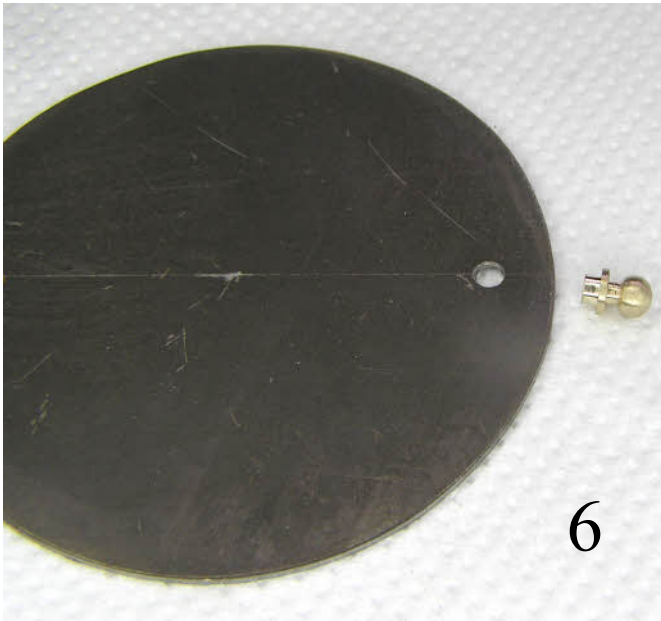
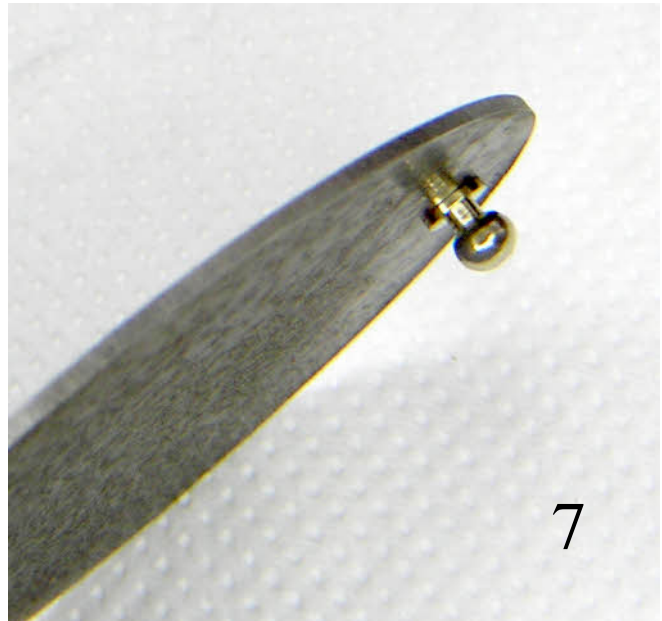
The brass knob finally riveted in place.

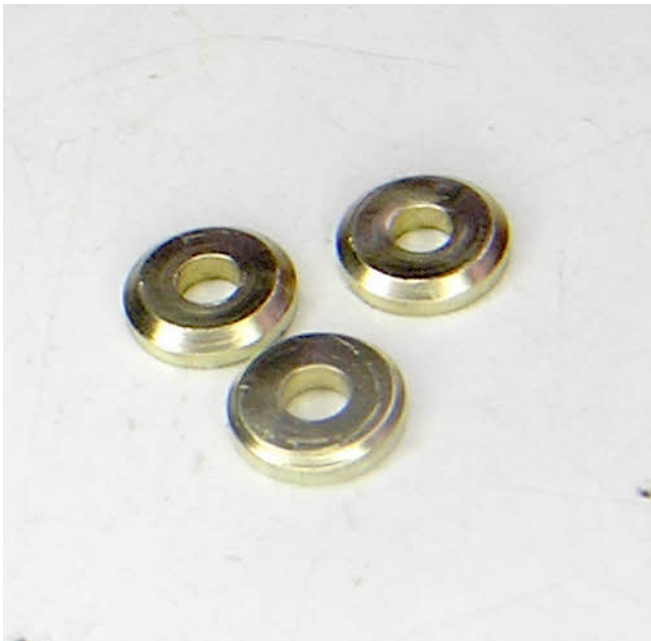
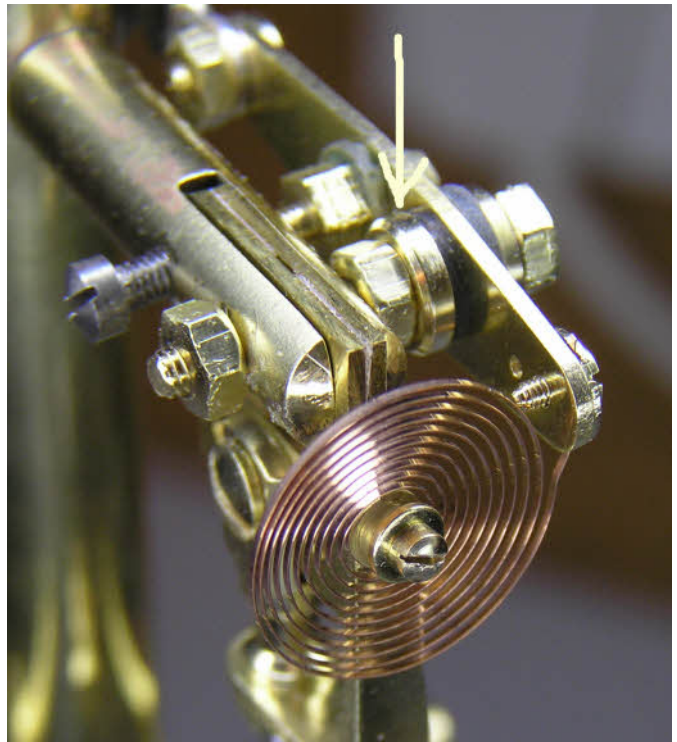
The three spacing washers required to finish the movement. The first was used on the pendulum contact assembly shown in the photo on the right. The other two were used to correctly space the movement onto the frame.

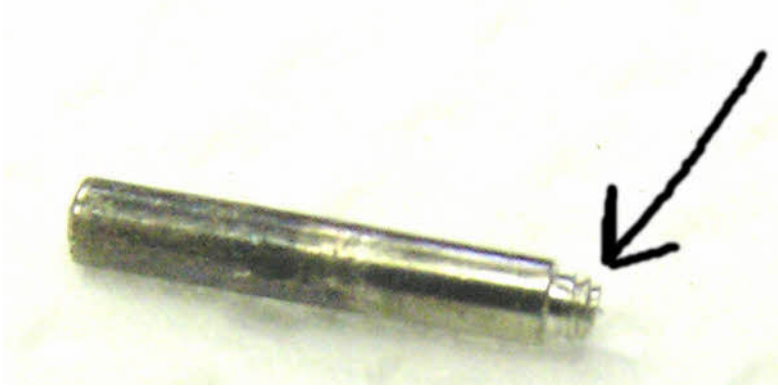
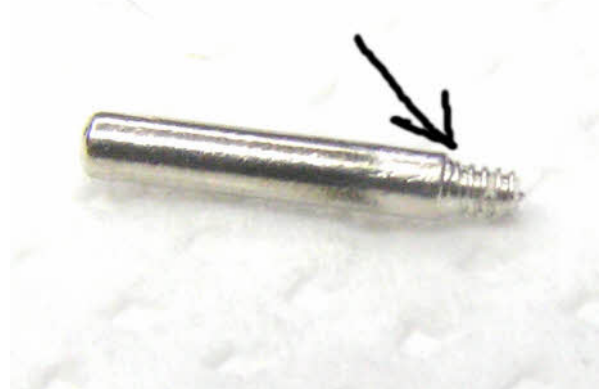
The contact pin was held in by just one thread. The replacement silver contact pin is shown on the right with four threads.

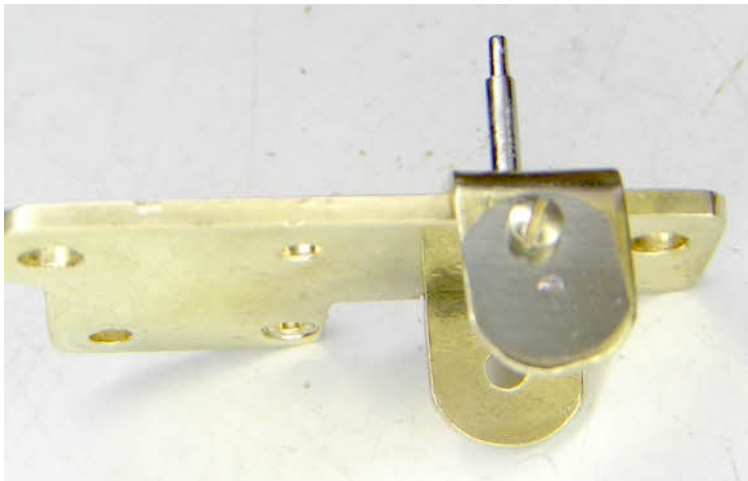
The photo left shows the original count wheel arbour bottom plate. I cleaned it up to have a detailed look. After polishing out as much wear as I could, I decided it was still very usable if turned upside down to present a new bearing surface. You can see the original dimple caused by the count wheel arbour.

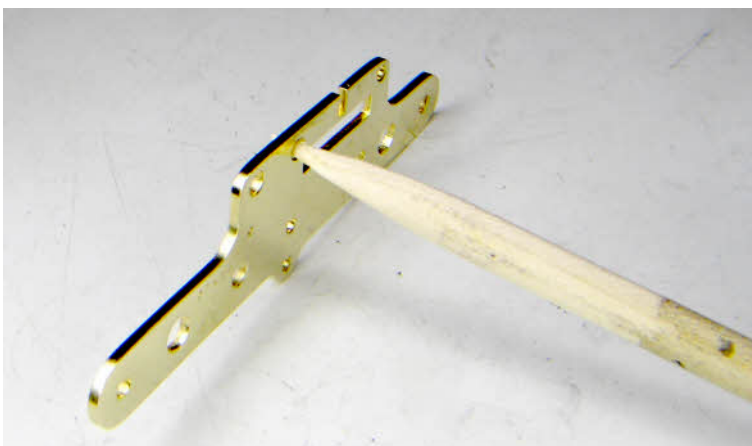
Even though the Bulle is an electric clock the movement still needs to be cleaned and repaired just as a mechanical one. This photo above shows "Pegging out" the pivot holes.

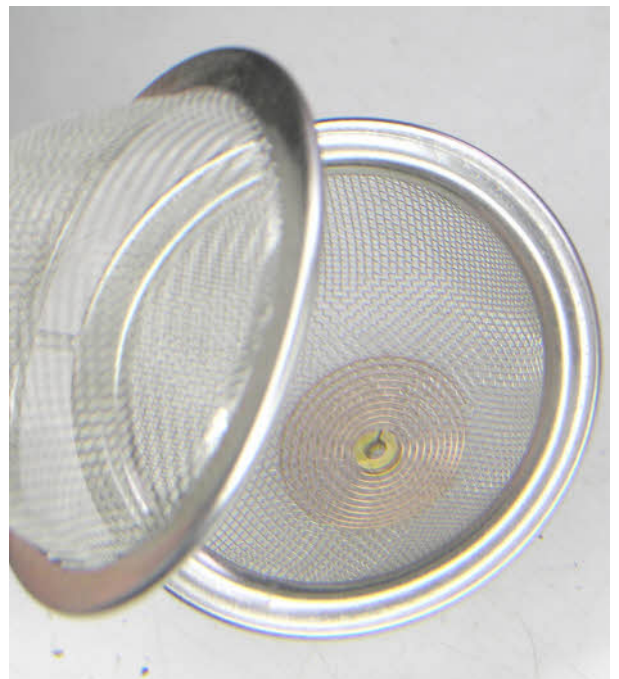
This photo shows the method of holding the hairspring for cleaning in the ultrasonic tank.

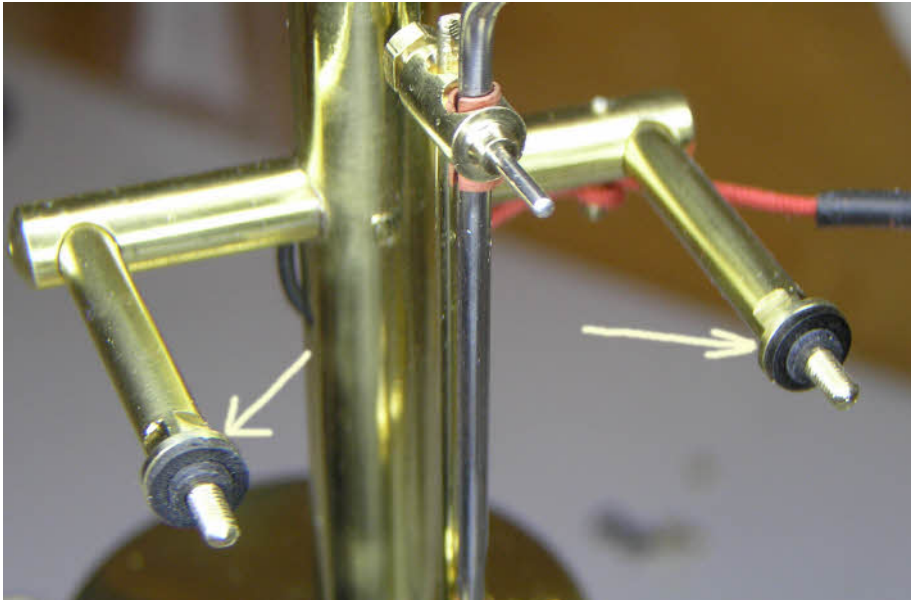
The frame ready to accept the cleaned movement. Note the two new spacing washers (arrowed).

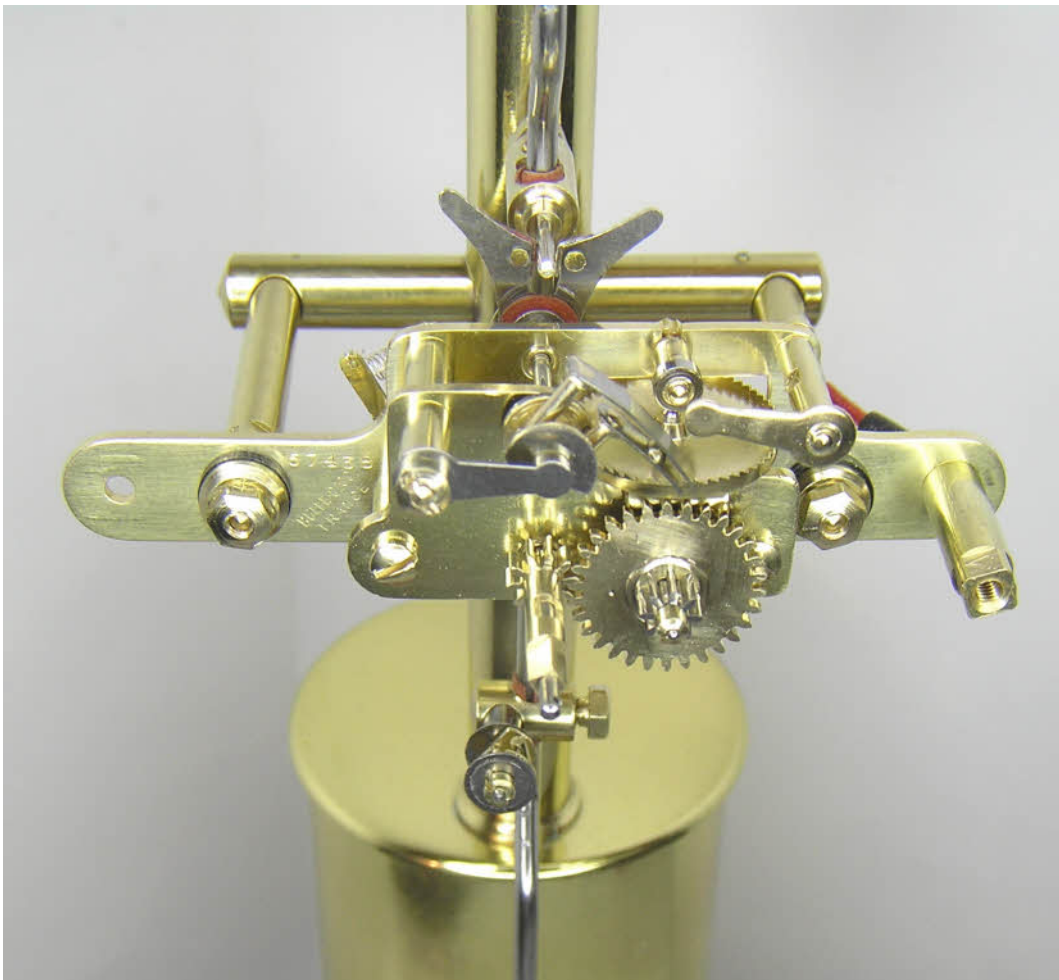
The movement mounted in the frame with the pin positioned in the fork.

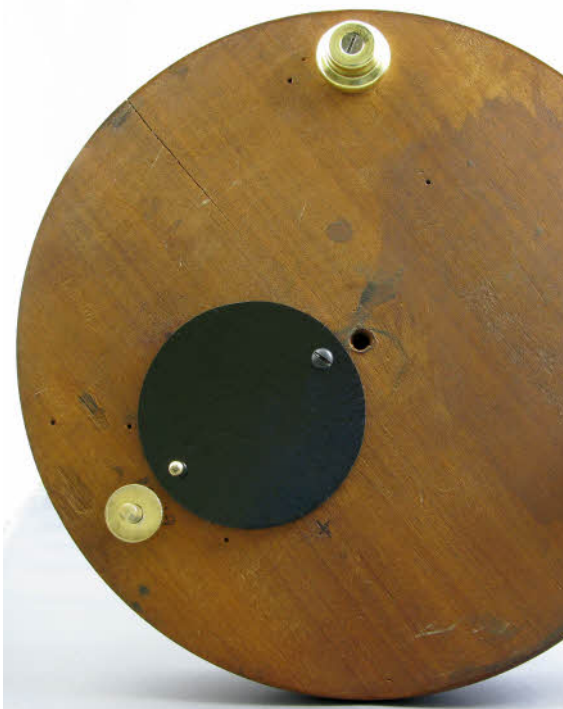
Above - The new battery cover

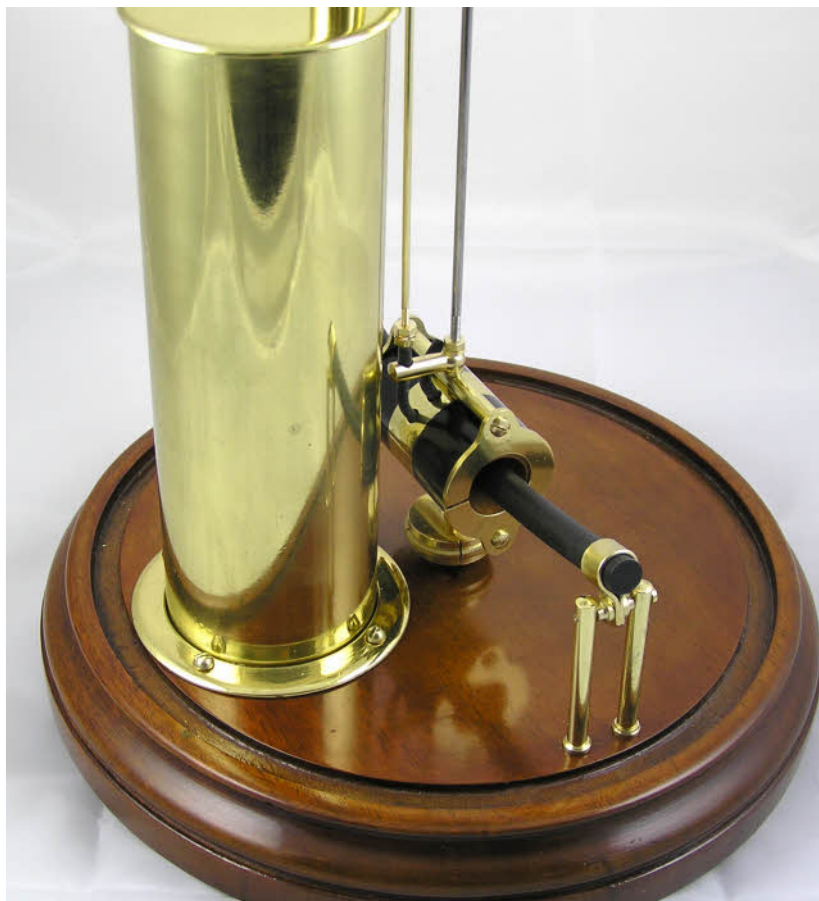
Above we see the new column in place on the finished clock

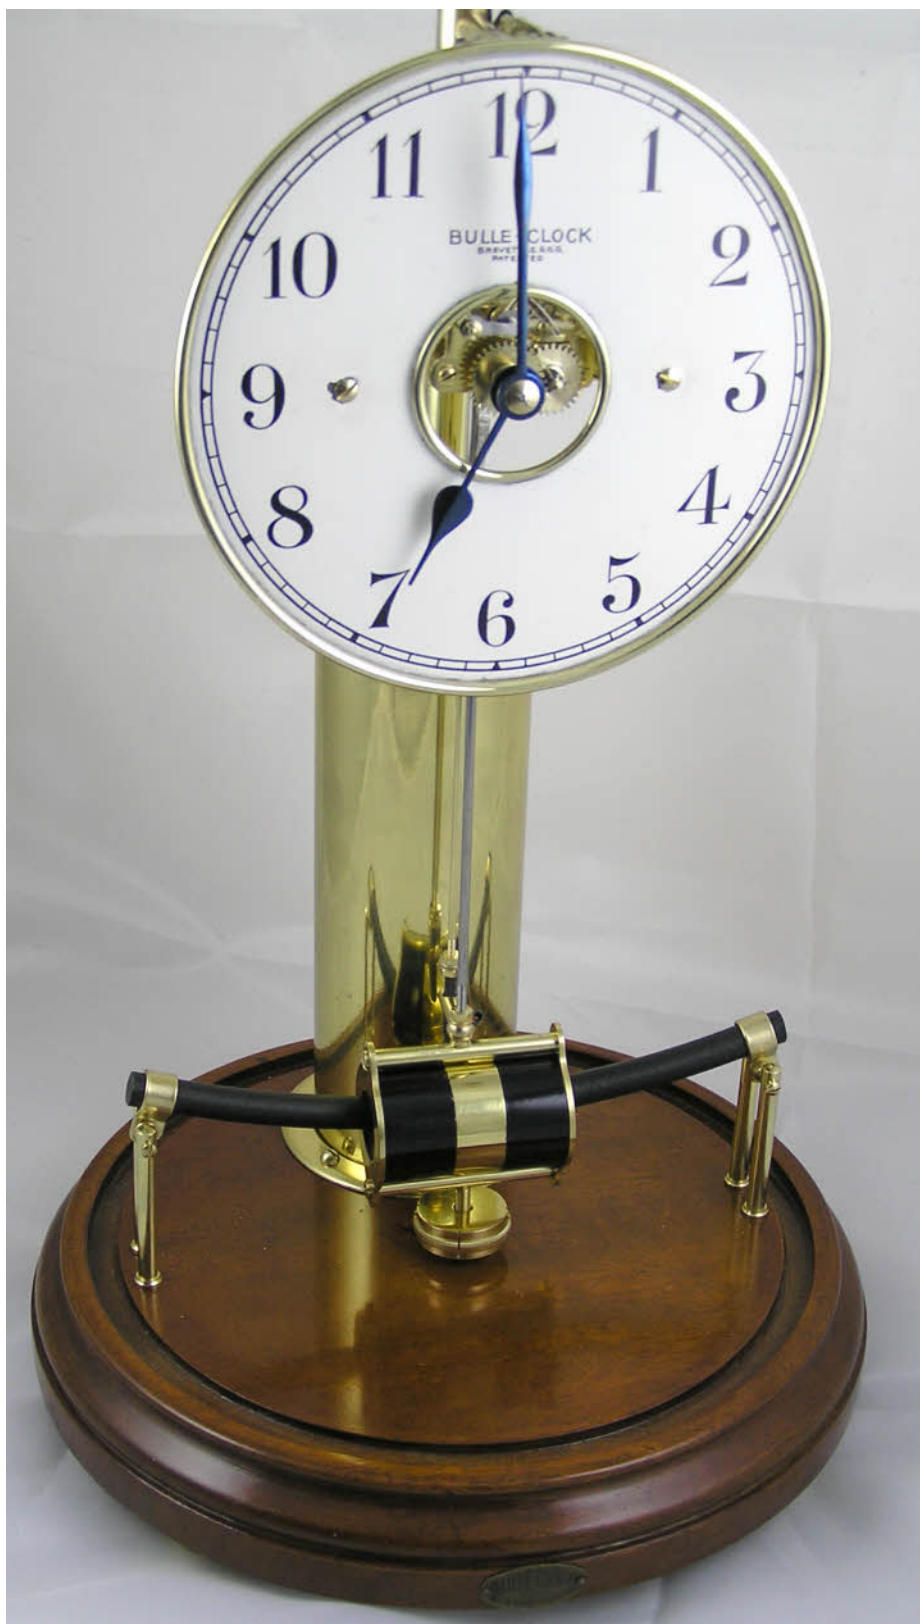
The completed clock
