Horologix

Restoration of Bulle Clock Serial Number 7221

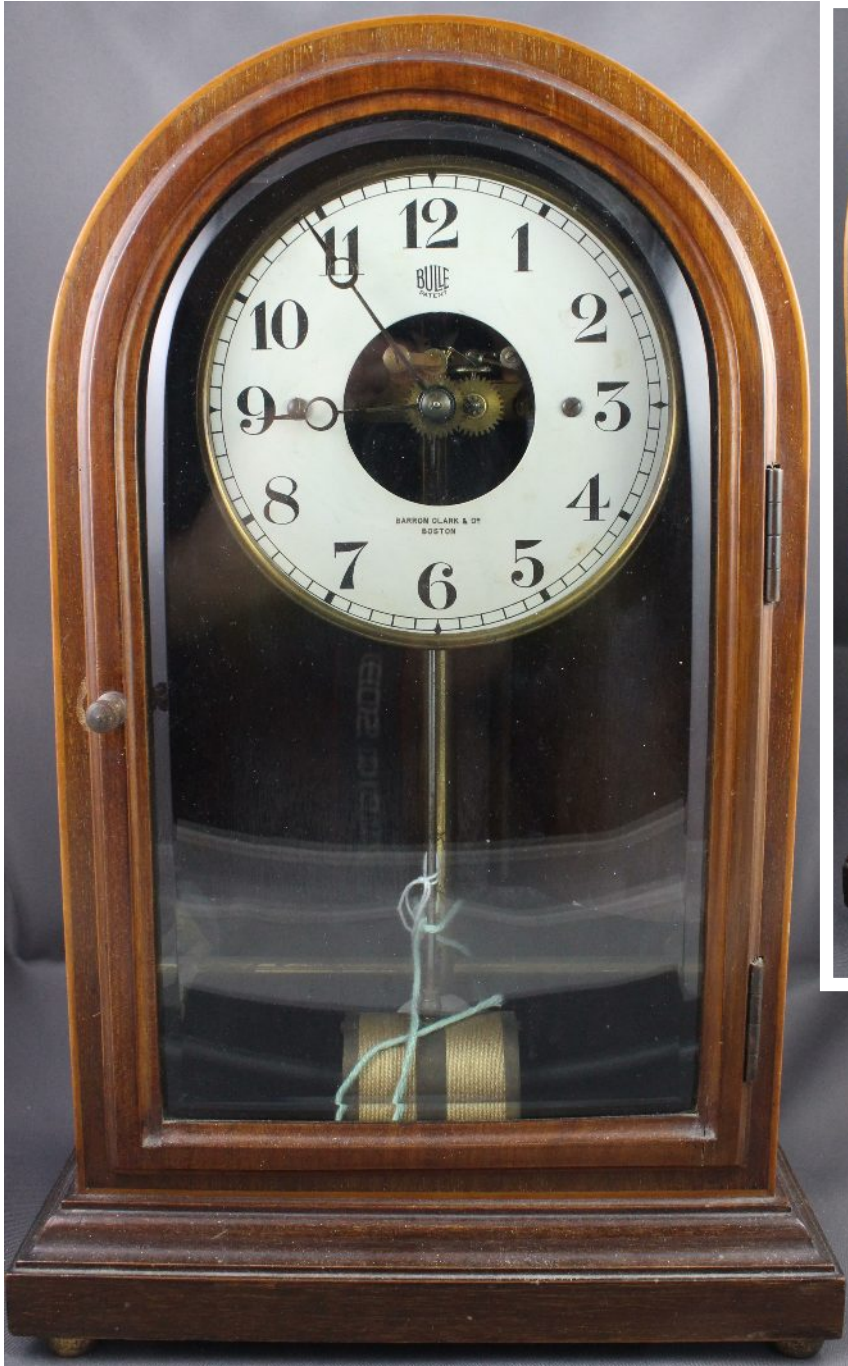
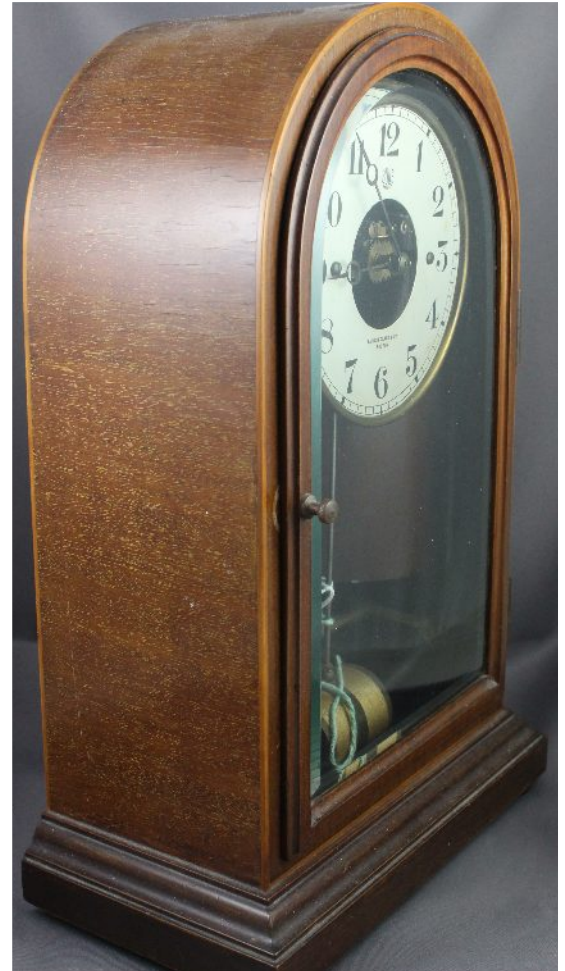
Photos by kind permission of the owner. A tall movement Bulle with a 0.50 beats per second pendulum in a mahogany veneered round top case with fully glazed front door. The glass is thick and bevelled. A small rear door houses the battery. Overall the clock looks to be complete and in good condition. The wood case is a little dry and will need a few good coats of beeswax to feed the wood.

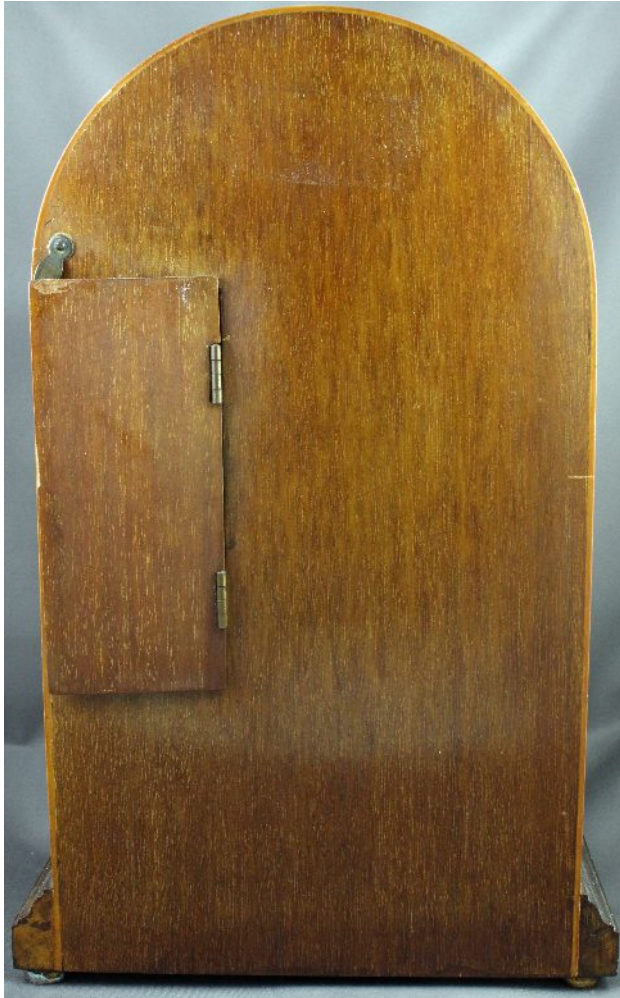
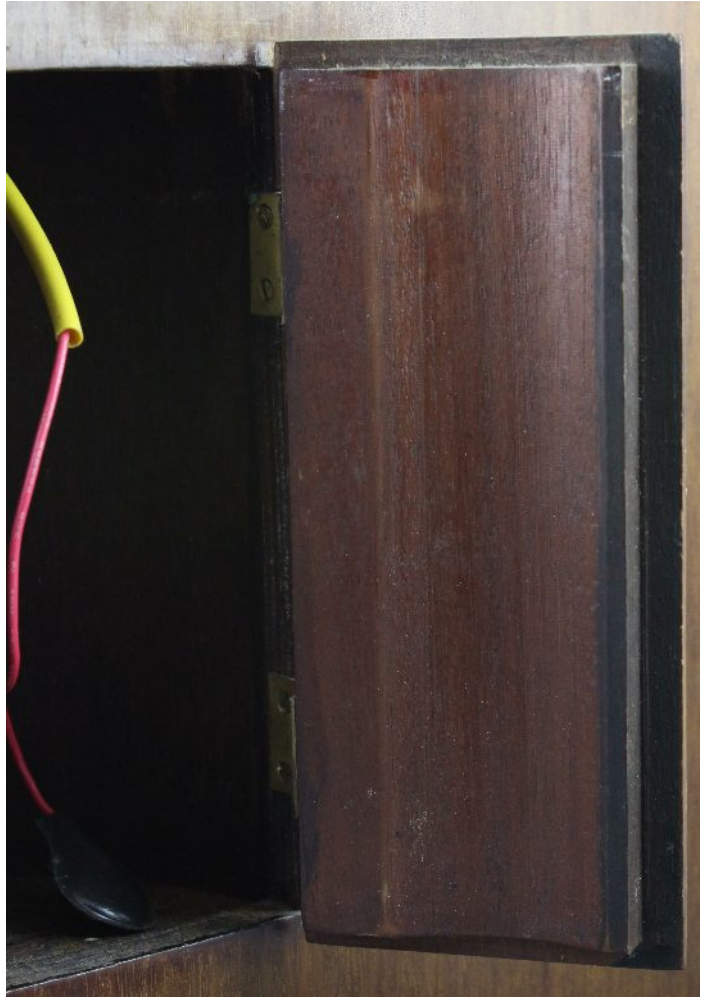
It's interesting to note that even though this clock is of the same design as the closely related s/n 7421, there are small differences. In this case the rear battery door has a machined recess to accept the battery. The door is much thicker than the one on s/n 7421. Note in the photo at top left that the case levelling foot is missing

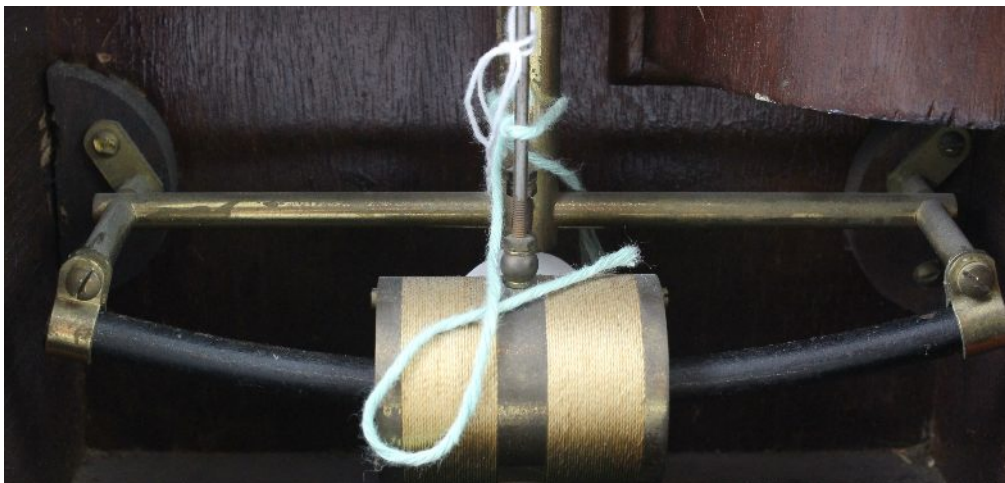
The pendulum bob looks to be intact .

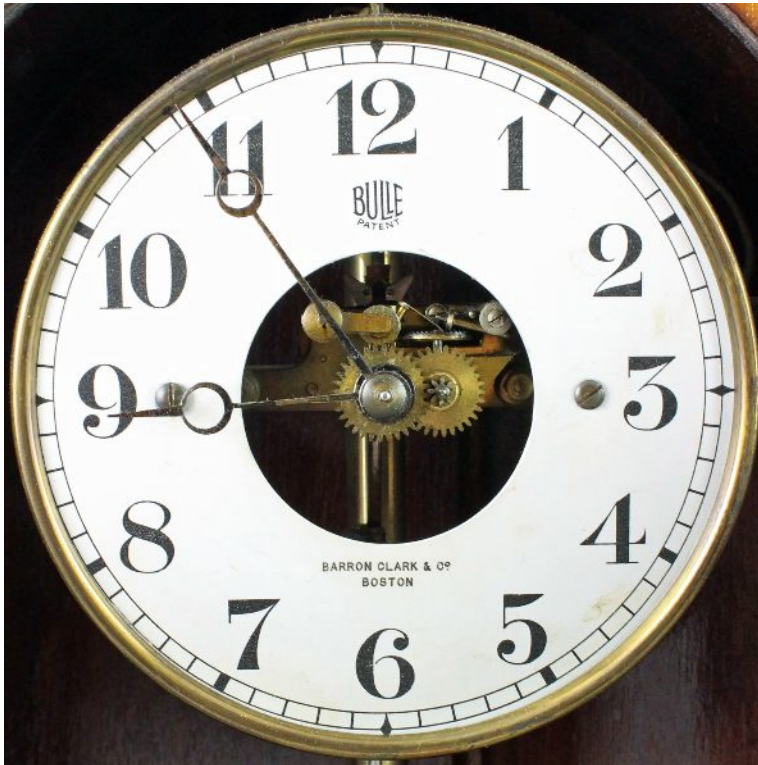
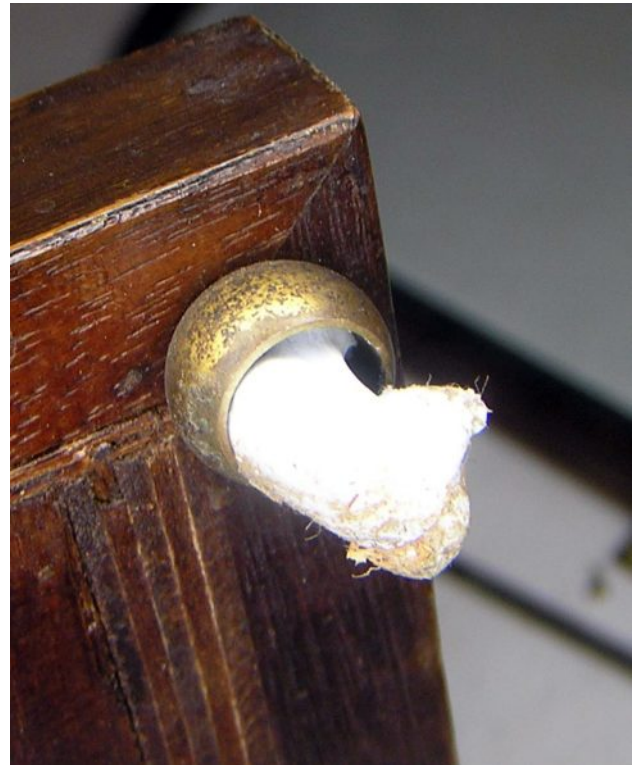
The dial above is in very good condition with just the brass in need of a polish. In the photo right above can be seen what I think is a white "Bluetak", probably used to stabilise the clock on a shelf.

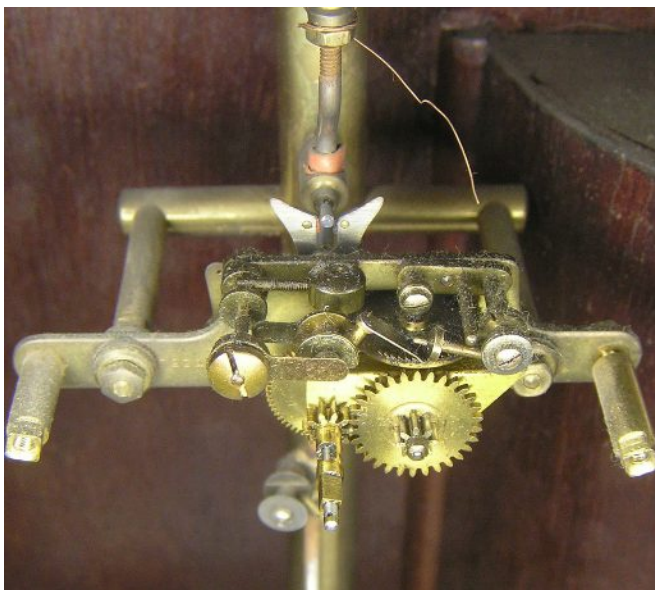
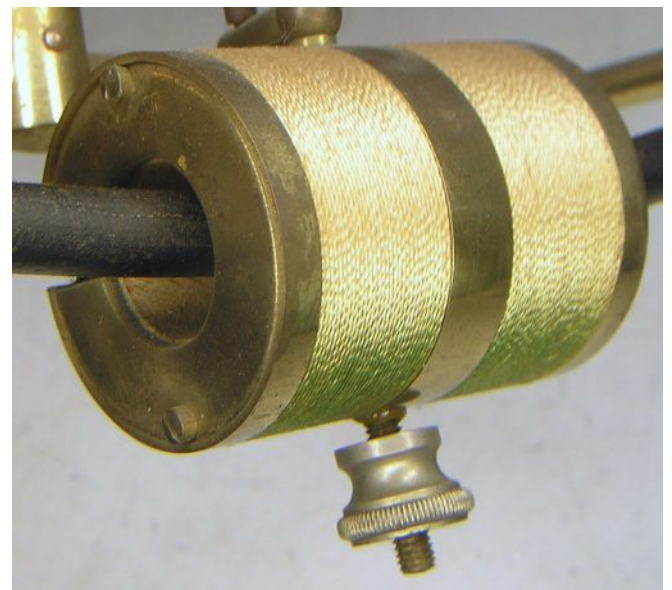
Below left is a shot of the movement before removal. All looks to be OK bar the dirt and oil. Below right is the pendulum coil with a replacement rating nut. It was probably changed to try and lighten the pendulum to try and make it run faster.

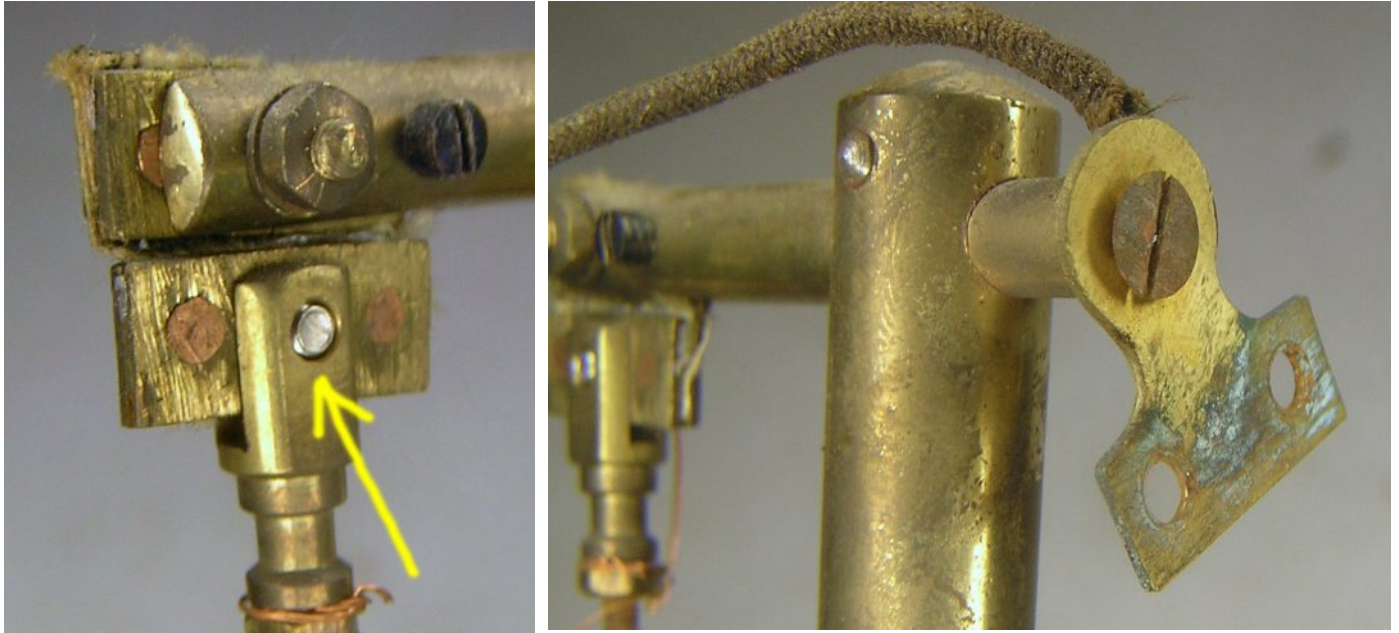
Above left is the suspension which as a problem in that the lower suspension screw is a replacement which has unfortunately snapped off and has been riveted through to keep it in place. This will need replacing or the screw removed. Above right is the negative electrical connection from the battery. It can be connected anywhere on the frame but this point will be hidden behind the dial at the back of the case and won't be seen.

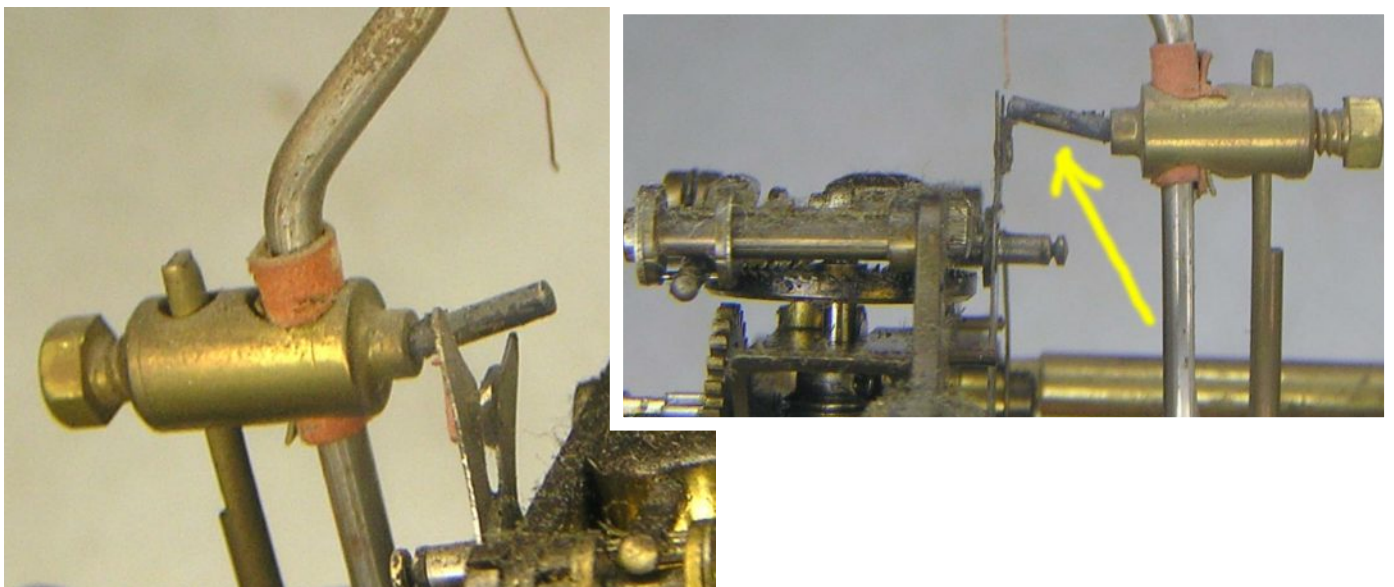
These two photos show the bent silver contact pin. Even though it looks bad, it can easily be bent straight if help in the correct position and bent back slowly.

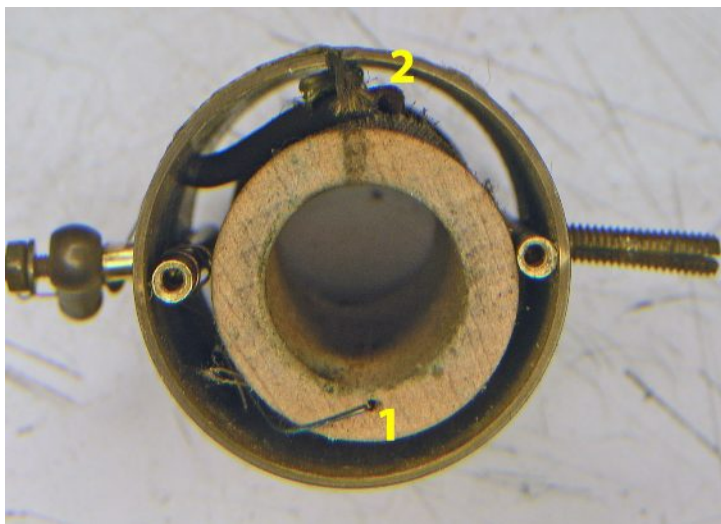
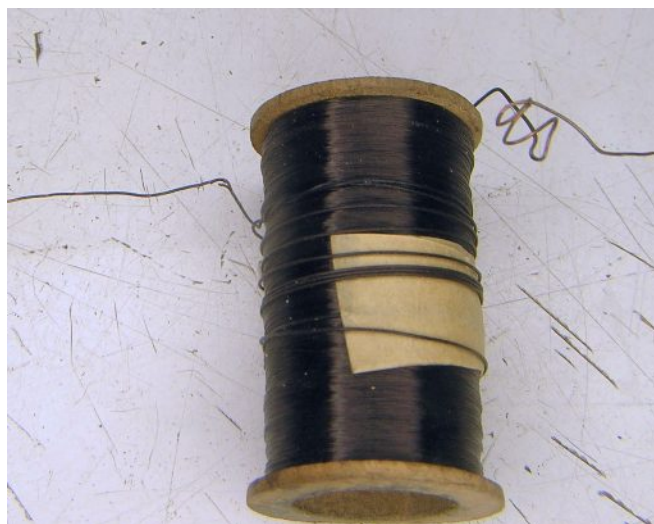
Above left is the pendulum bob with the cover removed. The lead out wire from the beginning of the coil winding (1) which exits through a hole in the wooden bobbin, is wound around one of the cap spacing rods, whilst the other lead out wire from the last turns of the coil (2) are insulated and exit the casing at the top for connection to the brass rod which runs from the bottom of the pendulum right up to the contact pin assembly. If the lead out wire from the beginning of the coil breaks then unless there is enough wire protruding through the wooden bobbin to enable a new joint to be made, then the whole coil will have to be rewound.

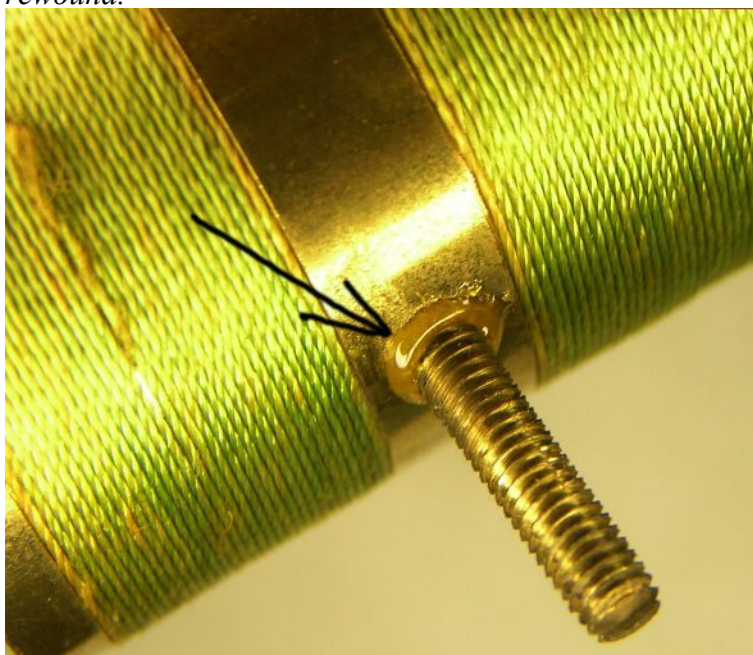
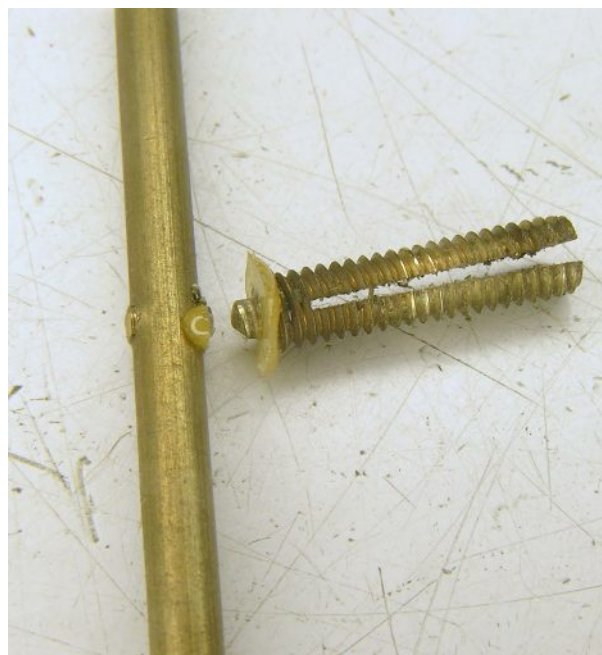
The stud upon which the rating nut screws up and down was found to have a ring of glue around its base. On closer inspection it was found that the stud had in fact snapped and was glued back in place. It didn't take any force to separate the parts so the rating nut could not have been used that much. Another item to be repaired or replaced.

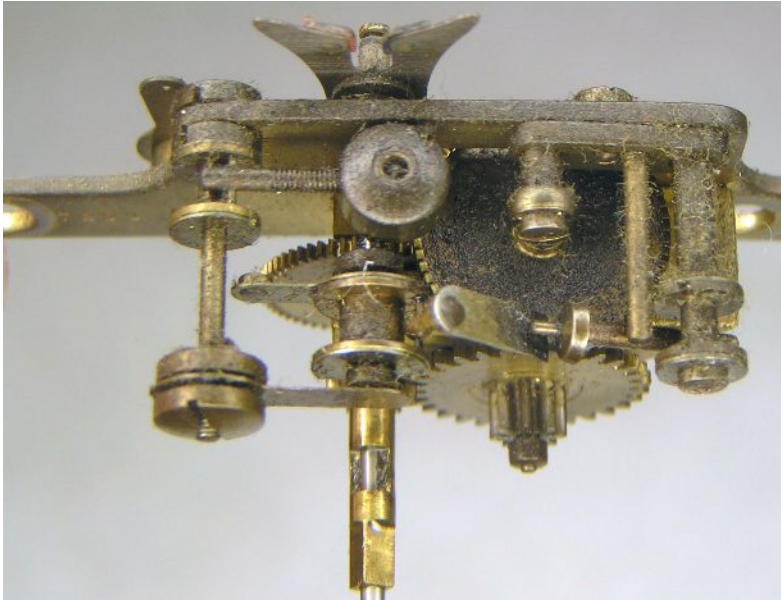
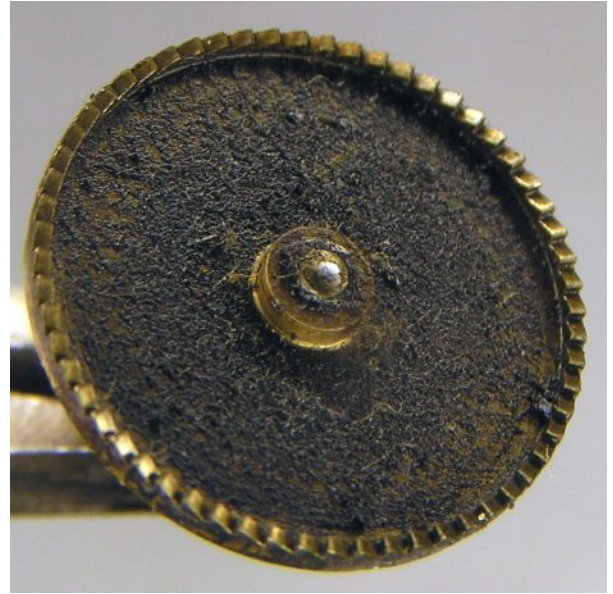
The photos above show the state of the movement especially the count wheel which is thick with oil and dirt.

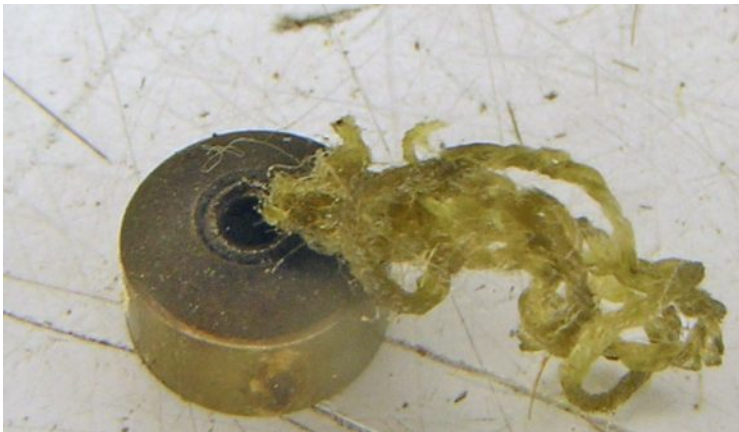
At left is a shot of the damper with the cotton cord partially removed. This will all need removing before insertion in the electronic cleaner.

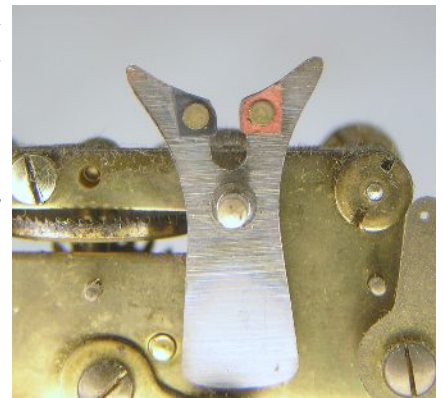
Although there is some wear on the fork contacts above, there is still plenty of mileage left in them and it wont be necessary to change them.

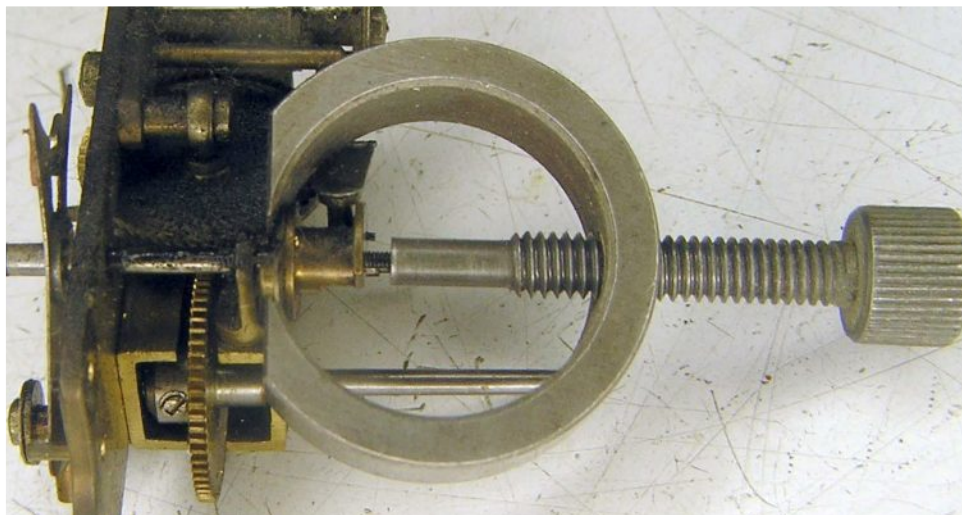
At left we see the correct method of removing the pawl bobbin. DO NOT ATTEMPT to remove the bobbin by any other method as the arbour is very hard and will snap easily. I get a lot of calls about replacing these broken arbours. You have been warned:)

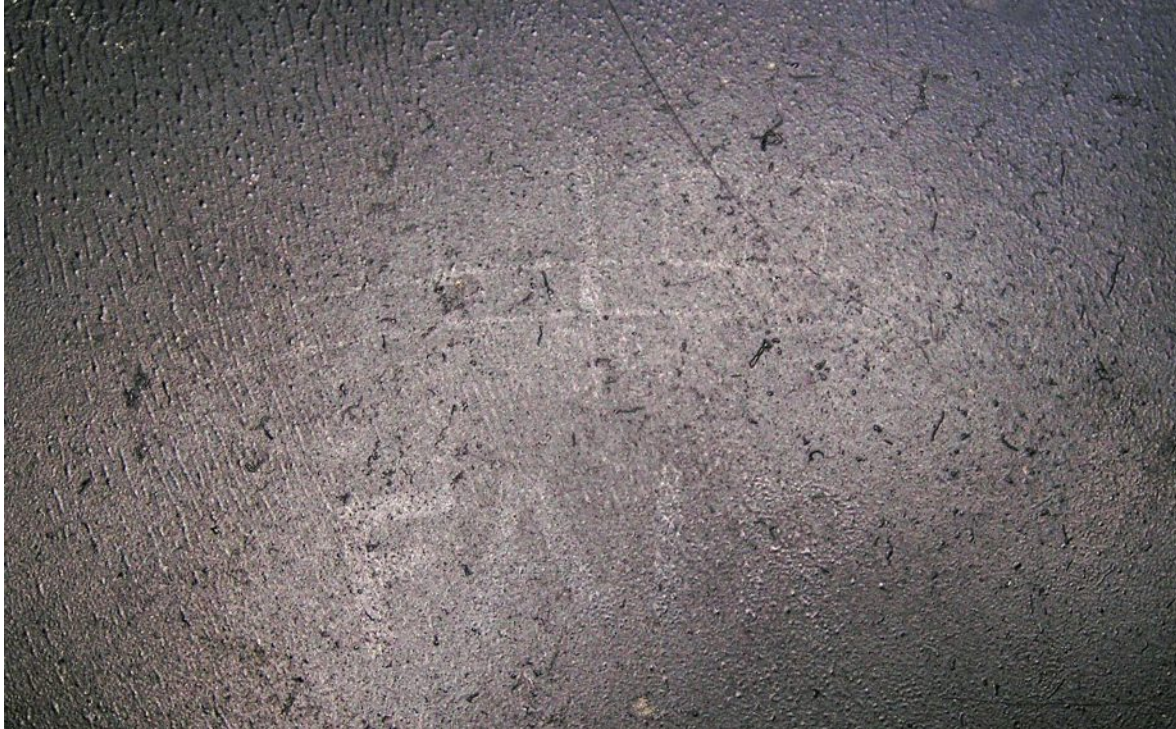
This photo of the bottom case cover is interesting in that it looks original but has been made from a barometer dial. You can just make out the word "FAIR" and the graduated markings around the outside.

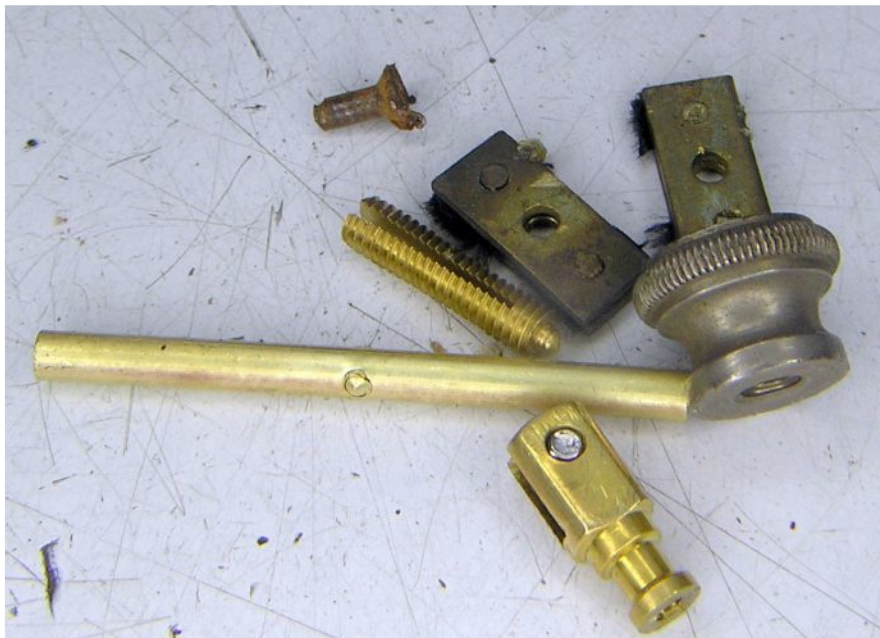
At left are all the parts that will need replacing or repairing.

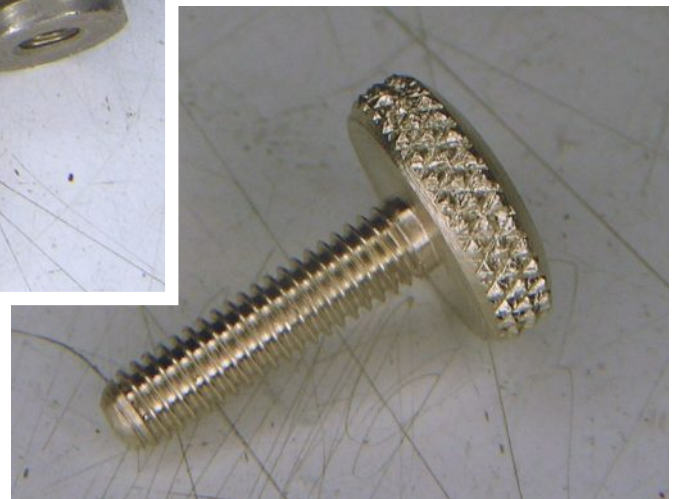
At right is the new case levelling screw turned up on the lathe.

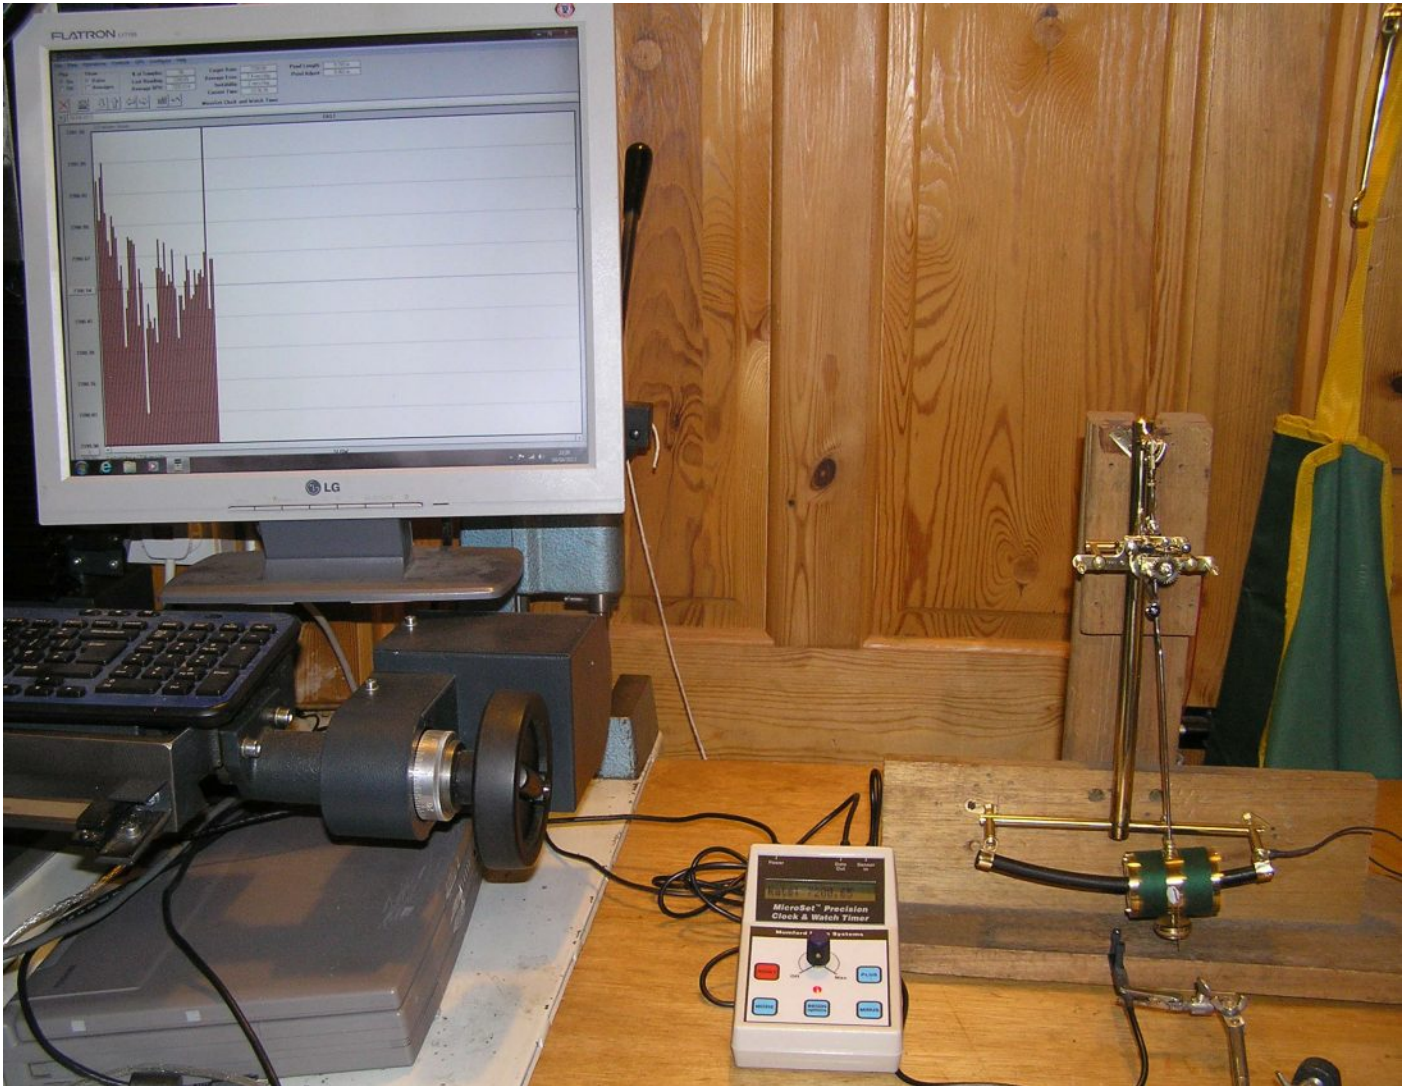
Above can be seen the clock on a wooden test stand being regulated with the "Mumford Microset Precision Timer". This device makes calibration of Bulle and Eureka clocks a doddle.

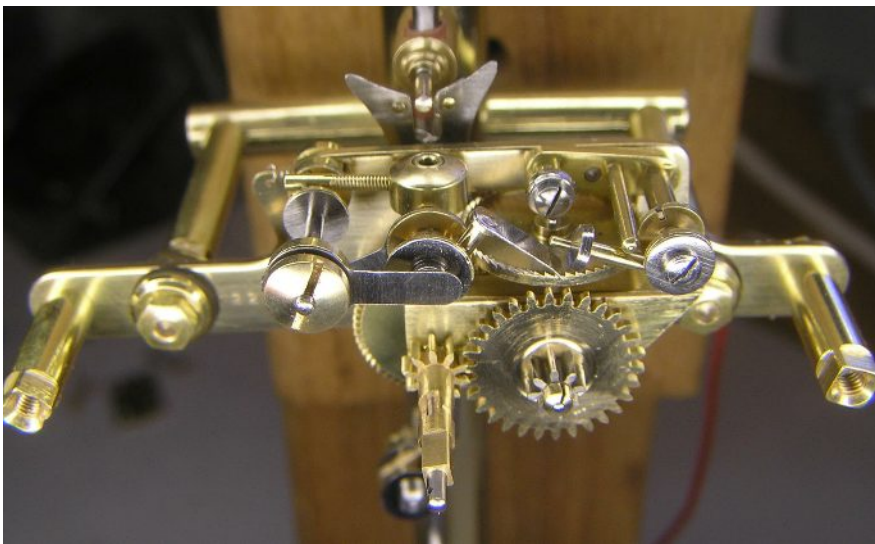
At left can be seen the movement cleaned and polished with the damper refilled with clean cord and one or two drops of watch oil.

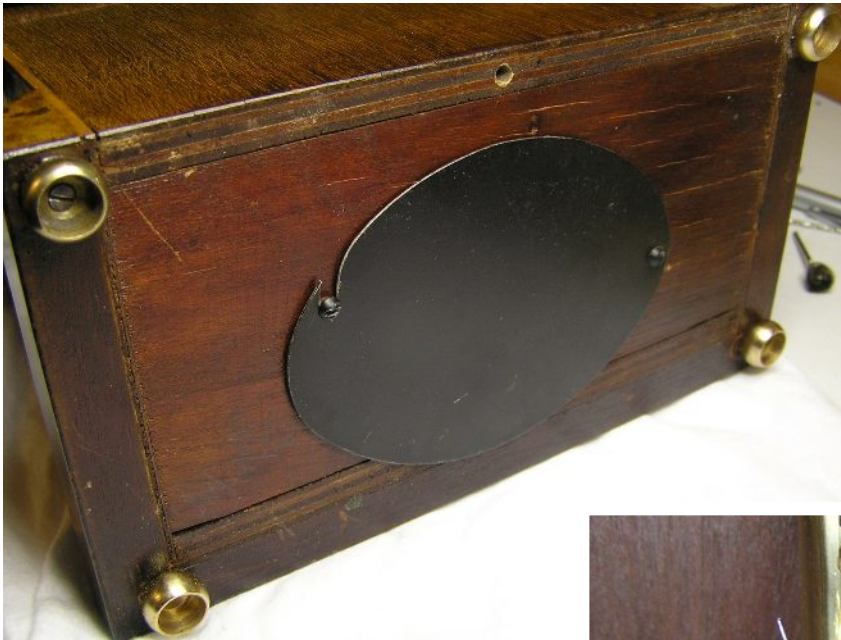
Above is the base of the case with the Barometer dial cover. Top right I sthe new levelling screw in place.

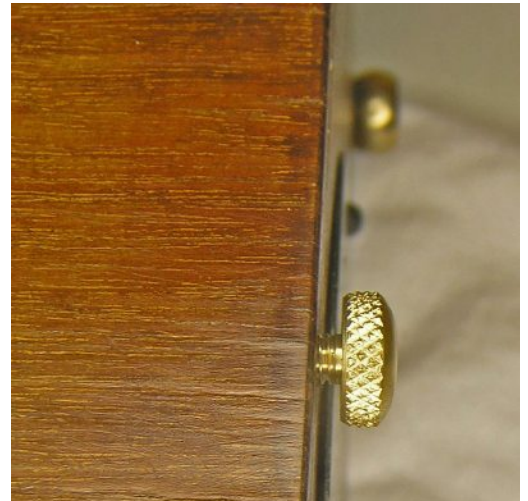
To the right is the movement back in place in the case ready for the dial.

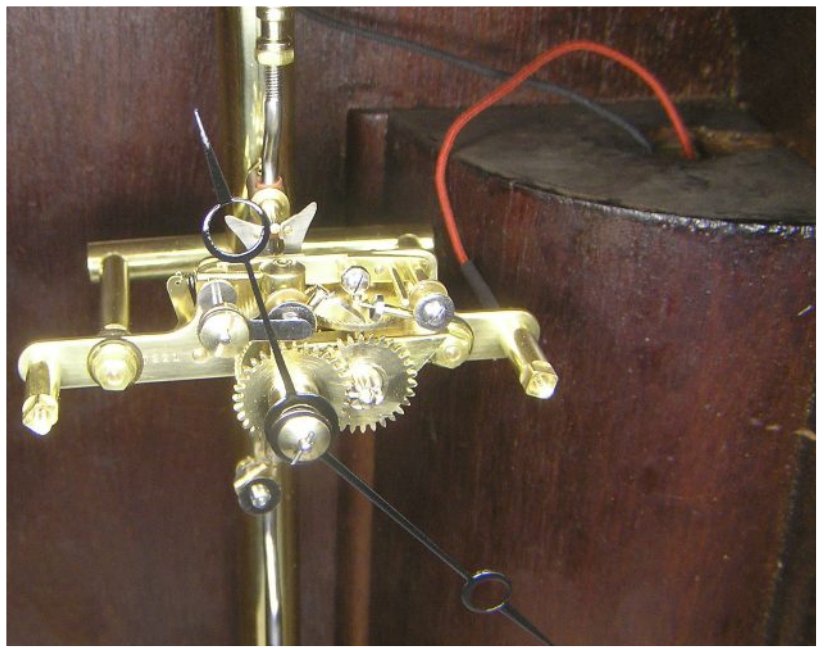
To the left is the pendulum casing with new cord and rating nut machined in the correct style..

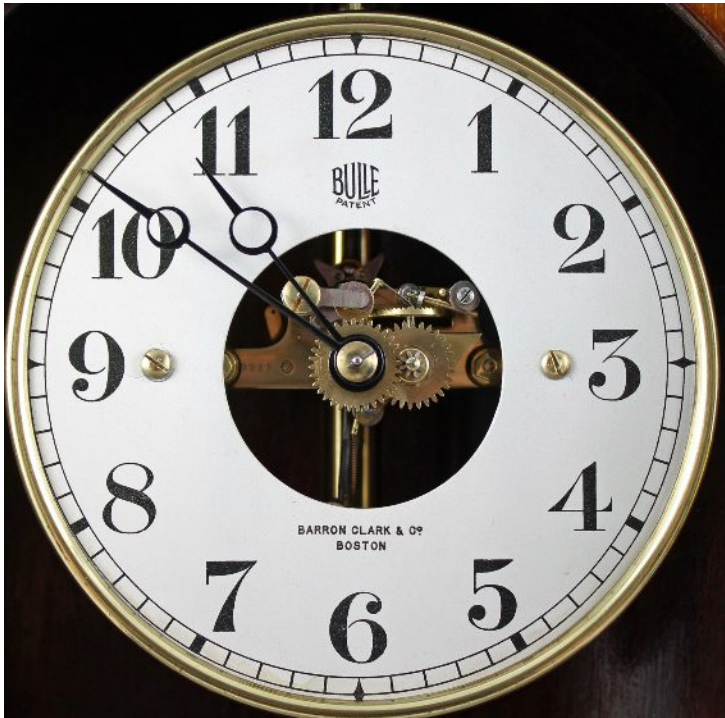
The finished dial with restored hands.
