**Bulle Clock Serial Number 7421**

*Restoration of Bulle Clock  
Serial Number 7421*

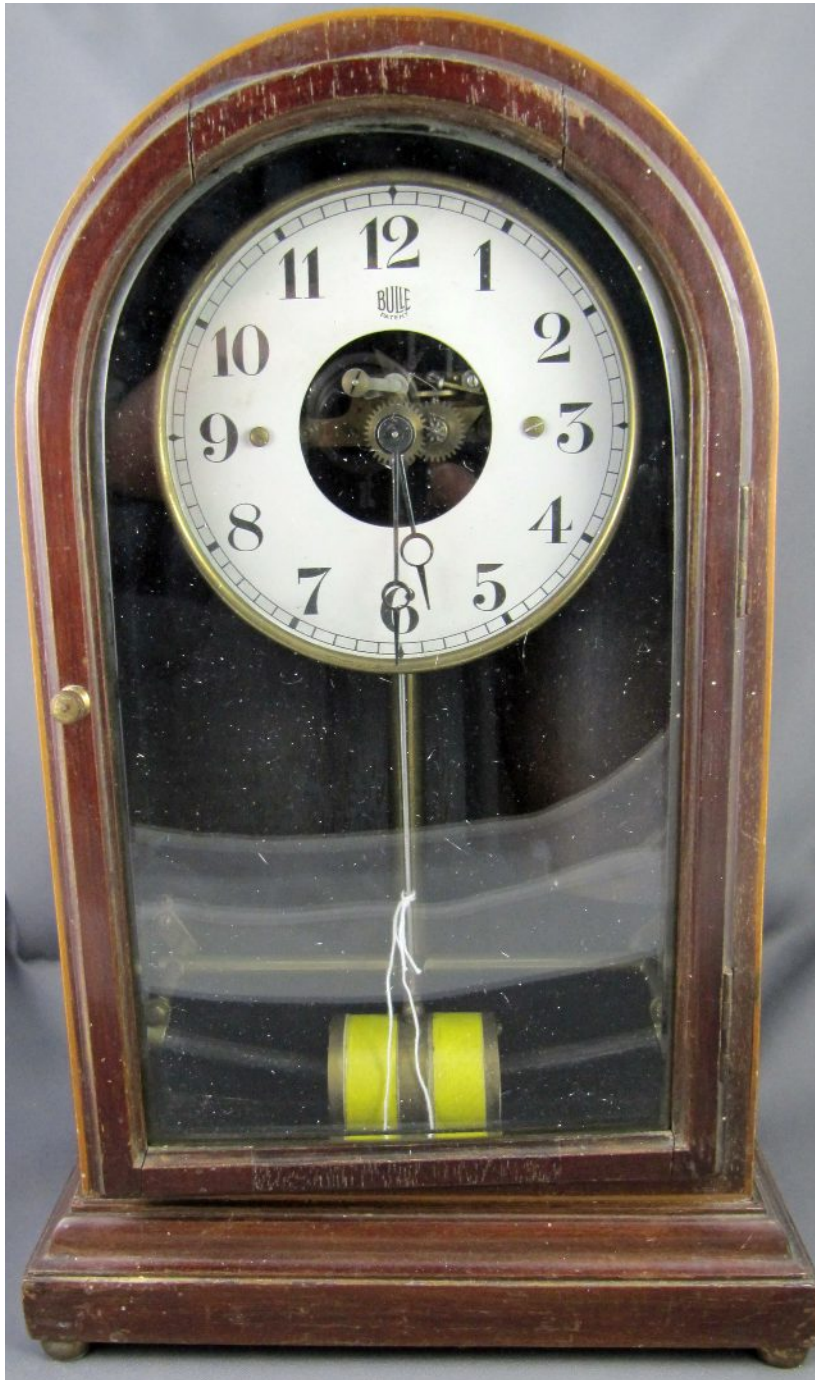
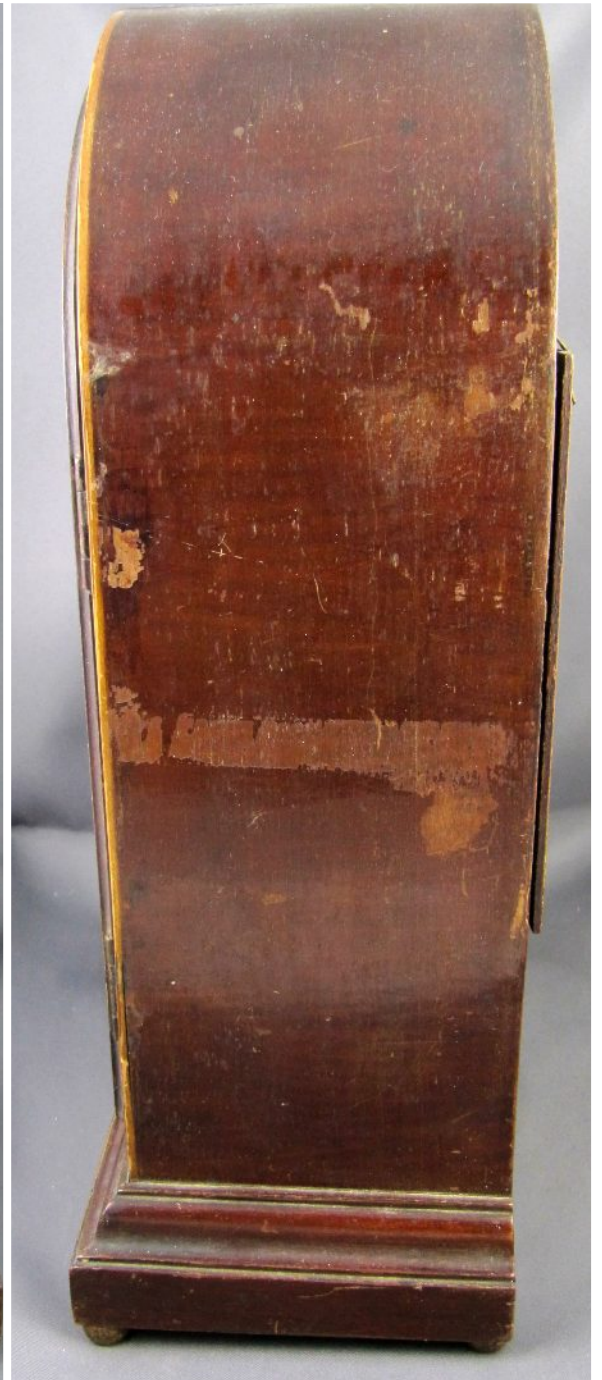
*Photos by kind permission of the owner. A tall movement Bulle with a 0.50 beats per second pendulum in a mahogany veneered round top case with fully glazed front door. The glass is thick and bevelled. A small rear door houses the battery. The clock looks to be complete but the case has suffered and is very dry with the finish stripped off in places. It also has a few cracks that will need attending to. The movement looks to be complete though.*

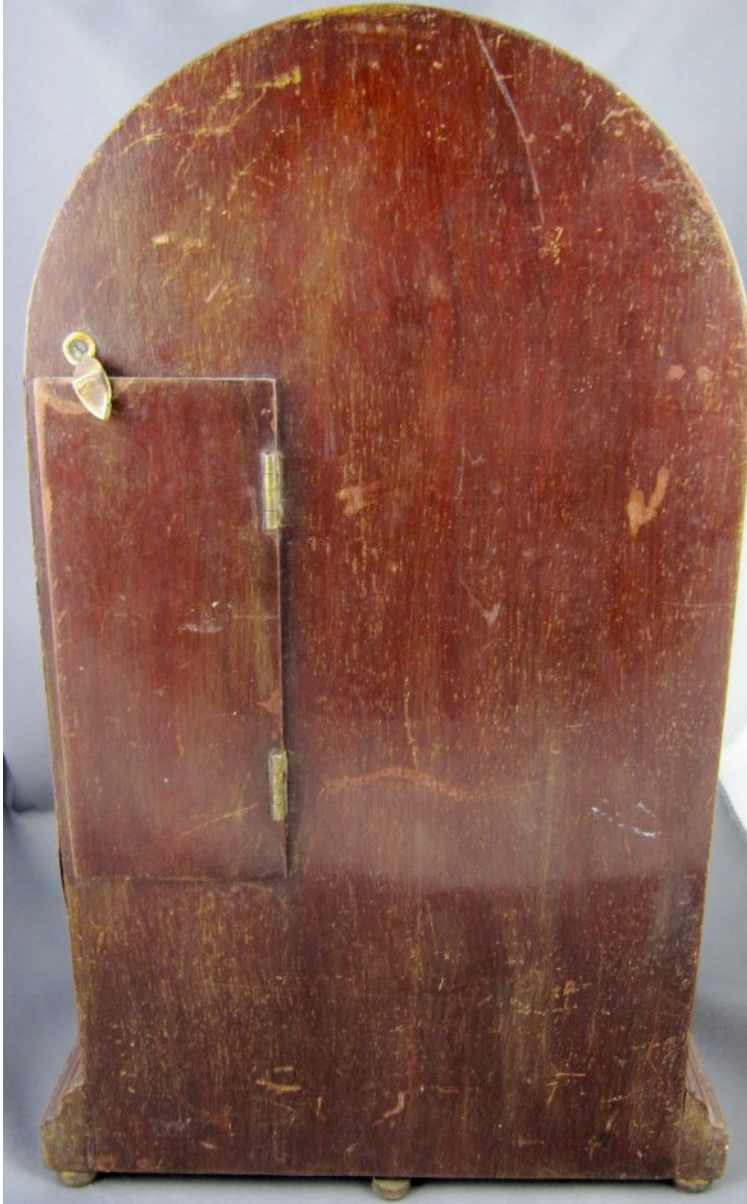
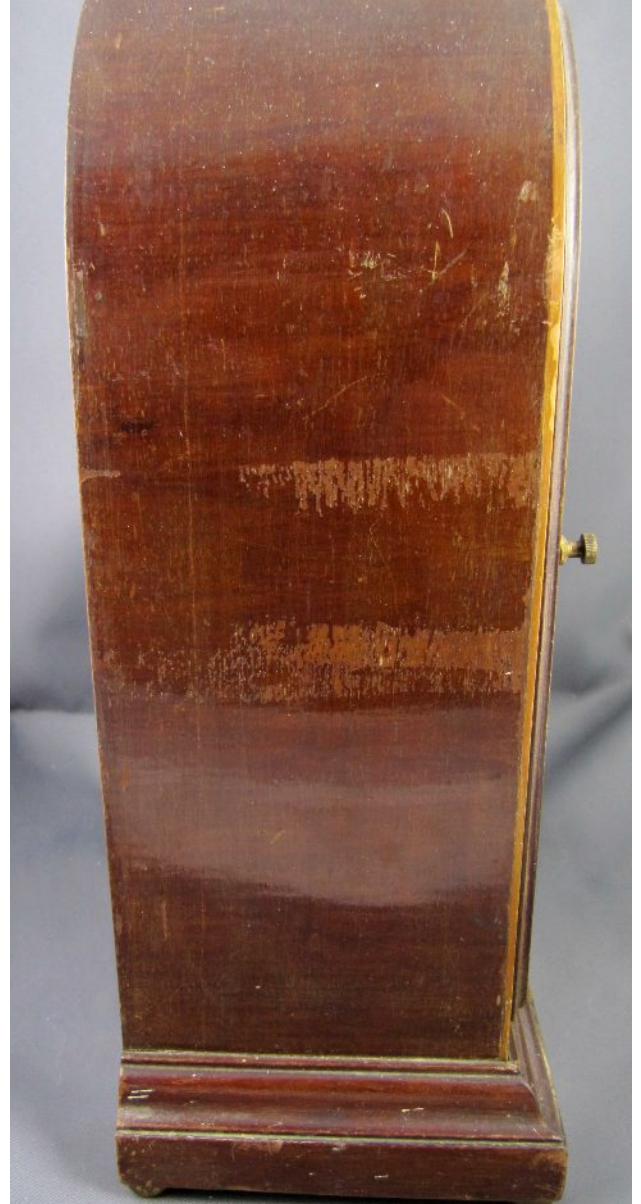
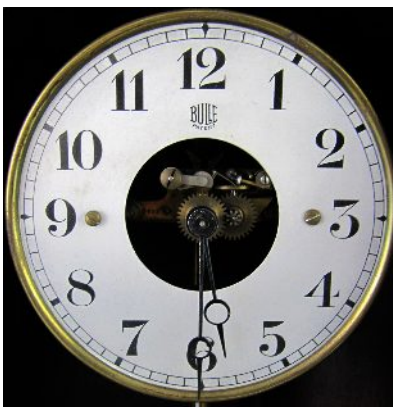
*These photos above show the state of the case. Although the finish is bad and peeling the carcass and veneer look to be quite solid with just a few areas where the veneer has separated. So I will make some repairs to the worst areas, strip off the old surface and then stain and French Polish. A lot of work but I think we shall see a great improvement. In contrast to the woodwork, the dial looks to be in very good shape and will require only a wash in soapy water and the brass rim brightened with wire wool. I have made a thin brass shim template to completely cover the dial polishing the rim.*

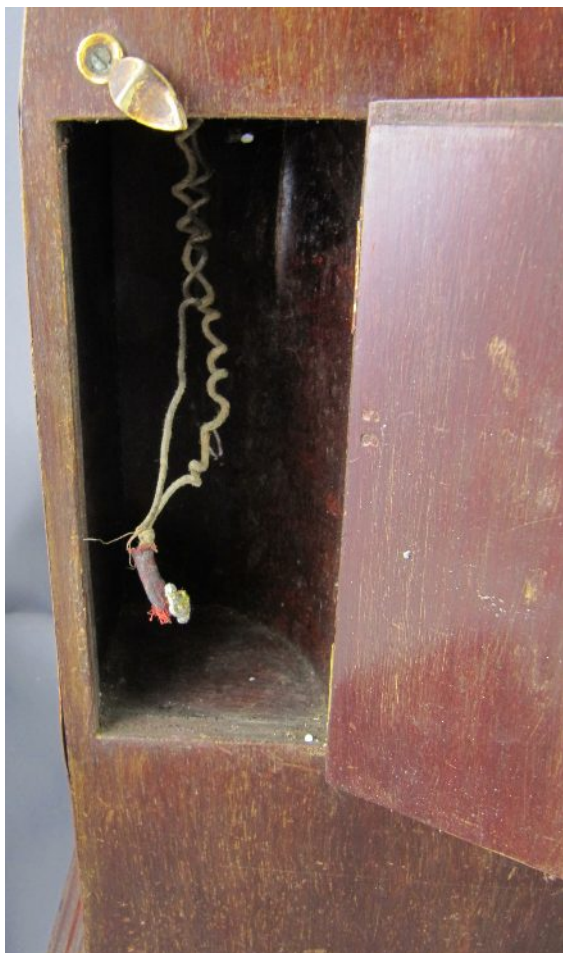
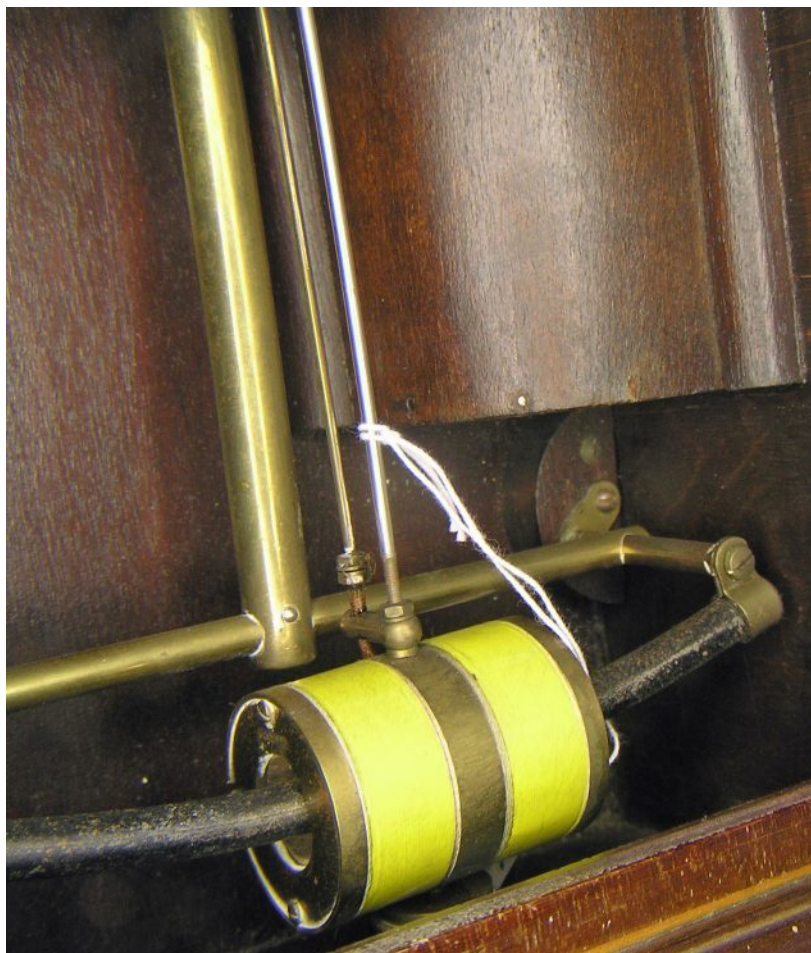
*The rear battery compartment extends into the case as a curved compartment. If it were square then it would not allow the pendulum to swing freely to the right as the magnet extends under the compartment. Notice the old wiring. It is a false economy to try and re-use this wiring as it tends to badly bent and brittle with some corrosion. I always replace it with new cloth covered wire.*

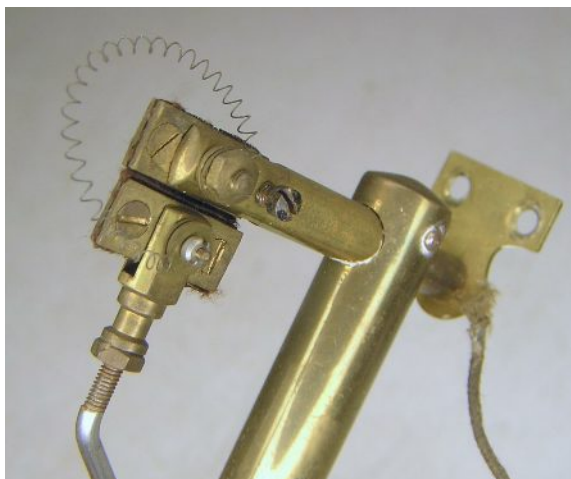
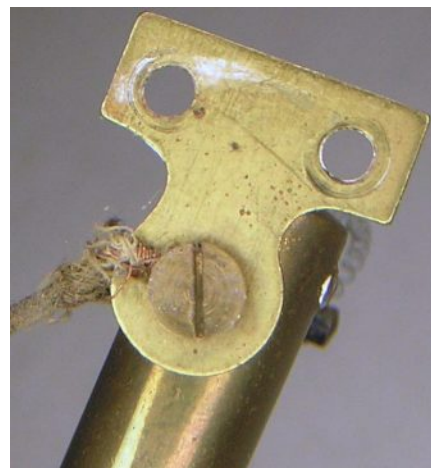
*These two photos show how the negative side of the battery is connected to the frame with a piece of wire bypassing the non conductive silk suspension and providing a path to the coil via the iron pendulum rod. Later clocks employed various methods of connection but this is the earliest and simplest*

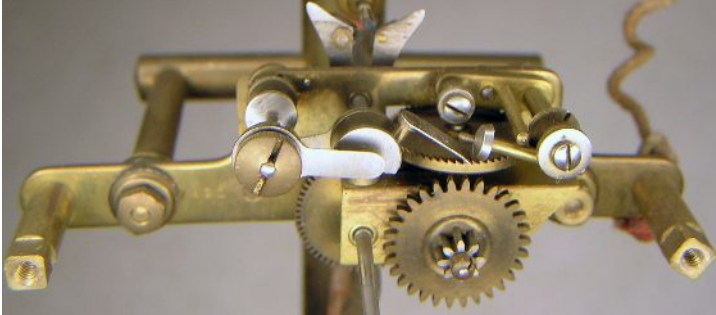
*The movement has no major rust or missing parts*

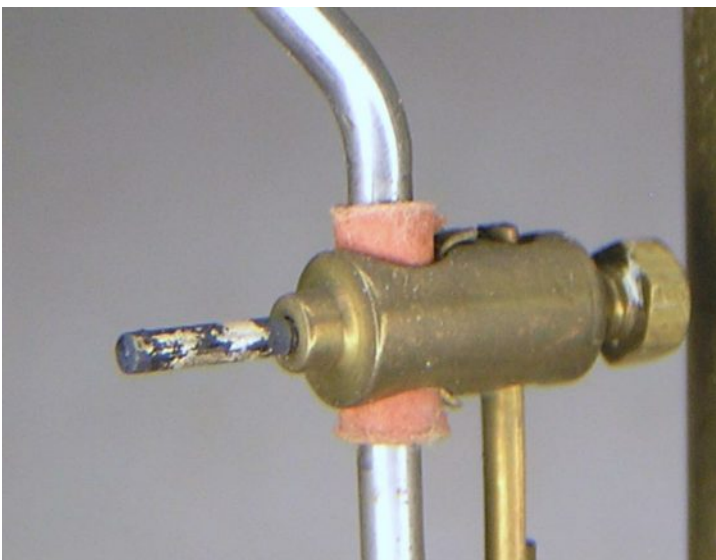
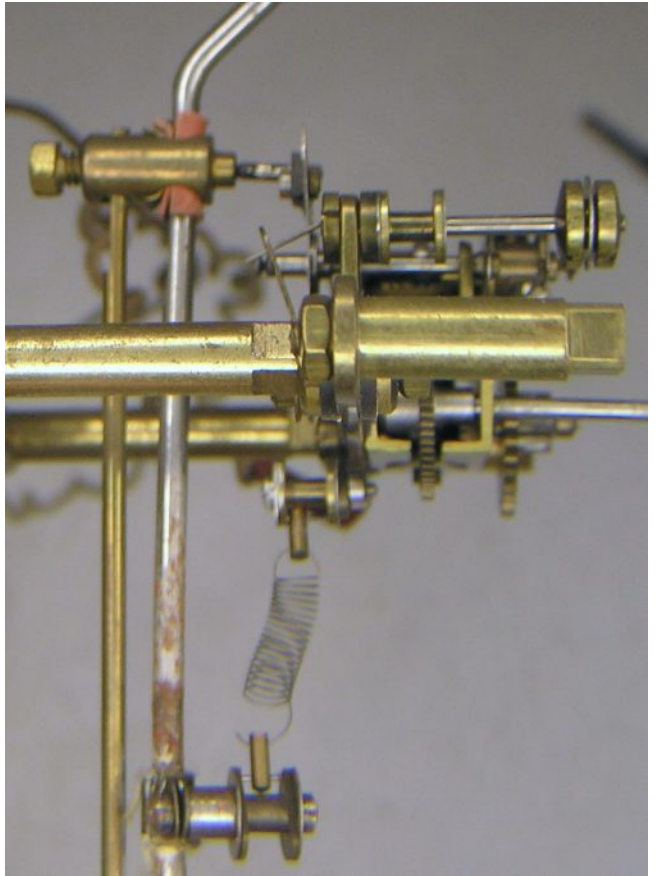
*This side view of the movement shows the the method used to secure the Isochron spring. There are two bobbins, one at either end of the spring connecting to the movement at the top and the pendulum at the bottom. When disassembling a Bulle clock note that the bobbin on the movement is the smaller of the two., With the lower on being "D" shaped. Between the two steel shims.*

*The silver contact pin may look badly corroded but this is just tarnish and is easily removed with a soft iron rotary brush mounted in a dremel. It normally has a 1.2mm thread that allows it to be screwed into the brass housing.*

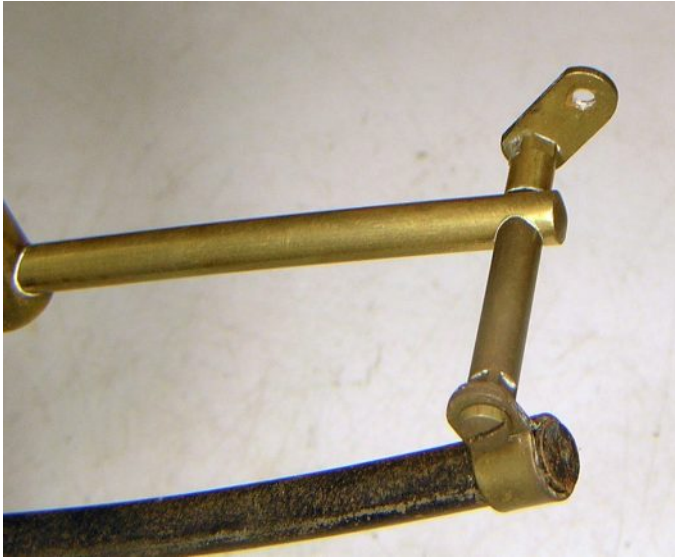
*Note the short extensions that carry the small bracket that allows the frame to be secured into the case. Some cases especially on wall mounted clocks do not have these internal brackets. Instead they have machine screws through the rear of the case with a large brass washer either side to protect the wood.*

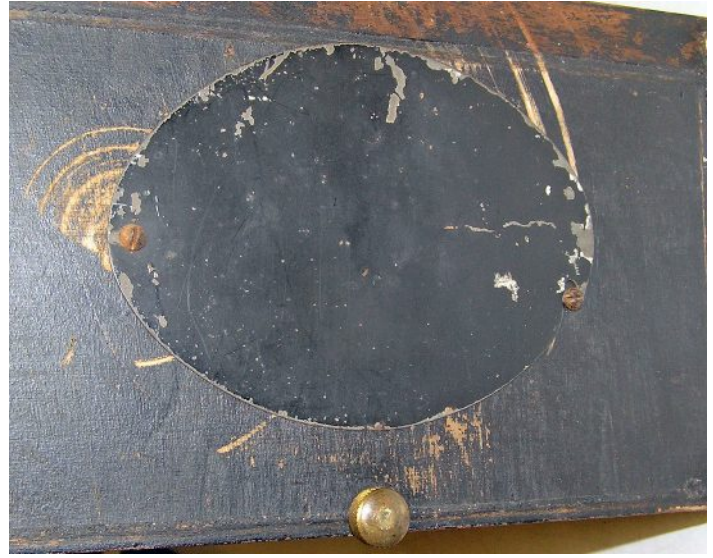
*The underside of the case has a large oval hole covered by a swing iron plate that allows the rating nut to be adjusted to time the clock. I have seen this particular style of case with and without the hole. It is preferable to try and adjust the clock through the glass door which will not necessitate the clock being lifted and turned upside down.*

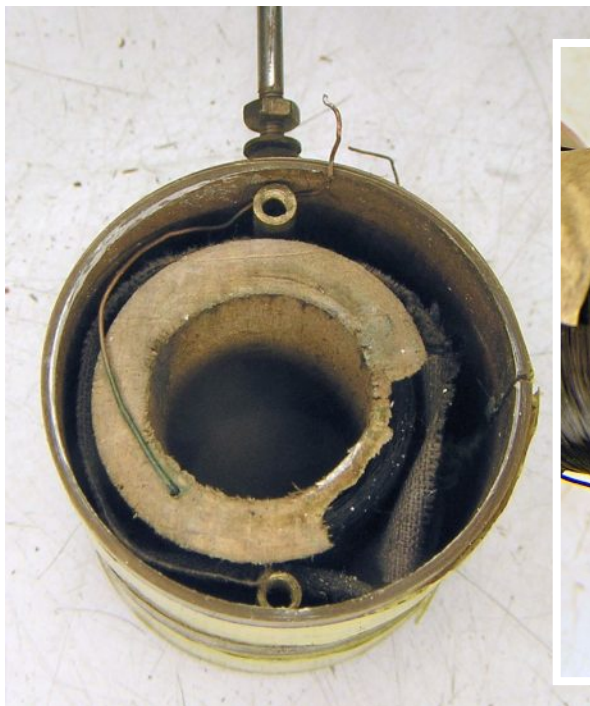
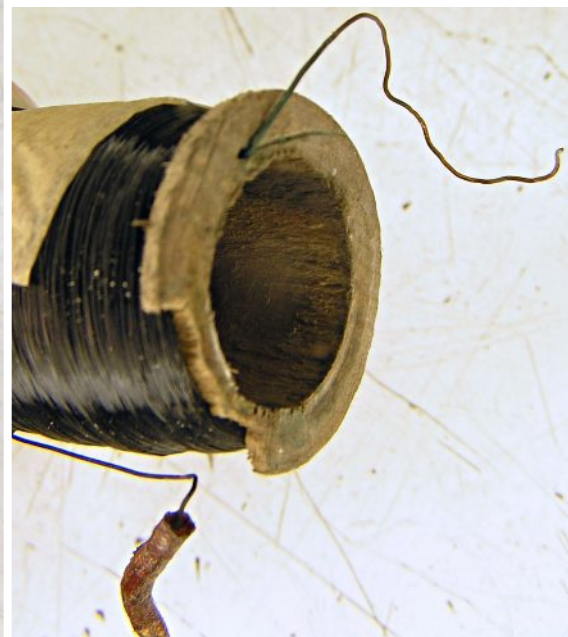
*The coil bobbin is damaged but the coil looks OK. I checked the resistance and it reads a good 1100 Ohms. So other than tidying it up and cleaning the single core lead out wires, I will leave it as is.*

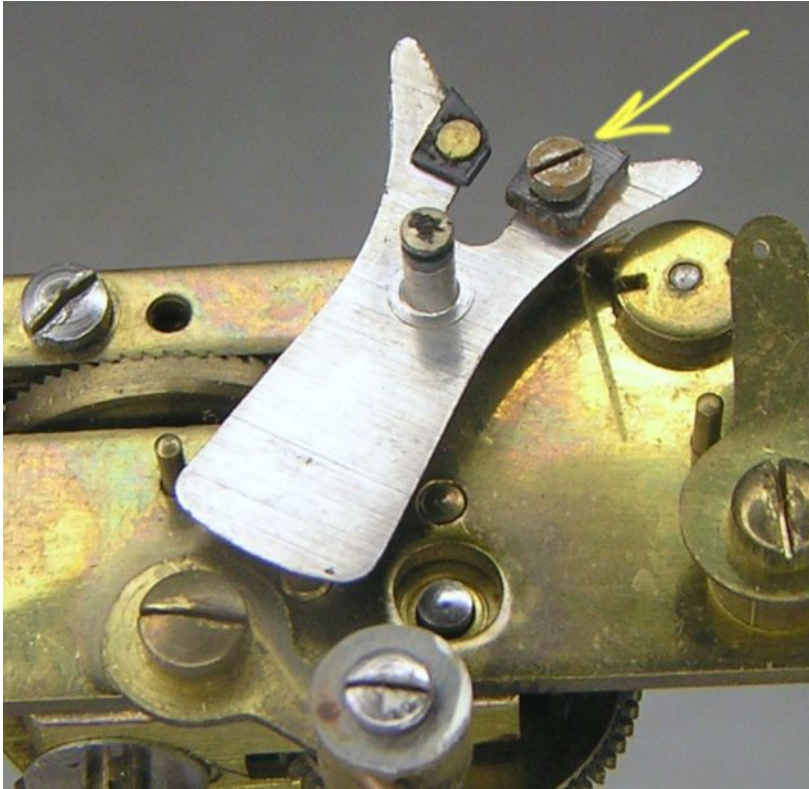
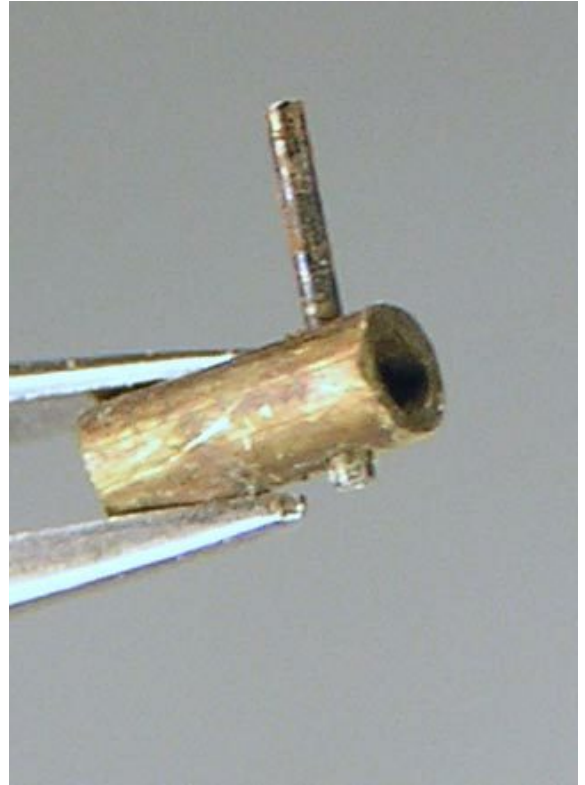
*The fork has had an interesting life by the look of it! A screw holds the insulating contact in place. A bit heavy handed but it must of worked because there are signs of wear on the fibre. The silver contact is heavily worn so both will be replaced.*

*This photo above shows that one of the Isochron "T" pieces needs repairing as the steel pin is in the wrong end and very loose.*

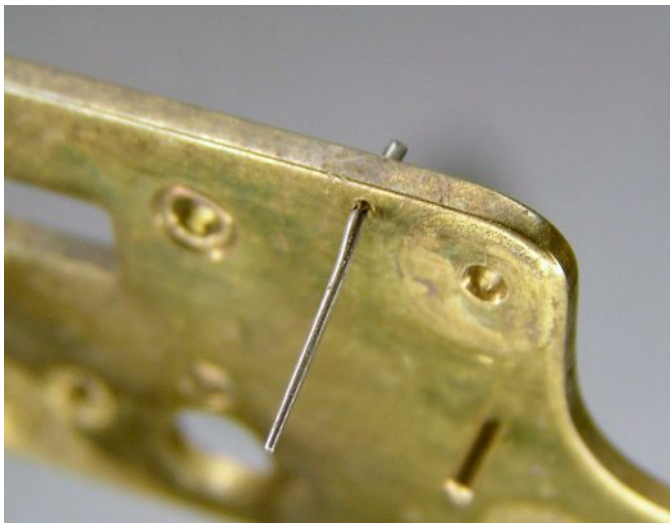
*This looks to be a spring [in from a French clock. Why it is here is a mystery. There is a perfectly good pendulum stop pin to its lower right.*

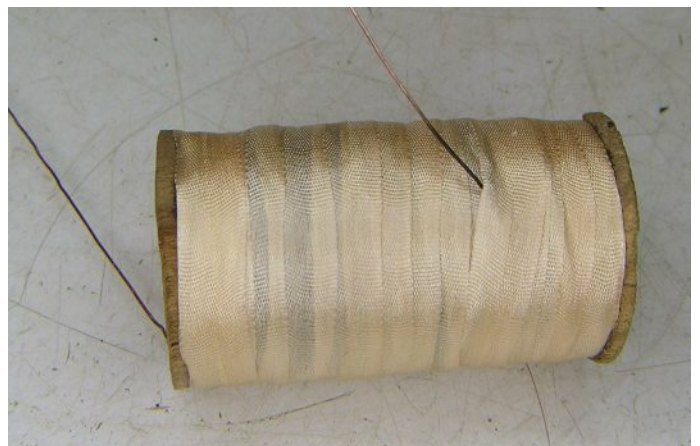
*The coil after a clean up and binding with silk ribbon.*

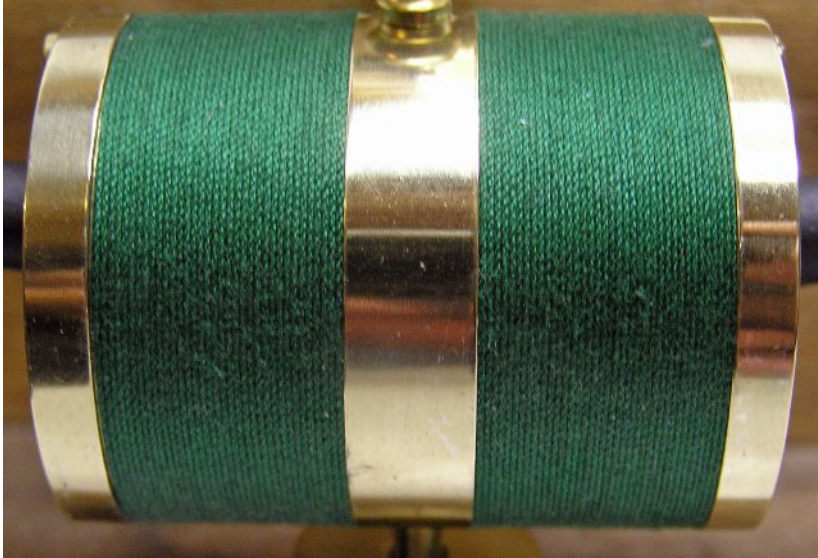
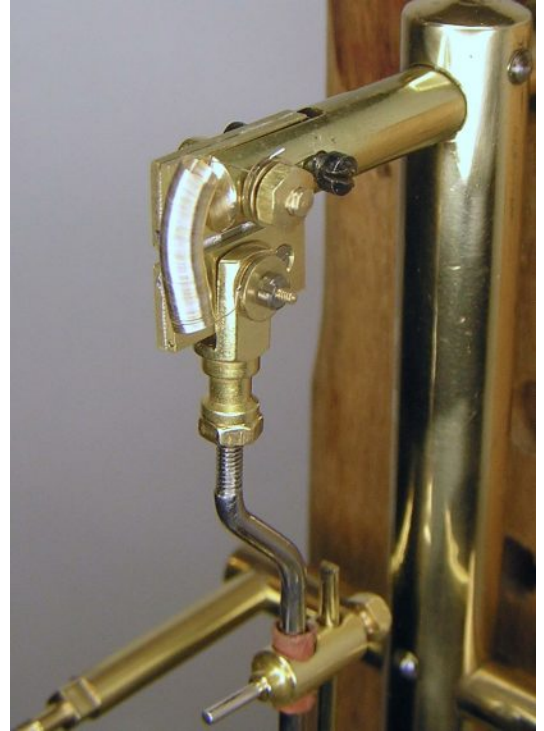
*The coil cover cleaned and rewound with green cord. The photo to the right shows the pendulum back in place with the new silver contact wire in place*

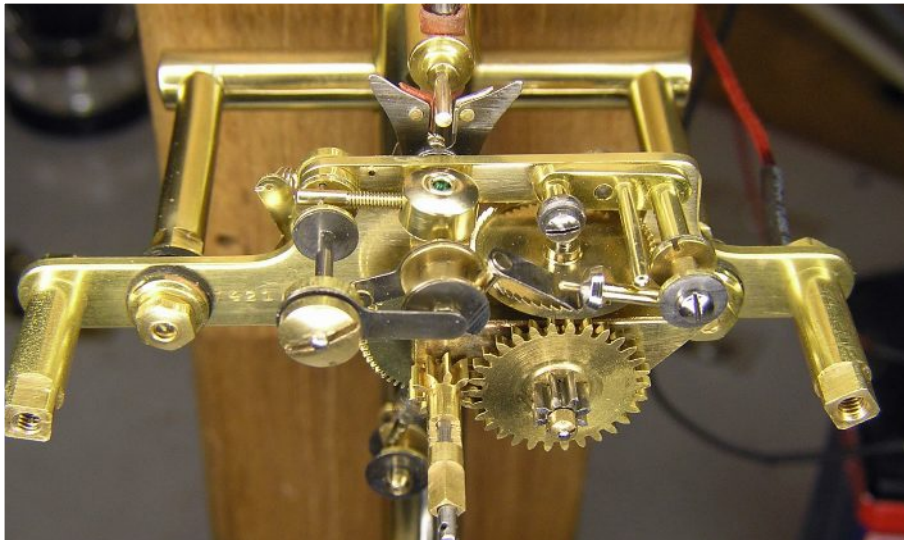
*Above is the movement restored and back in place. Note the contact pin position between the new silver and fibre contacts.*

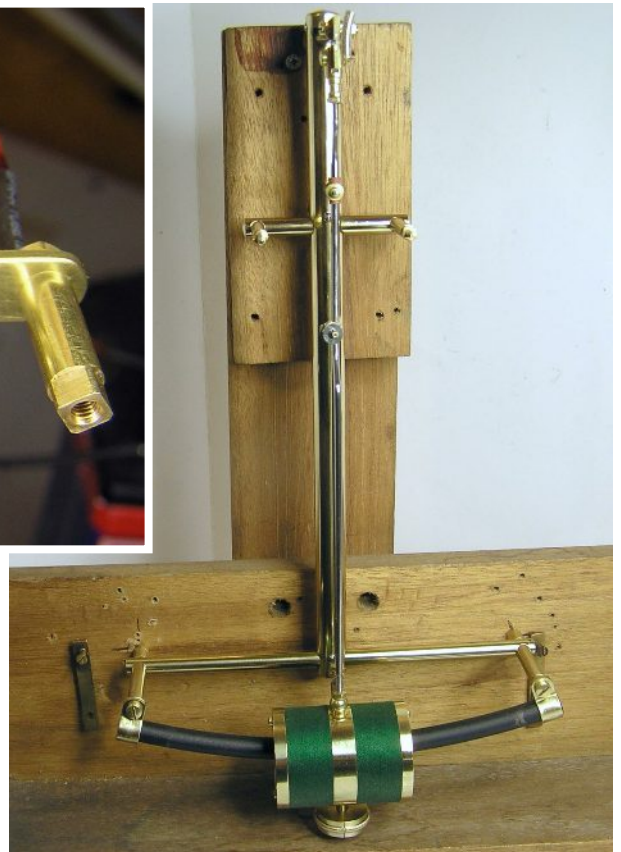
*To the right is the magnet, frame and pendulum secured a test stand ready for proving the function of the magnet and coil.*

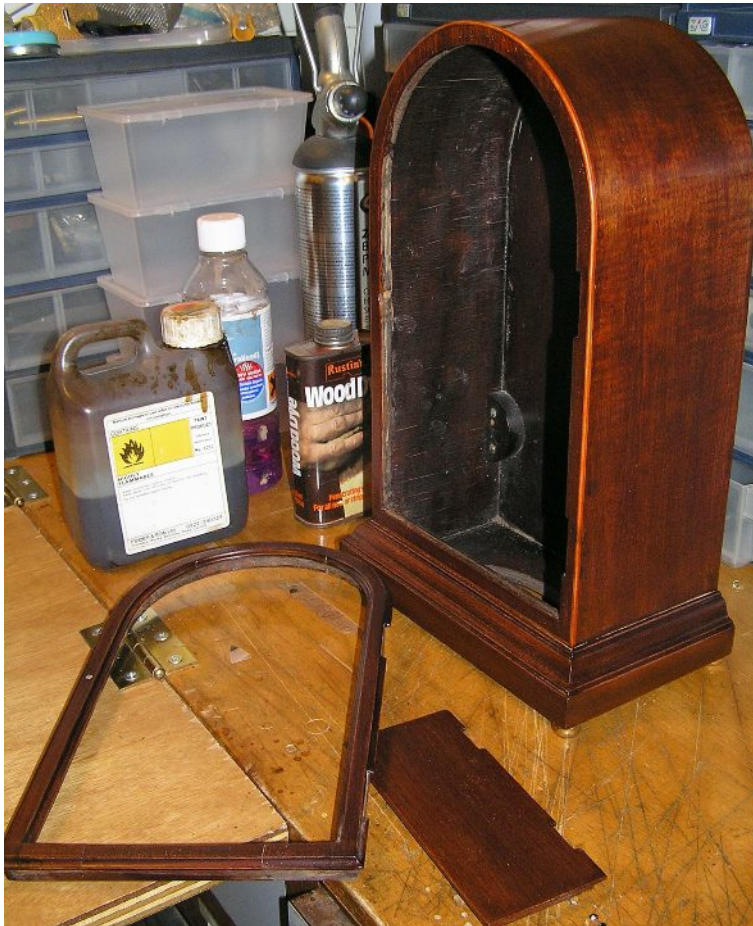
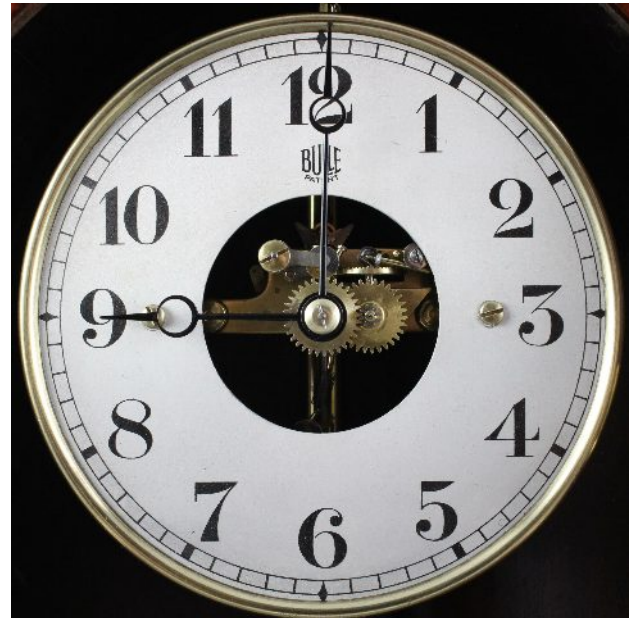
*The photo on the left shows the case after gluing the various fractures and lifted veneer. A stain has then been applied followed by a sealer and about four coats of French Polish. The photo above shows the cleaned dial back in place with the restored hands and replacement collet.*

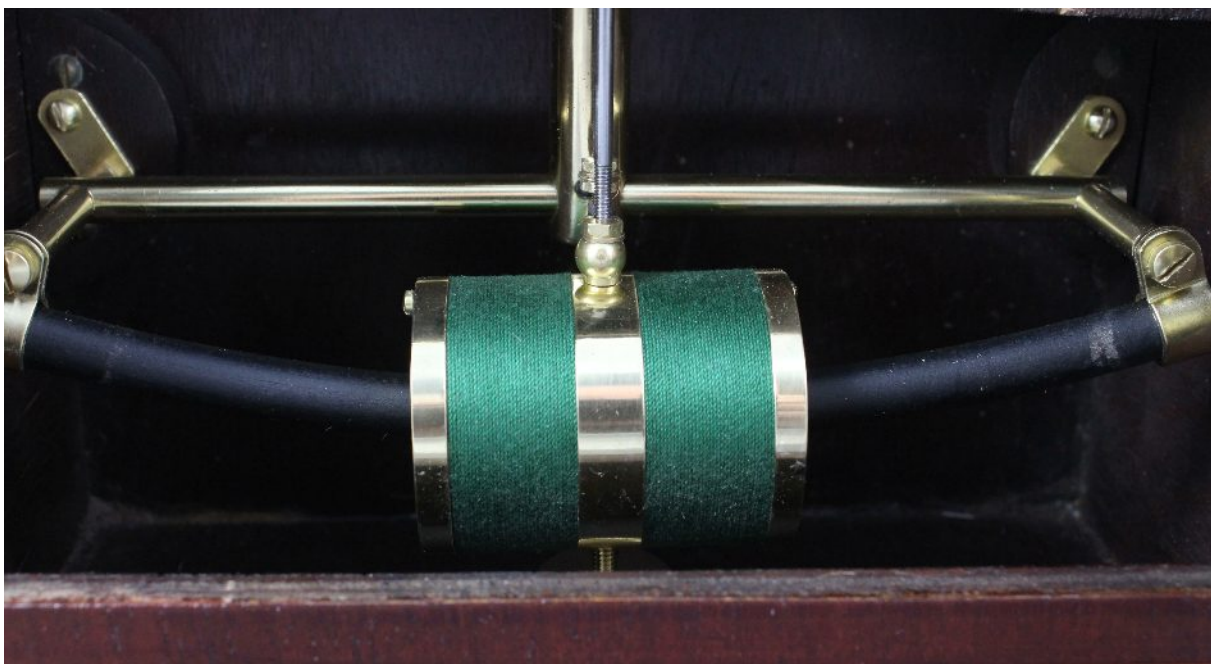
*The frame back in place in the case.*

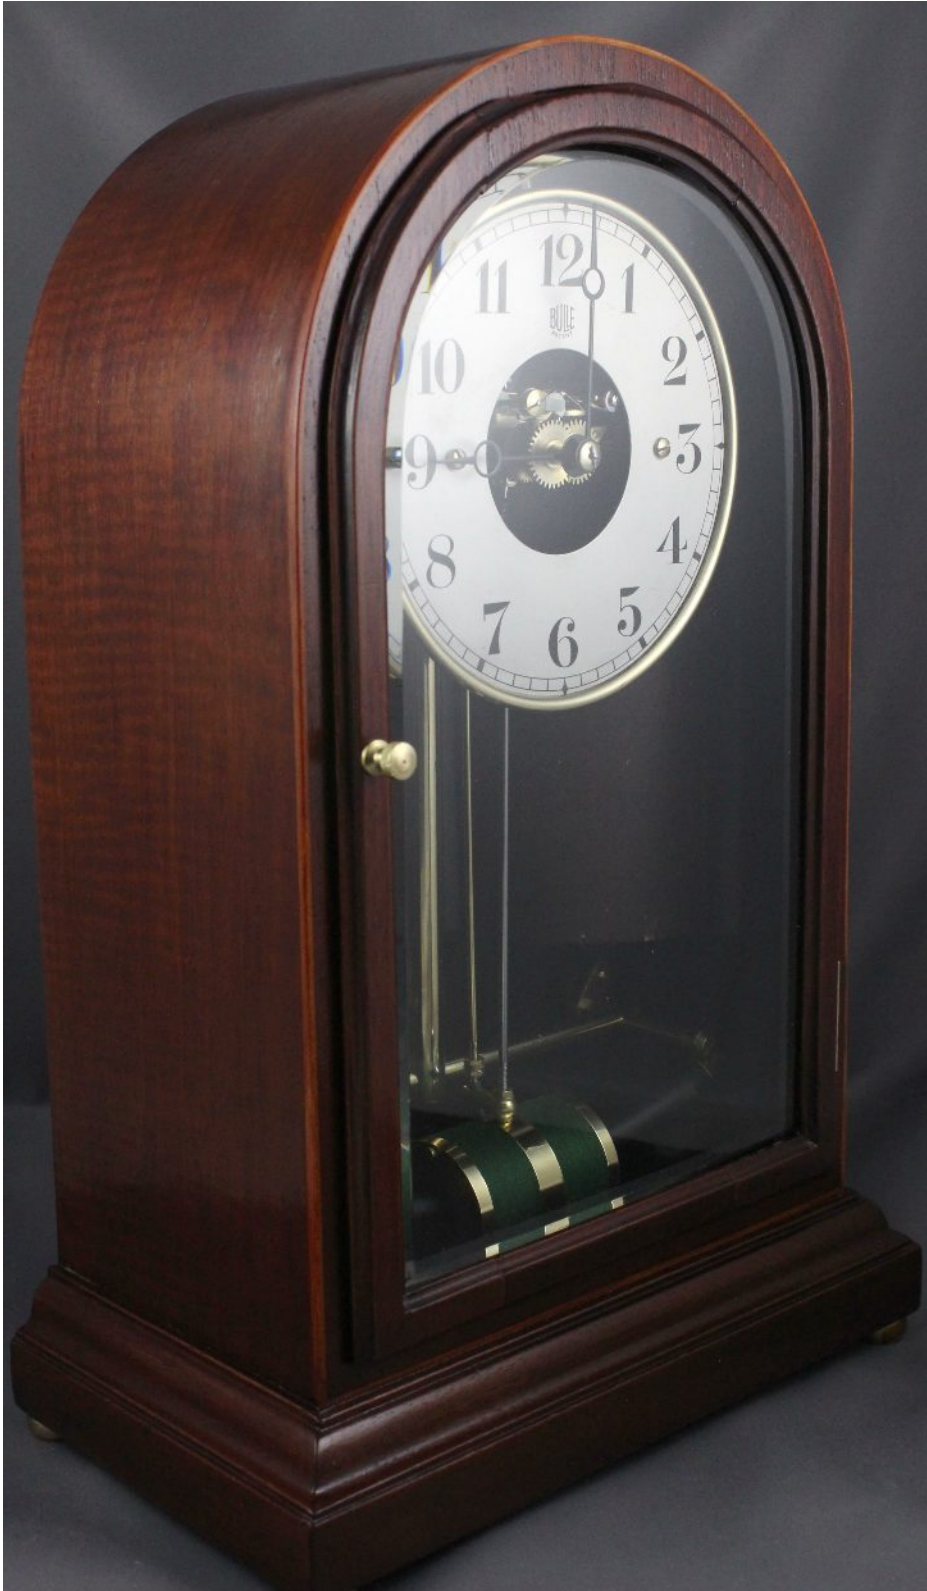
*The finished clock back together and on test. There was a small piece of the door missing as can be seen at the top of the curve, but I decided against trying to repair this as it is not a major issue and does not detract from the overall appeal of the clock. In fact I think it adds a little history to it..*

*These particular cases with the large glass doors are inherently a bit fragile as the surround is very narrow and yet two large hinges are required to secure it to the case. The case itself is very narrow at the point of attachment and is frequently damaged around the hinges.*

*It is always prudent to be aware of their fragility and handle them carefully when adjusting the hands.*

*This case was also very dry which didn't help.*

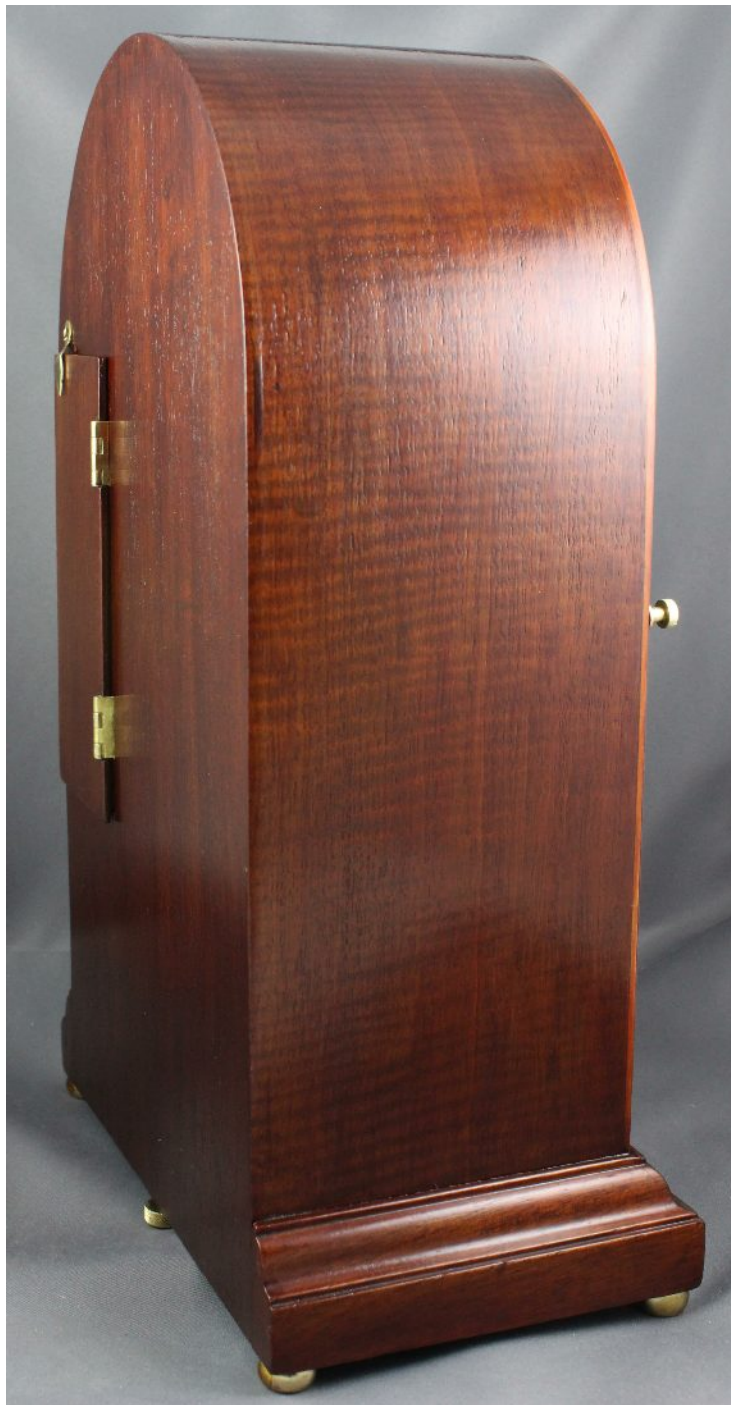
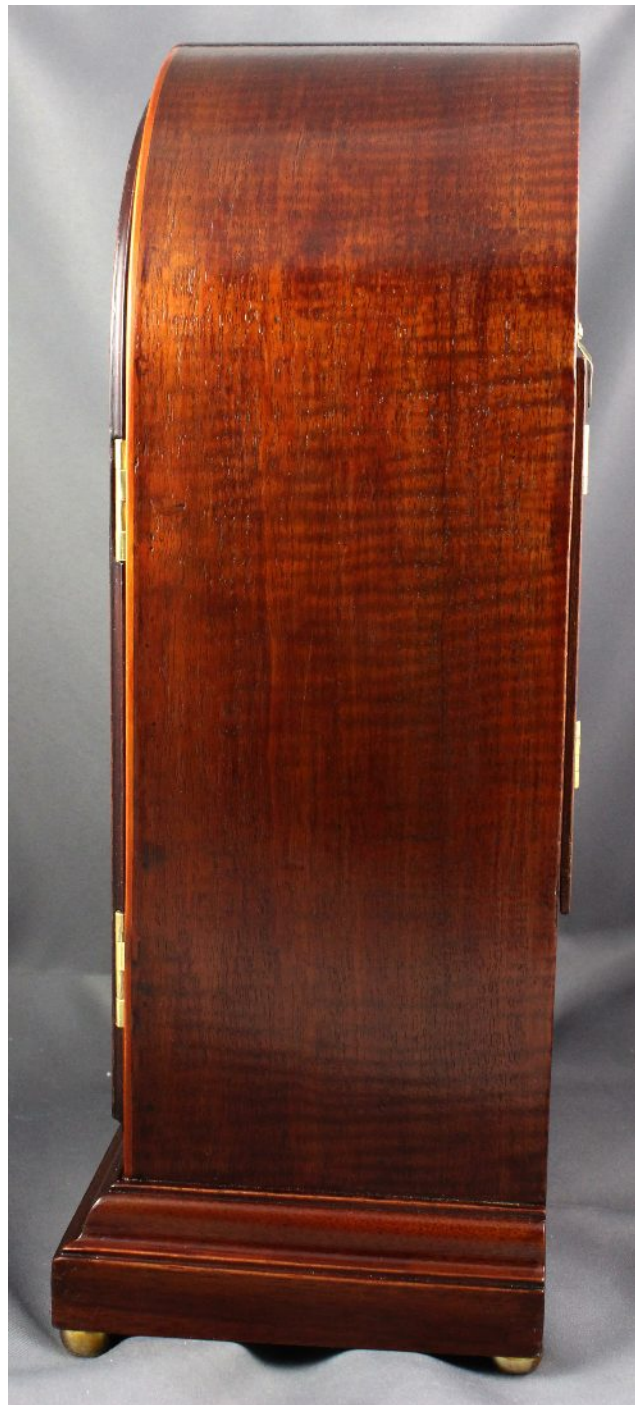
*Two side views of the finished case. I must admit I love the horizontal figuring that has come through once the polish was cut back.*

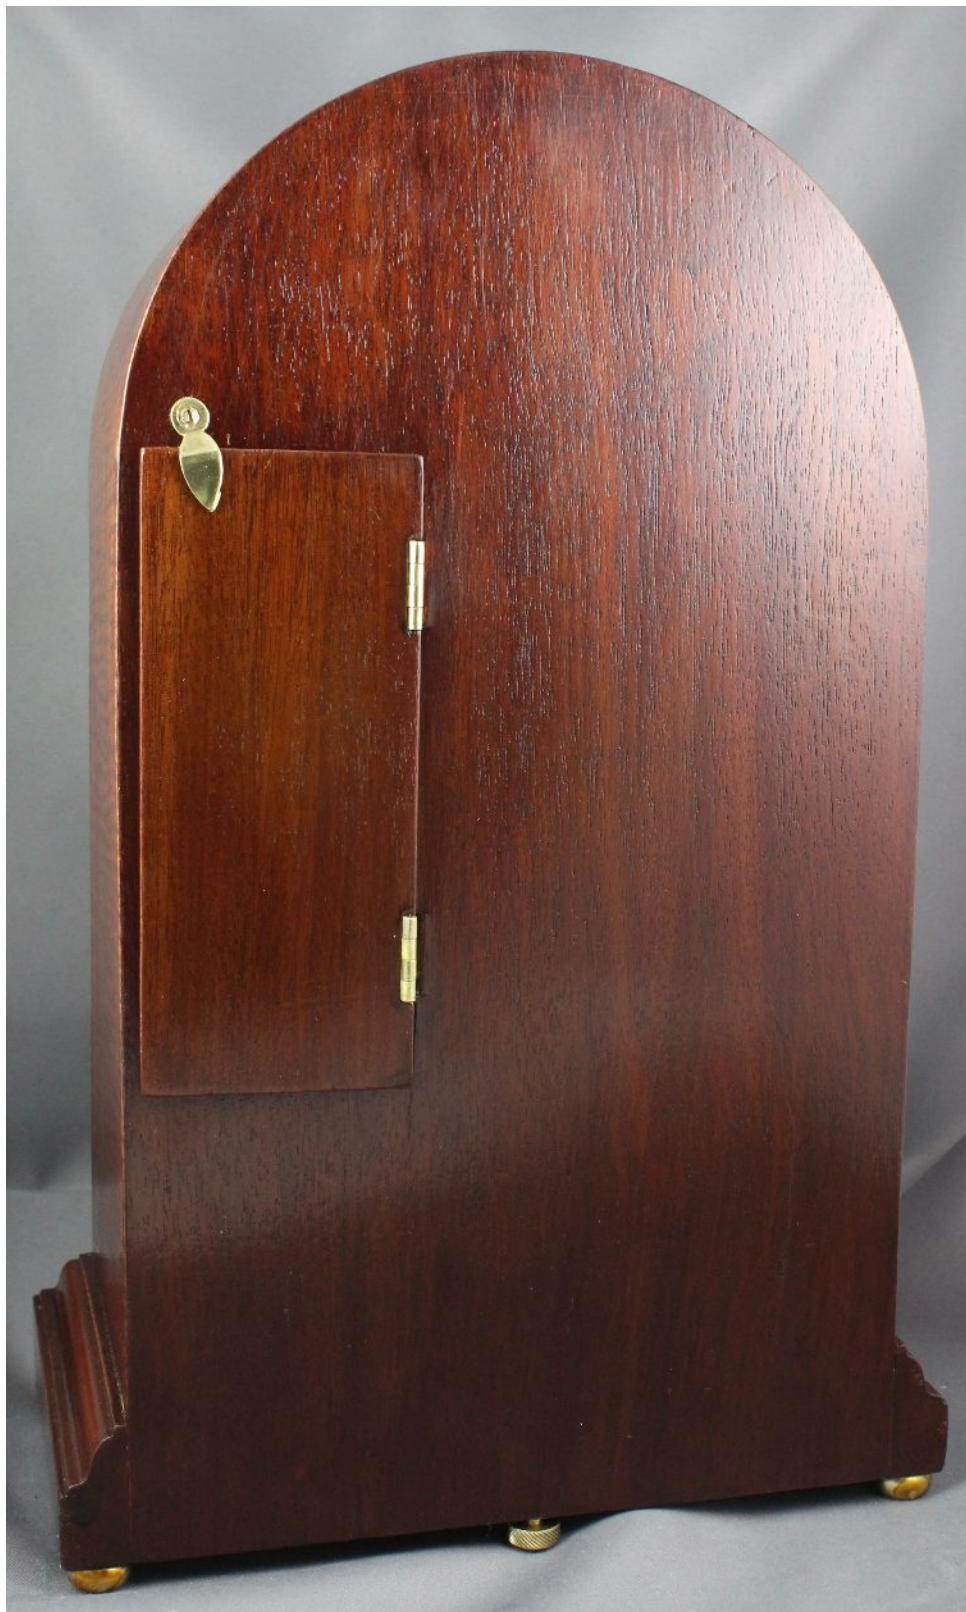
*The rear of the case. Note the small brass levelling foot to the rear. The two rear “Bun” feet have a lower profile than the two front feet to allow the levelling screw more active height.*

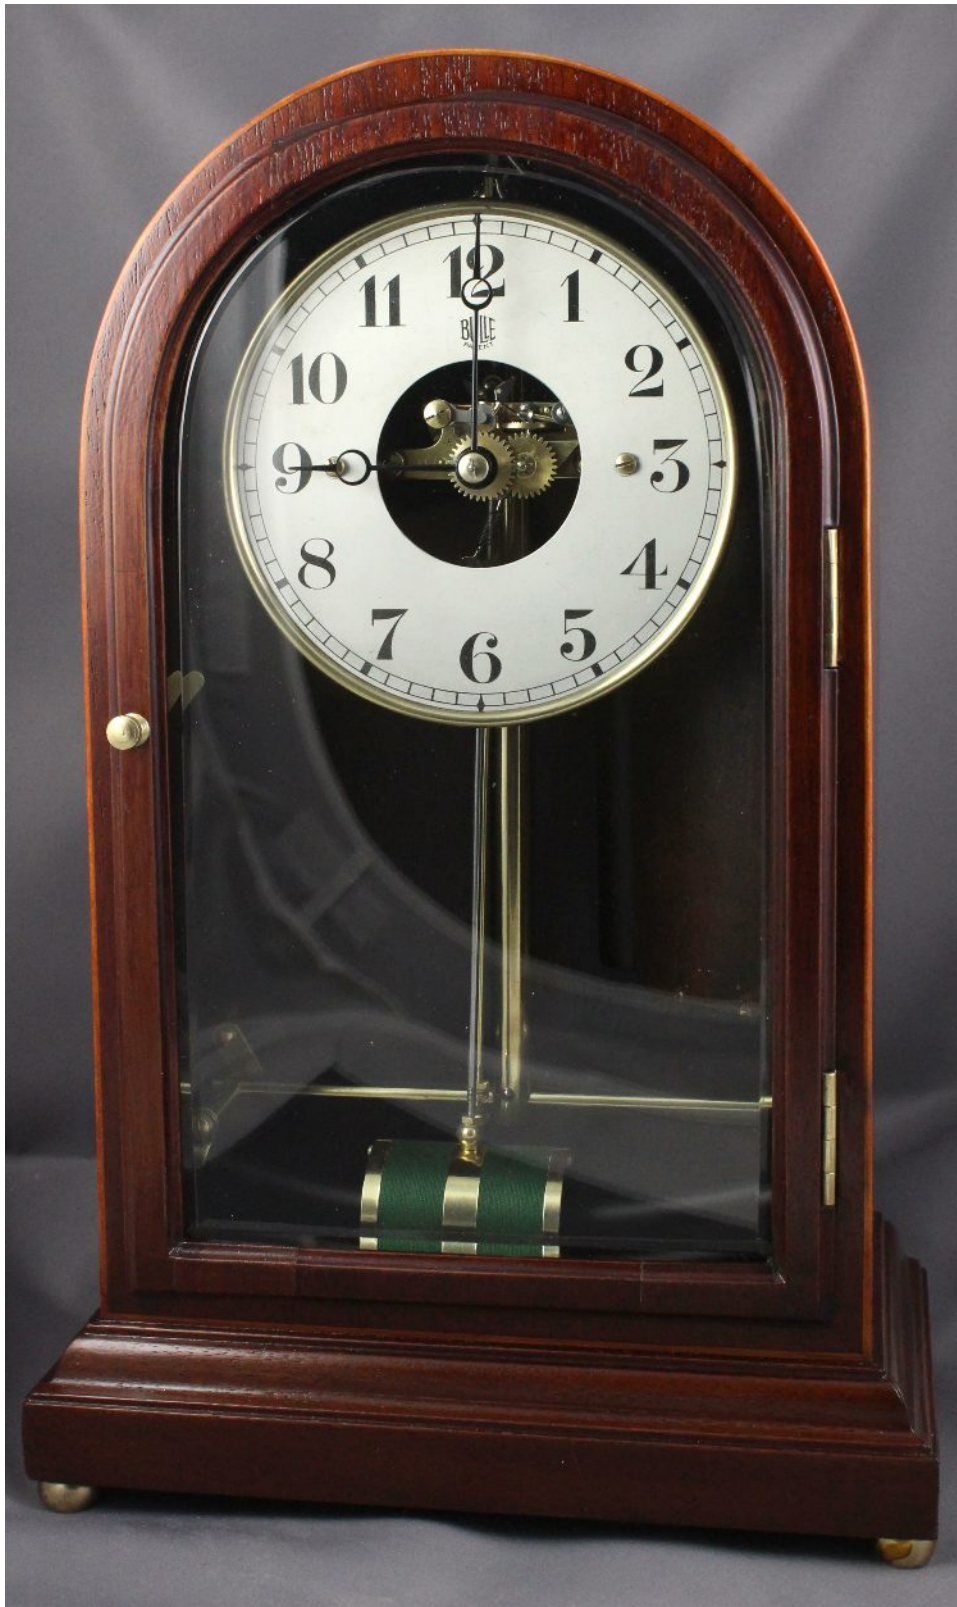
*The finished Clock*
