Bulle Clock Serial Number 95099

Restoration of Bulle Clock Serial Number 95099

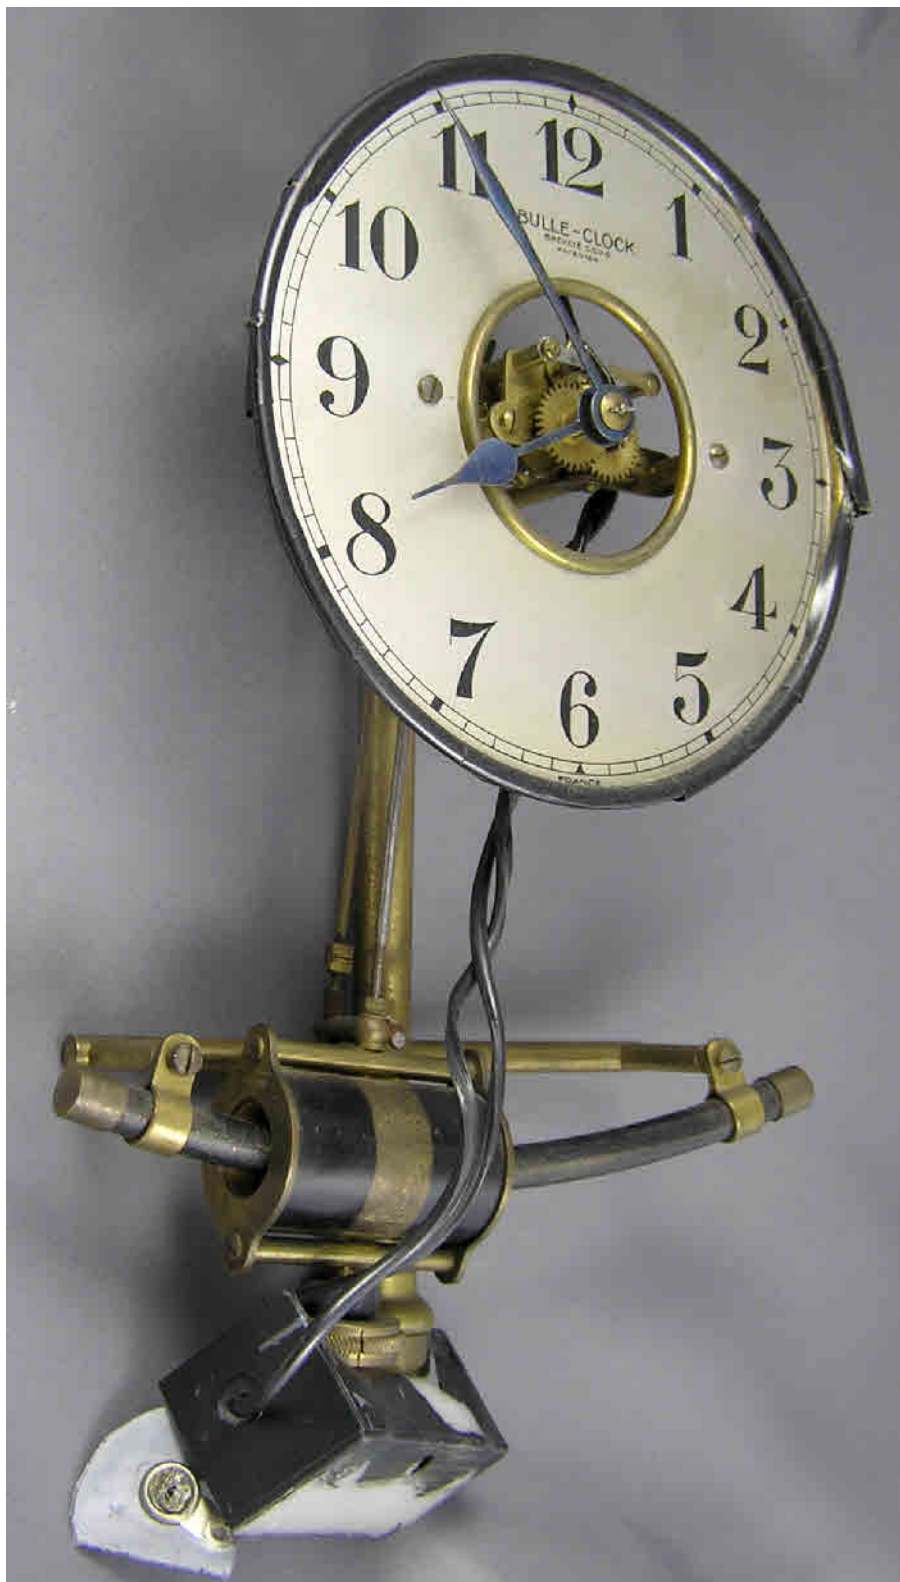
The clock was delivered as seen on the left, without case which is of the brass lancet type.

The dial has black insulation tape around the edge for some unknown purpose although the dial itself looks to be in good condition with no major marks or scratches.. The rest of the movement seems in good condition with nothing missing. The pendulum coil casing is brass painted black with an unpainted section in the middle to imitate a solid collar.

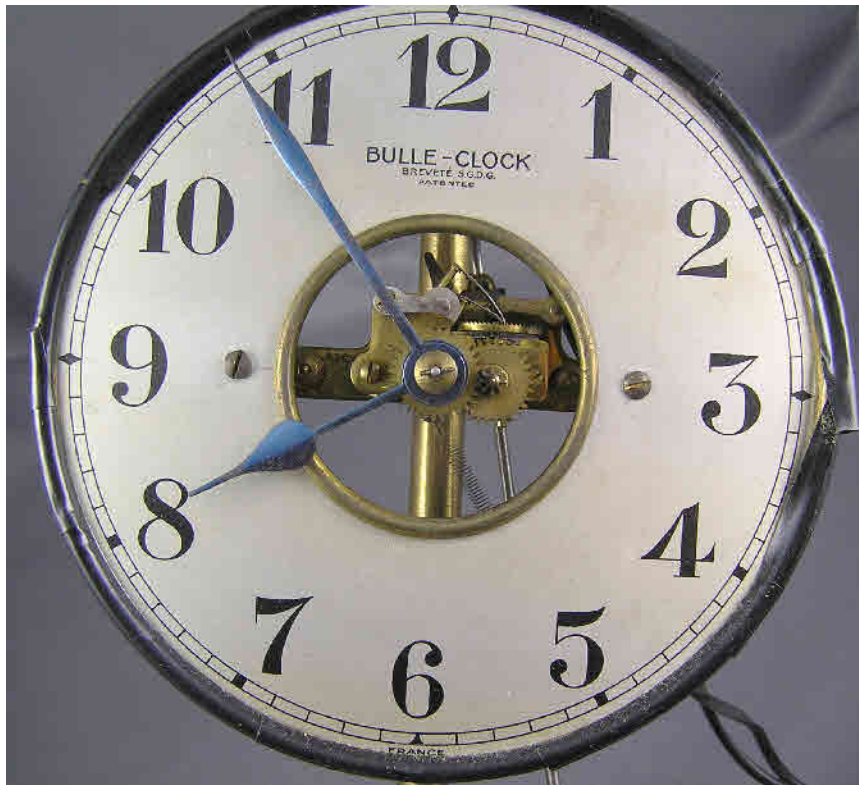
Close up of the dial showing insulation tape. The tape was found to be glued on (see photo below) which makes removal and cleaning of the brass pan surround very difficult when you are trying to leave the dial itself undamaged..

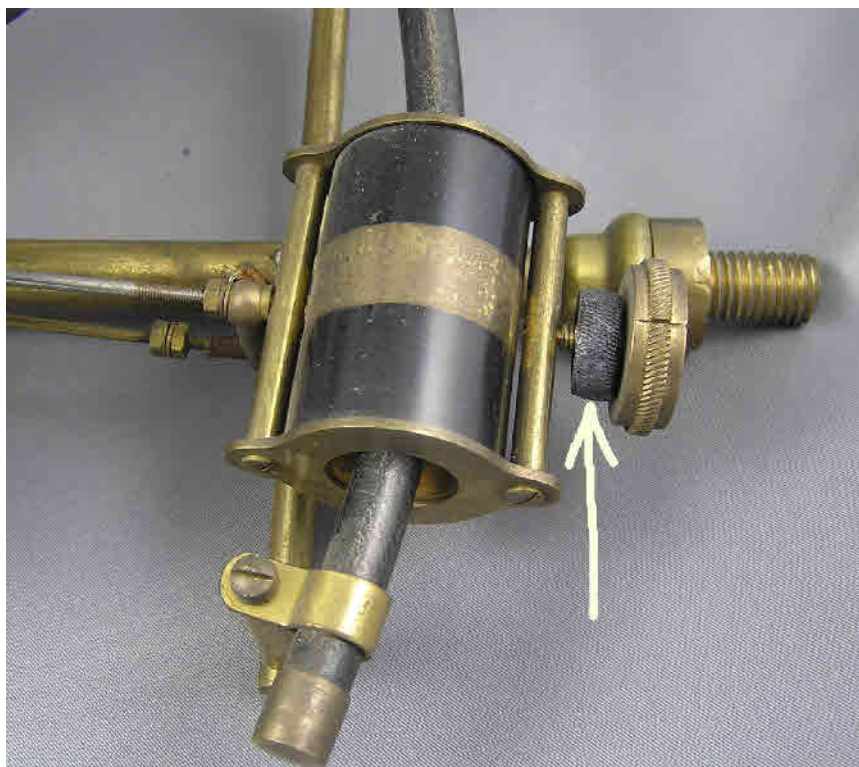
This photo at left shows the pendulum coil casing and the extra piece of plastic above the rating nut. I assume it has been put there to increase the weight and therefore slow the clock down. But the plastic has no weight to it an would not have contributed much.

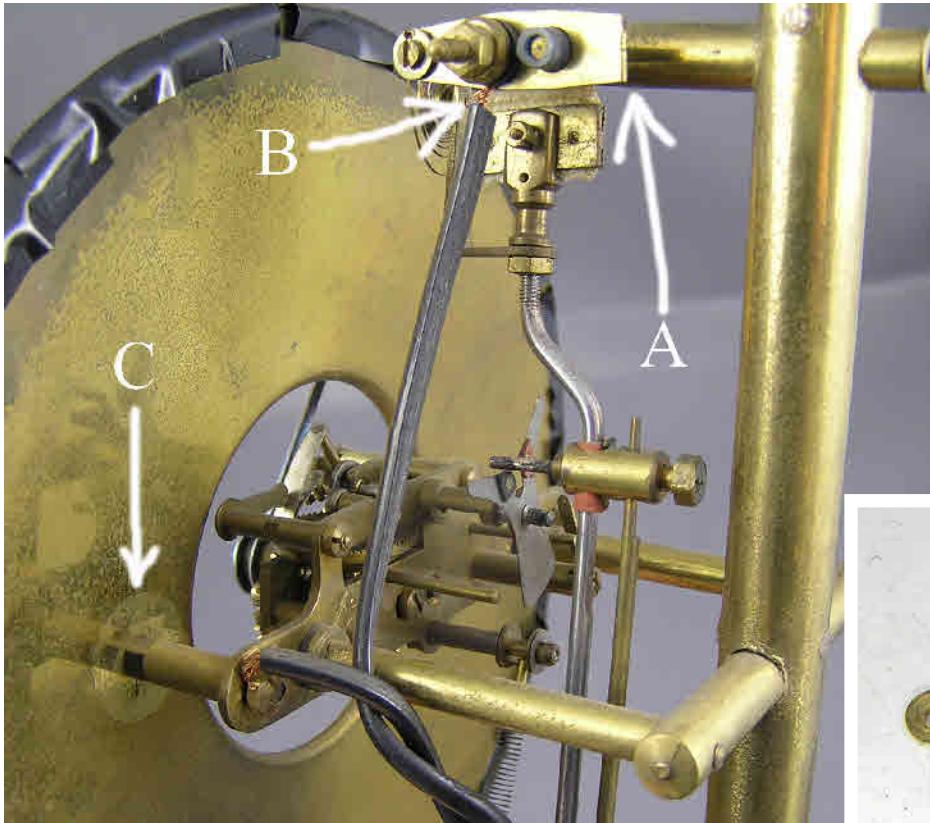
This photo shows **A)** The broken bar of the insulated negative terminal assembly. This should have a hole through which a nut and screw (see photo below) are used to attach the wire from the negative side of the battery. **B)** The point where the wire is now wrongly attached. **C)** The mark left by the missing 15mm washers that support the dial and stop it from bending.
