Eureka Clock Serial Number 3141

Restoration of Eureka Clock Serial Number 3141

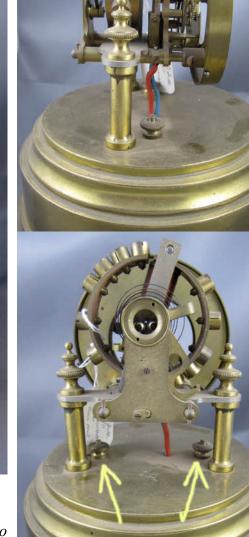
This short movement Eureka looks to be in fair condition with no major parts missing, although it is quite dirty with some rust. I also noted that the battery cage underneath the base has the knurled nuts on the top outside of the base as arrowed instead of the underside holding the battery. There should be discreet countersunk screws here, so something is amiss. The clock was delivered without a dome..

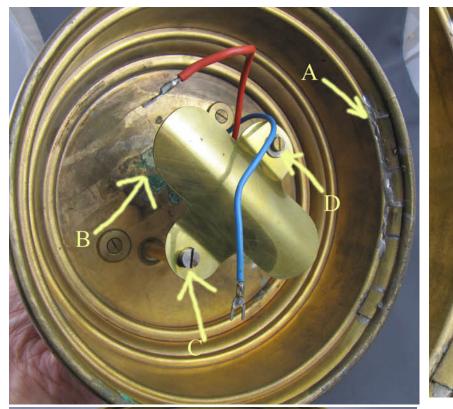
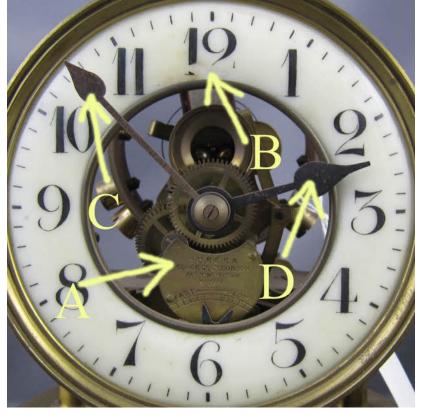
The registration plate (A will need to be re-waxed to show up the serial number and timing marks. The dial has damage underneath the twelve (B and will need specialist attention. Both the hands are wrong and will need to be replaced. The bearings are badly gummed up with old oil but that has saved them from the dreaded rust.

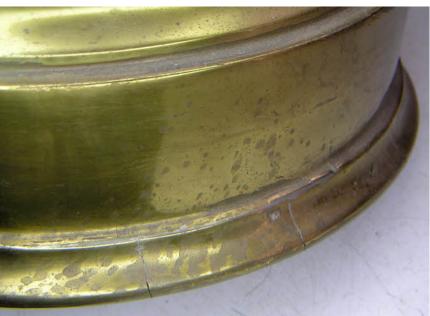
This photo shows the acid damage in This photo shows the outside of the base where the brass has been reinforced. There are solder burn marks but these should polish out OK. But the joints will still be noticeable.

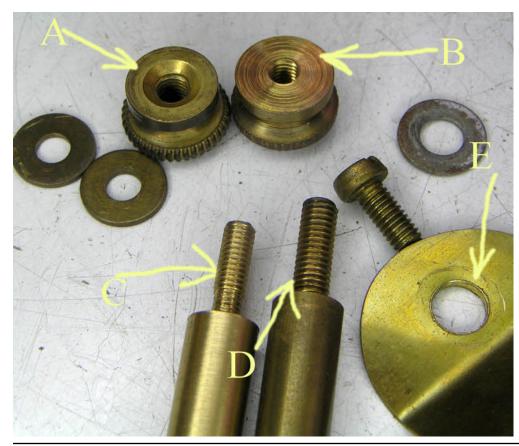
Here we see the battery support pillars and knurled nuts. Note that (B and (C are replacements that have different threads. Ι will manufacture a new set with the same dimensions and threads as the originals (A and (D. Note the rough hole through the battery retainer. (E. I will tidy this up a little.

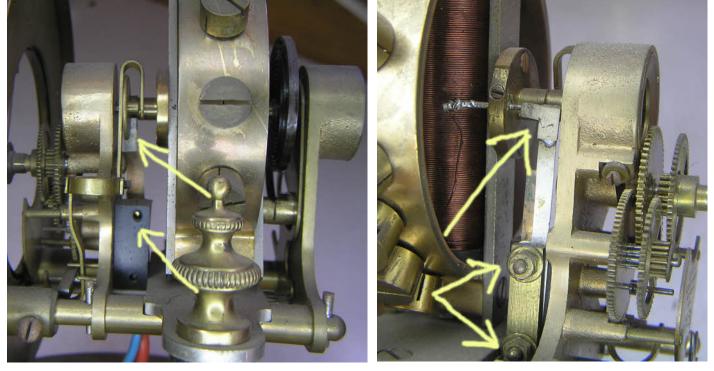
This photo shows that the flag contact assembly is a home made piece of spring steel with a piece of silver soldered in place. The block to which it is attached looks to be damaged with two large nuts and bolts holding the flag in place. The whole assembly will need replacing.

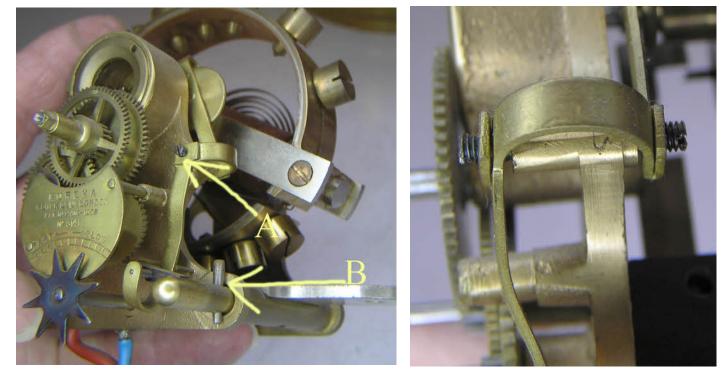
This is interesting as it is the first Eureka I have restored with setting screws (A used as pivots for the impulse arm. Not also that the frames are held in place by large taper pins (B rather than nuts.

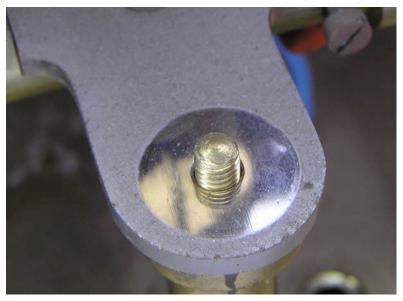
The condition of the nickel plating under the ornate finial nuts is in almost perfect condition compared to the unprotected areas.

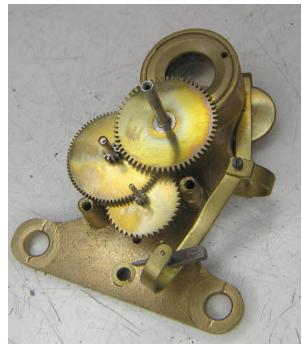
The front plate and motion work ready to be disassembled.

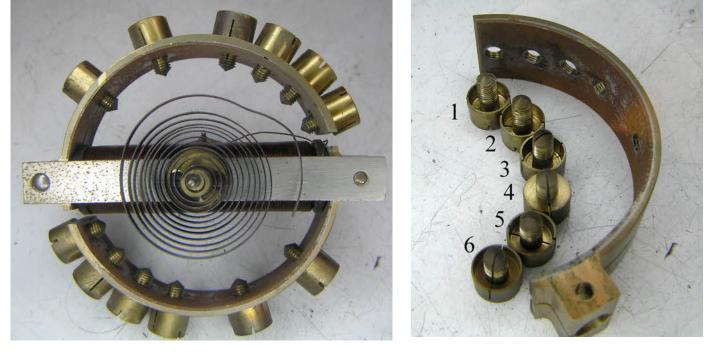
The balance spring is in a bit of a state but with a little care it can be straightened. When removing the balance wheel screws I note the clock position of each one (1 o'clock, 2 o'clock etc) and weigh them on a sensitive balance to within one tenth or a gram. I then record the position and weight. After cleaning I only need to weigh them again to find the correct position. Note the rust on the steel of the balance wheel rim. Unfortunately removing the rust will also mean removing some of the nickel plating. But its position will mean that it will not be that noticeable.

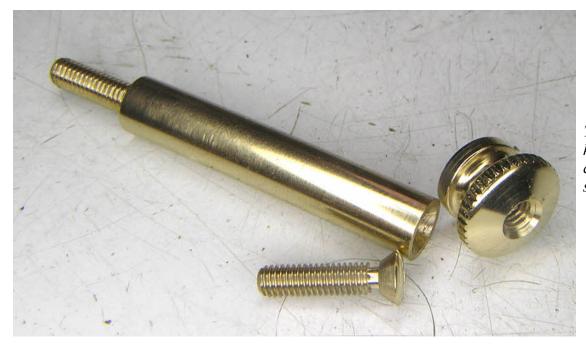
The new pillar, knurled nut and countersunk screw.

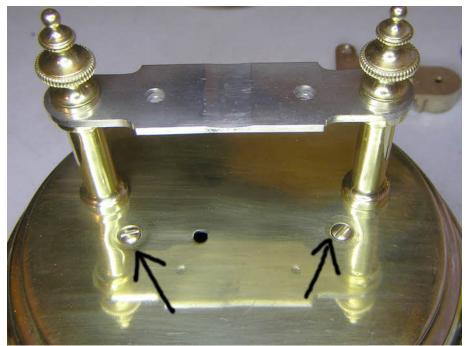
The new screws in position showing how they should look from the top of the base.

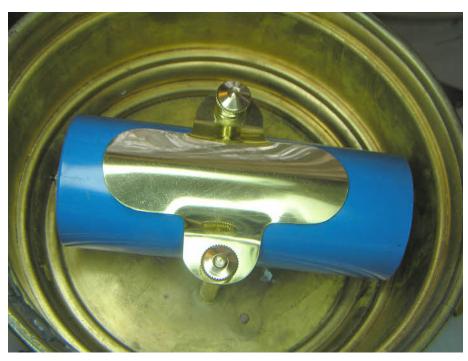
The underside of the base with model test battery in place with knurled nuts.

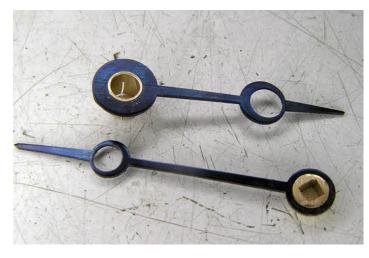
The finished hands.

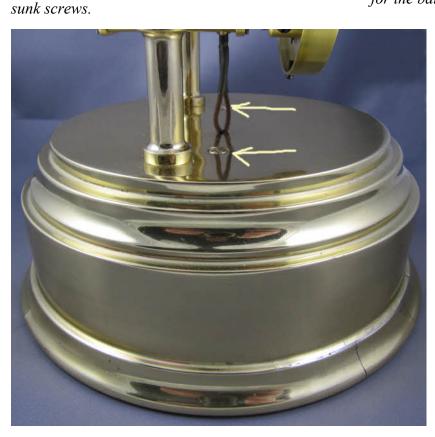
The photo below shows the finished base and countersuch screws

The underside with Horologix battery in place.

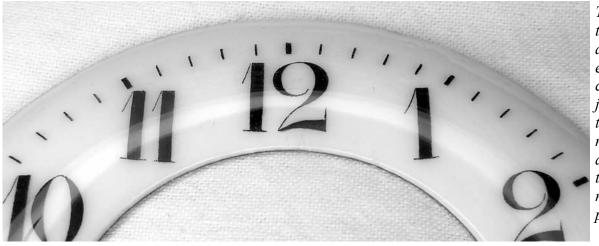
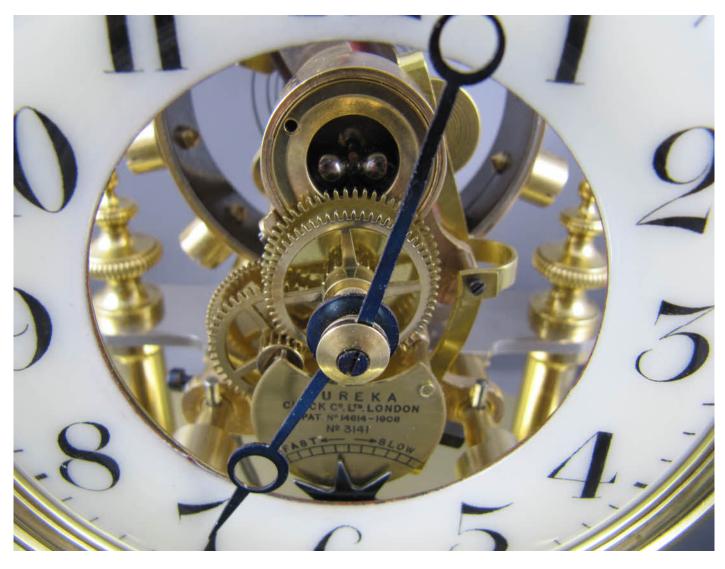
The dial as returned from the dial restorer. An excellent job .I couldn't see "the join". Below is the finished movement, dial and hands. Note the newly waxed registration plate.

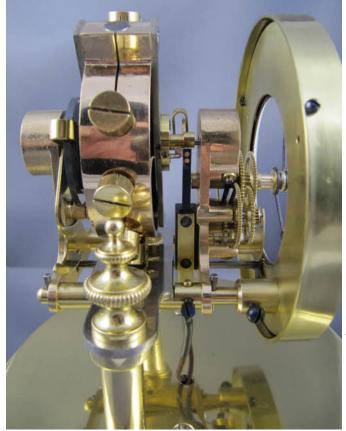
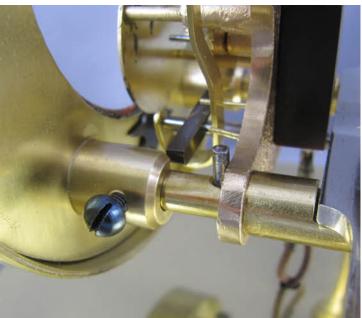
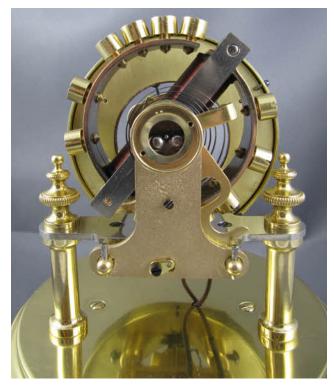
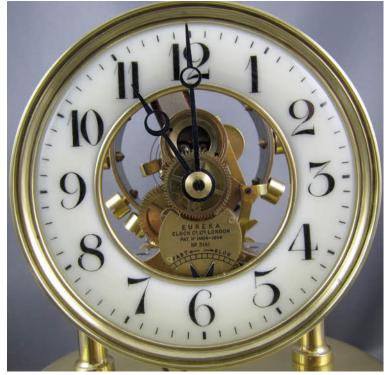
Above is a view of the dial pan screws after blueing and holding the pan in place. The photo at left is a view of the movement with new flag and block in place. Below left is a rear view of the finished clock while directly below is a full on view of the face.

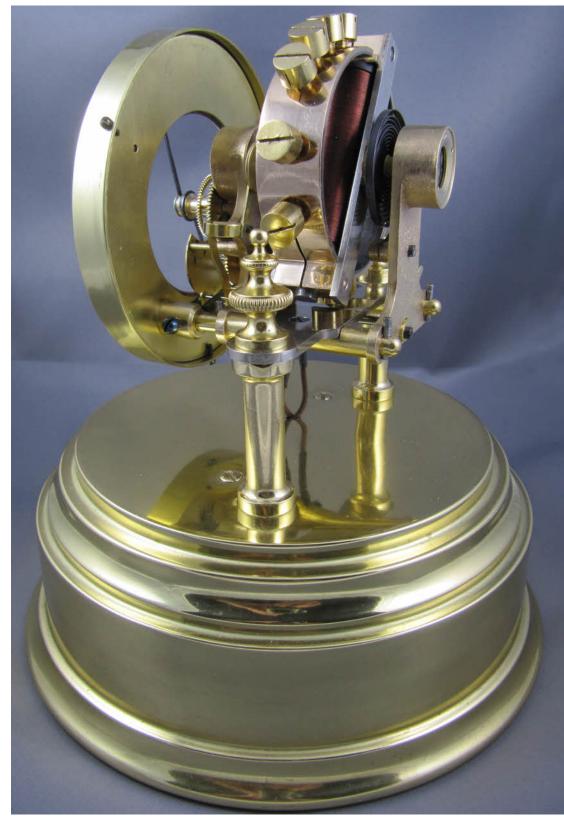
Side View of the finished clock

Normally. I would not polish a Eureka base if there is a substantial amount of the original gilding left but in this case the finish had been polished and rubbed off many years ago so I decided to polish and lacquer it. The only issue was the repair marks on the front (as seen on the next page) where the thin brass had been reinforced with inserts. The cracks can be seen from the outside but other than spending many hours removing the old repair, and then silver soldering in new segments for an invisible repair, I decided to leave well alone. Besides which the brass is so thin in that area that I doubt whether it would be substantial enough to effect a decent repair. It all adds to the character of the clock

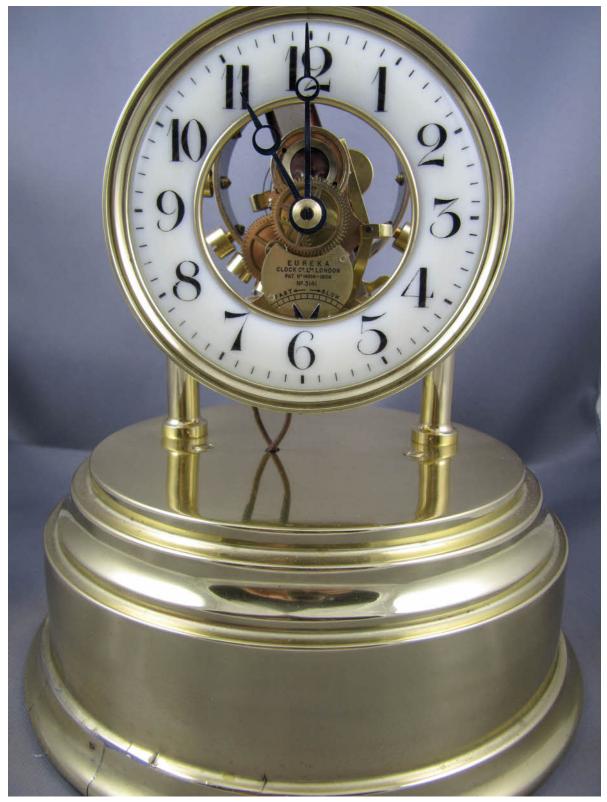
The finished clock
