## Eureka Clock Serial Number 3309

# *Restoration of Eureka Clock Serial Number 3309*

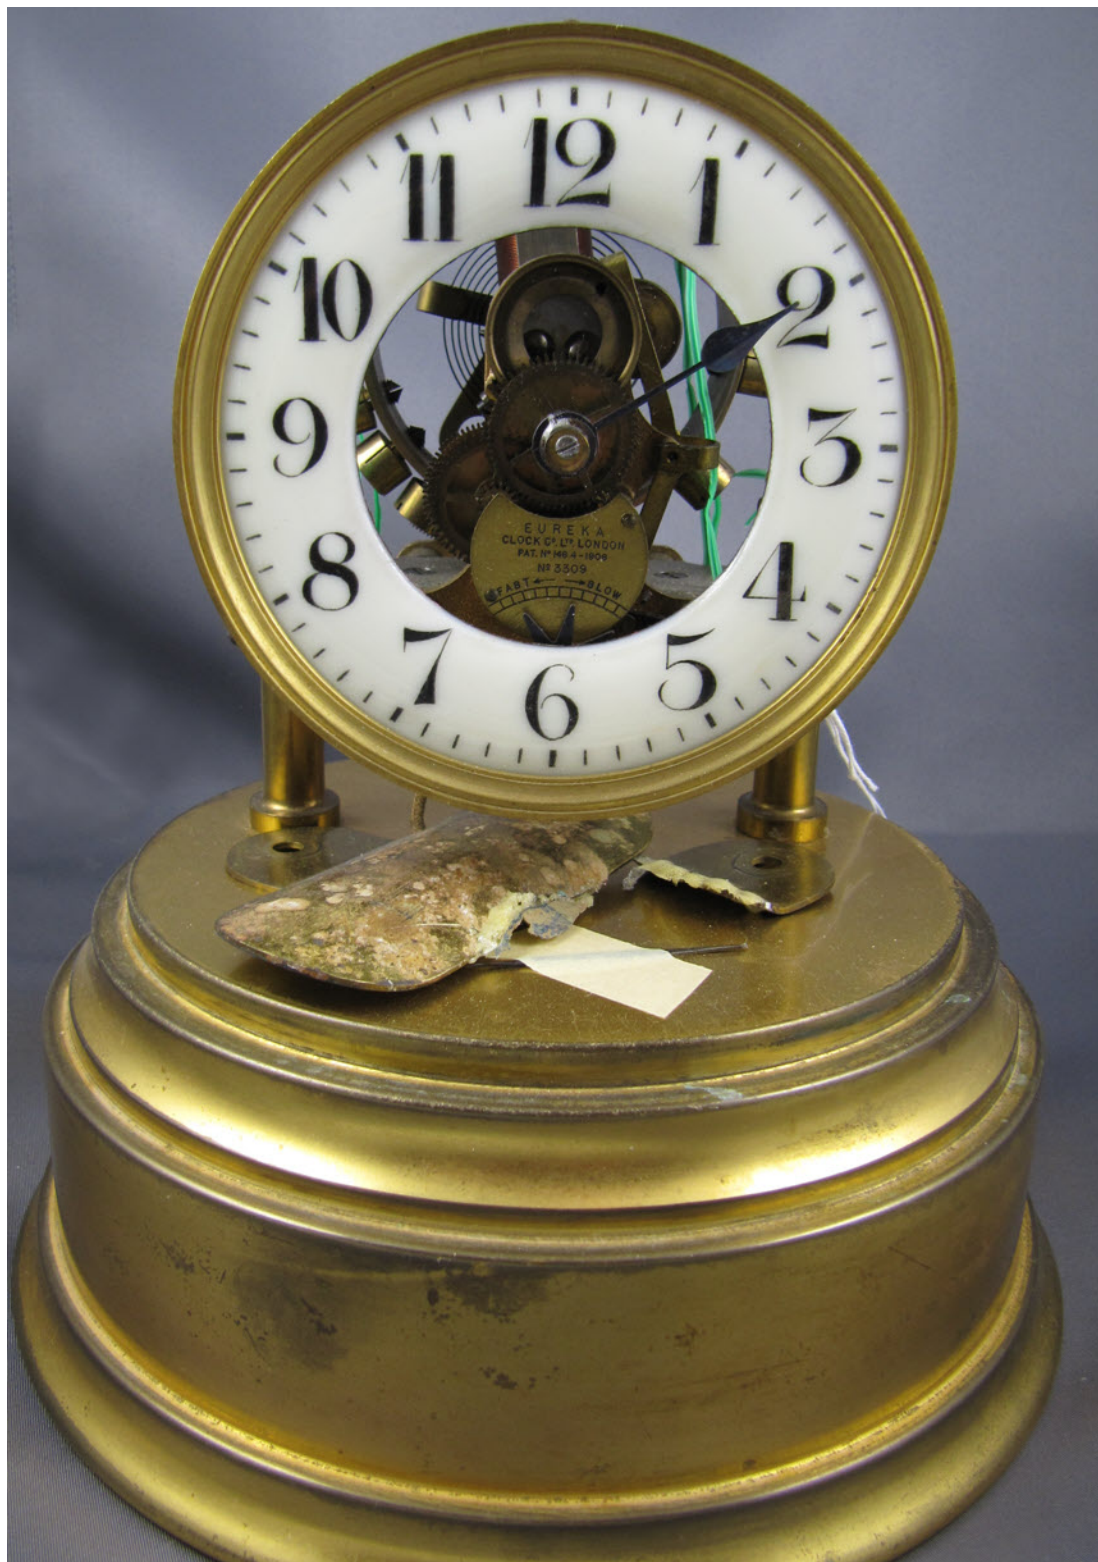
*A short movement clock with the open dial displaying the balance wheel situated behind the movement. The round pressed brass base is in good condition and will only need a wax coat to protect it. There is a temptation when restoring these clocks to remove the gilding and polish up the brass but this should be resisted. As can be seen from the photo the minute hand is broken as well as the battery retainer. The rest of the clock looks to be OK.*

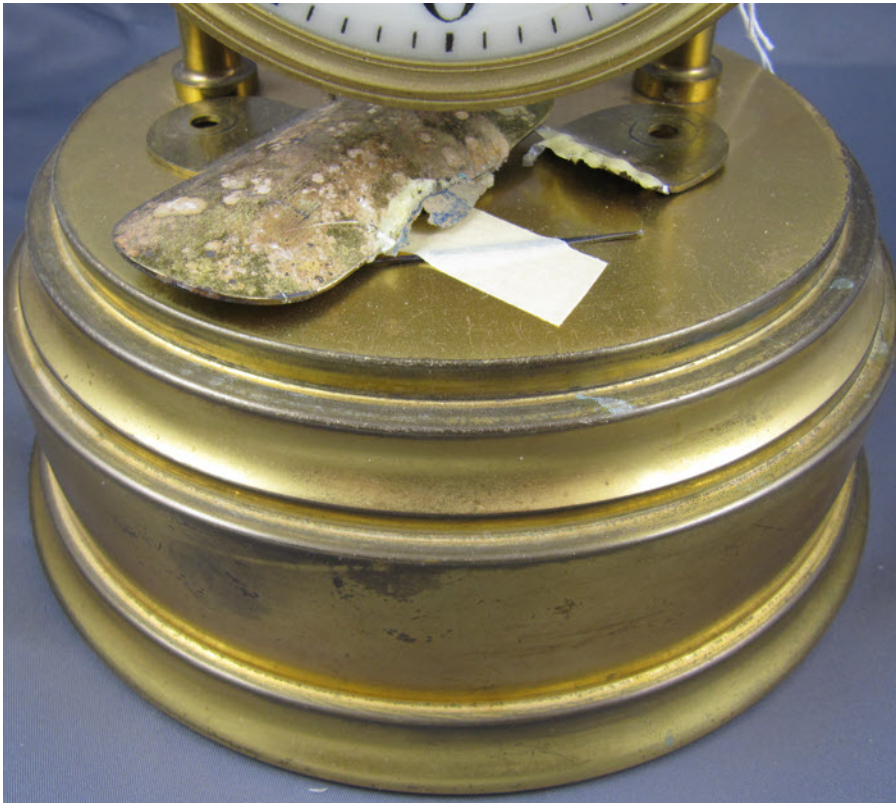
*This detail shows the remains of the minute hand taped to the base. The battery retainer is in a very bad way and seems to have been eaten through by leaking battery acid. One good thing about this style of Eureka clock is that the battery being housed in an open base, cannot leak acid onto the base itself and so you rarely find base with bad acid damage.*

*In this case though the damage to the retainer is extreme and will require a lot of cleaning and probably brazing which will enable us to deposit some brass to replace the loss. .*

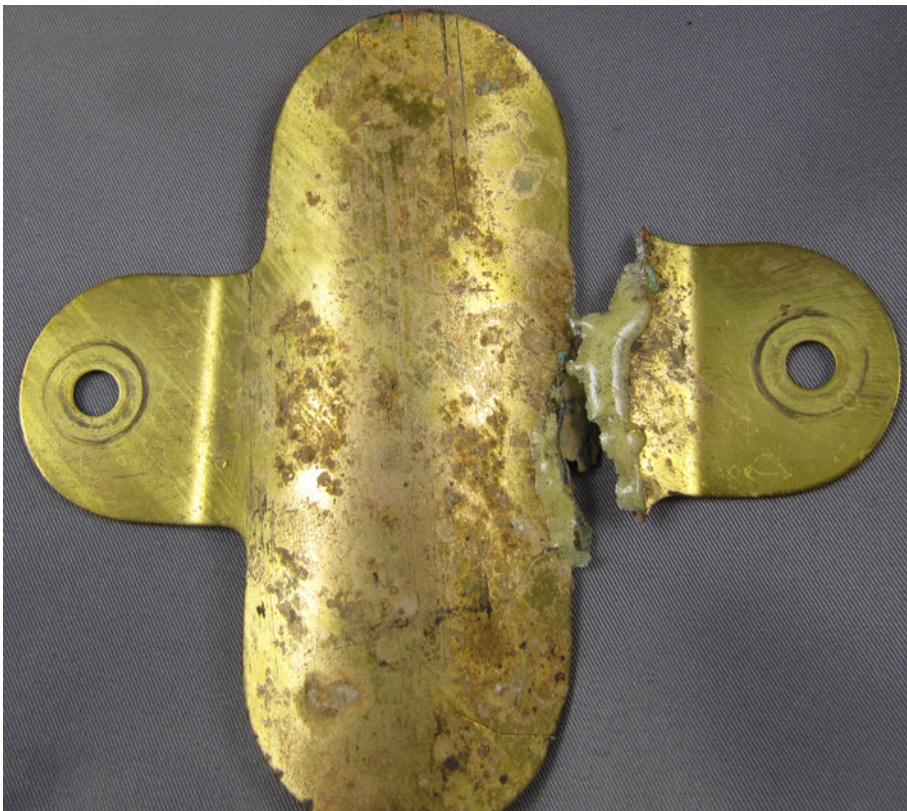
*This photo shows the extent of the damage which has not only eaten through one of the wings but has also left pits in the body of the retainer.*

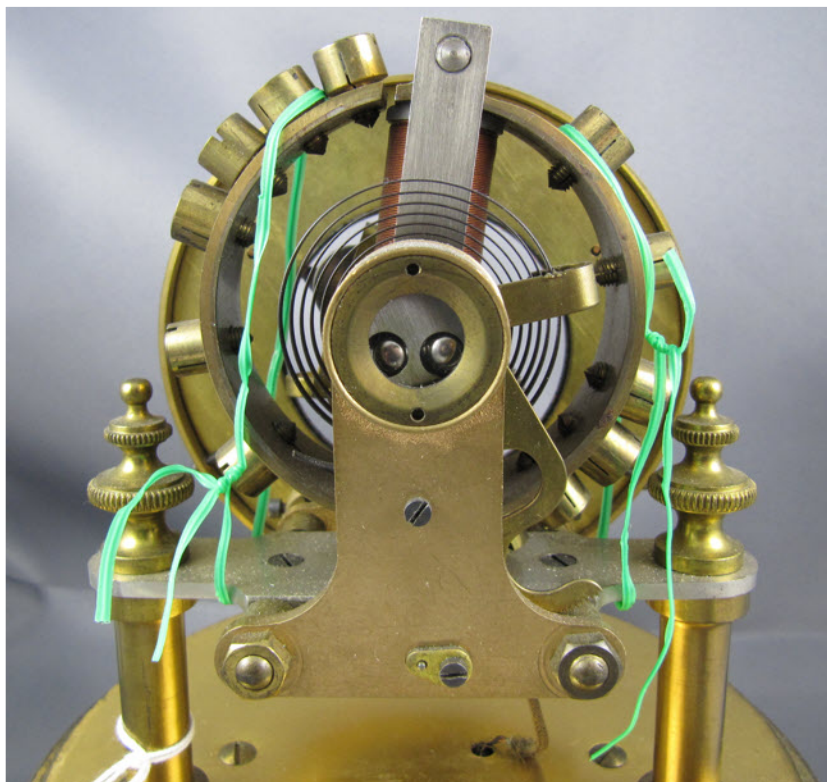
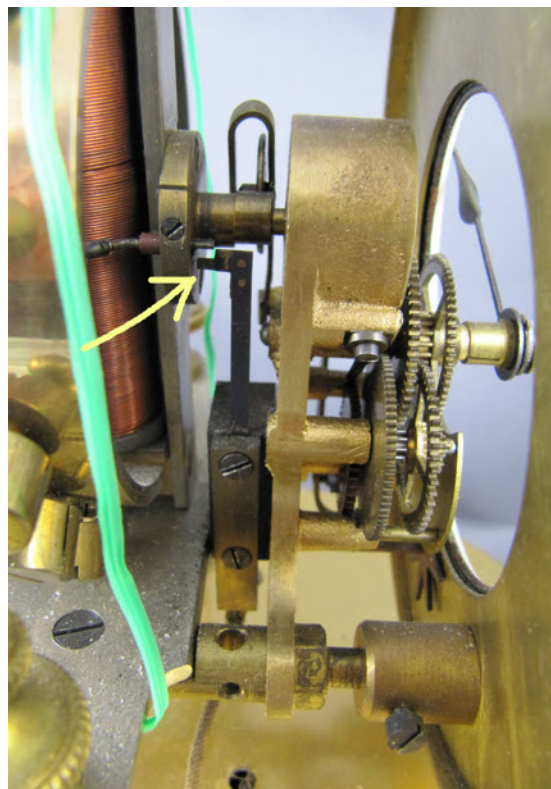
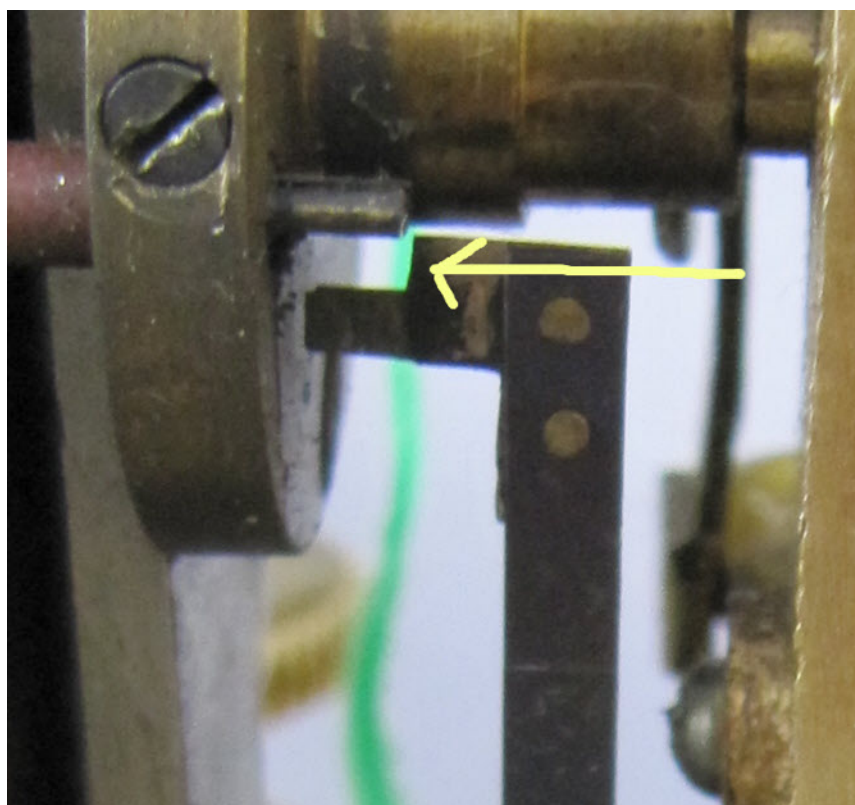
*The clock was bound in plant ties which did a good job of stopping the balance wheel from swinging in transport. The arrows show the contact flag and the accumulated wear over the decades. We will fit a new contact flag and pin.*

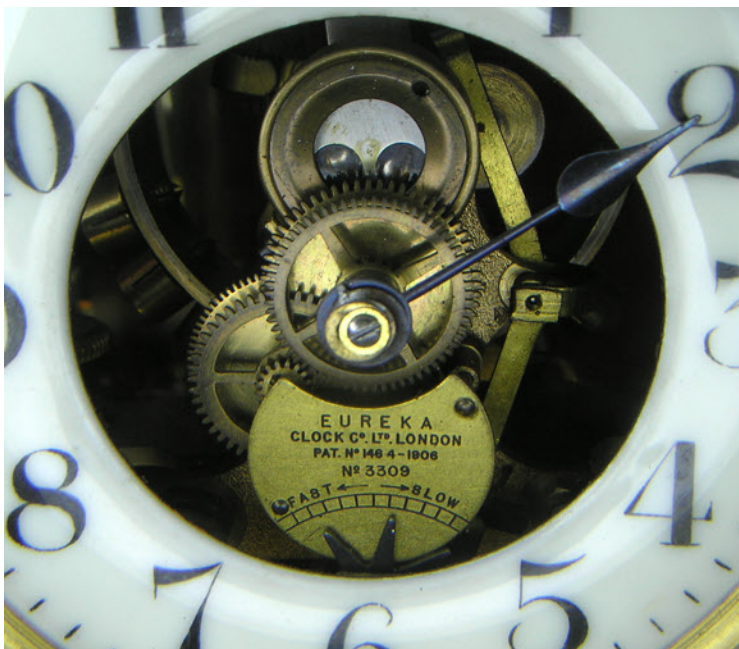
*The movement s/n plate and star adjusting wheel.*

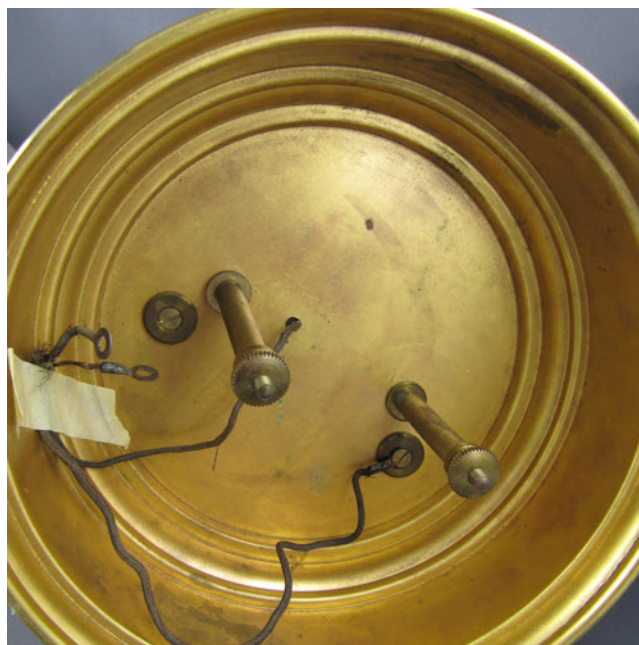
*The underside of the base shows no sign of damage.*

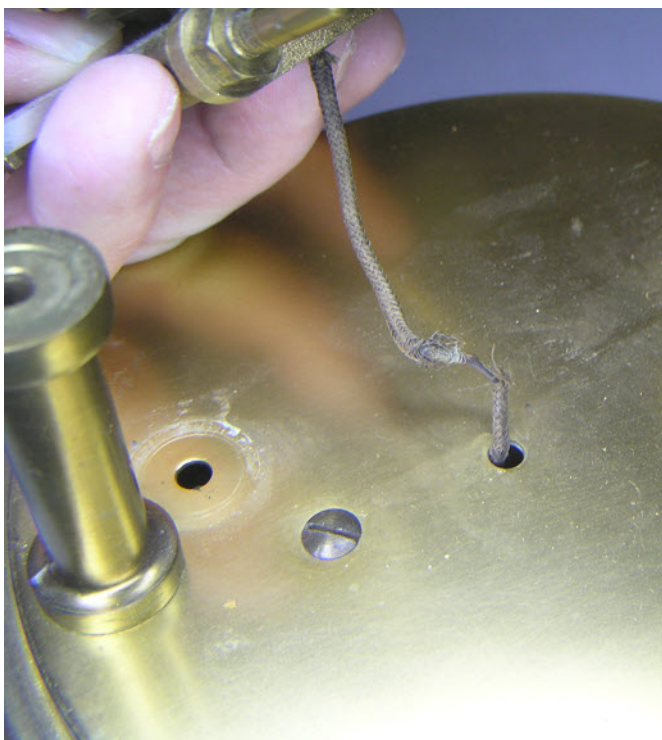
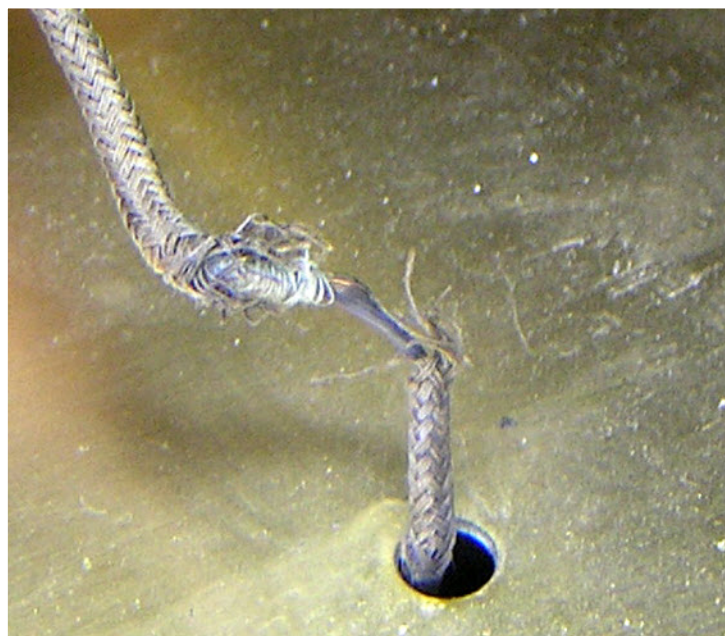
*The positive lead has been cut nearly through and will need to be replaced.*

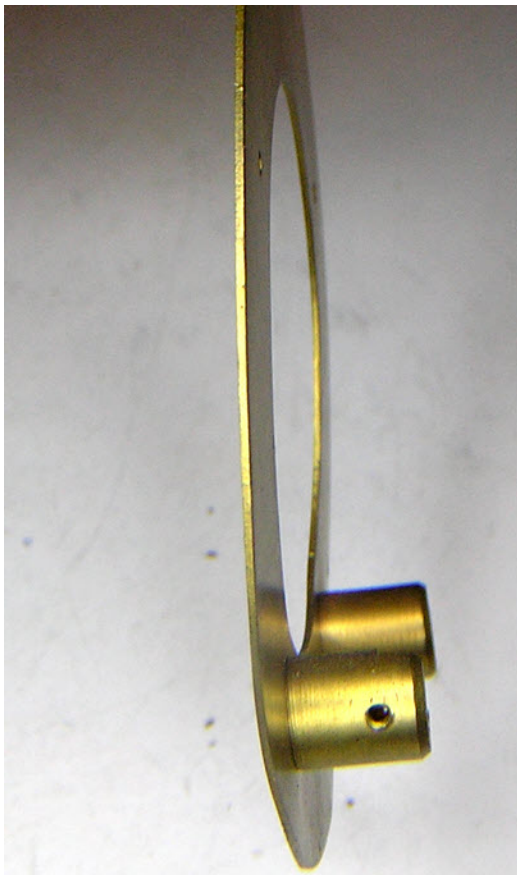
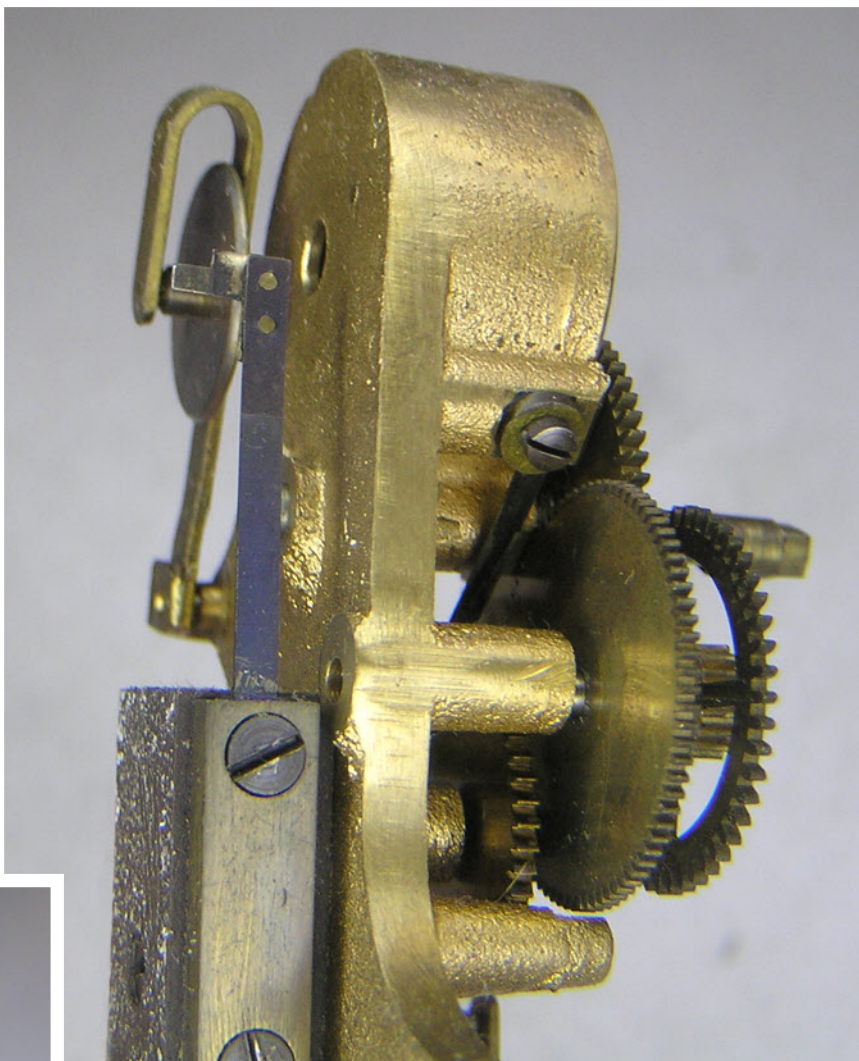
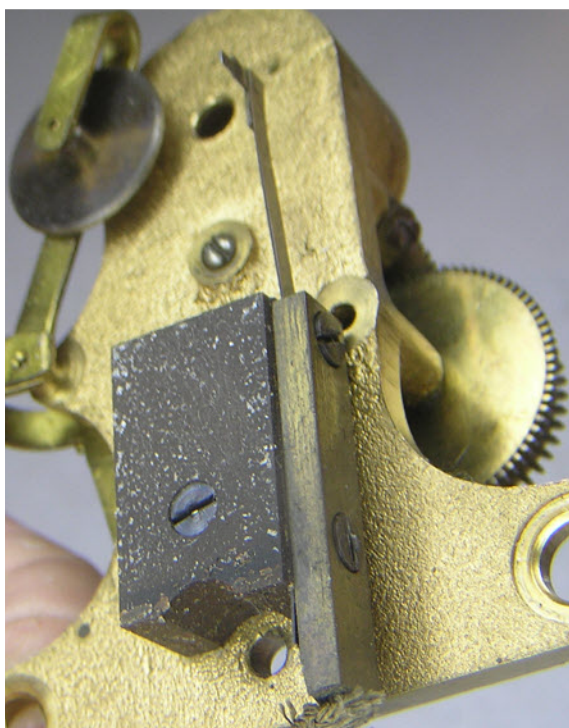
*The photo top left shows the dial pan which is in a bit of a state. It will require some judicious bending and hammering to straighten it out. The other photos show some detail of the motion work and insulating block that carries the contact flag.*

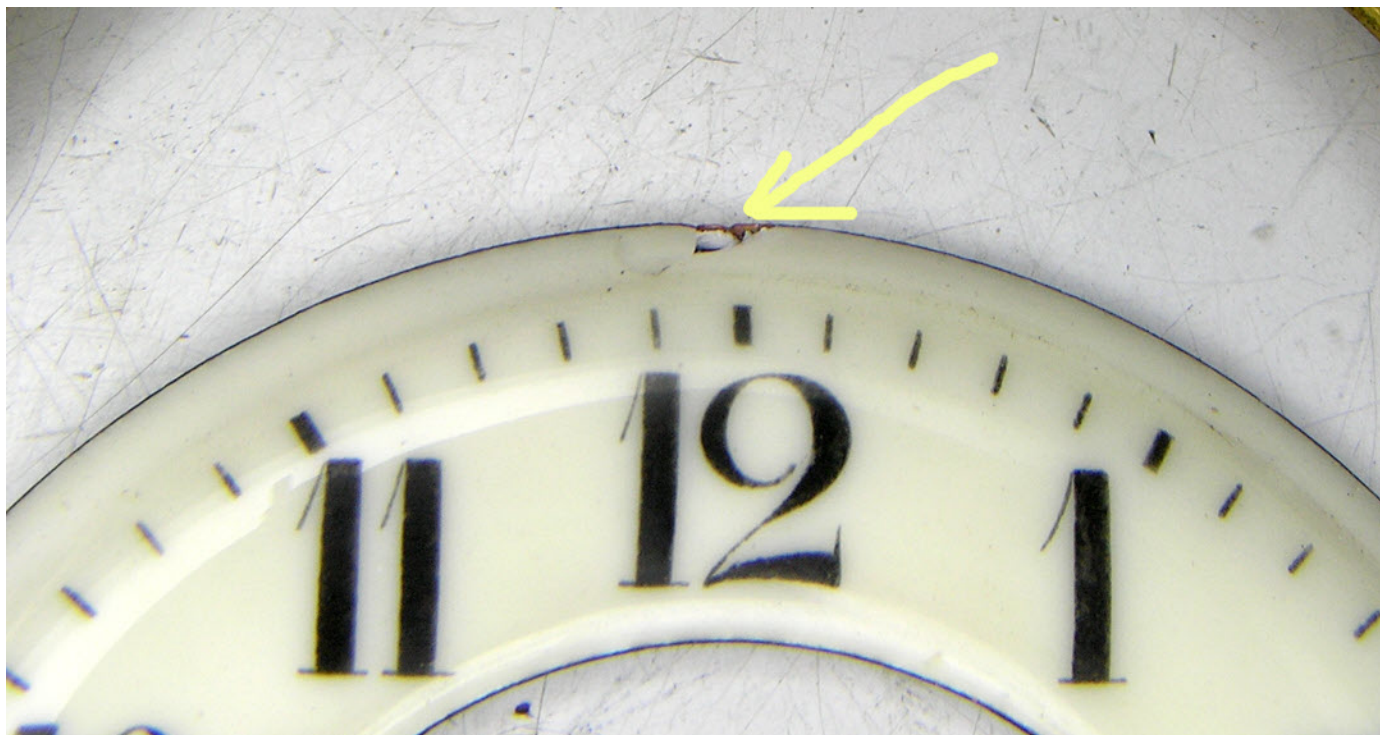
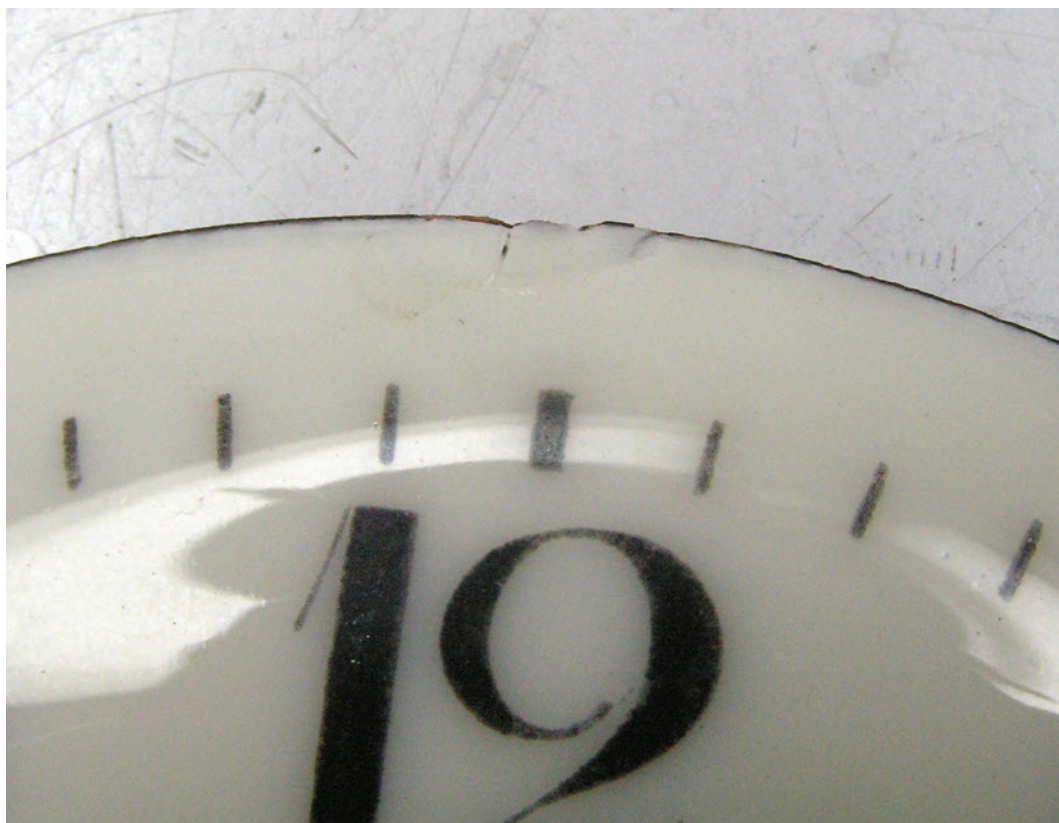
*On removing the brass dial surround I found that there was a small chip at the twelve o'clock position. Luckily the shard was found at the bottom of the surround and was glued back in place. The brass surround covers this anyway so it will not be seen. The dial was washed in warm soapy water to remove all the grime.*

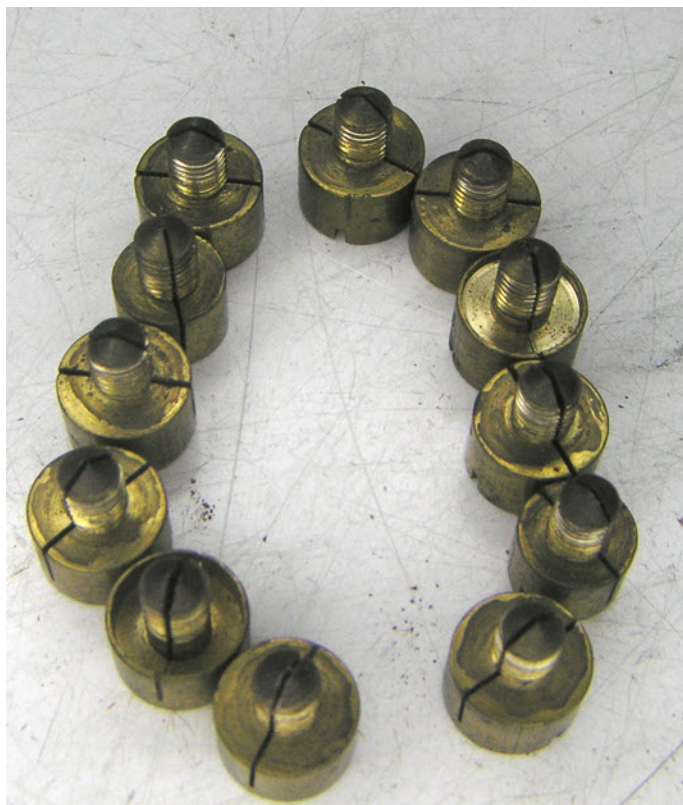
*If you ever take a balance wheel apart then you will note that not all of the screws will be the same. Besides the fact that two are dimensionally smaller than the other ten, all of the screws may have been undercut to varying degrees such that they may end up as empty casings. This was done to balance the wheel. Sometimes on or two may be treated this way or sometimes all of them. When removing the screws I number them from one to twelve as per the numbers on a clock face. So that number one is top right and then numbered in a clock wise direction. In the photo top left, The screws at three o'clock and eight o'clock have been undercut slightly to lessen the weight. Rather than try and physically mark the screws with a position I find it easier to use a set of miniature electronic scales that are accurate to a gram and weigh the screws. I then write down the weights with the screws position. It is then a simple matter to weigh the screws when cleaned to ascertain their position..*

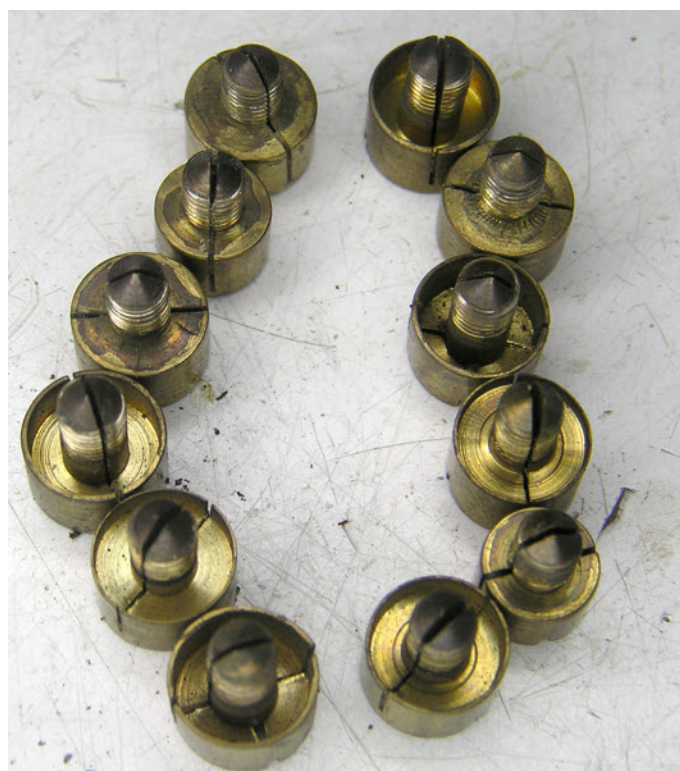
*This photo of screws from another clock show the far more extensive undercutting in the screws at one, three, four, six, seven, eight and nine o'clock positions.*

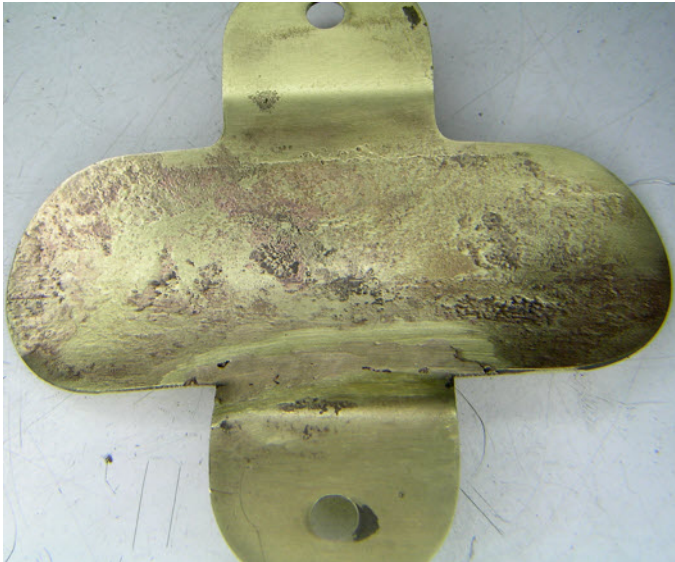
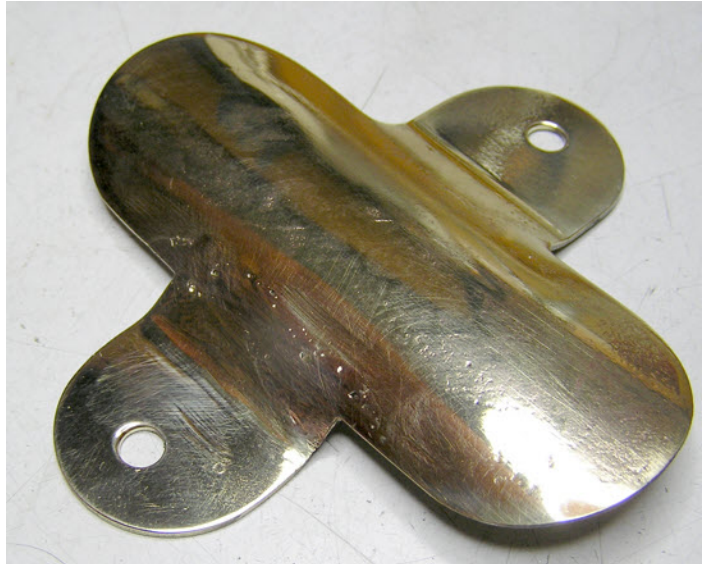
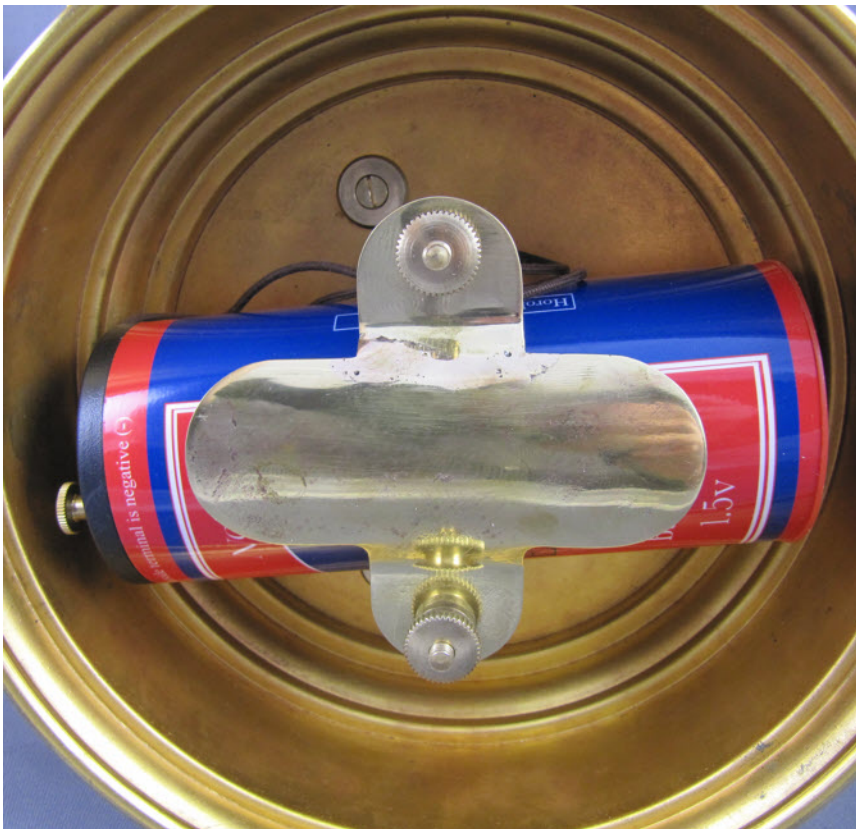
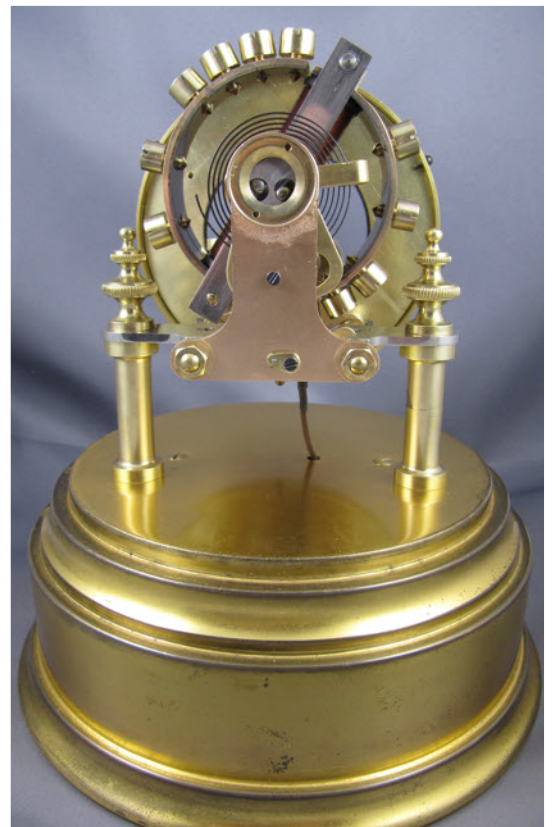
*The battery clamp after brazing. Note the pits on the underside. The brass has been cleaned and the acid burns removed but there are still pits on the underside. But considering the condition on delivery it's not a bad job. The brazing has deposited a lot of extra brass to recreate the dimensions. It is certainly strong enough to accept the battery and to be screwed down tight. The photo at bottom right shows the rear of the completed clock.*

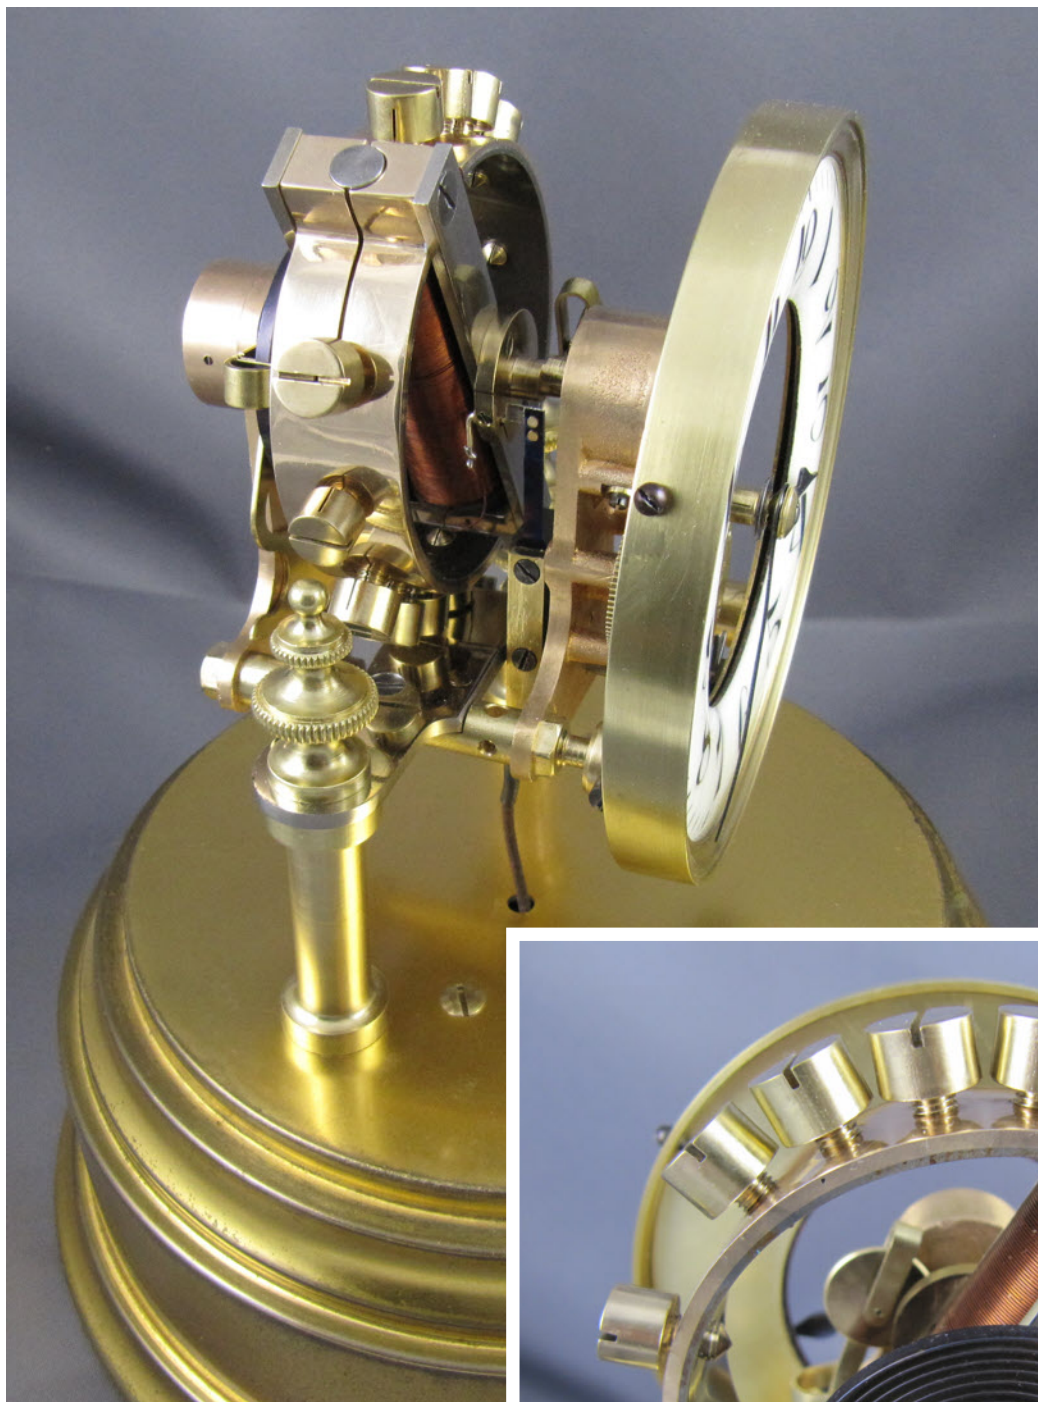
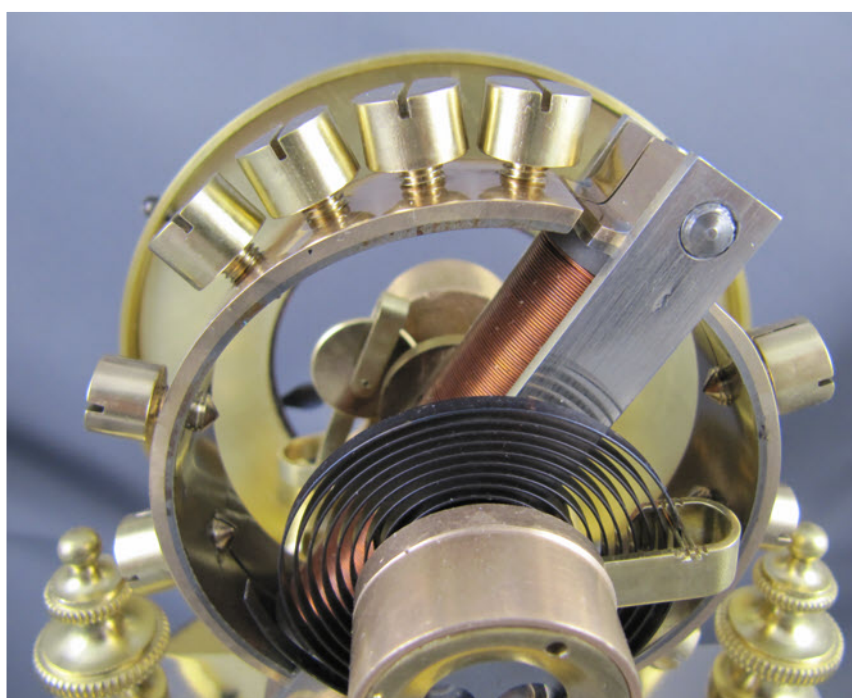
*The side and rear of the  
completed clock.*

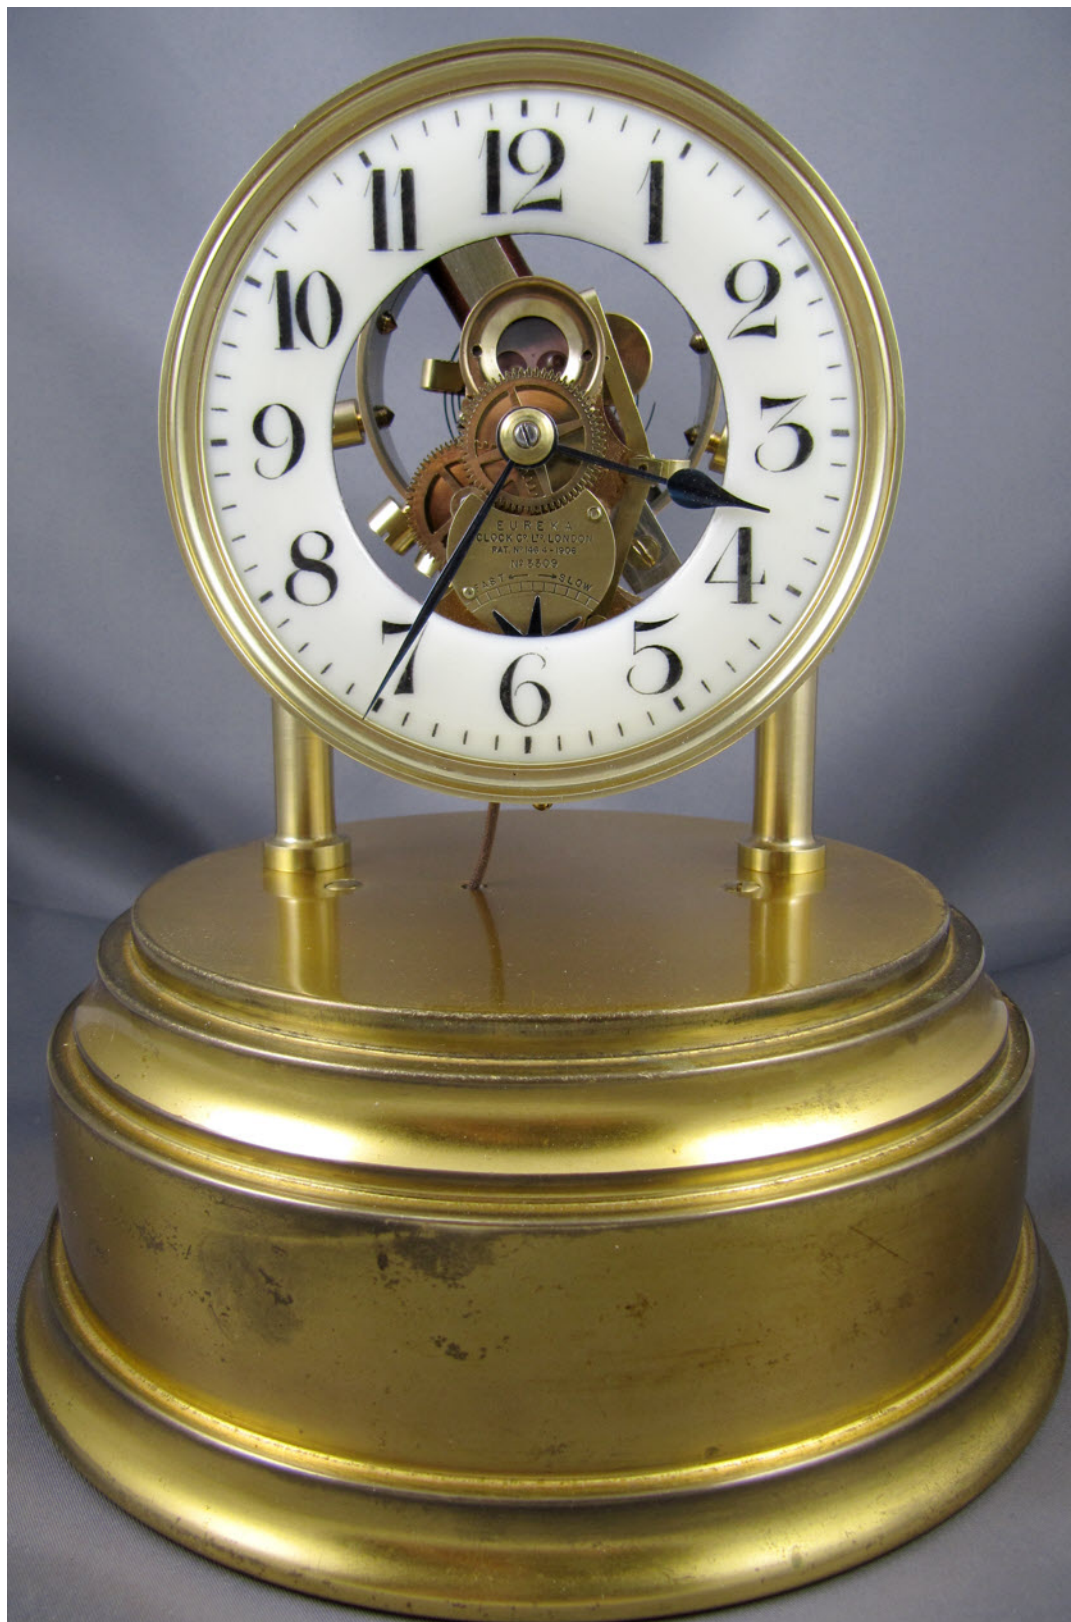
The completed clock.
