**Horologix**   The place to come for all your Bulle and Eureka restoration parts.

# *Eureka Clock Serial Number 404*

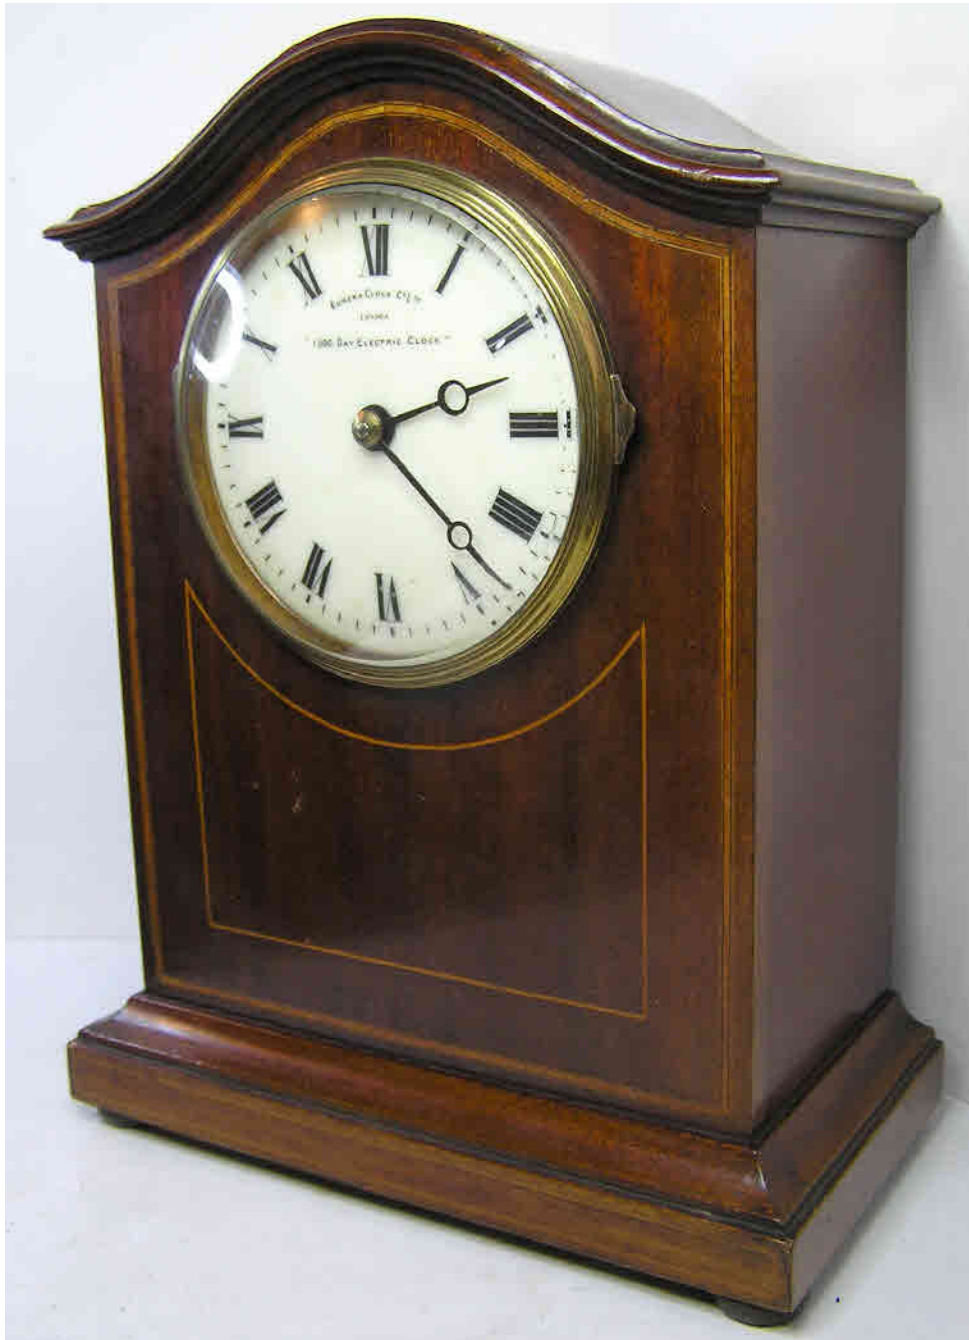
*The short movement in this clock, s/n 404, is completely hidden by the case and dial. The case is of mahogany with inlay to the front. It is in very good condition and will only need a light polish with a good Beeswax. There seem to be no major marks or damage.*

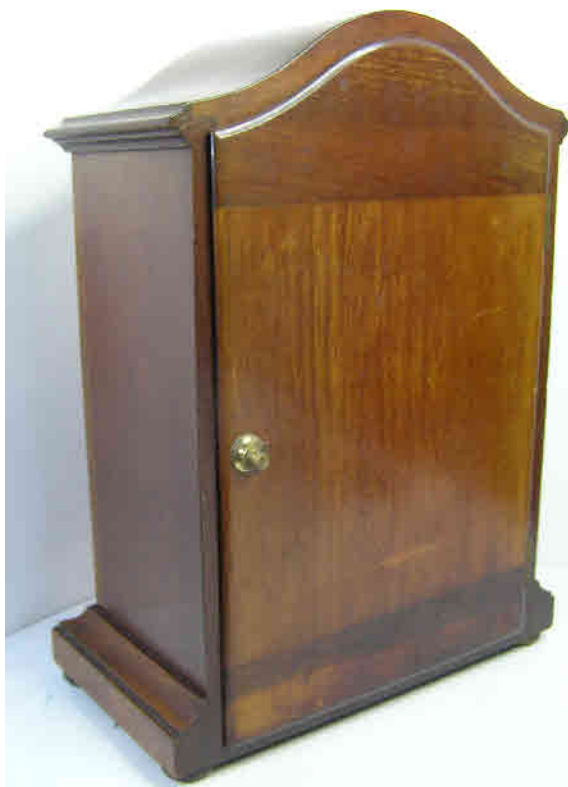
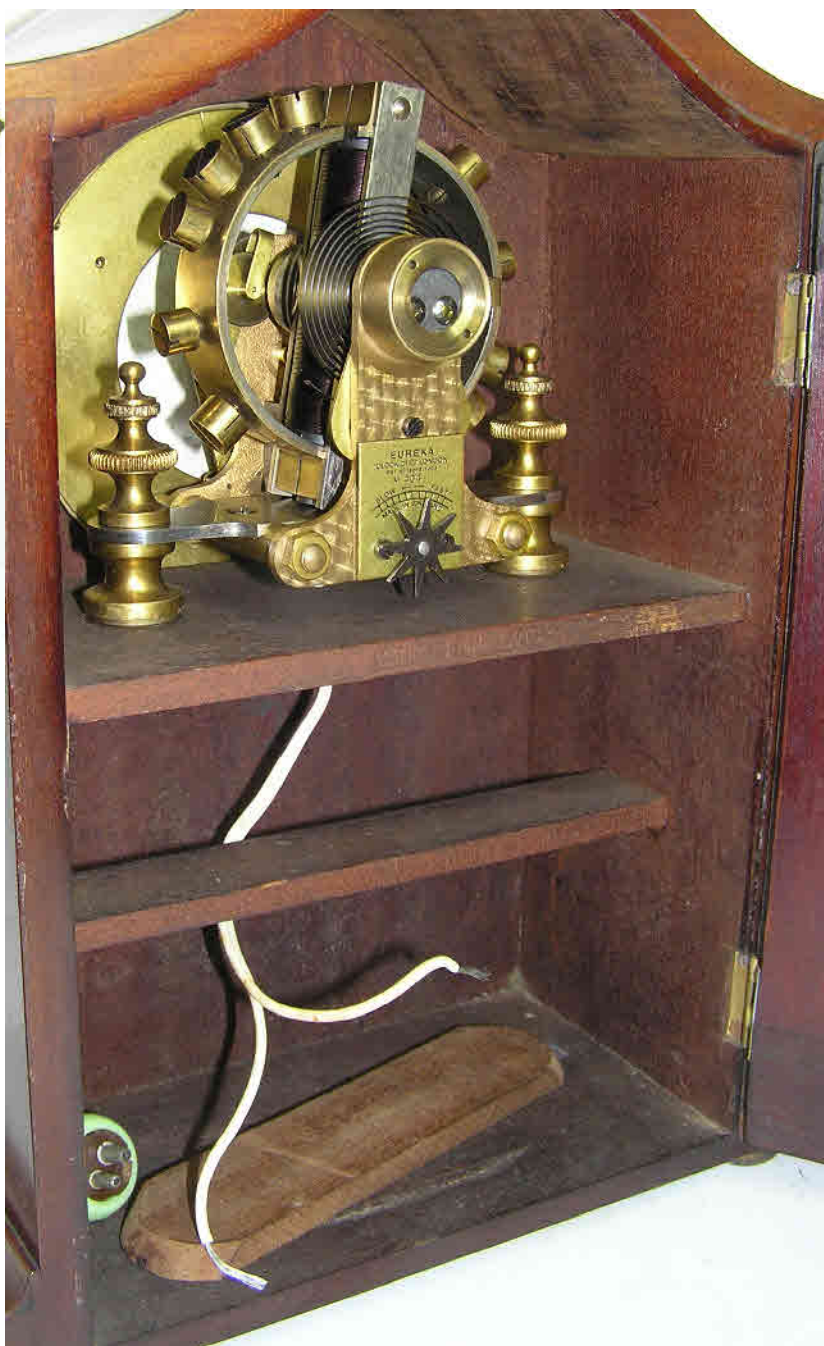
*The rear of the case has a full length door with a brass catch.*

*The movement sits on a seat board above a compartment that used to hold a full size 1.5volt Flag cell battery. Most clocks now are fitted with a small modern "D" cell battery in its place. This clock has been modified with some sort of 1950's connector. It may have been run on a 3 or 4.5 volt battery. Suffice to say the clock does not run once connected to a 1.5volt cell. It may just need a good clean or there may it be something more fundamental. The balance spring looks to be in good condition with the right number of turns.*

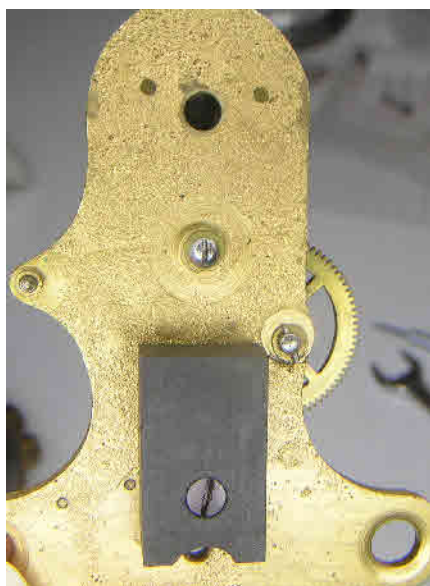
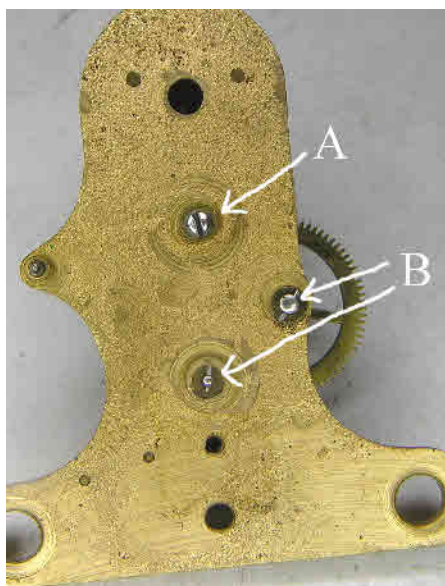
These two photos at left show the fibre block that the contact springs are screwed into. The block insulates the flag from the rest of the frame. The motion arbours extend through the front plate and are retained with either screws (A) or pins (B). The fibre block covers the lower arbour completely and needs to be removed before the retaining pin can be extracted. Note also the washers that take up some of the end play on the arbours.

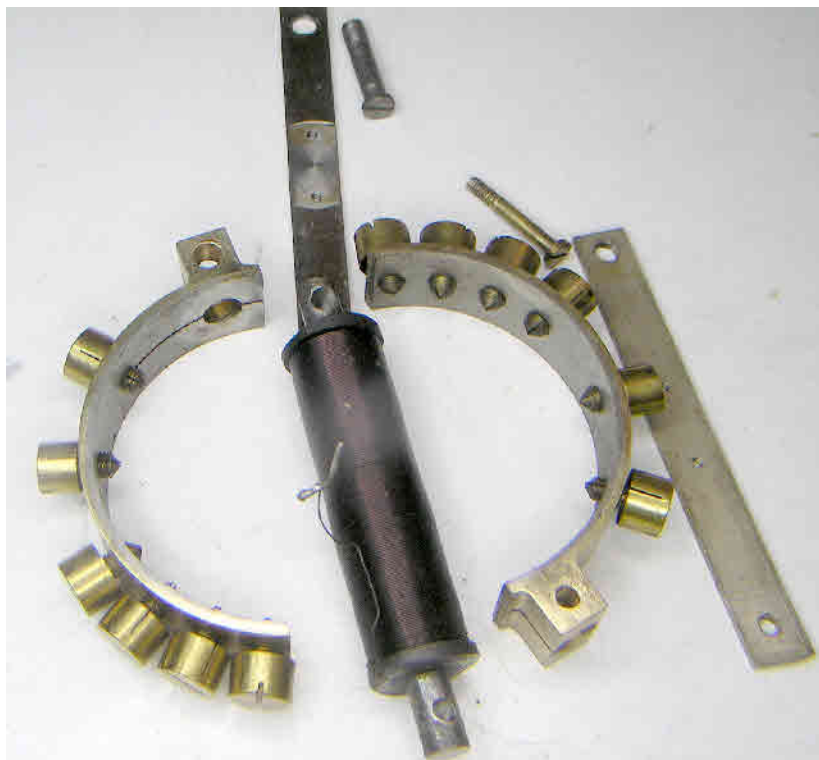
This photo shows the armature and balance wheel disassembled. The winding should be checked for resistance. It should read 20 Ohms give or take 3 Ohms. This one is reading a steady 20 Ohms. The winding must be treated carefully and should only be lightly brushed to remove dust etc. The rest of the assembly can be cleaned in the normal way. The armature ends should be cleaned lightly with wire wool so as to provide good electrical contact. Either take a photo or carefully draw the parts in situ as its important to reassemble in the same order. The enamelled wire, for example, exits the coil through the fibre cap which must be positioned in the gap between the balance wheel halves.

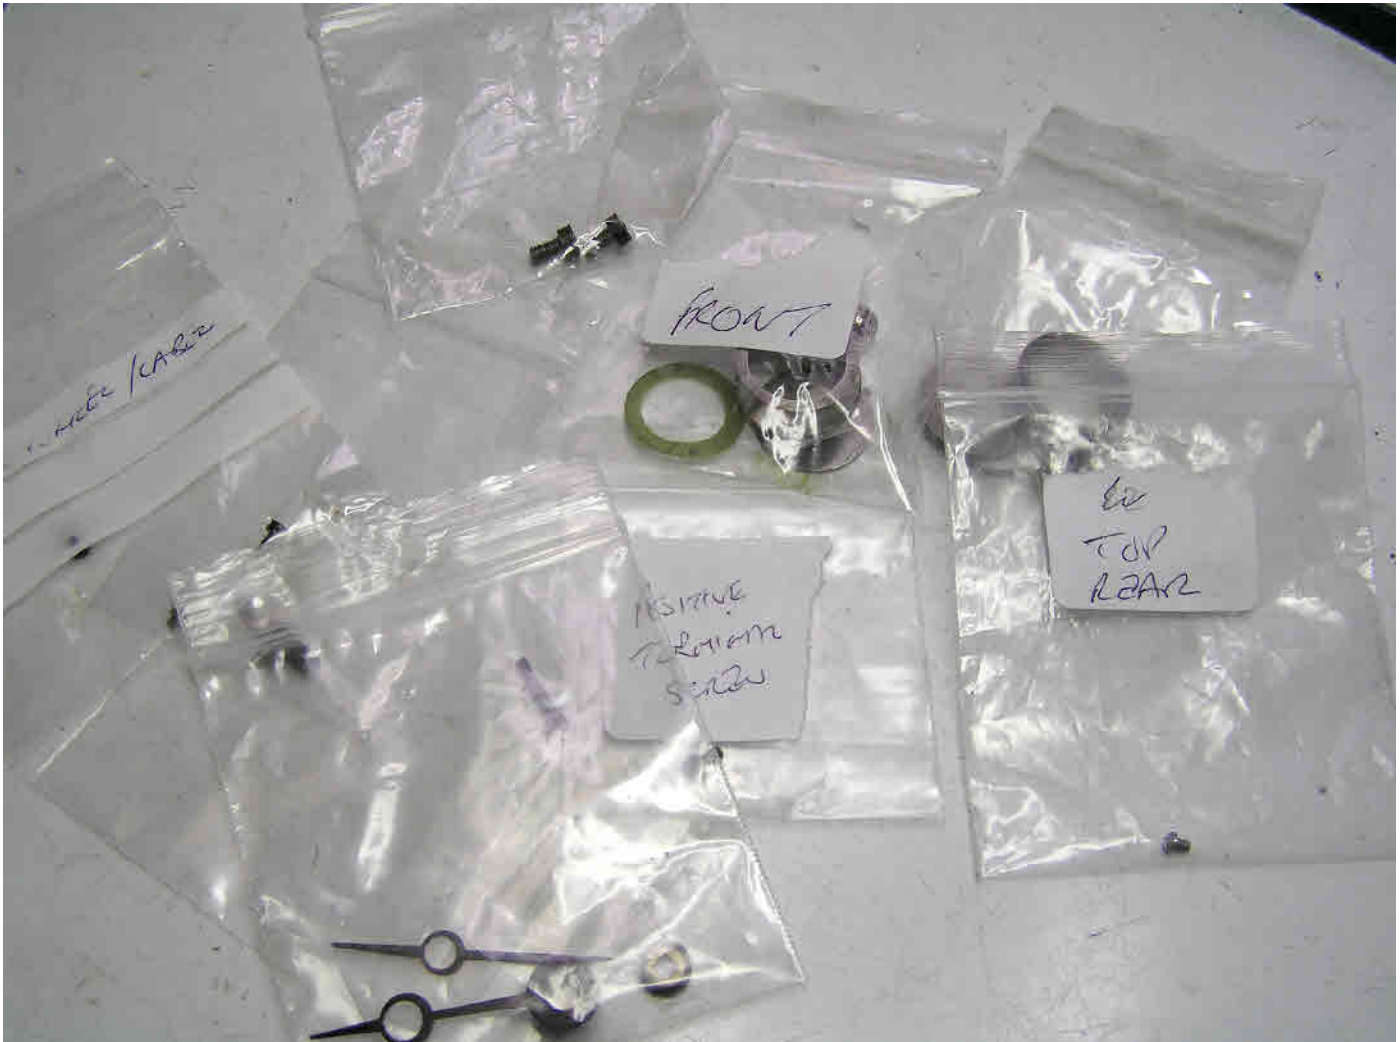
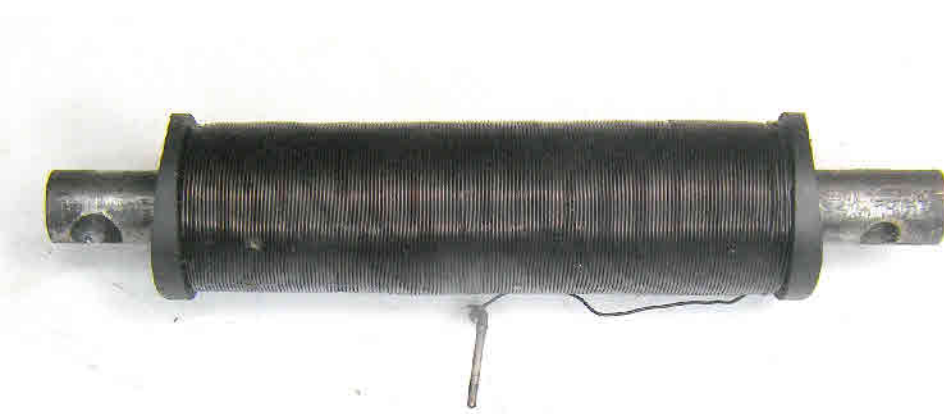
*All the steel work has been bagged separately so that they can easily be identified and replaced in the correct order.. I normally clean all the brass work first and only clean the steel work at the time it is required in re-assembly. The lower photo shows the armature ready for cleaning and testing. (20 Ohms approx)*

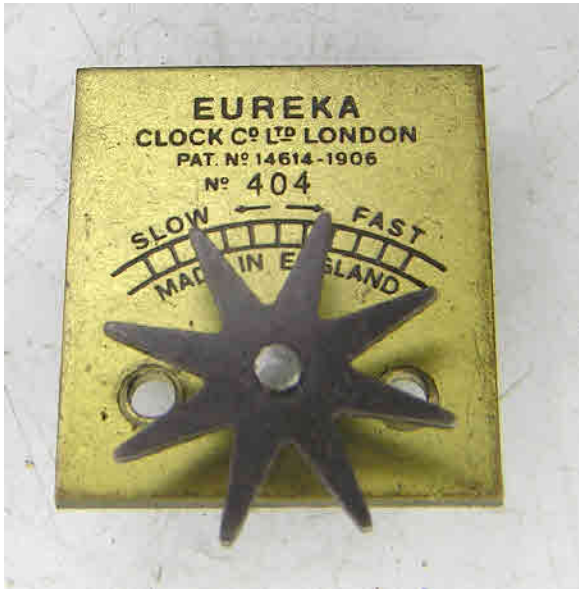
*In this clock the identification plate carries the regulator pinion and star. Unfortunately the star and pinion are riveted together through the plate and cannot be removed without damaging the pinion arbour, plate or star. So as long as there is no damage to either the plate or the pinion there is no need to do anything other than lightly clean and add a drop of oil.*

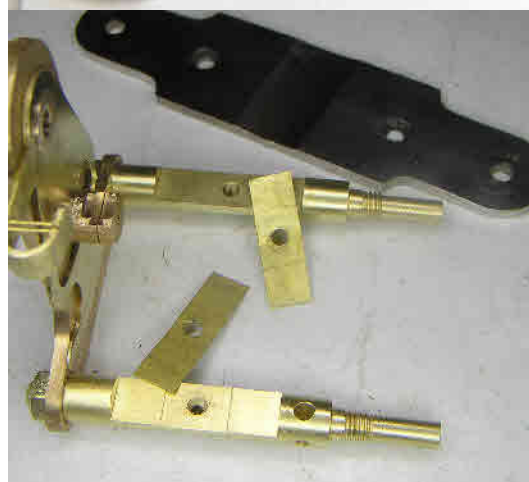
The photo at left shows the shims being prepared under the steel base plate. They should be added until the armature of the balance wheel is as close as possible to the plate when in the vertical position. A gap of a few thousandths of an inch should be aimed for.

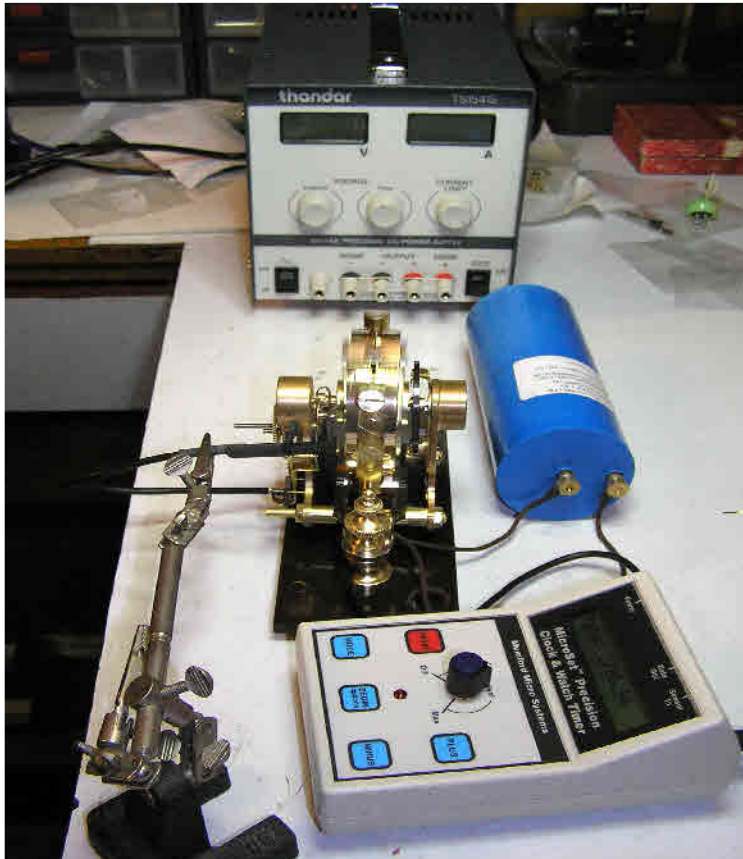
The set up I use for testing a Eureka. The Micro-set timer is invaluable for quickly assessing the rate of the clock. In this case there should be 2700 beats per hour for this clock. It only takes 20 oscillations to check the rate. The Thandor unit at the rear of the lower photo is a variable power supply with fine adjustment. I use this first to regulate against exactly 1.5 volts. Once the clock is running correctly with at least 310 degrees of swing then I switch to the battery that will be installed in the clock. In this case it is a replacement "Flag" cell battery with the same dimensions as the original.

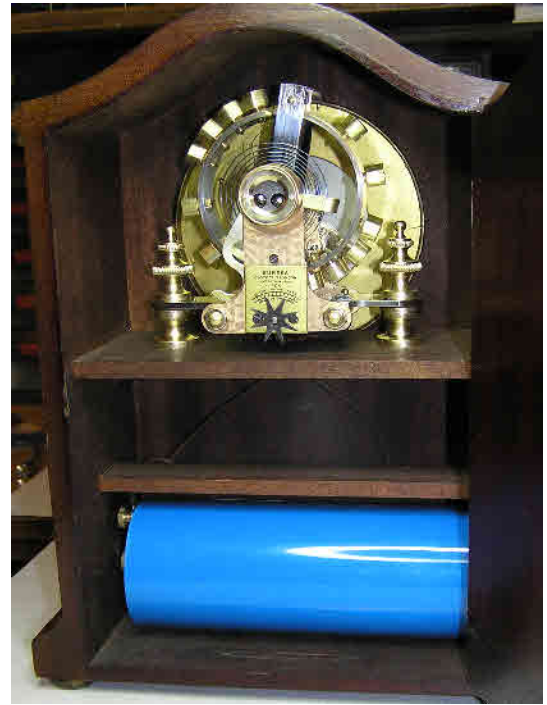
*Photos of the re-assembled clock. Note the replacement flag cell battery fits perfectly in the original housing.*

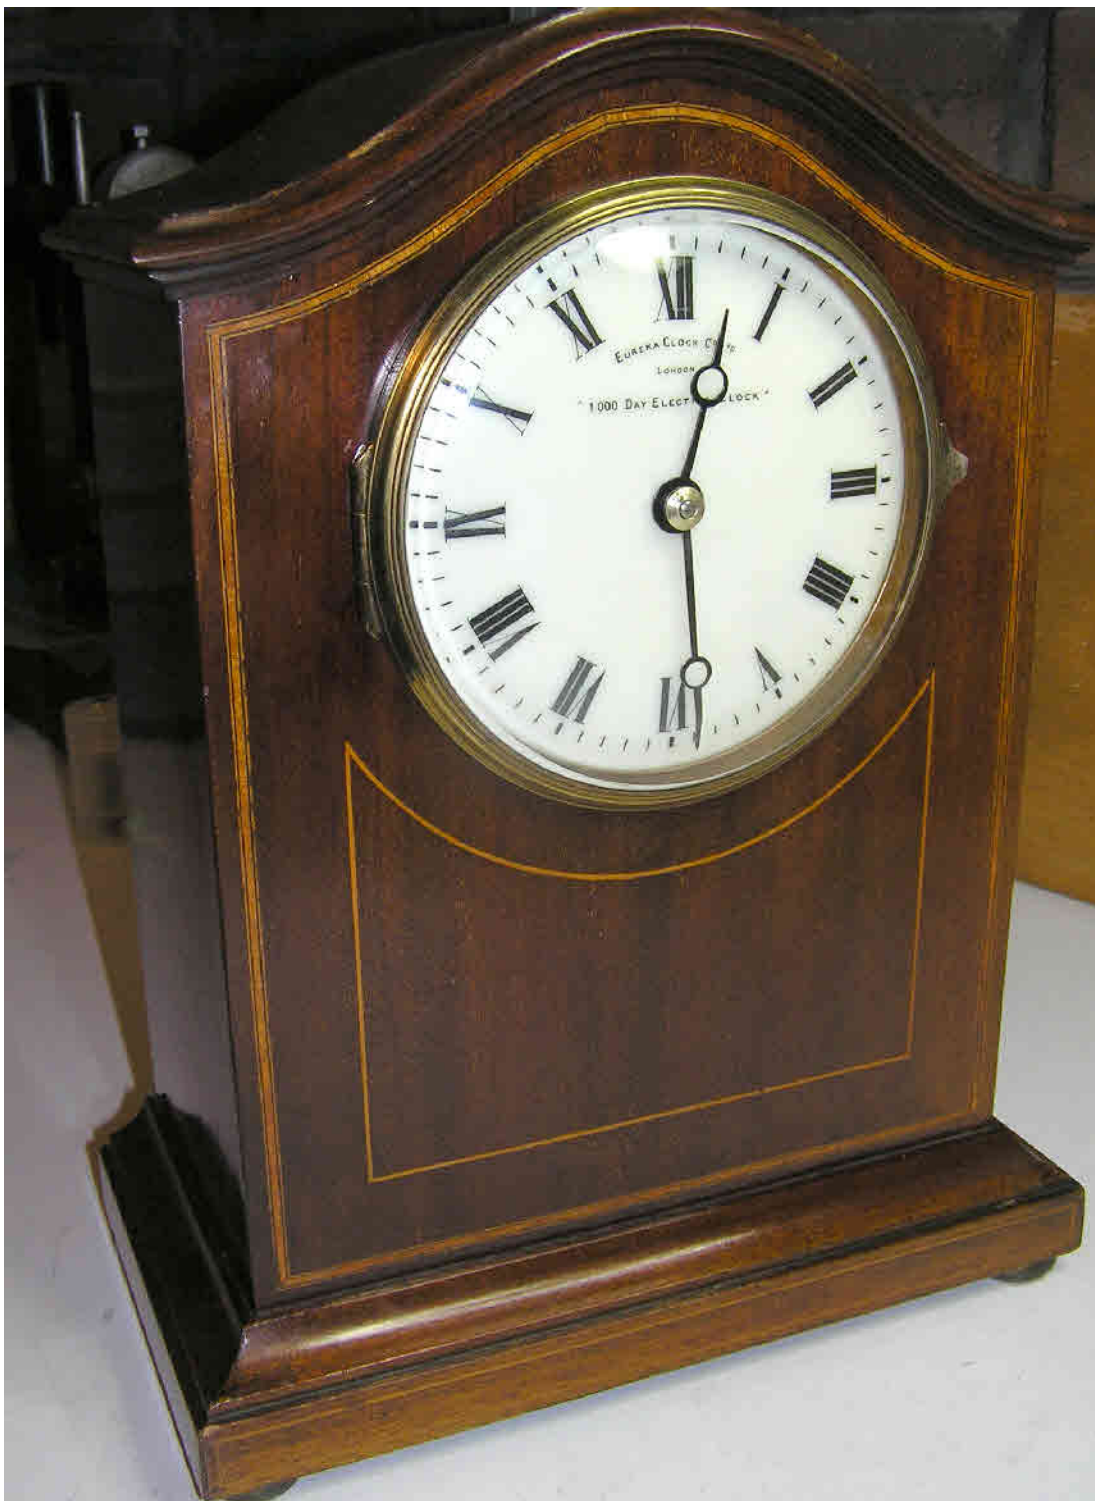
*The completed clock.*
