**Horologix**

The place to come for all your Bulle and Eureka restoration parts.

## *Restoration of Eureka Clock Serial Number 4440*

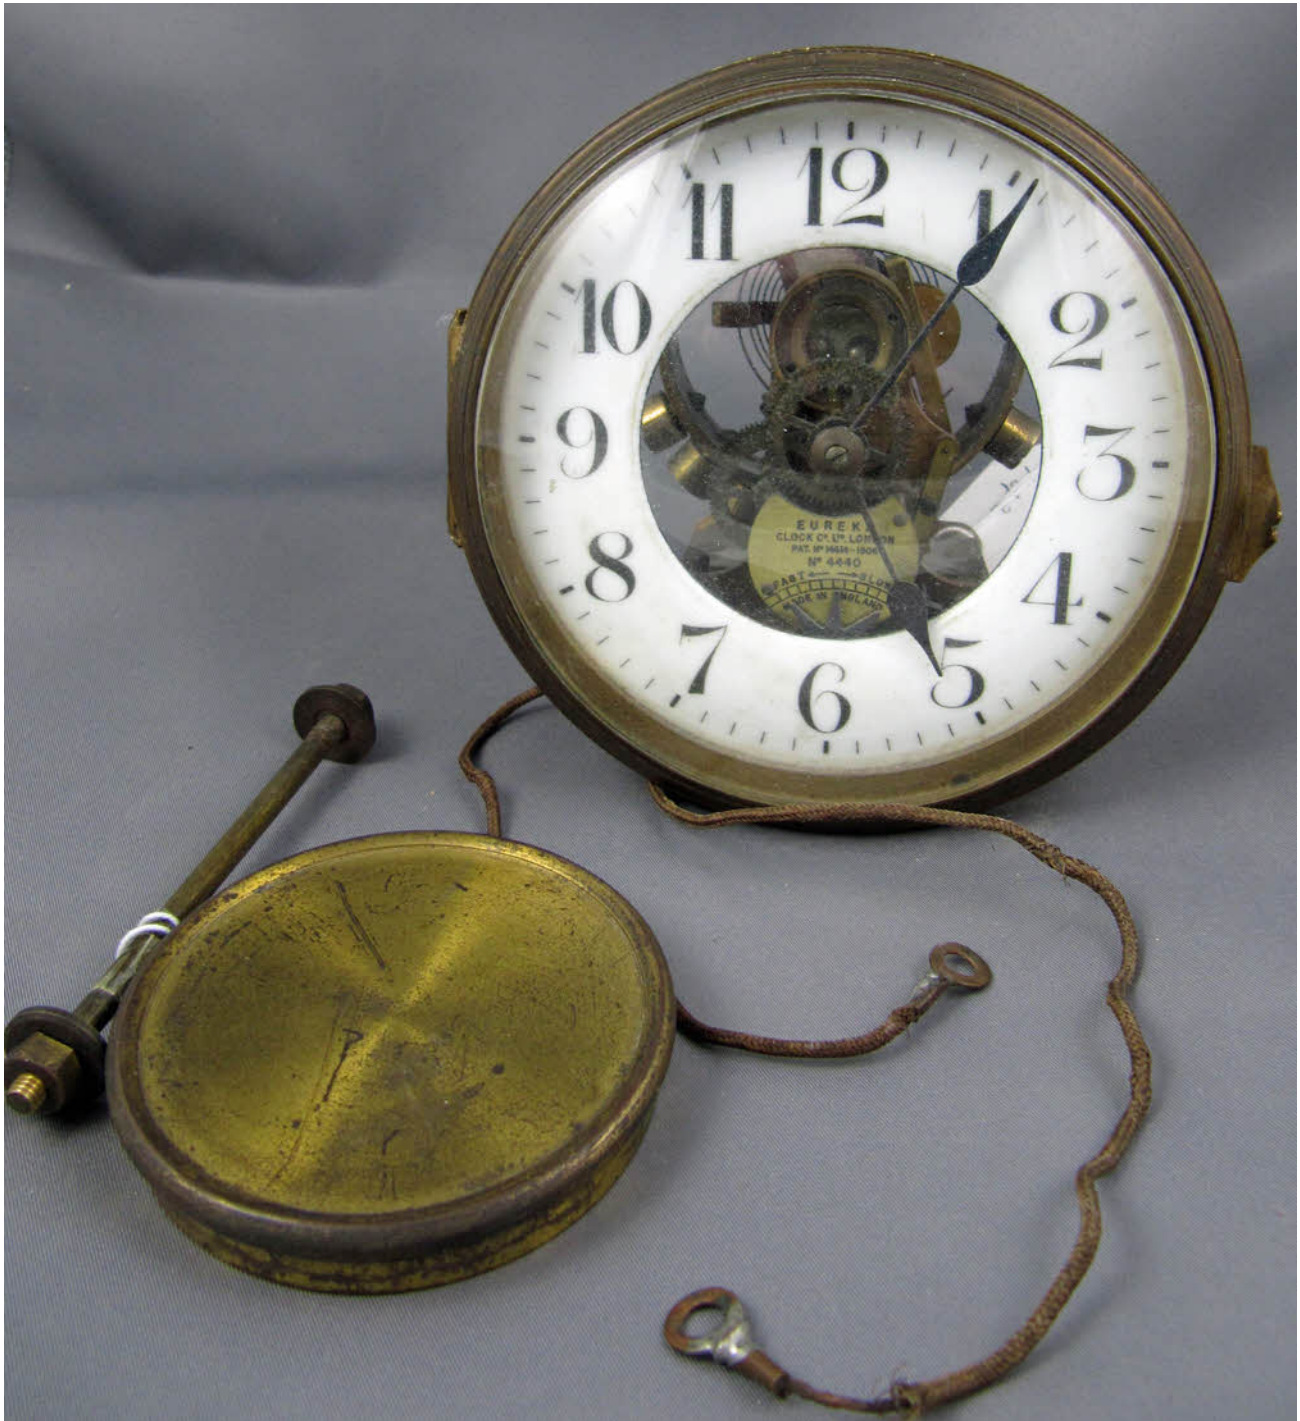
*A short Eureka movement from an enclosed case (retained by the owner). The owner has asked for a new securing bar as only one came with the clock. The existing bar is shown on the left of the photos. The cap is the inspection cap from the rear of the case.. The overall impression is that the clock is in good order with no missing parts, albeit a little dirty.*

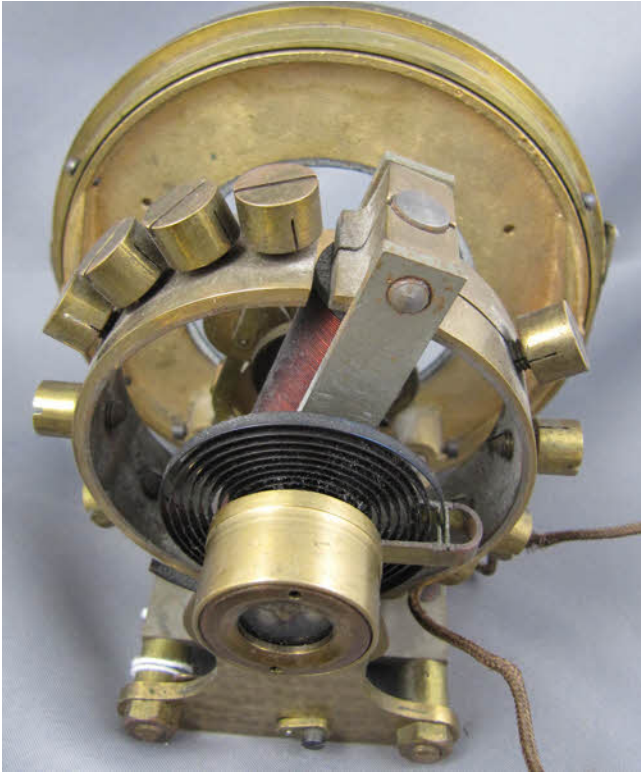
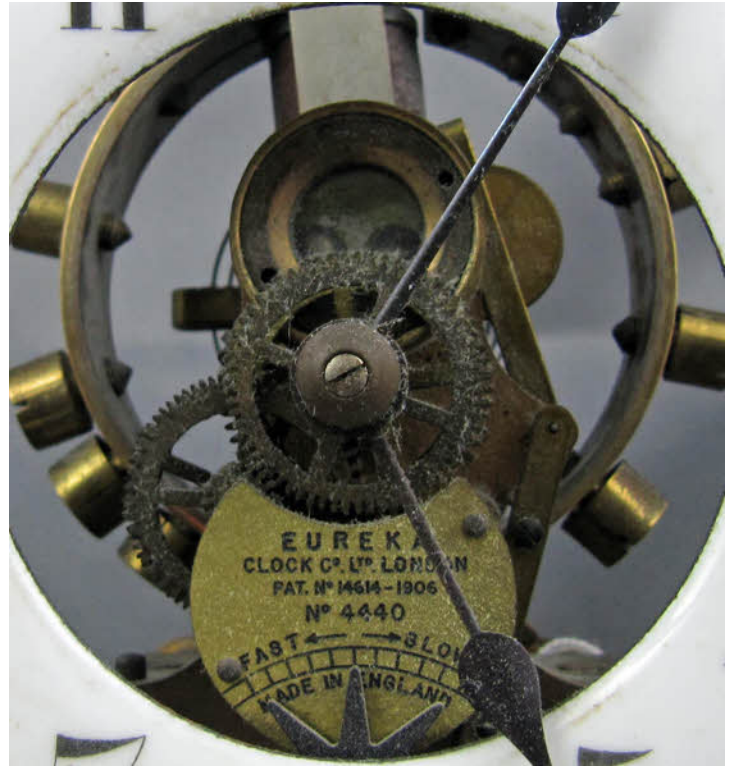
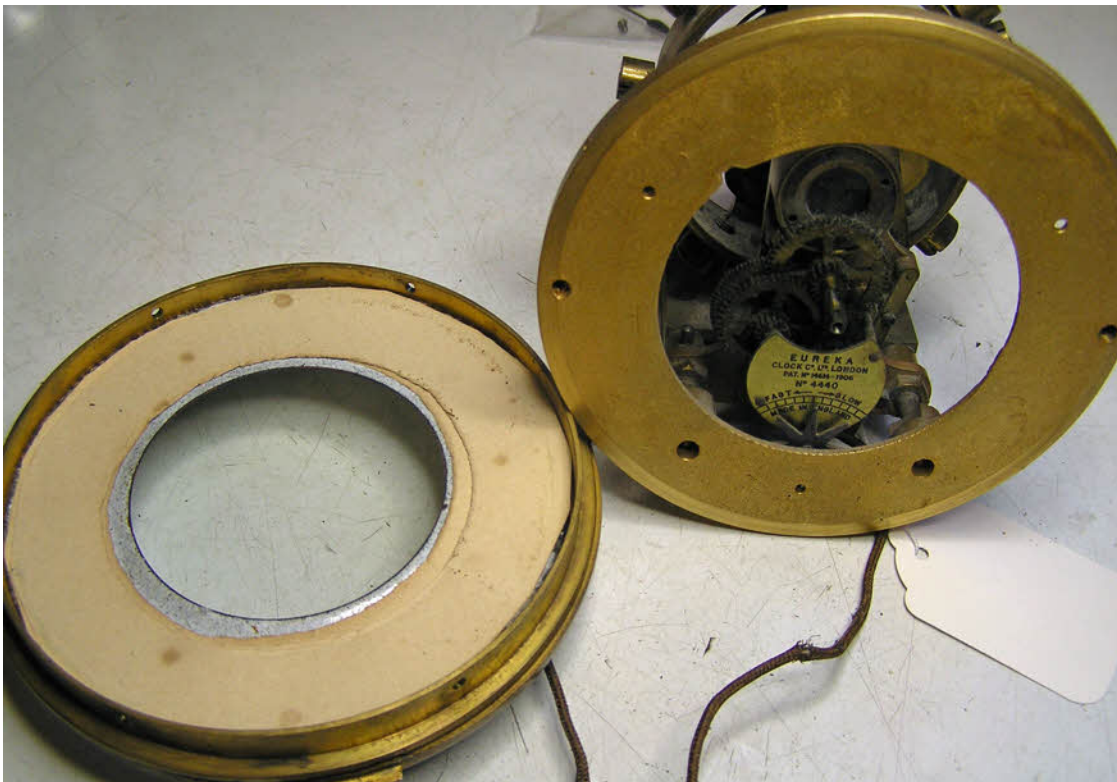
*Views of the move-  
ment showing no  
great problems oth-  
er than the dirt.*

*The last photo  
shows the dial re-  
moved and the card  
placed between it  
and the cast back  
plate.. Although the  
back plate has three  
holes to secure the  
dial as normal, the  
dial itself (next  
page) does not have  
the usual pins pro-  
truding from the  
back. The move-  
ment is secured to  
the case with two  
long bolts screwed  
into this backplate.*

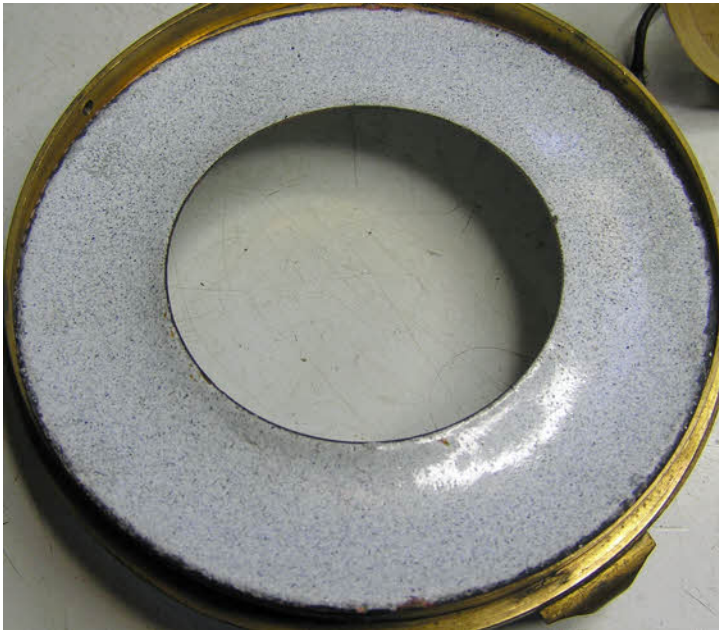
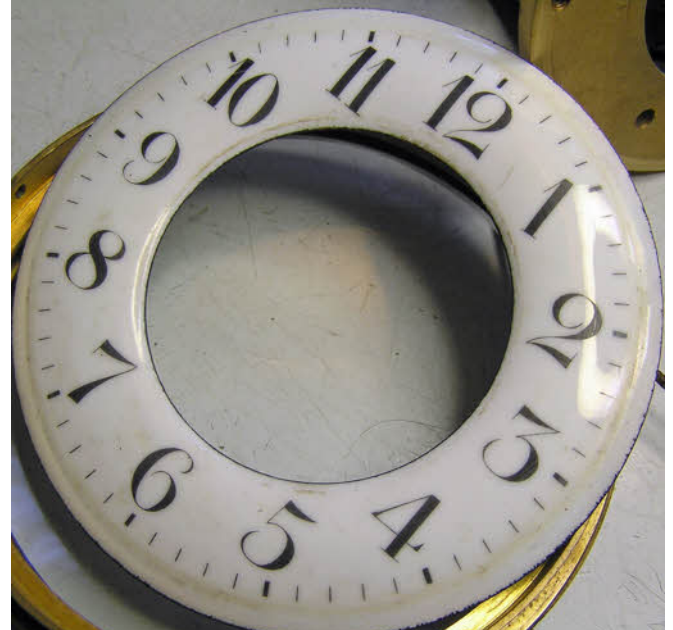
*The dial front and back. It is in near perfect condition with just some dirt and grime around the edges which is easily cleaned with warm soapy water.*

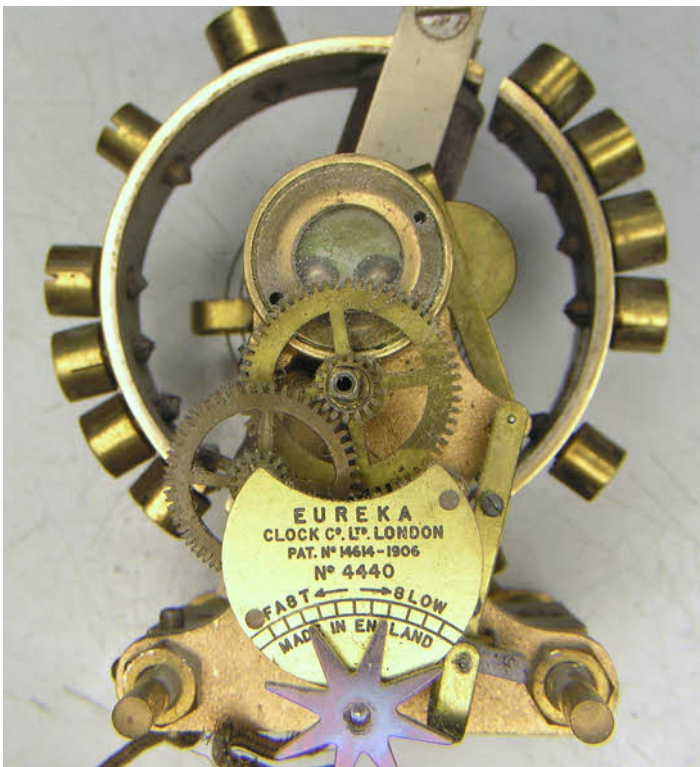
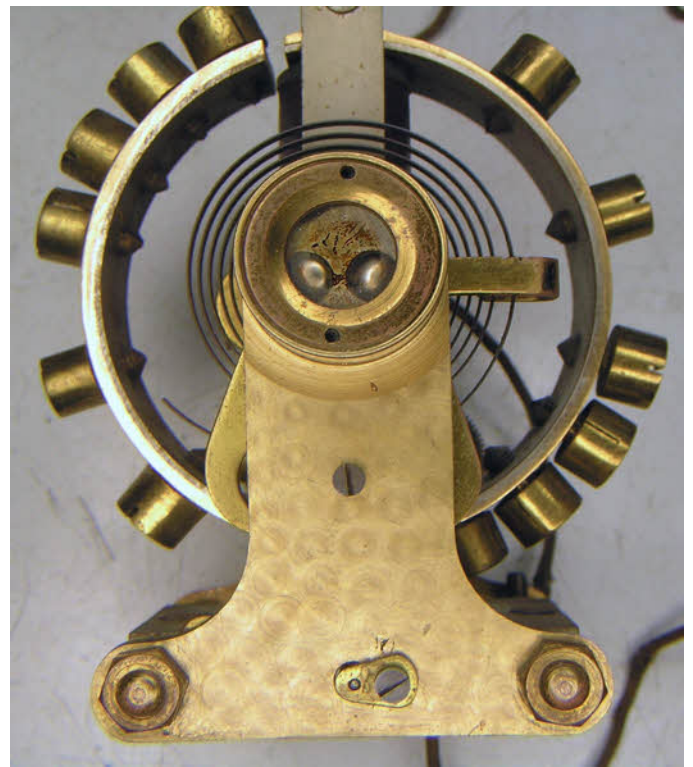
*The front and rear bearing housings. Both look good with no chipped glass. Note this is a two ball movement with hardened shim plates that take the thrust of the pivots.*

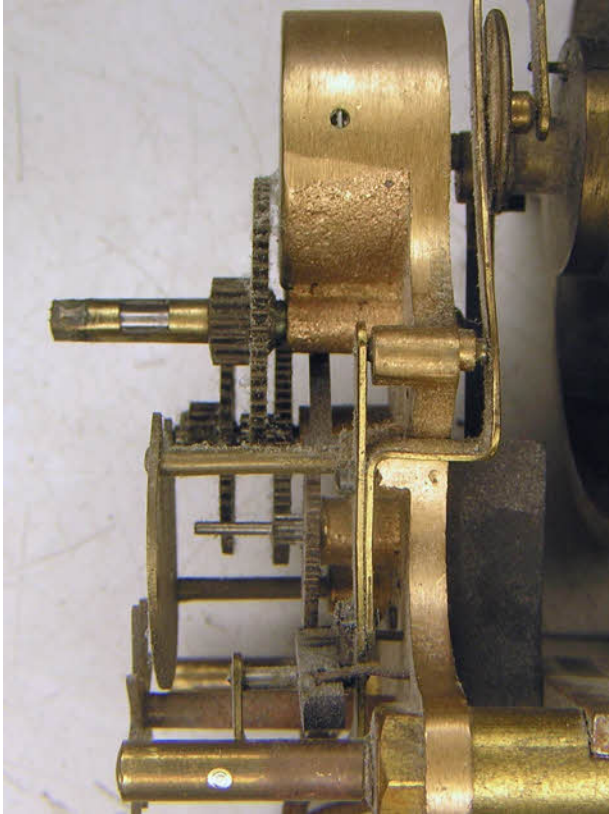
*The wheel work and impulse arm shown in the photo at left are all OK. This particular arm is mad from two separate pieces of press brass screwed together. Some are made from a single piece of brass that is pressed and bent to shape. The arrow shows the slightly worn silver flag. This will be replaced.*

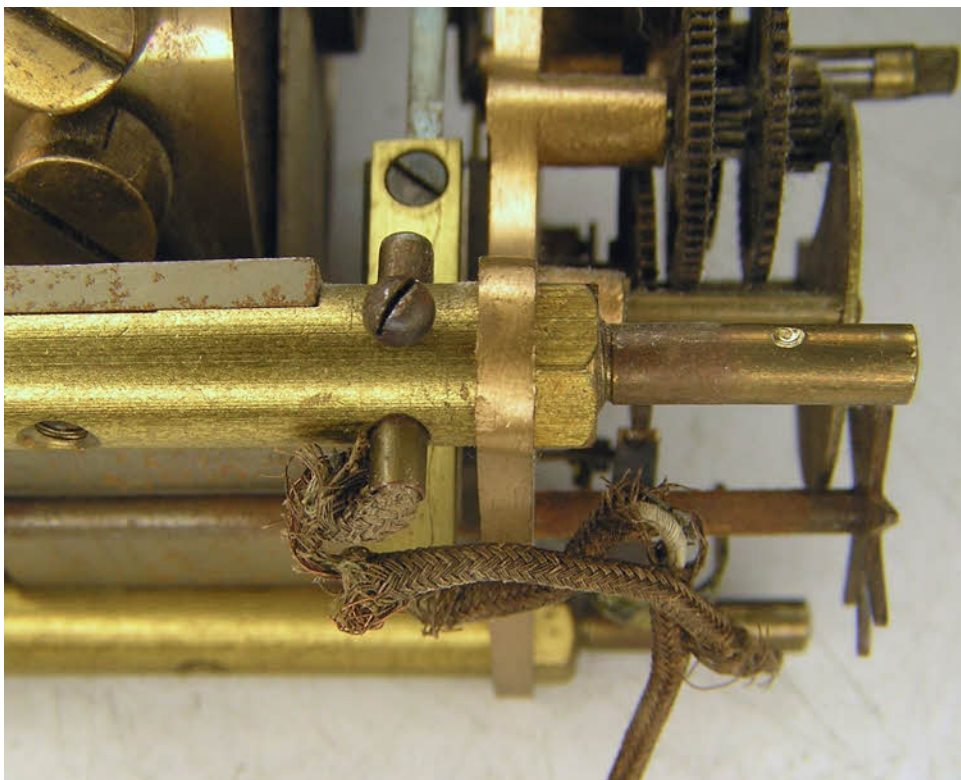
*This last photo shows the underside of the movement and the wiring which is just about to fall apart. All the wiring will be replaced with new cloth covered wire.*

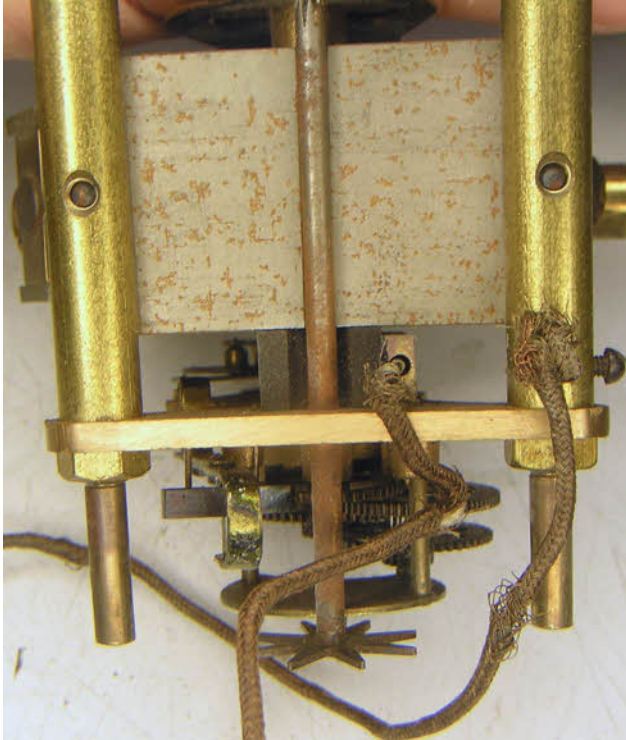
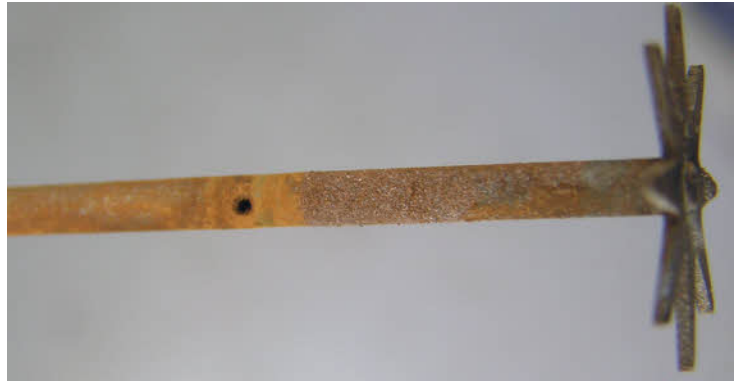
*The underside again showing the rusted arbour of the balance spring star wheel adjuster. It should clean up well, as will the underside of the base plate. This base plate is the short version with no extension with bolt holes. This short version has no need of bolts to hold it down as the movement is held in place by the lobg bolts shown earlier. Further evidence that this movement is from a cased clock rather than one under a dome or in a four glass case.*

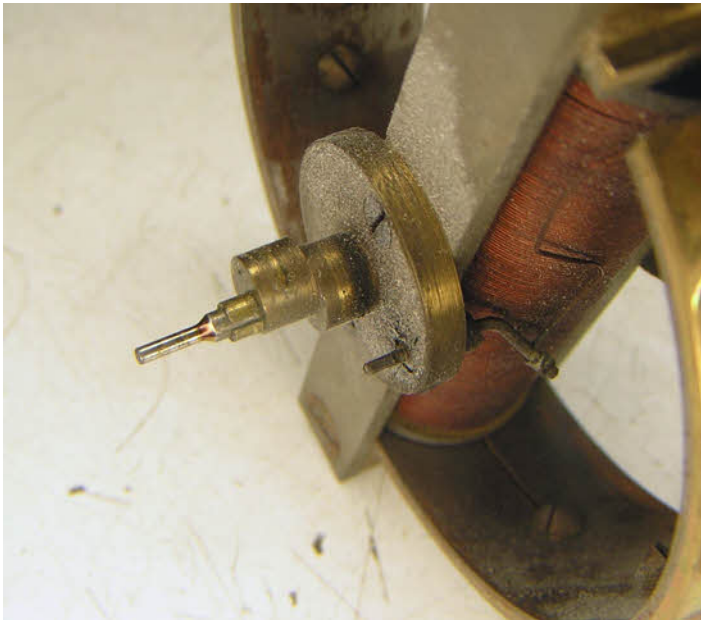
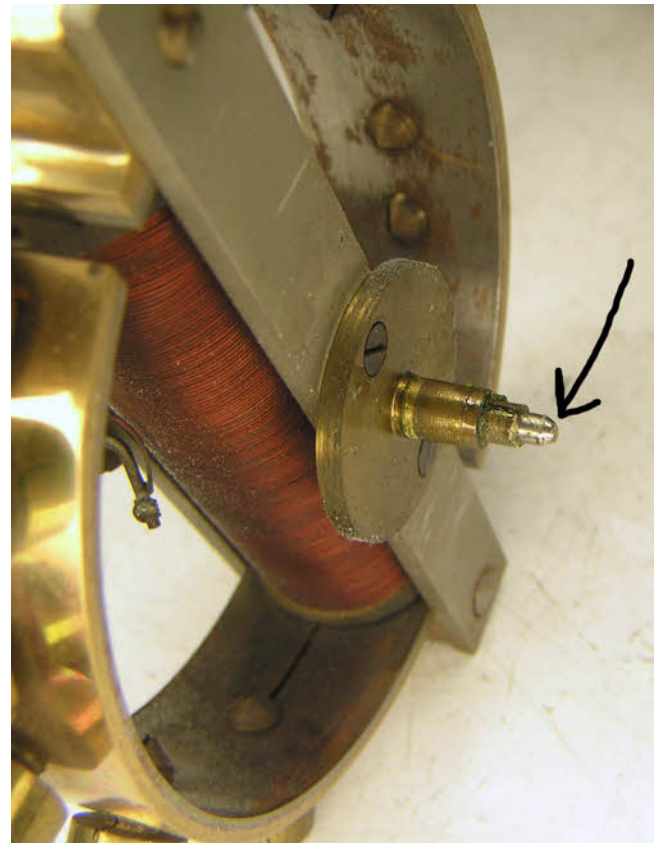
*Oh dear! This is bad news. The photo on the right shows that the rear pivot has snapped, which would have stopped the clock dead. The front pivot shown above looks good and unworn. The brown mark is dried oil. I will need to make a new pivot.*

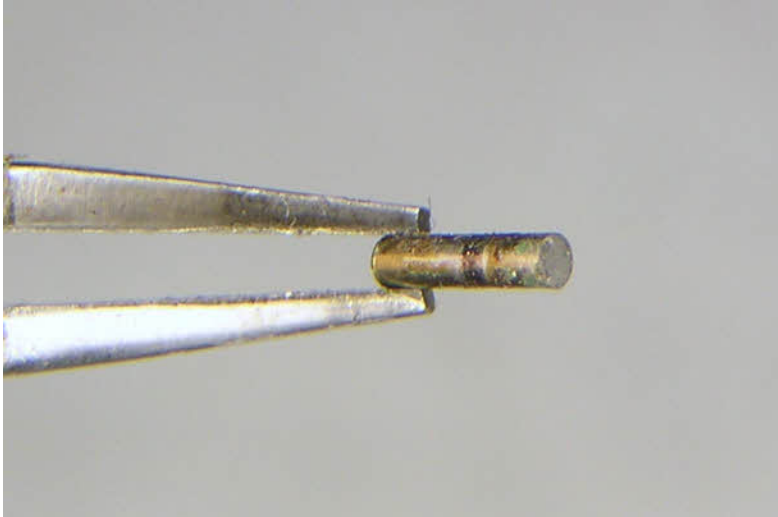
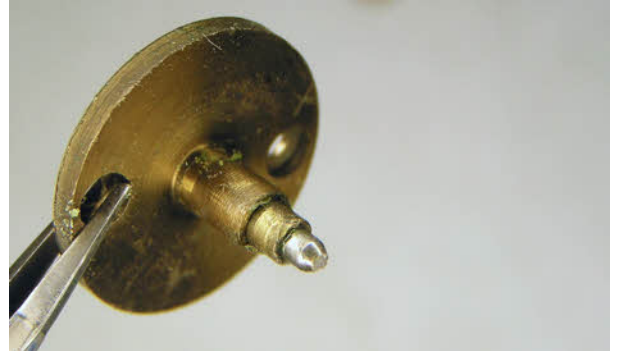
*The broken pivot and housing. It should be a simple matter of setting up the clockmakers stake and driving out the broken pivot and driving in the new one when made.*

*I found the other half of the broken pivot sitting quietly in the rear bearing housing. Nice clean snap. I wonder if the clock was dropped or had some traumatic blow? But there is no other damage to the clock so it must just have been metal fatigue.*

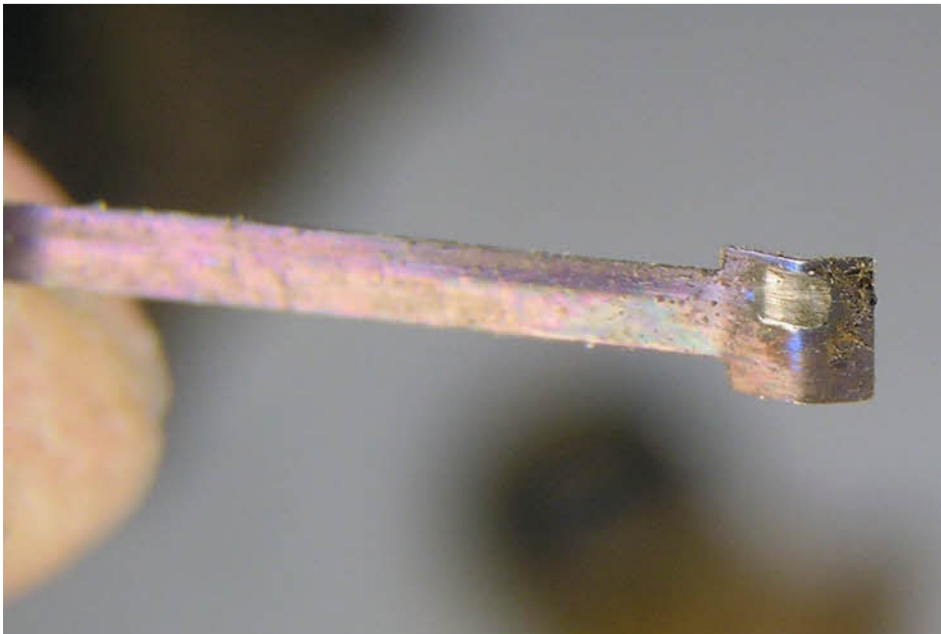
*This photo above shows the worn detent spring that acts upon the count wheel to stop it returning when moved forward one tooth by the impulse arm. It is worn approx 70% the way through and I will need to sort it out. I find the best way is to soft solder a new piece of spring steel over the wear rather than replace the whole spring*

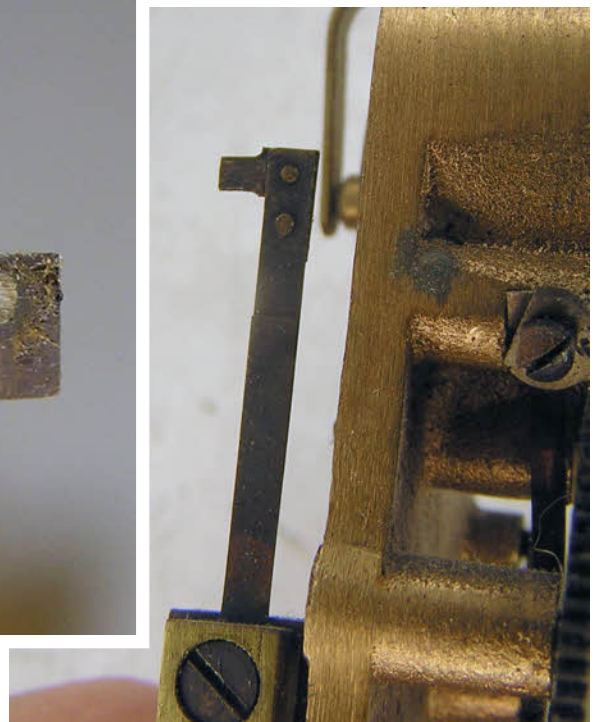
*A close up of the worn flag with about 25% missing.*

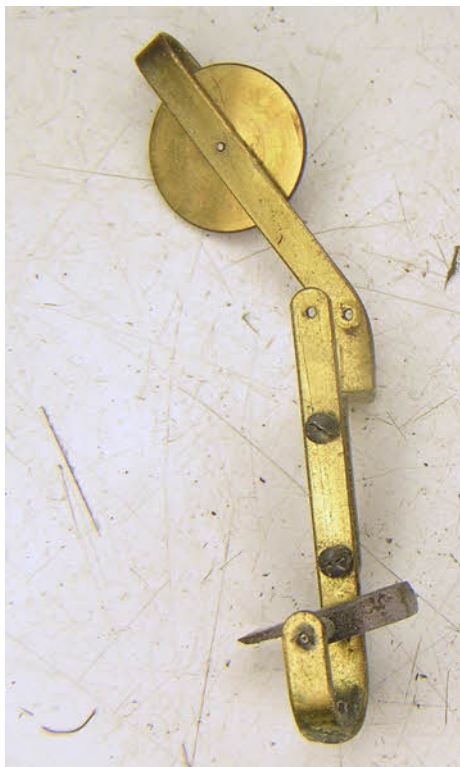
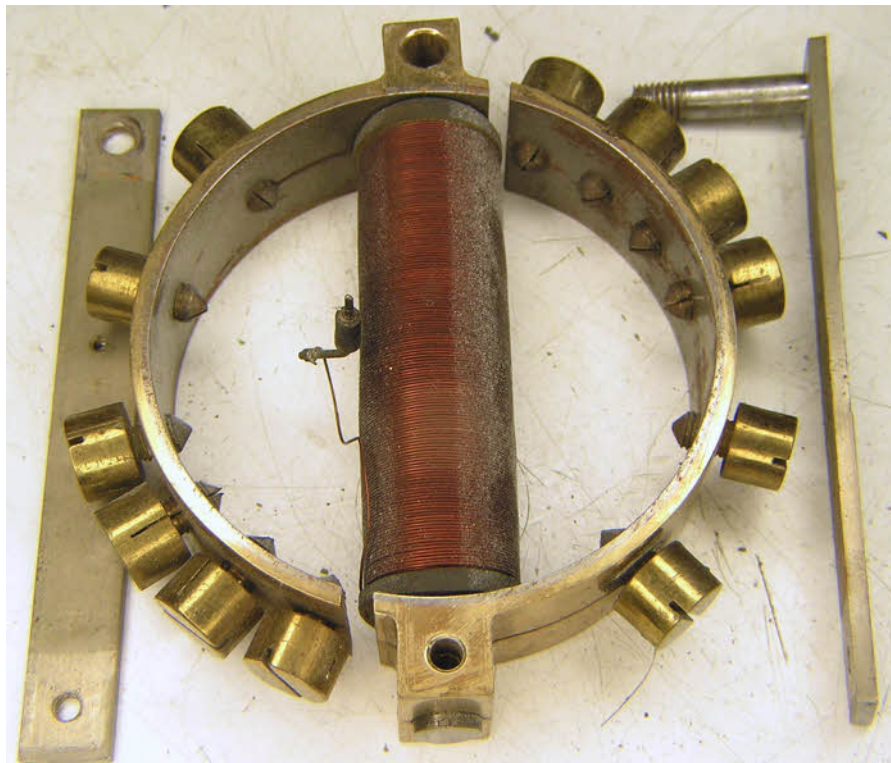
Above shows the balance wheel partially disassembled. A good time to check the resistance of the coil which should be approx 20 Ohms

The photo on the top left shows the two part impulse arm.

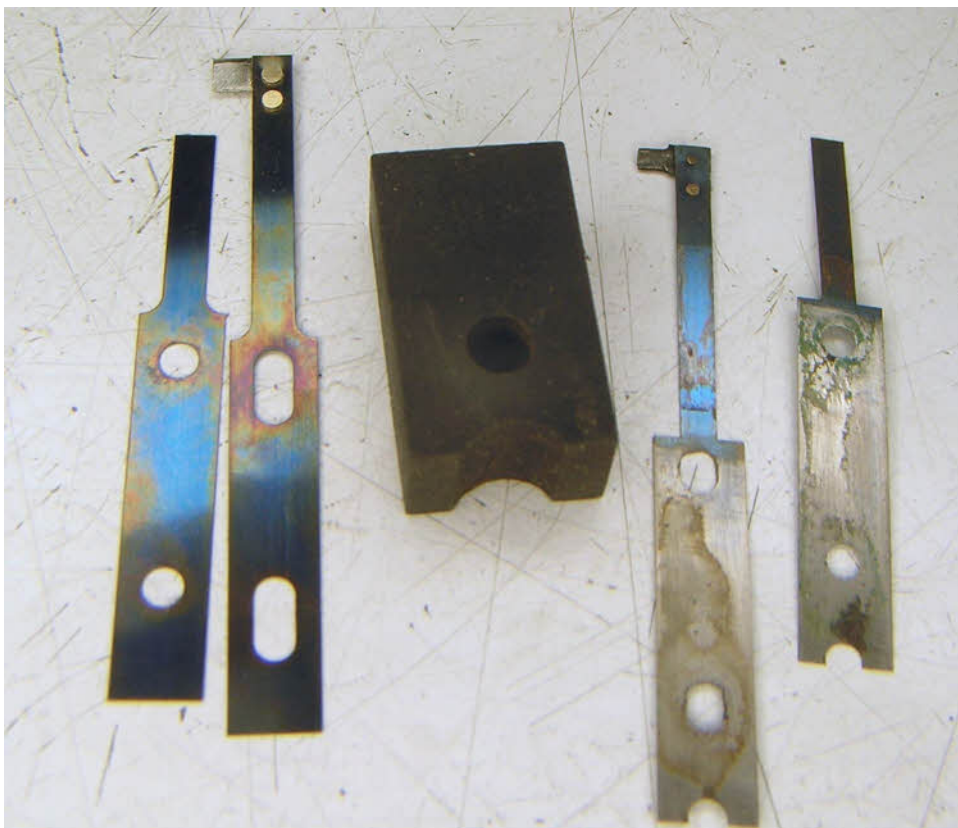
The photo to the left shows the new flag and buffer spring on the far right with the original on the near right. The fibre block is in good condition with good mounting holes. You sometimes find that the screws that secure the springs to the fibre block have been turned up to tight and the threads have been stripped inside. Then its a case of making a new block or sometimes you can get away with filling the holes with black epoxy and then drilling and re-threading.

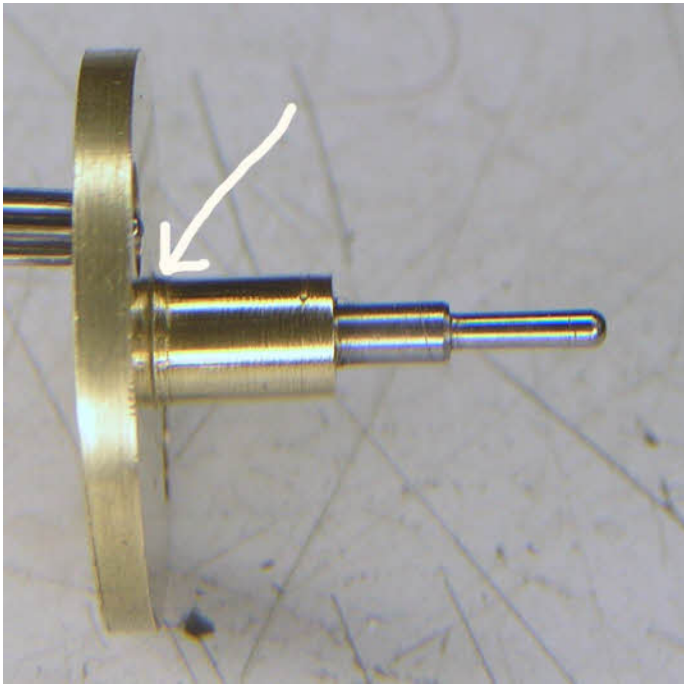
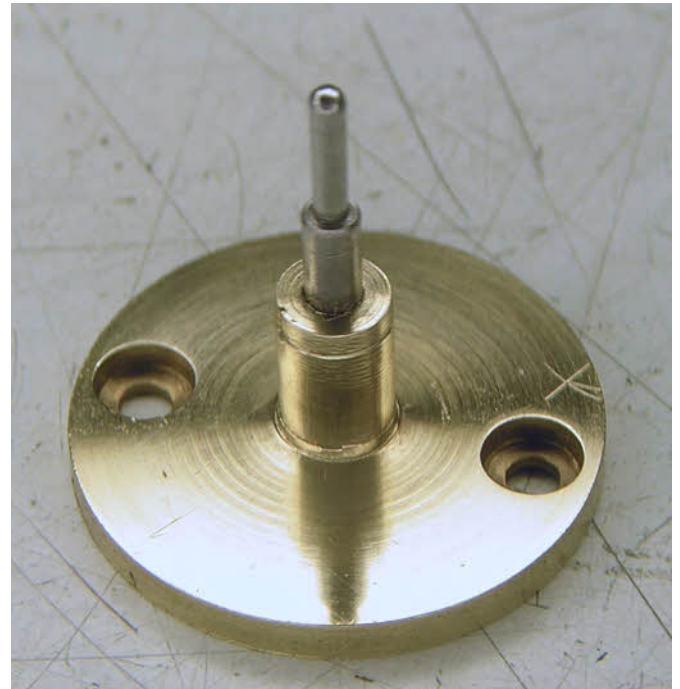
These photos above show the new pivot secured into the rear pivot housing.

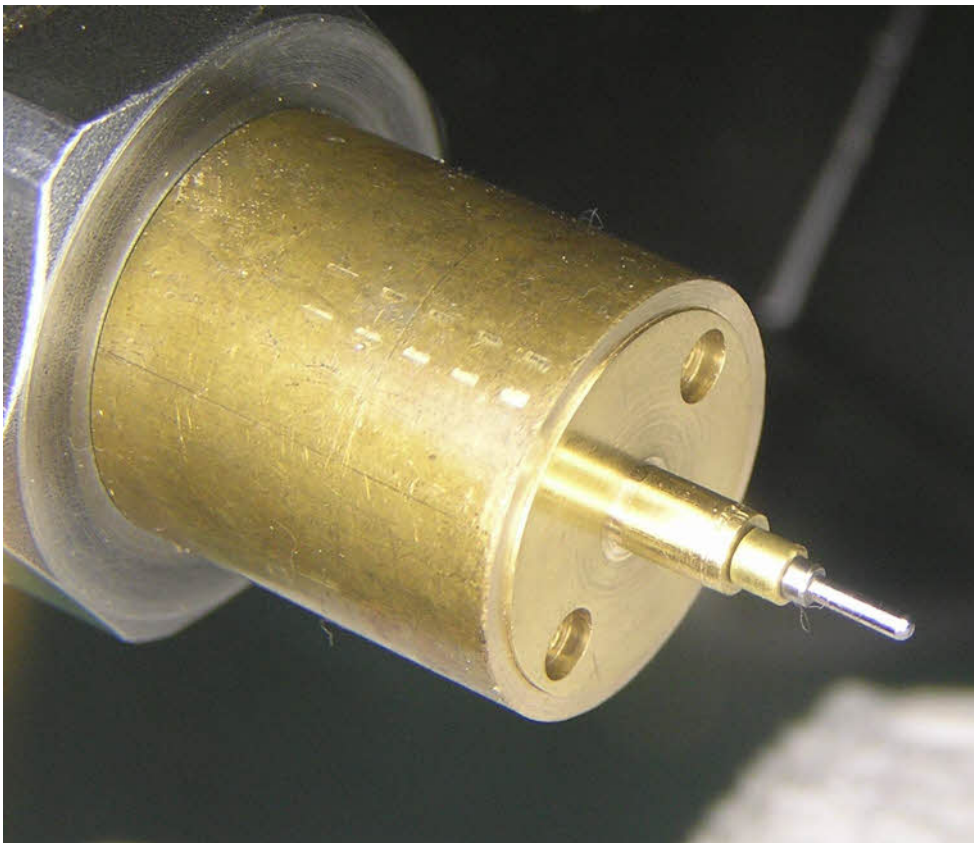
*When I tried to assemble the balance spring onto the housing, I noticed that it would not sit correctly and saw that there was a slight lip evident at the back of the housing as arrowed above. So I turned a piece of brass in the lathe to accept the whole housing and turned the ridge off with a sharp tool.*

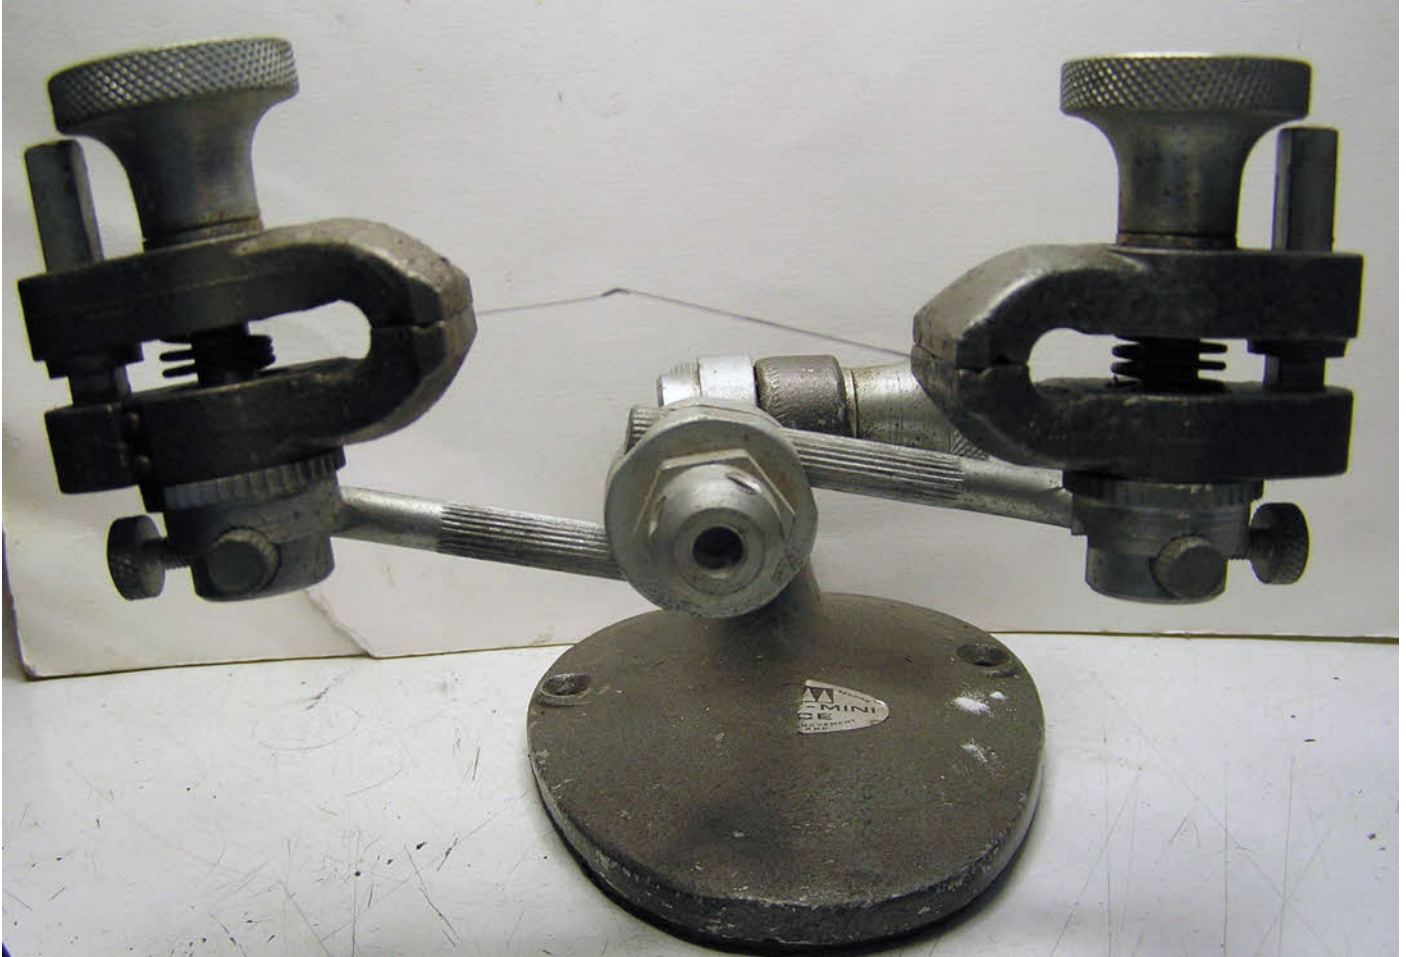
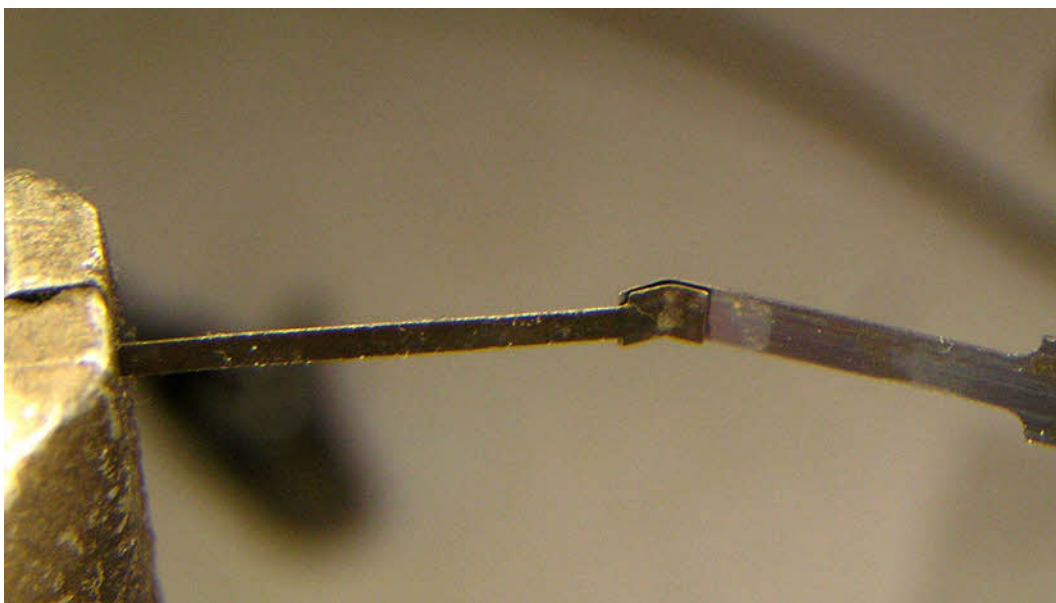
*Using a set of "Helping Hands" to set the new piece of blued steel to repair the wear in the spring. I used .004" blued steel offcut from a buffer spring. I then bent it at the same angle of the original. The photo on the left shows the new piece behind the original ready for soldering. Both have been cleaned and degreased before soldering.*

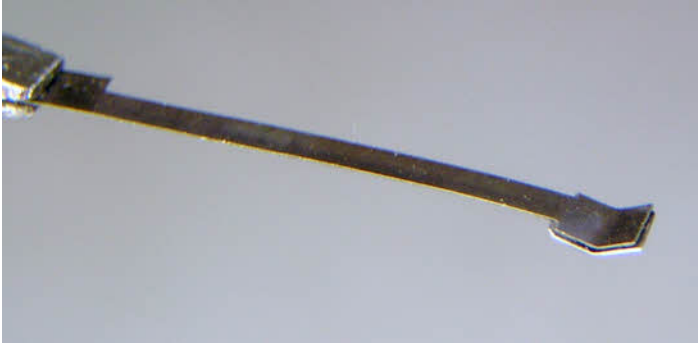
*The spring with the new piece soldered in place ready for grinding the side flush. This is a neat repair and saves as much of the original as possible.*

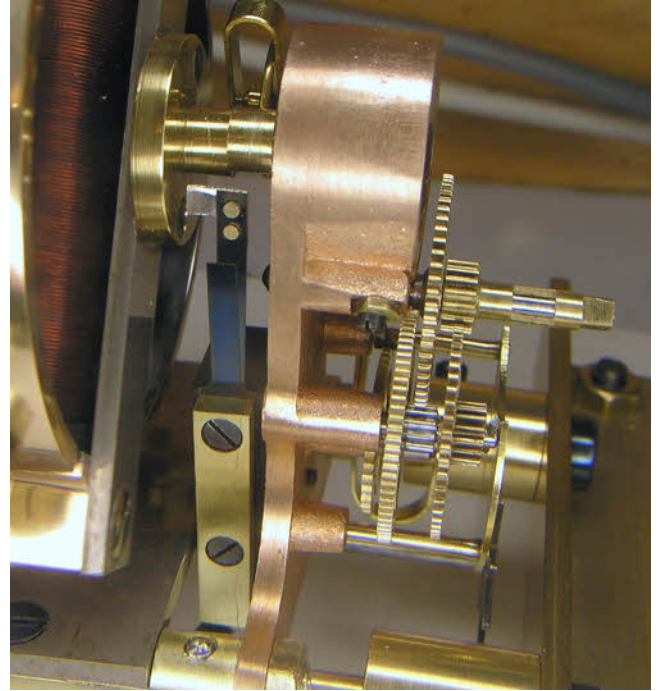
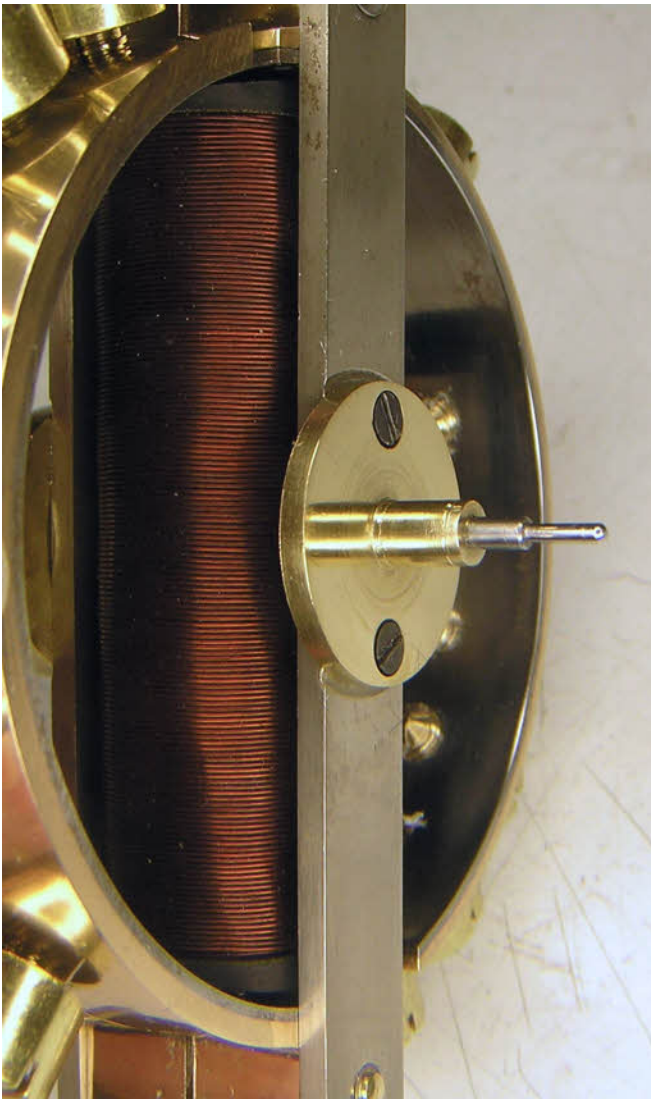
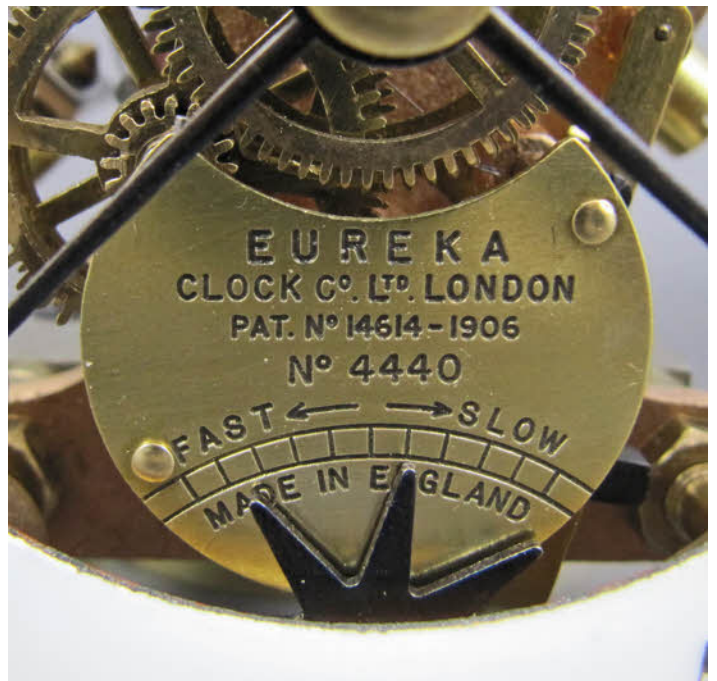
*These last photos show the movement finished and ready for testing and the new pivot and machined housing back in situ on the balance wheel*

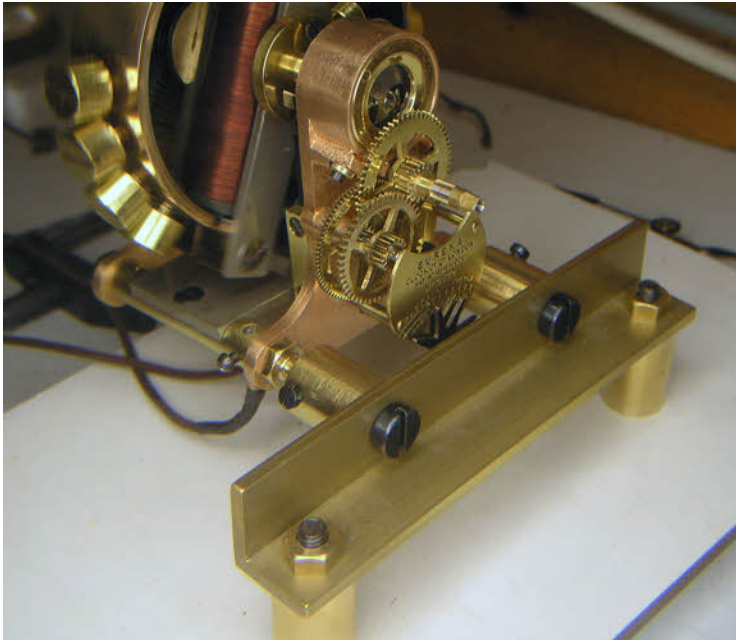
*The movement on the test bench*

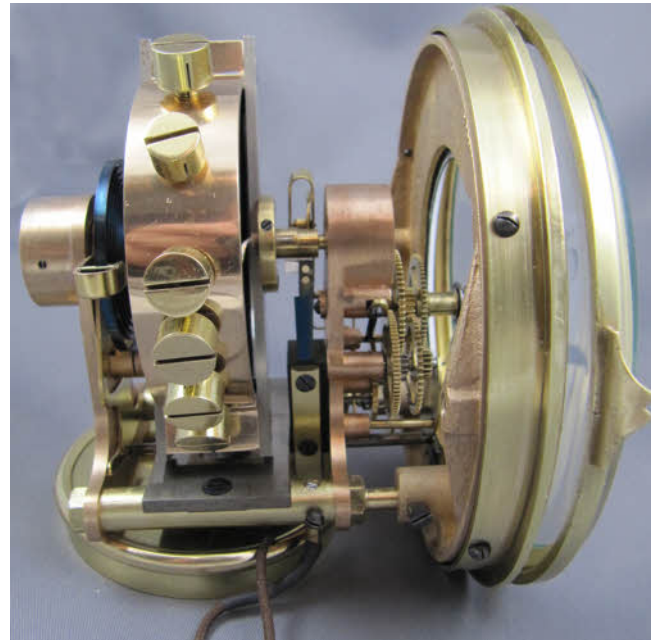
*Right side view of the finished clock.*

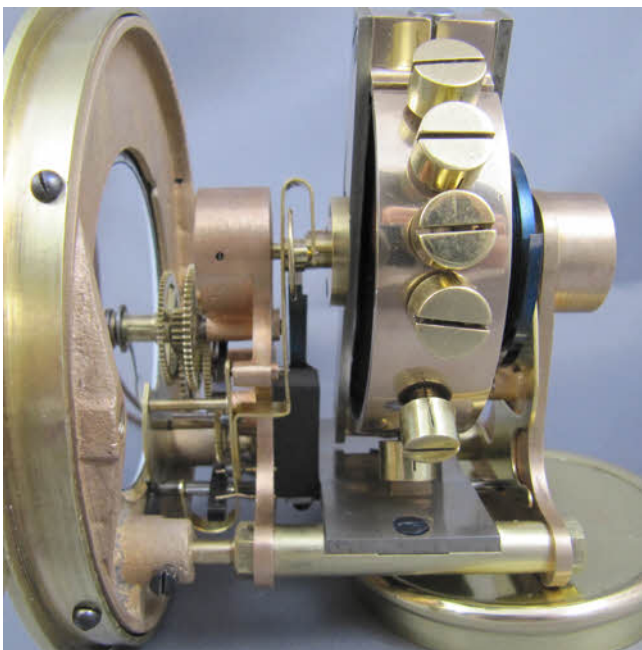
*Left side view of the finished clock.*

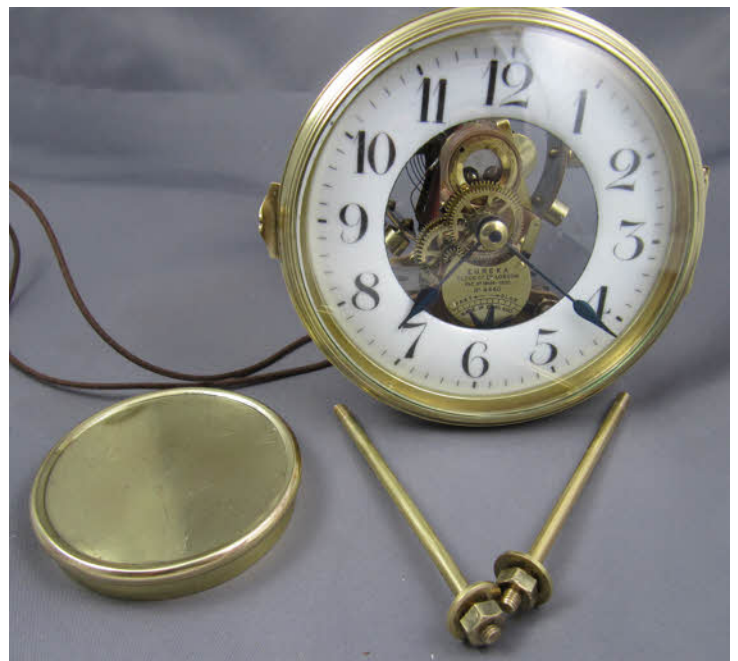
*The finished Clock*
