Eureka Clock Serial Number 4793

*Restoration of Eureka
Clock Serial Number 4793*

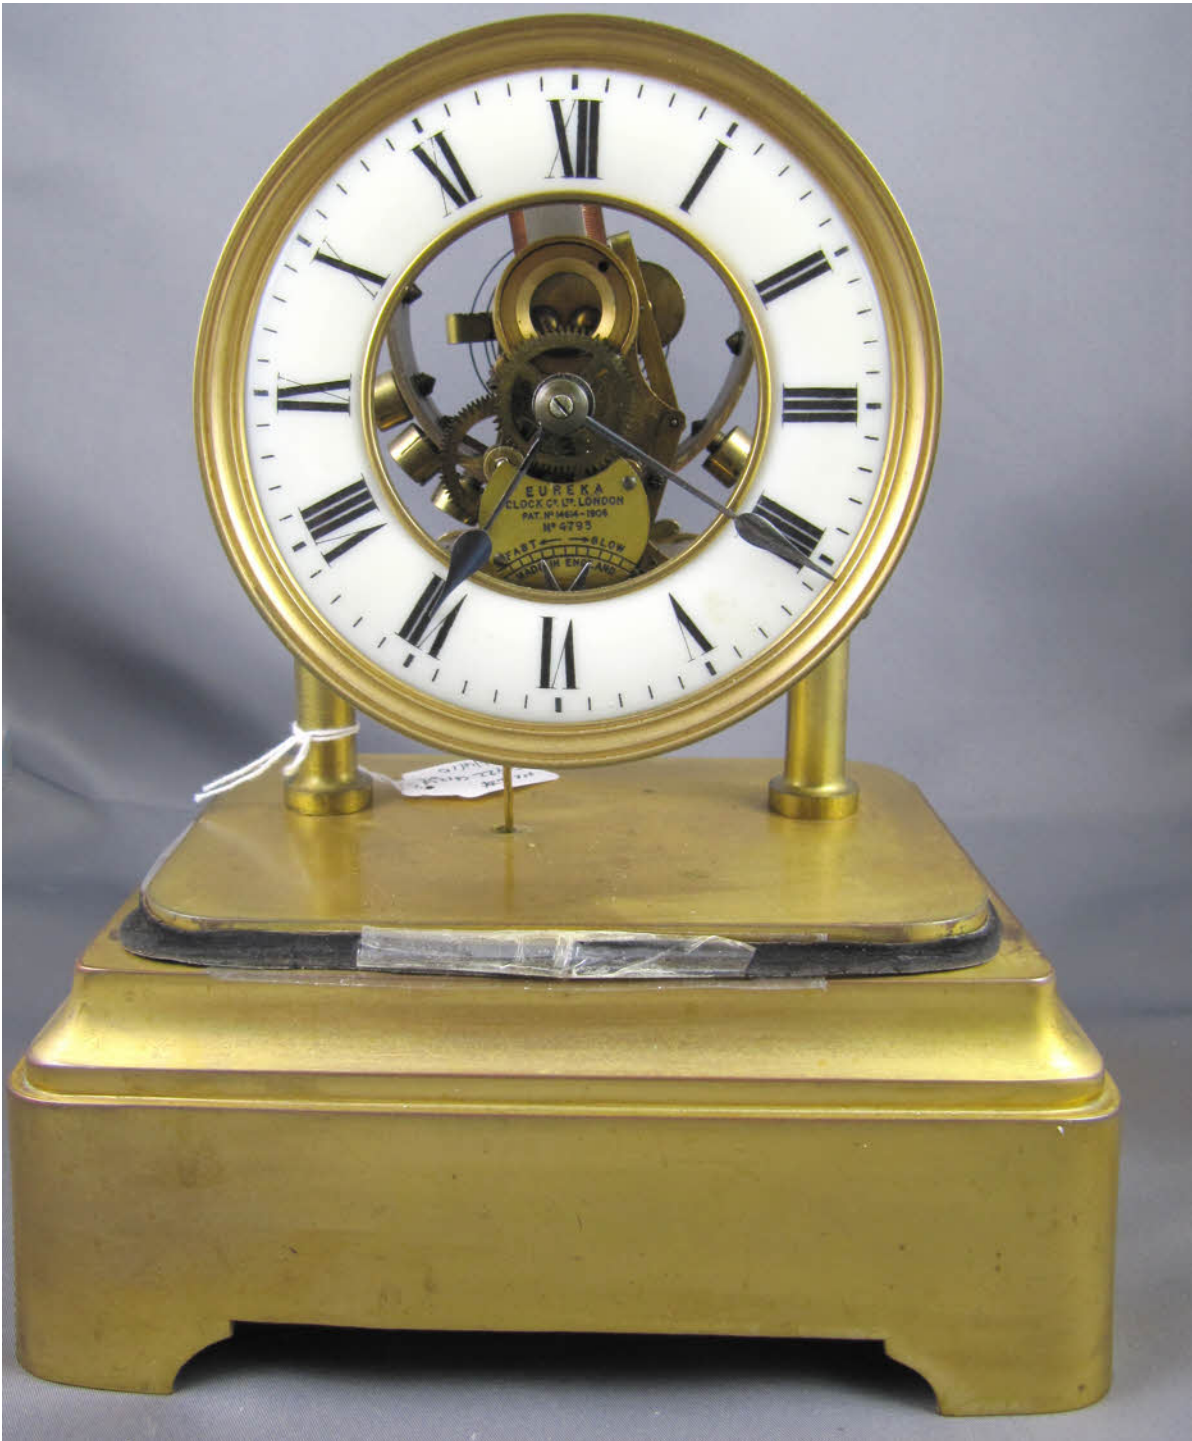
A short movement with ceramic skeletonised dial. The dial has a thin brass decorative ring on the inside edge. The dome, although not presented with the clock, is a square lower half rising to a round upper half. The clock generally looks OK with no major damage. The original felt is held in place with cellotape.

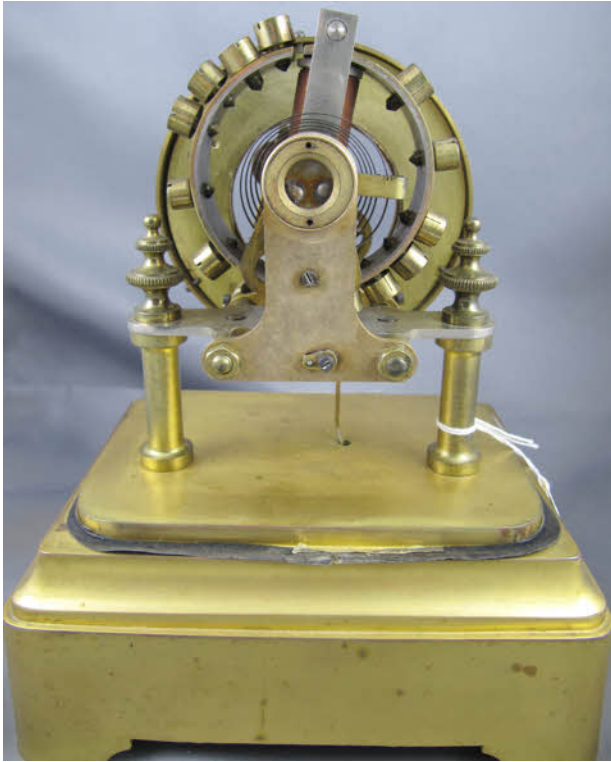
The rear of the clock

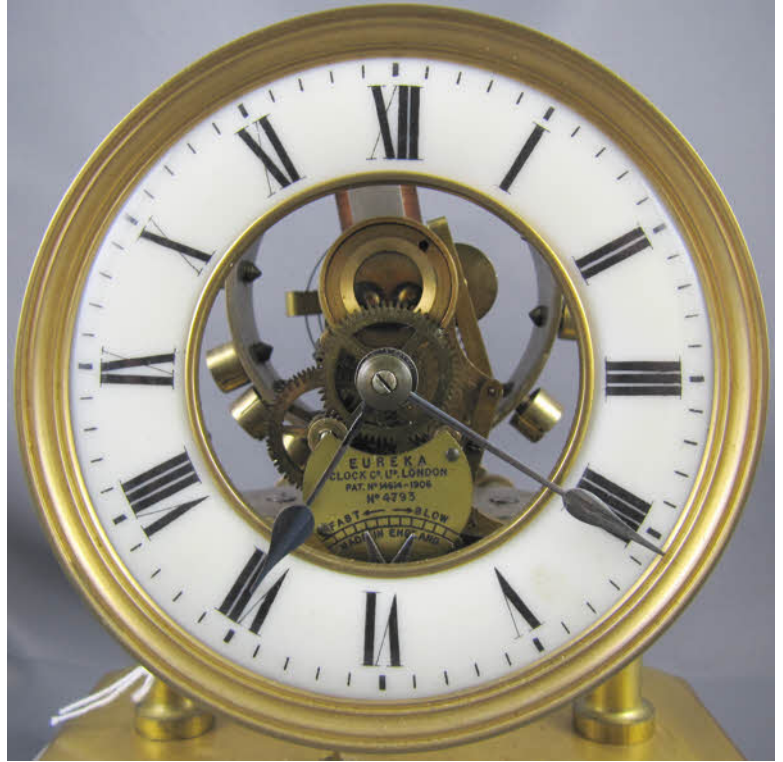
The hands are of the fine spade design

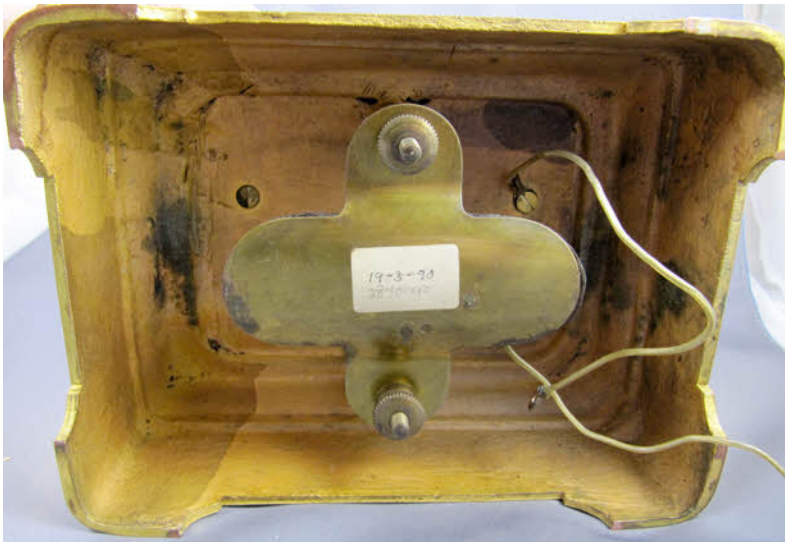
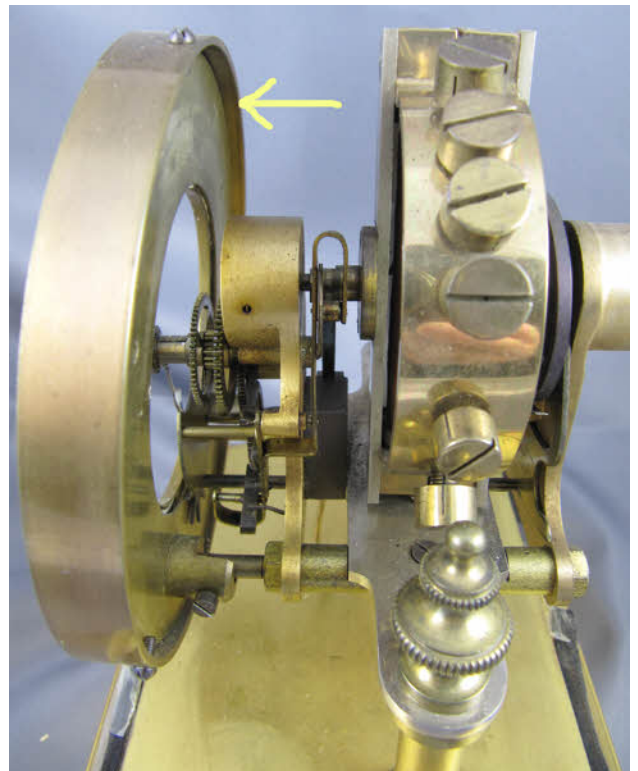
The underside of the base looks to be in good condition with all parts present. The modern wiring will be replaced.. The last photo shows the twist evident in the dial pan.

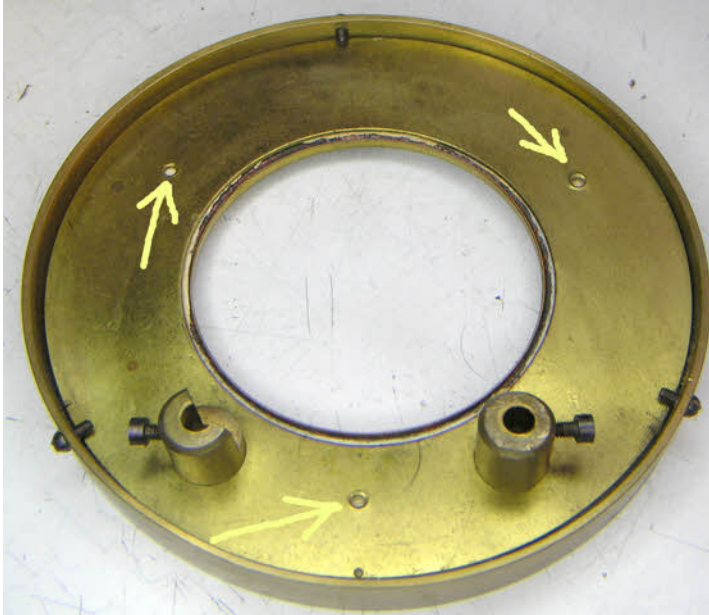
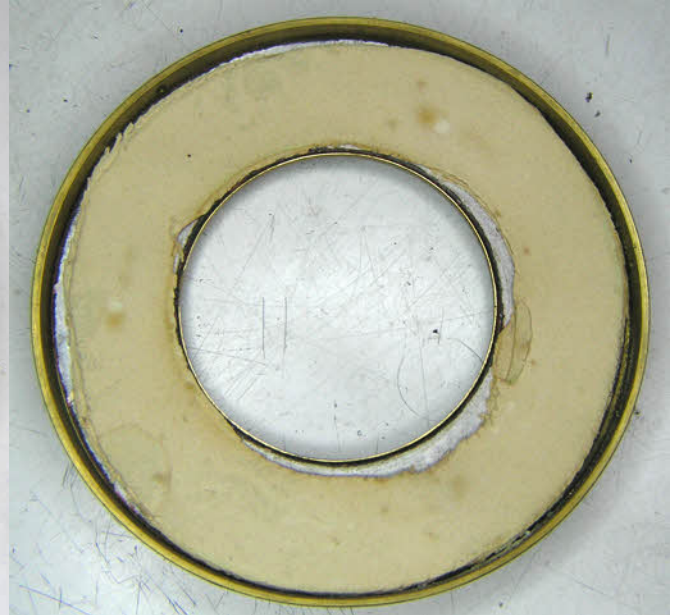
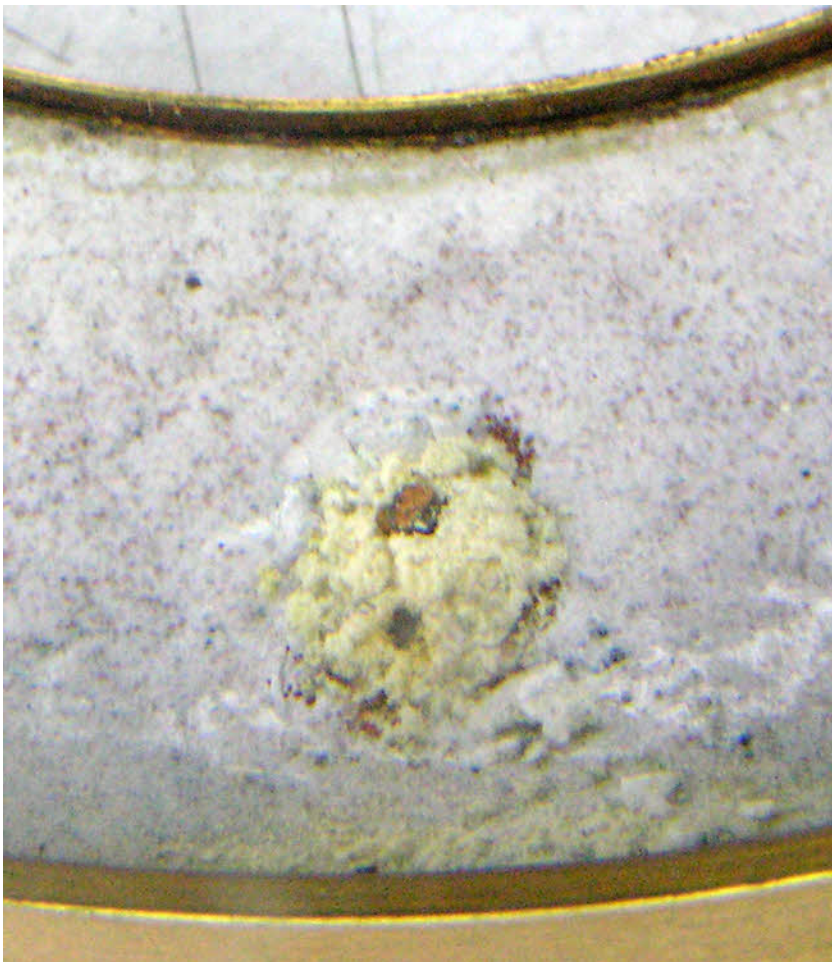
The first photo shows the rear of the dial pan and the three holes through which there should be copper pins that were manufactured into the dial. These hold the dial in place and position the face correctly with 12 o'clock at the top. The pins are missing which suggests that there is some problem under the pan. The second photo above shows the pan removed and the cardboard set behind the dial. The last photos shows the damage to the dial where the three pins have been removed. After tidying up, the missing pins should not present any problems other than the difficulty of aligning the face.

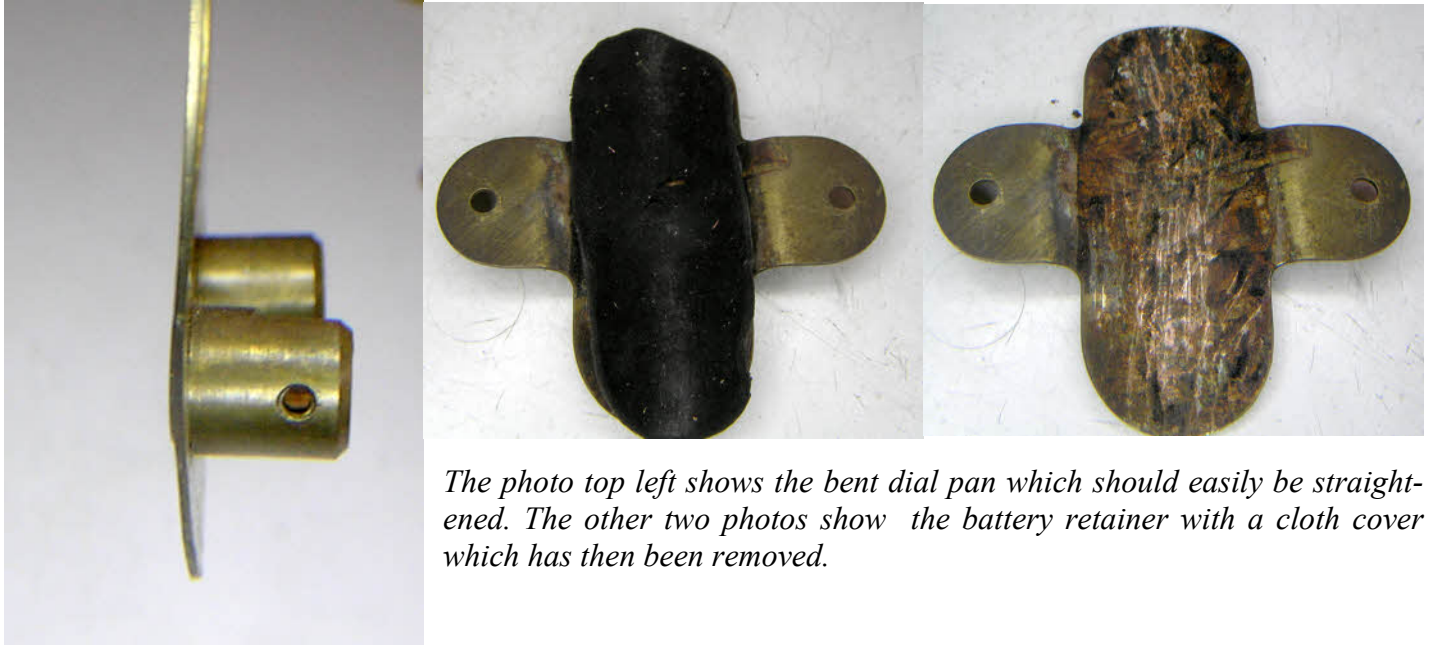
The photo top left shows the bent dial pan which should easily be straightened. The other two photos show the battery retainer with a cloth cover which has then been removed.

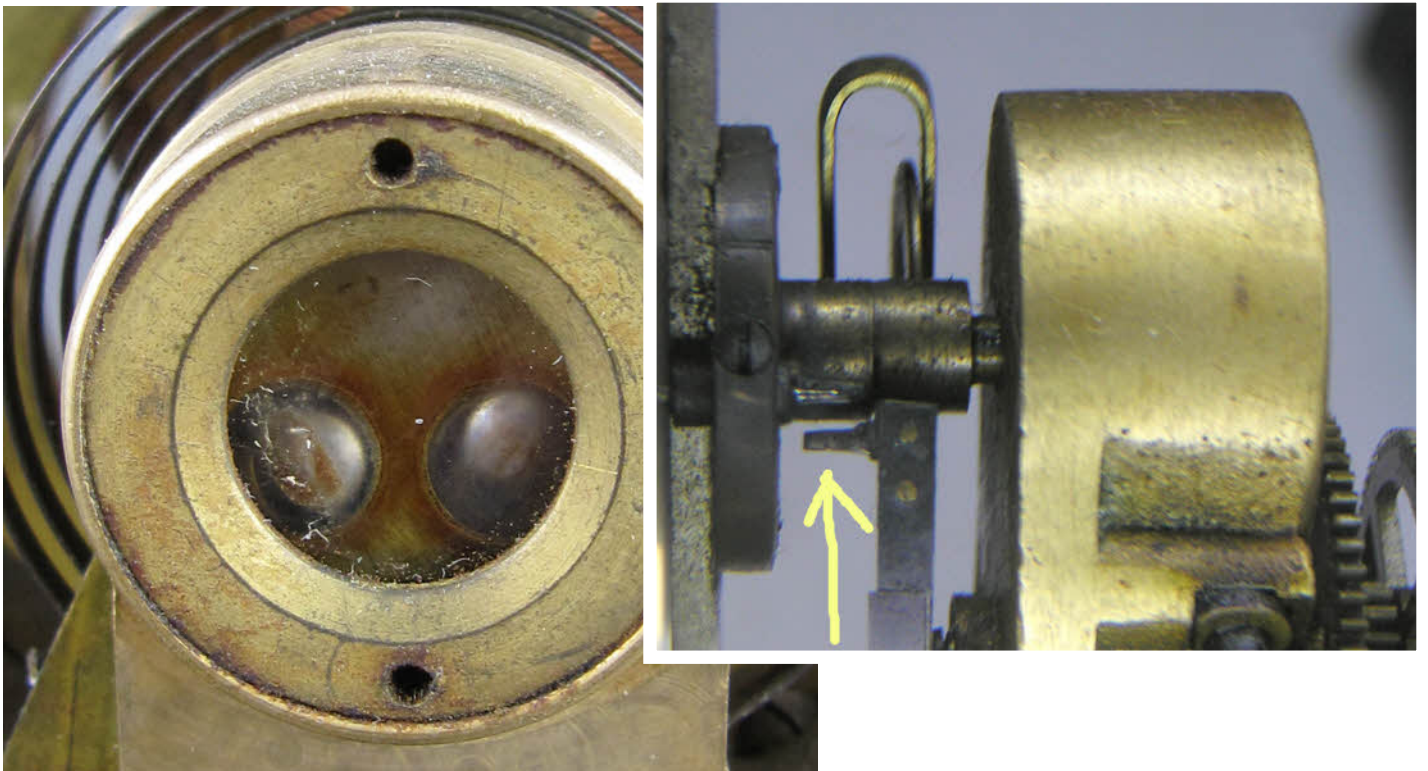
The first photo above shows the rear bearing housing and the grime on the interior. This should only be old thick oil but it could just be rust! The second photo shows the contact flag (arrowed) which has worn considerably by millions of contacts over the years. This and the pin will be replaced.

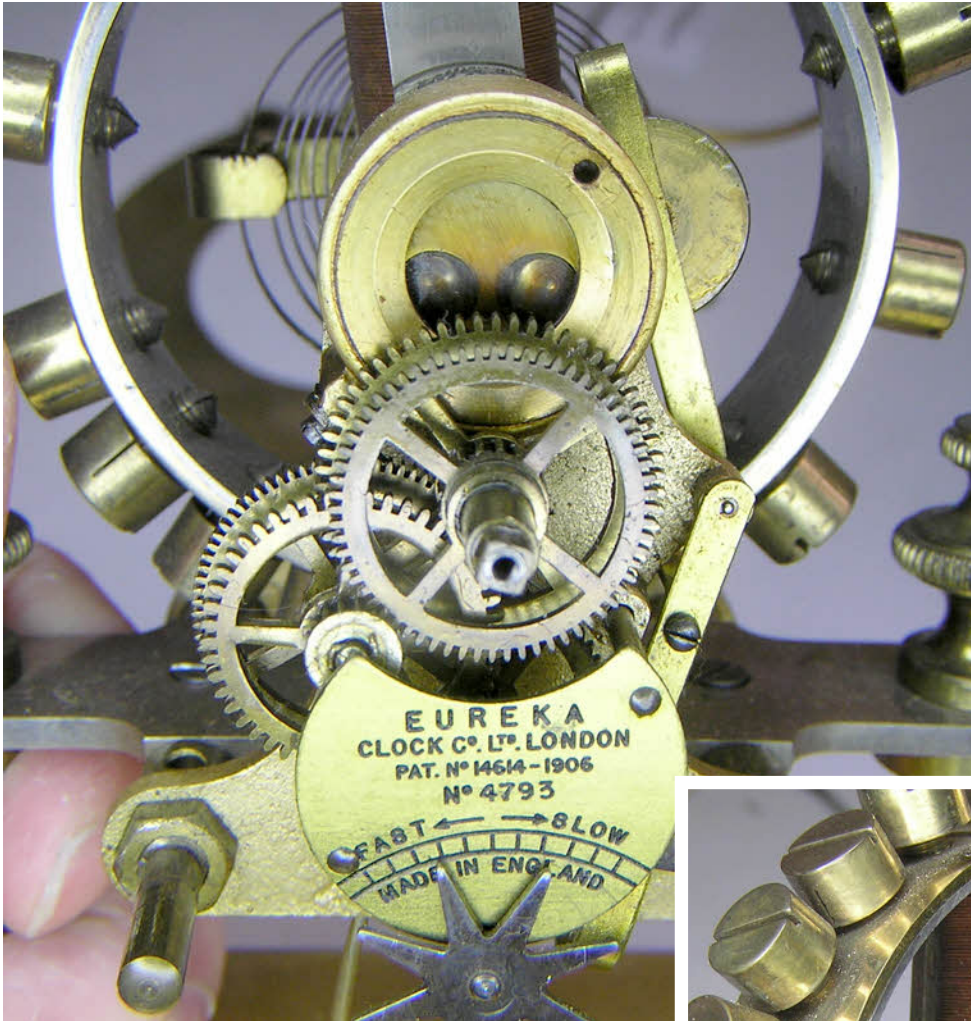
The front of the movement which seems all in place bar the grime in the bearing housing, although it doesn't seem as bad as the rear.

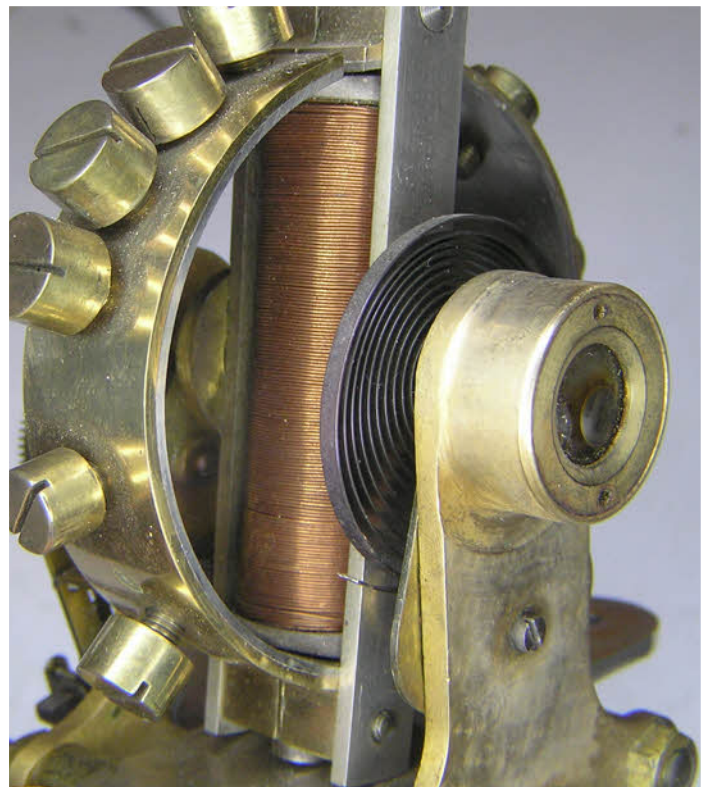
The balance wheel and spring look to be in good condition.

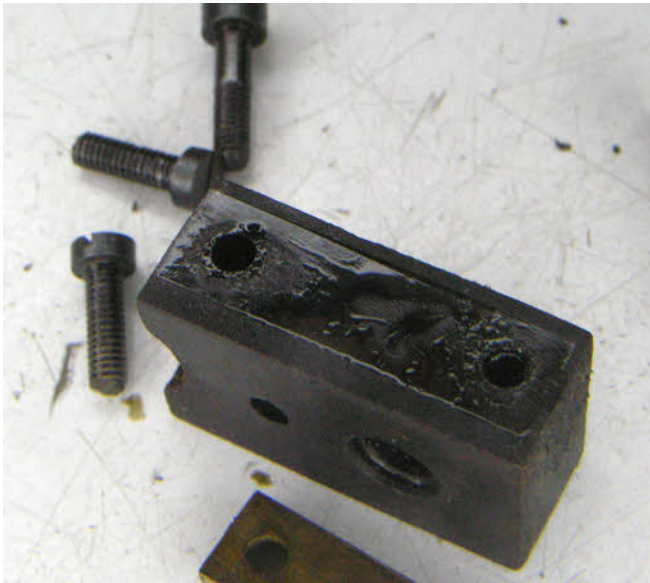
The contact flag insulating block is covered in oil and wouldn't have been good for the electrical contact. It should clean up OK .

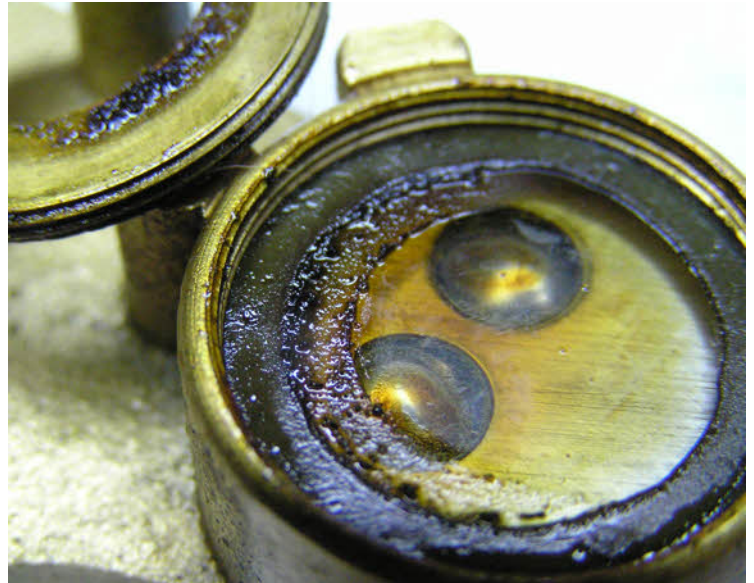
The grime in the rear bearing housing turned out to be caked oil; thank goodness. This is a lot easier to treat than rust.

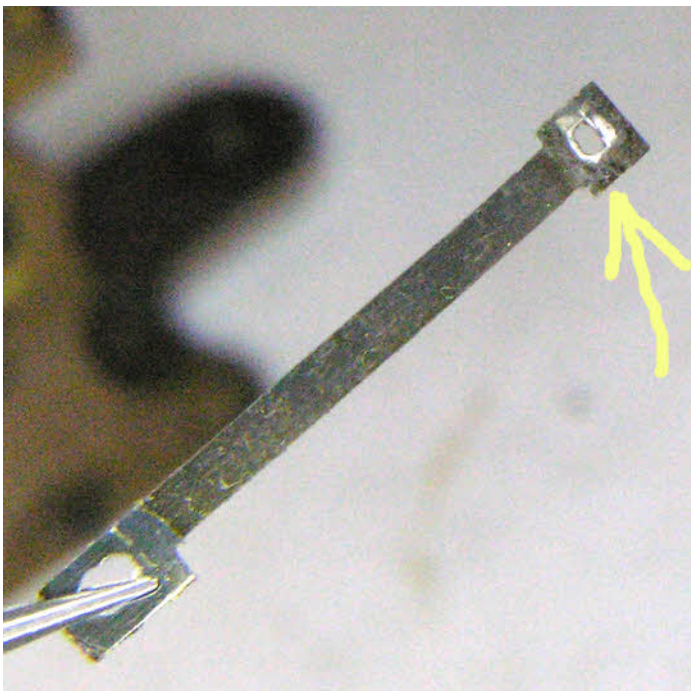
The stop pawl spring has been worn completely through and will need replacing.

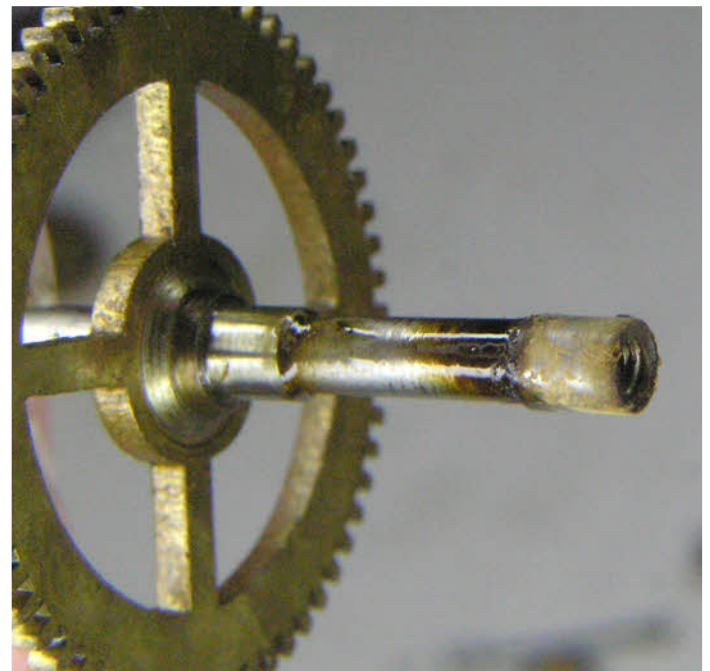
The centre minute wheel arbour was extremely difficult to turn and was in fact sealed in by old caked oil. Once the arbour was cleaned and polished the wheel turned easily.

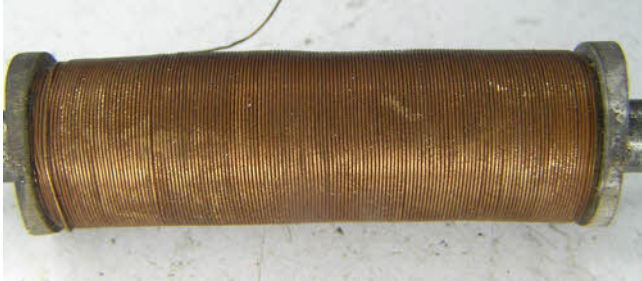
Although it is not entirely clear from the photo above, the coil was very dry and the shelac finish had come off completely in places. So it was cleaned and then laquered to provide a seal.

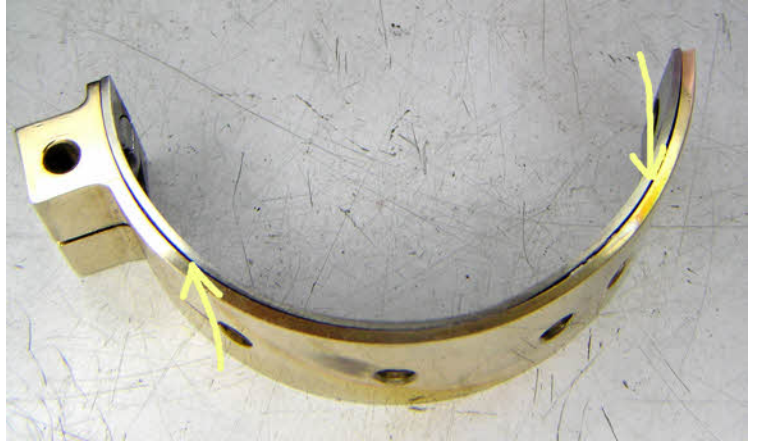
The semi circular brass and steel of one of the balance wheel arms was separating as shown in the photo above.

The rim was heated gently until the two metals separated. Both parts were then cleaned up ready for re-soldering. Before doing that I needed some way of holding them together. After carefully aligning the rims, I clamped them tightly together and used some of the screws to hold the two pieces tightly before applying the heat. This ensured that the holes were lined up and that the screws would enter the threads easily when cool. The whole procedure only took a few minutes and the two pieces adhered perfectly.

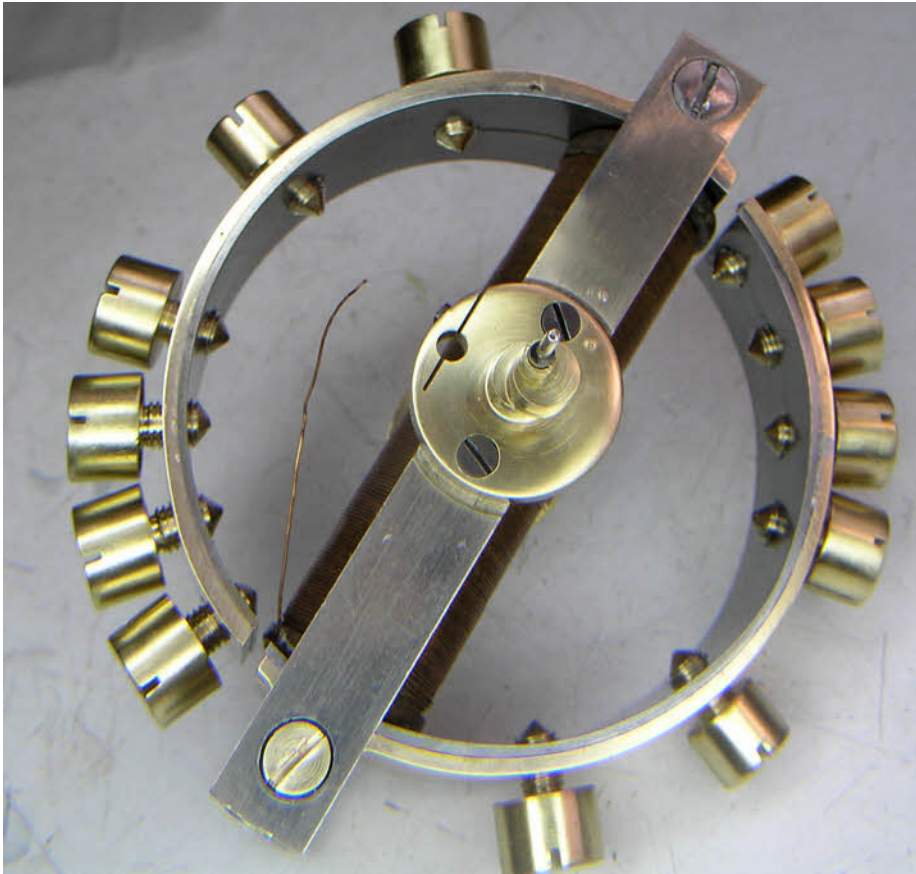
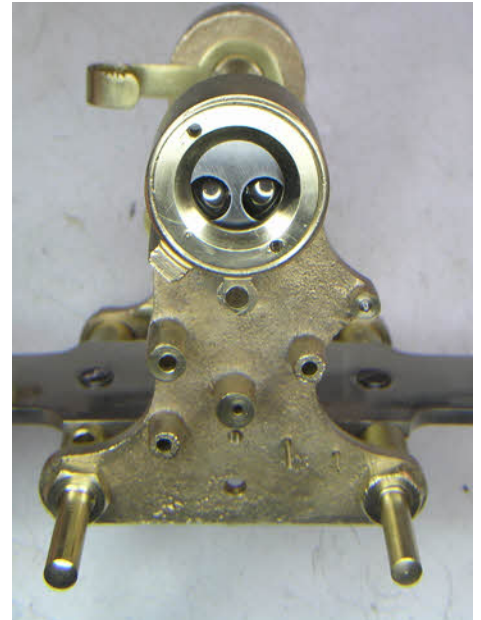
At left we see the balance wheel after repair. The contact pin now needs to be soldered in place. Above is the rear bearing after cleaning.

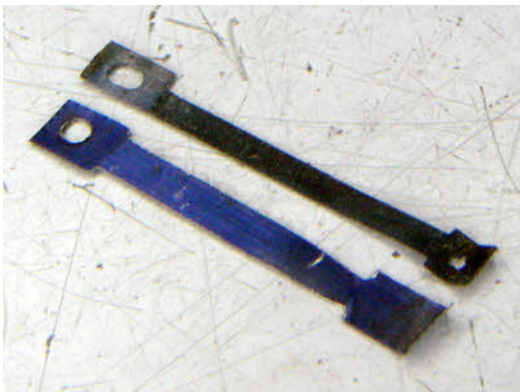
This photo shows the new stop spring after initial cutting out from 0.004" spring steel. It just needs final shaping before fitting.

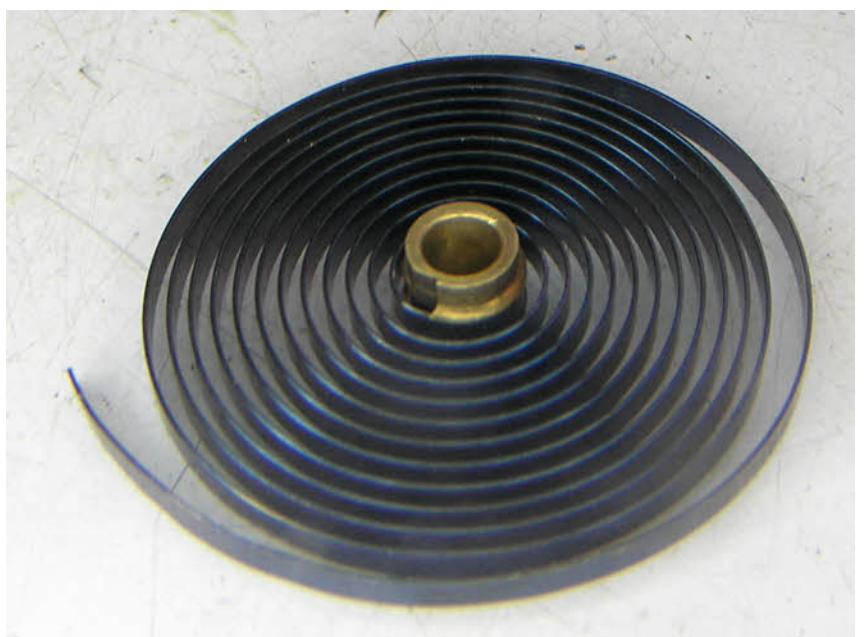
The last photo shows the cleaned balance spring.

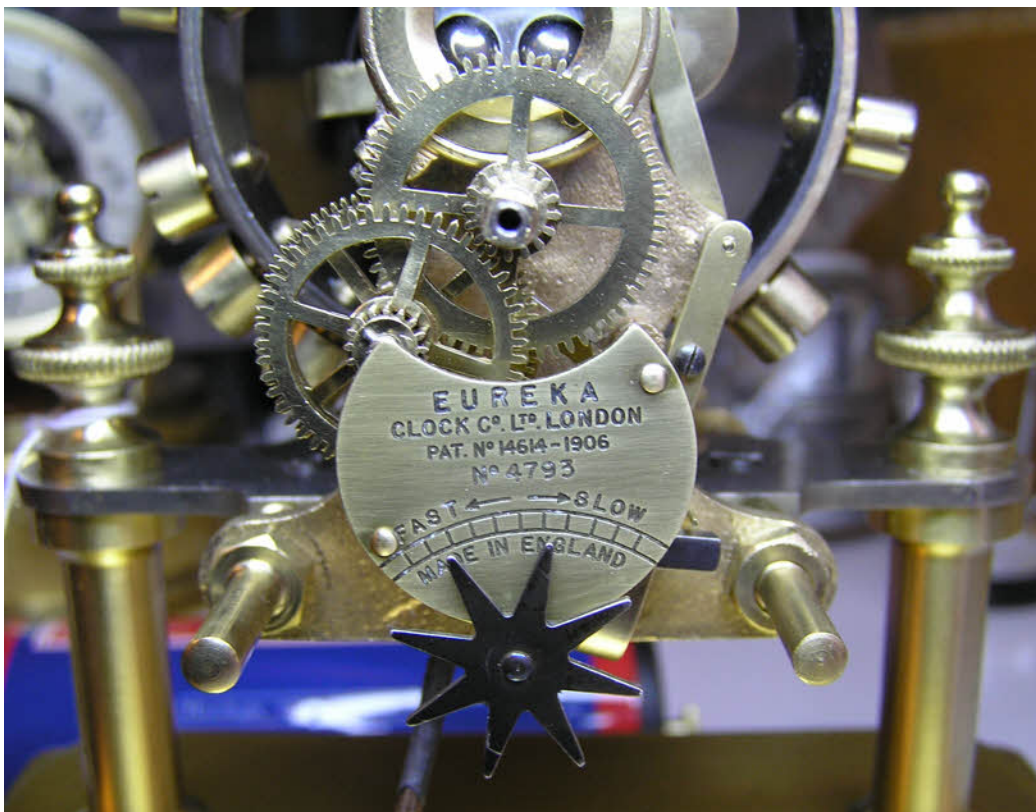
The front of the clock after fitting the motion work and s/n plate.

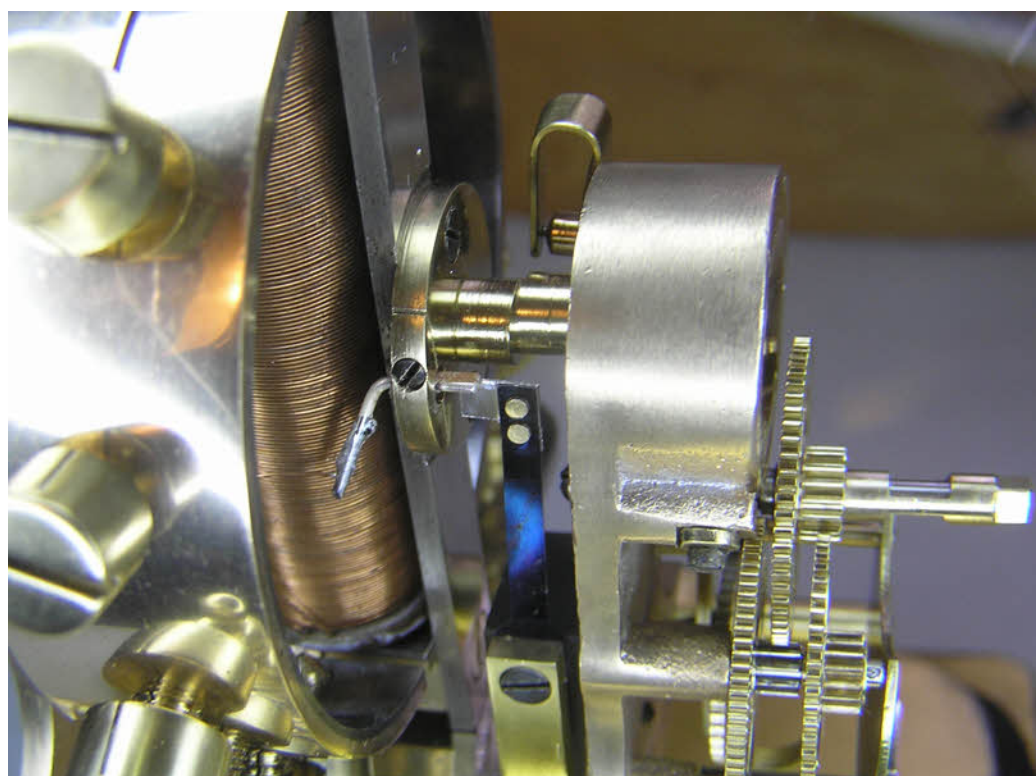
The new contact pin and flag fitted.

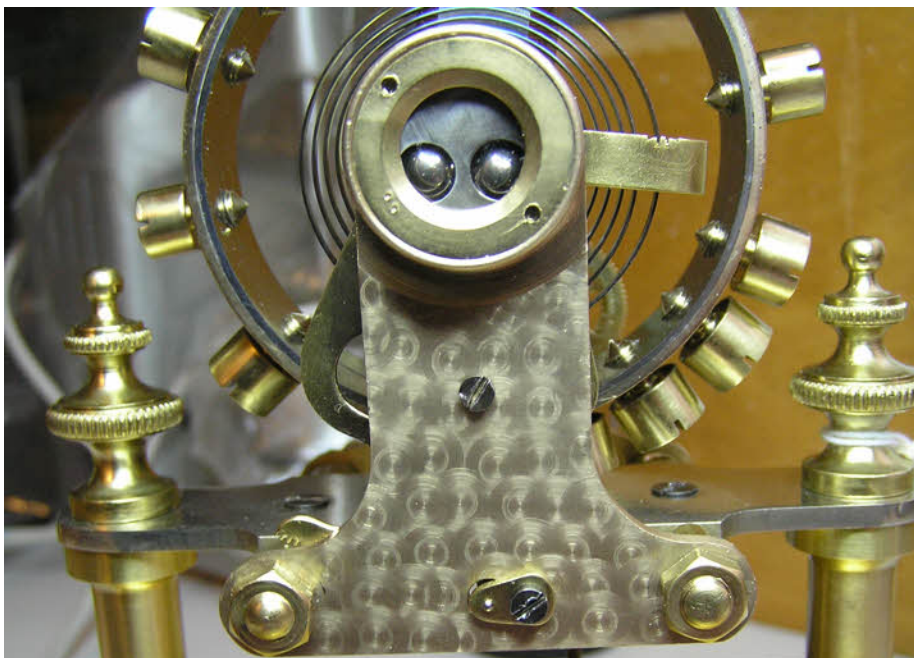
Two views of the rear of the clock.
