**Eureka Clock Serial 7169**

*Restoration of Eureka  
Clock Serial Number 7169*

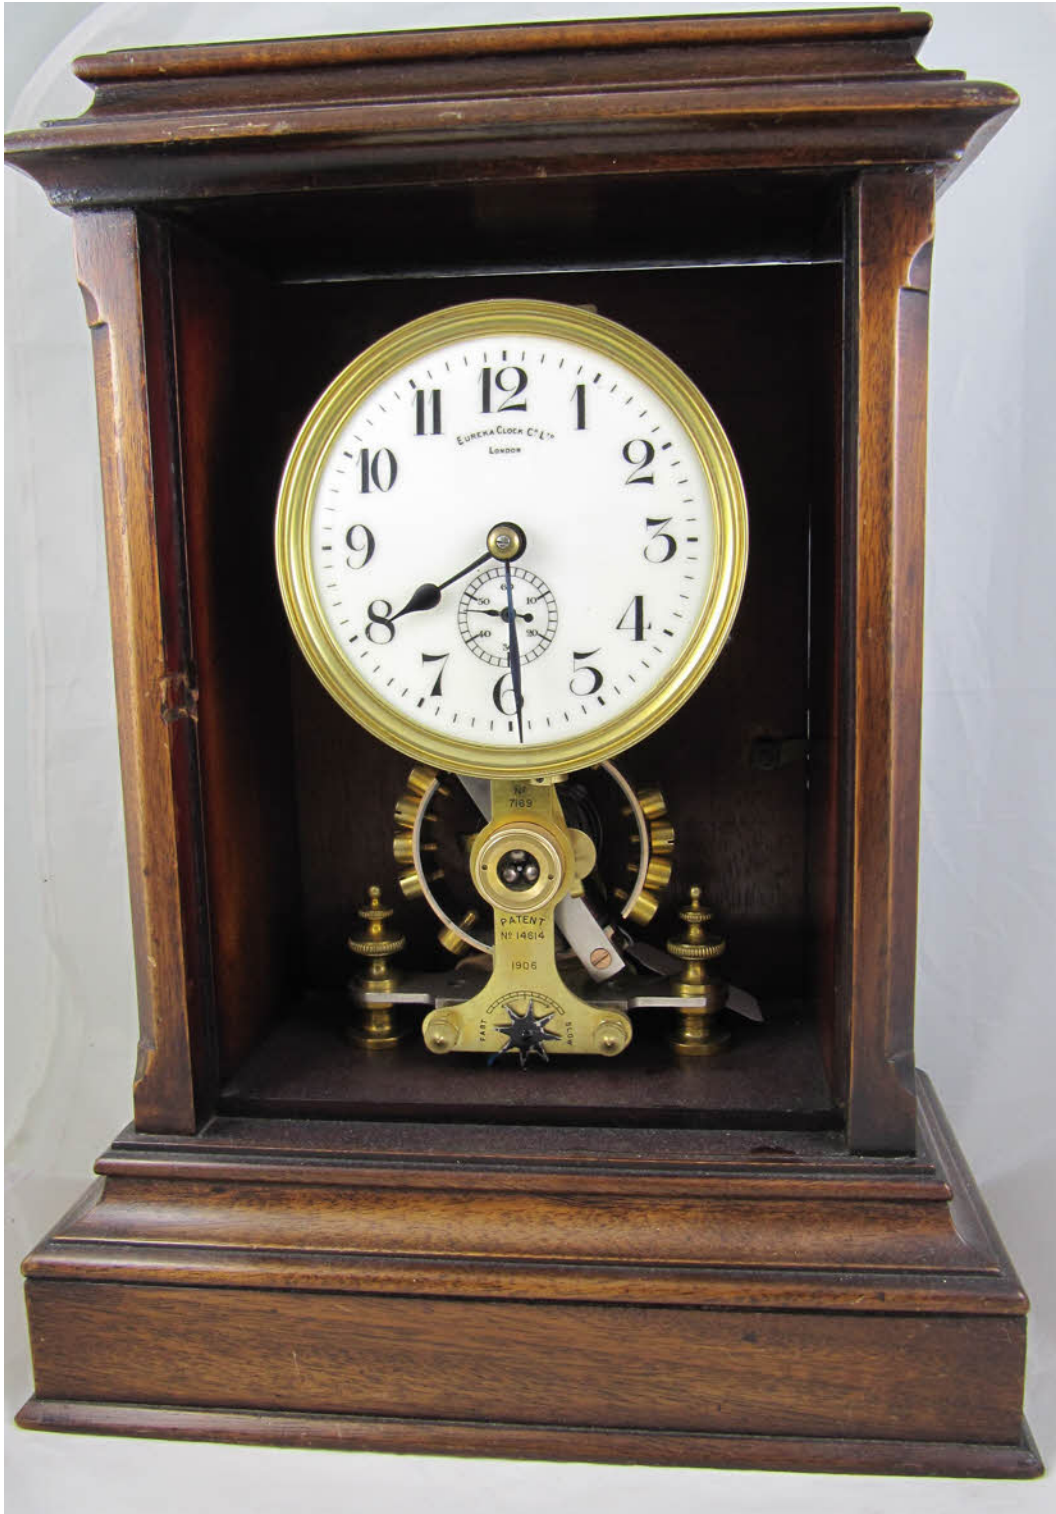
*This tall Eureka clock has a three ball bearings and a second hand. The dial is in good condition with just a faint hairline crack which is not really noticeable. The door and glass has been retained by the owner.*

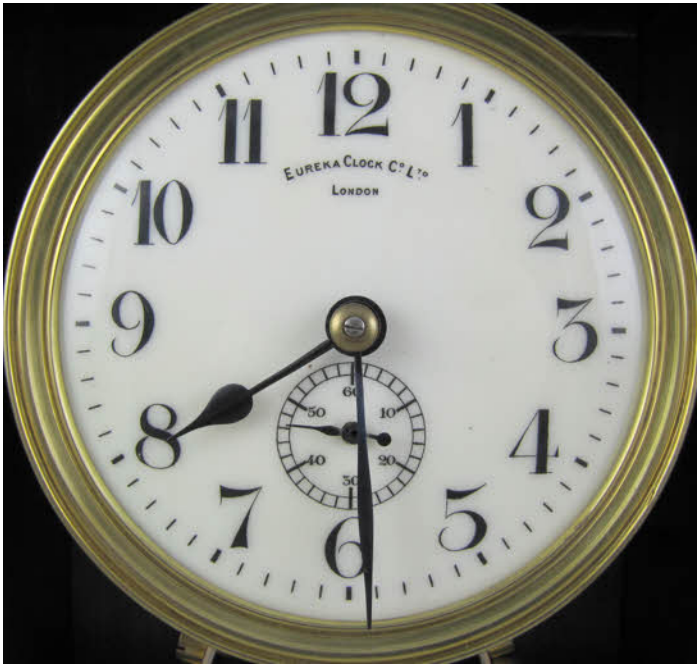
*The clean dial with seconds hand.*

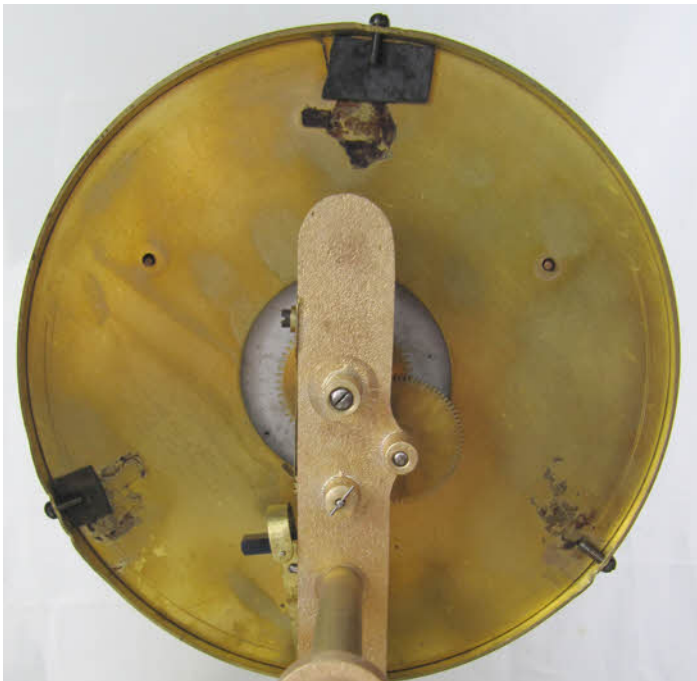
*The rear of the dial shows some bad marks and some padding where the screws are not holding the enamelled dial tight the dial pan. I'll investigate and remedy this.*

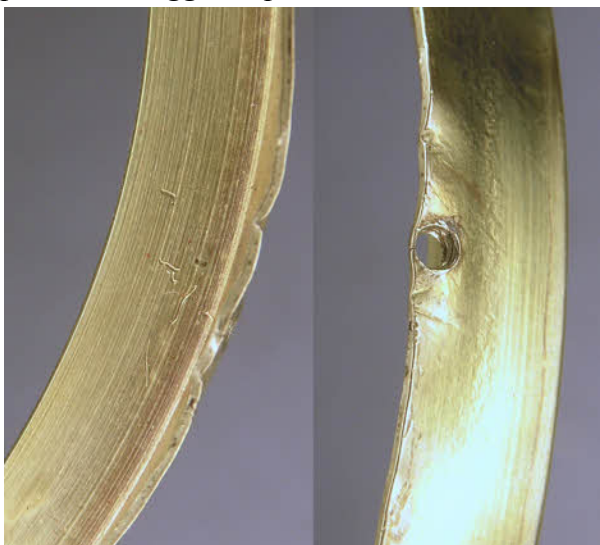
*These photos on the left shows the state of the dial rim. These are made from solid brass rather than thin spun brass. It looks to have been hammered around the screw holes. I will try and smooth these out as best I can and fit blued screws.*

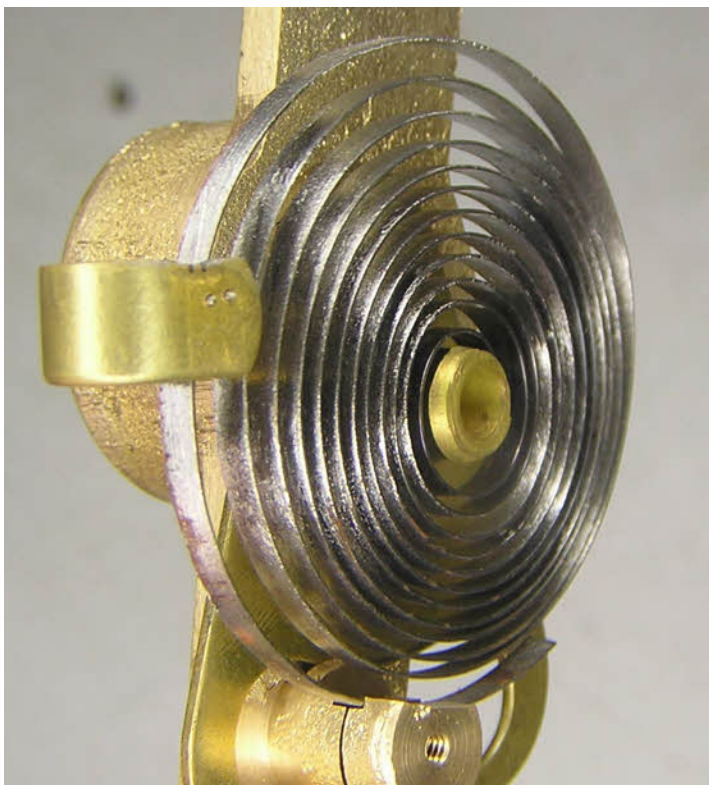
These two photos above show the condition of the balance spring. This one looks complete but it must have been very rusty at some point because it has been cleaned rather badly with a coarse abrasive. In fact as it later transpires, the spring has been severely weakened and I had terrible trouble trying to get it to beat at the correct rate for the 40 tooth count wheel. This will explained later on.

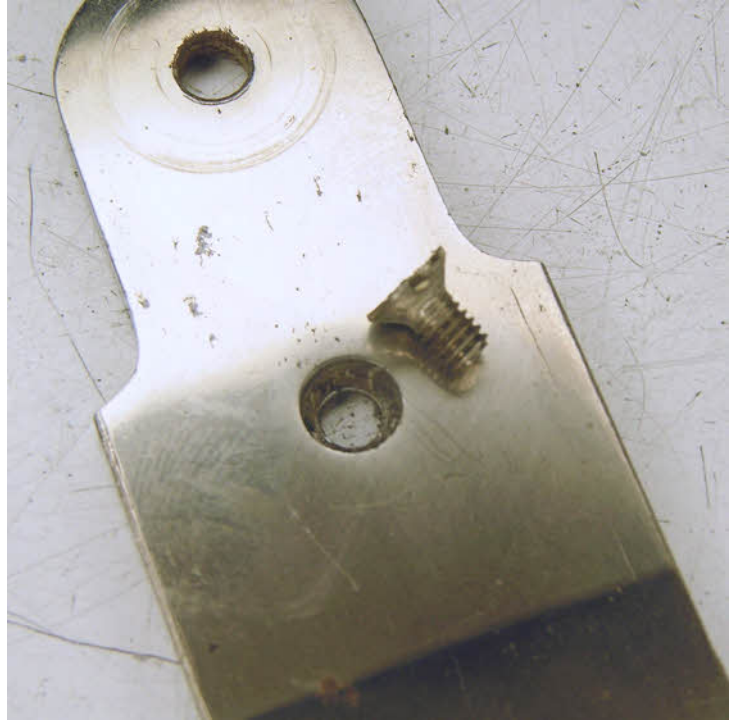
*The screws that secure the base plate to the pillars are wrong. They should be shouldered cheese heads. I will turn some up on the lathe.*

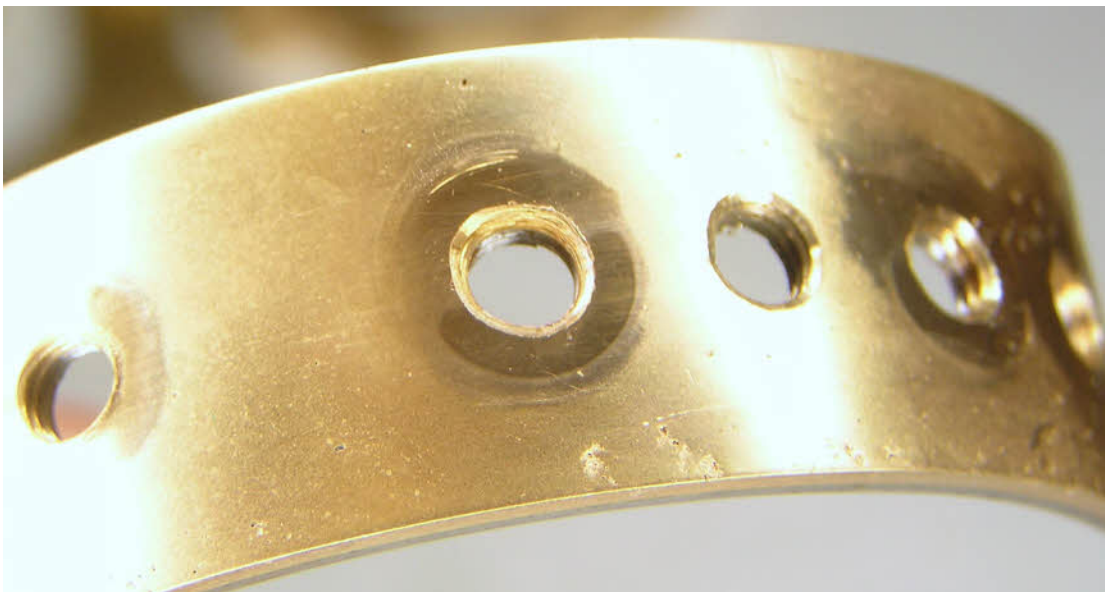
Unfortunately all the balance screws had damaged threads in the balance rim. I re-cut the threads as best I could before re-fitting the screws. Other than that the only thing to be done is to replace both the rims and the screws.

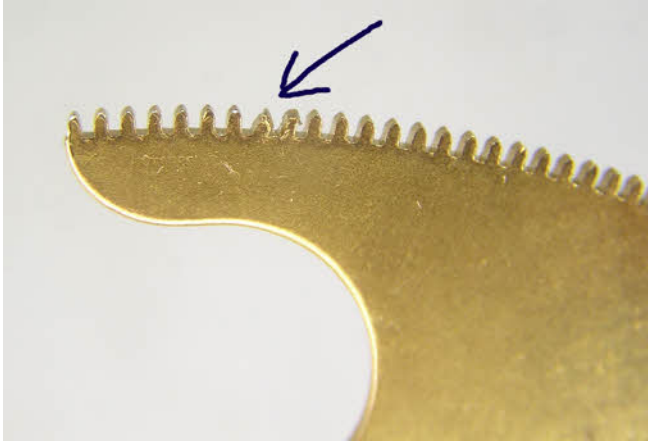
*Even the quadrant has not escaped damage. Note the bent teeth (arrowed). I will straighten these relatively easily with a little care.*

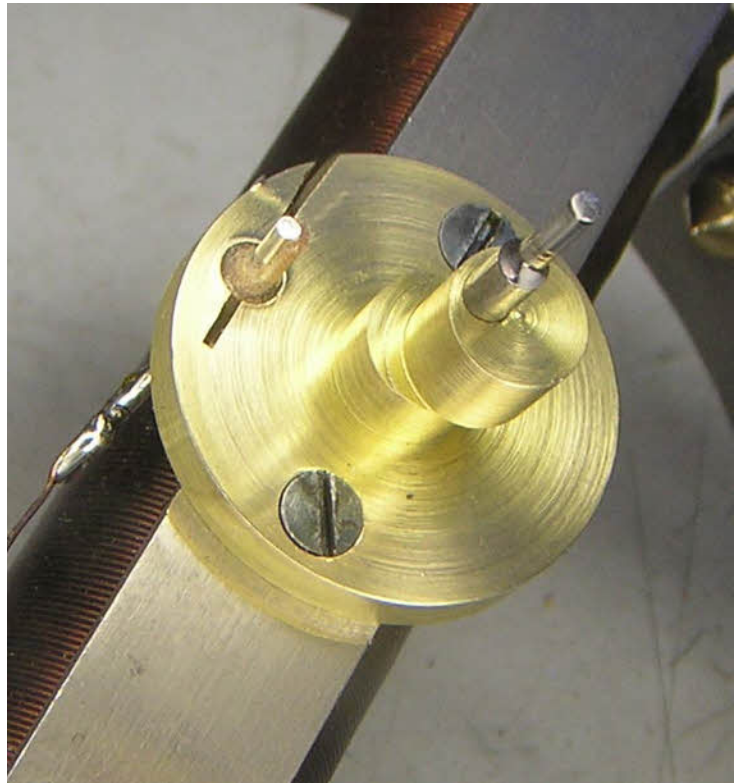
*Here we have the new pivot assembly which was turned up on the lathe. It has an offset cam which needed a little extra concentration when machining. The first one I made finished up with the cam on the opposite side near the contact pin. What a waste of time purely through not paying attention to the machining operation at hand. The pivot itself is re-used from the original. The screws are the ones from the other pivot assembly.*

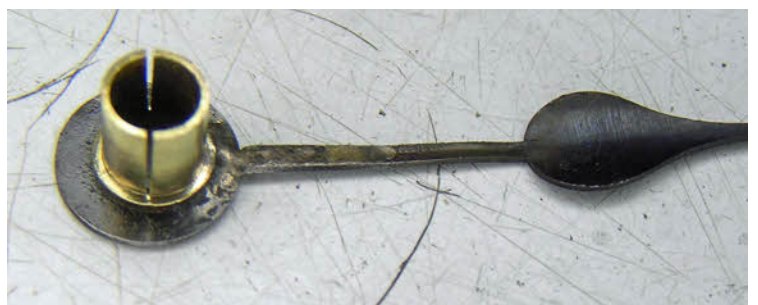
*The hour hand had a silver solder repair which is hardly noticeable from the front so it was left as is.*

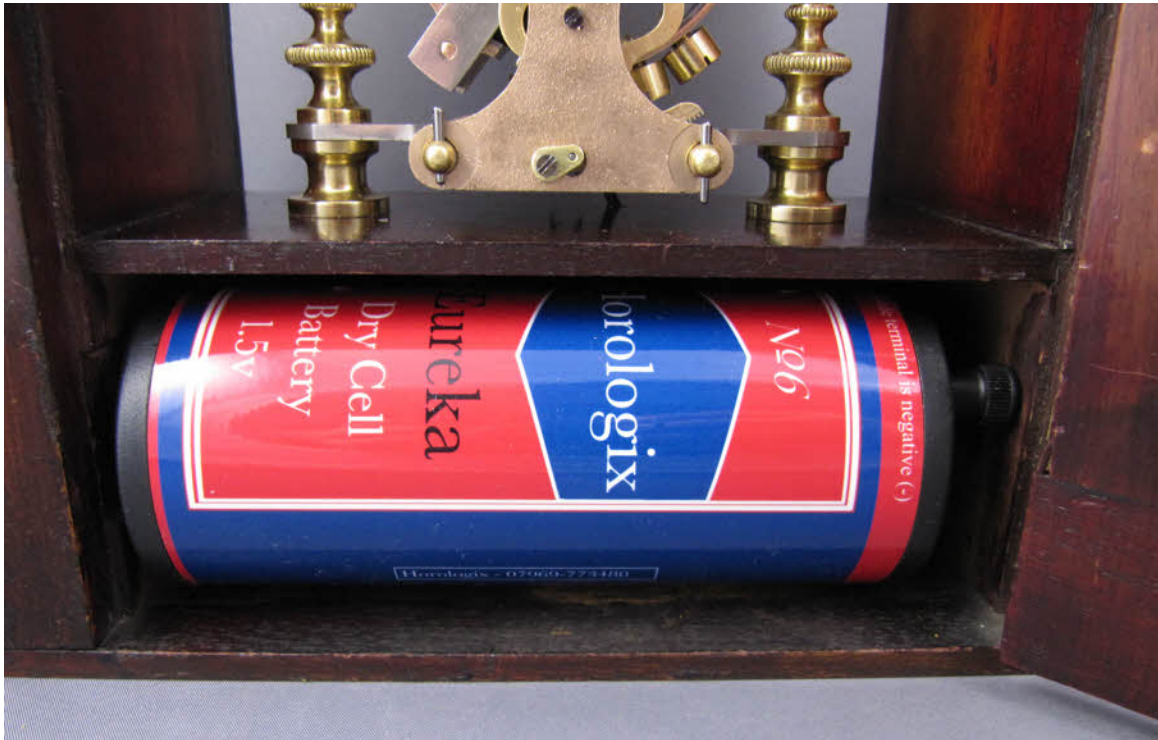
The battery compartment fitted with my Horologix flag cell battery. This battery holder takes four "C" cell batteries and regulates the supply to the clock at the desired voltage of 1.6 volts. It certainly looks the part!

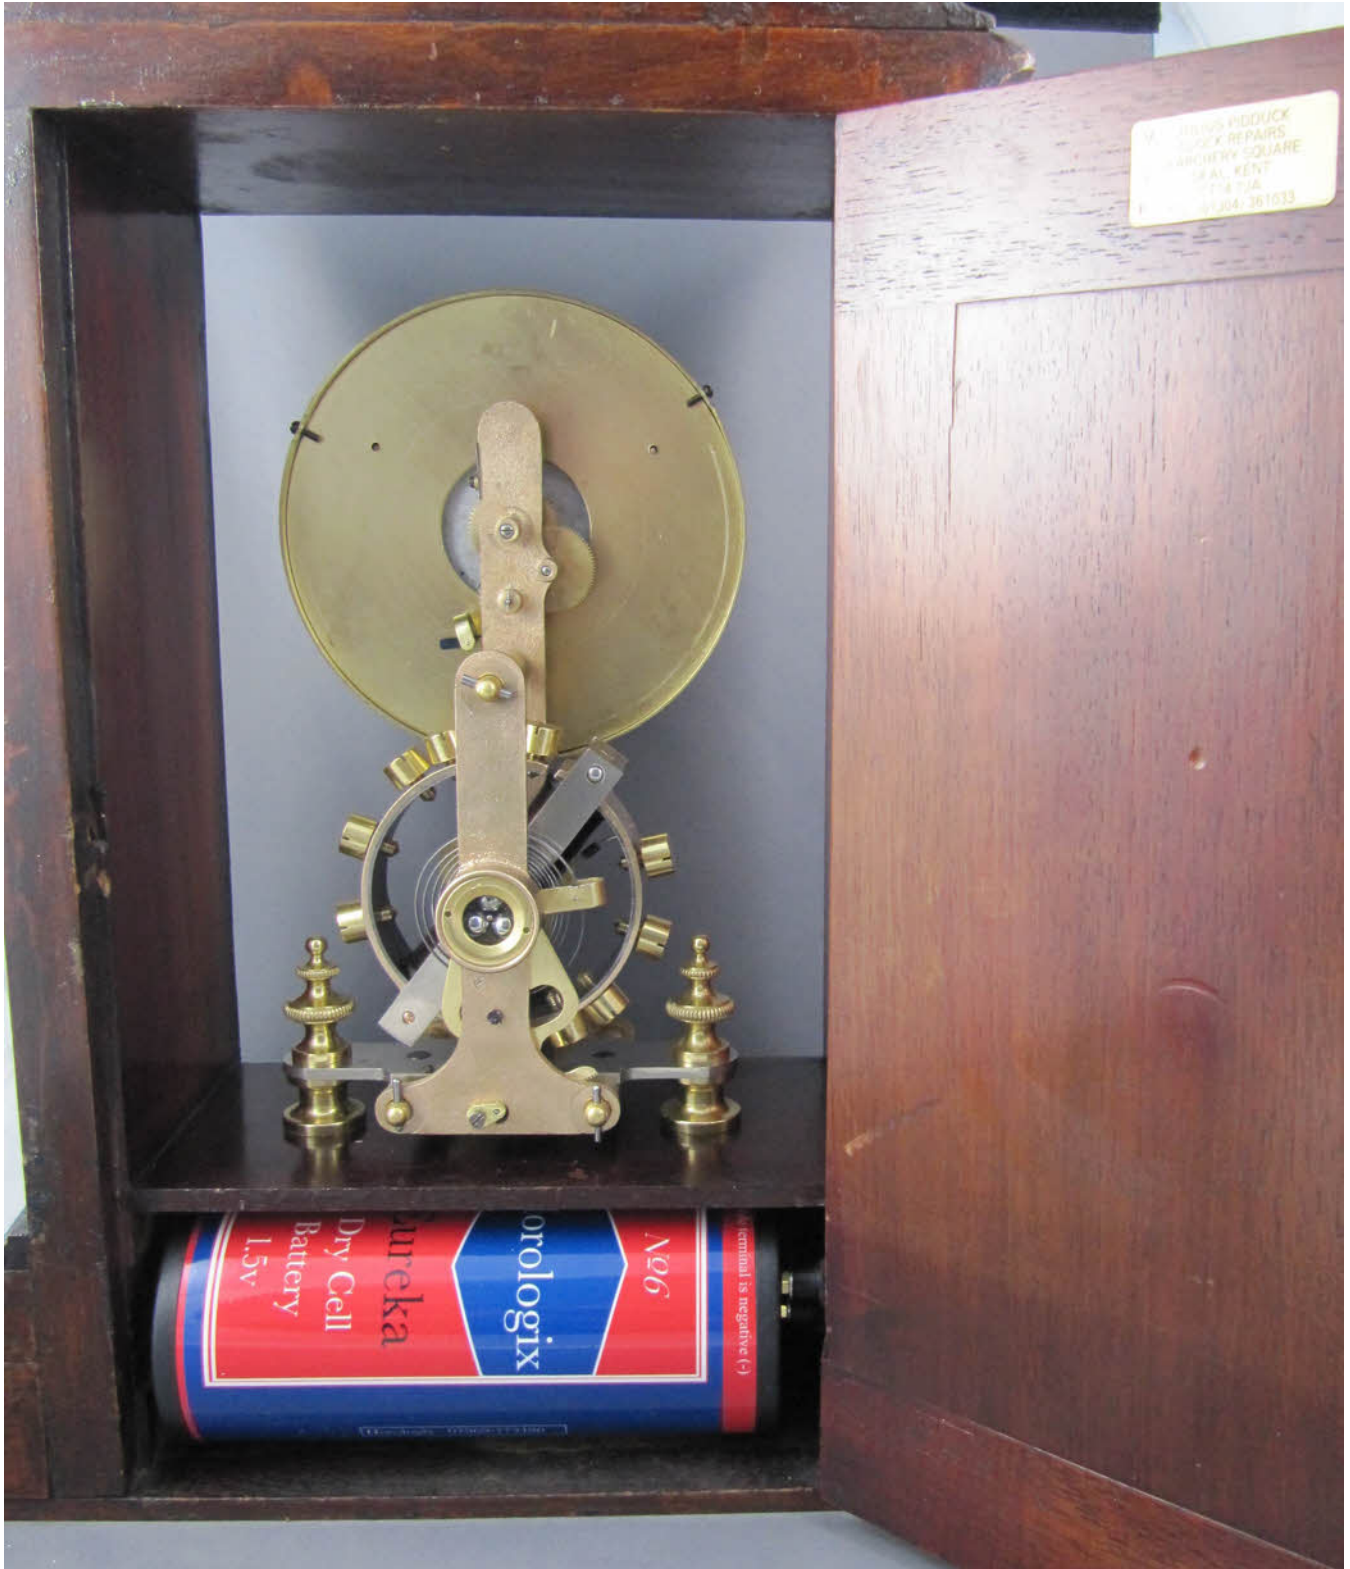
*Rear view of the completed clock. The case only need a good wax polish.*
