Eureka Clock Serial Number 7502

*Restoration of Eureka
Clock Serial Number 7502*

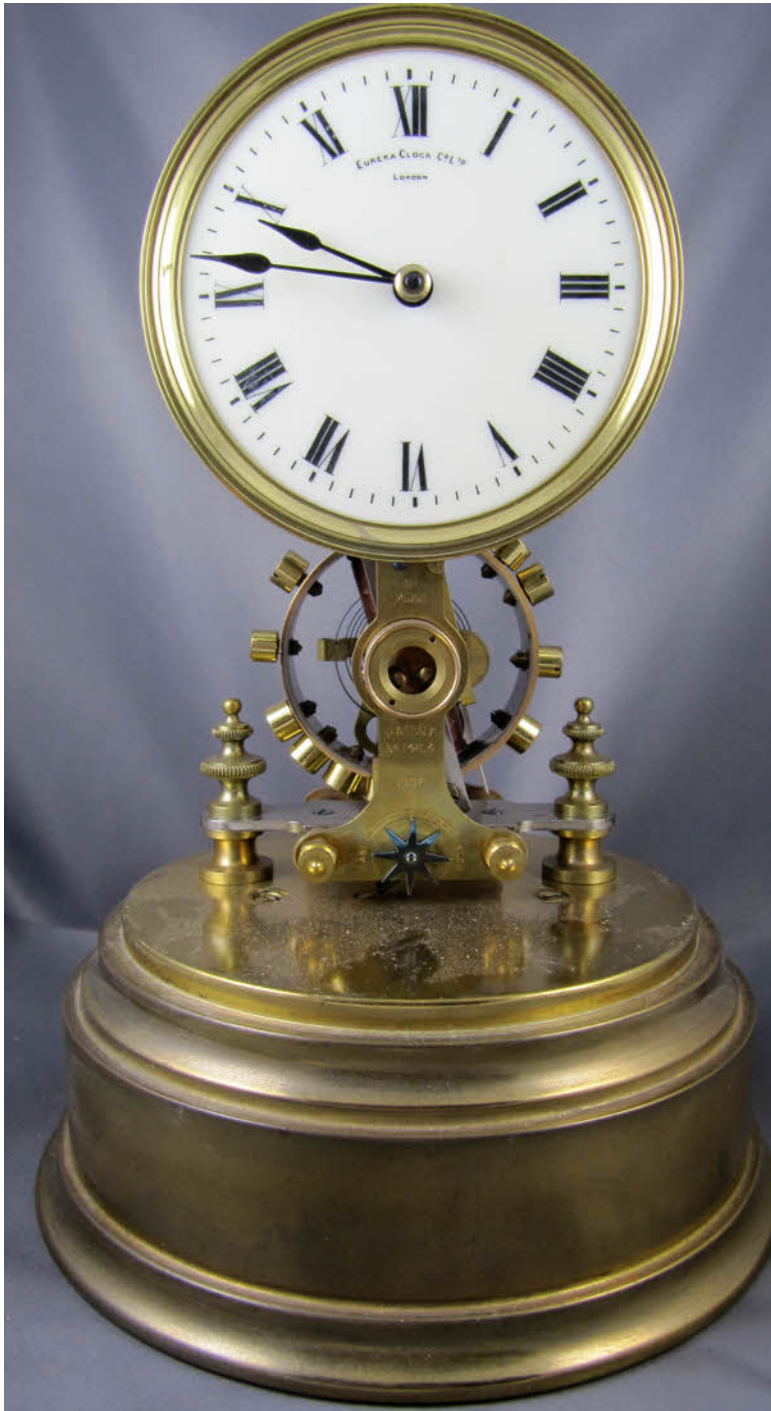
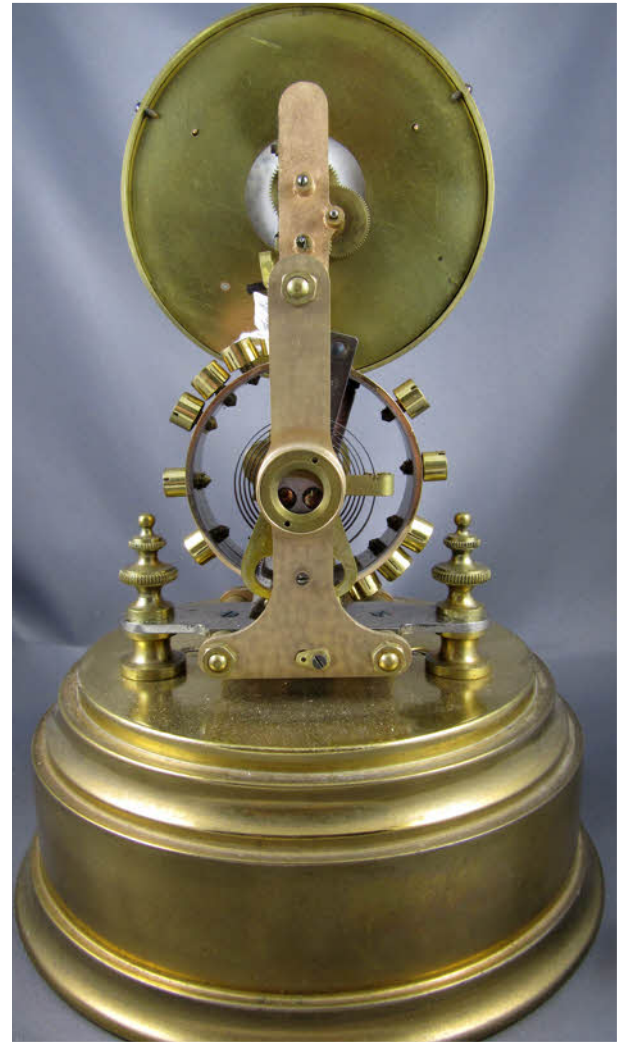
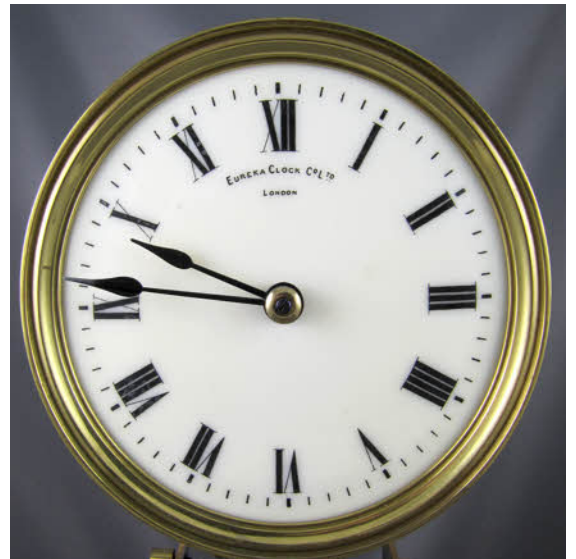
Photos by kind permission of the owner. This tall movement has a solid porcelain dial with no seconds hand. The movement has two balls with front steel plate and sits on a round pressed brass base. Overall it looks to be in good condition with no major damage or missing parts. The dial is in excellent order.

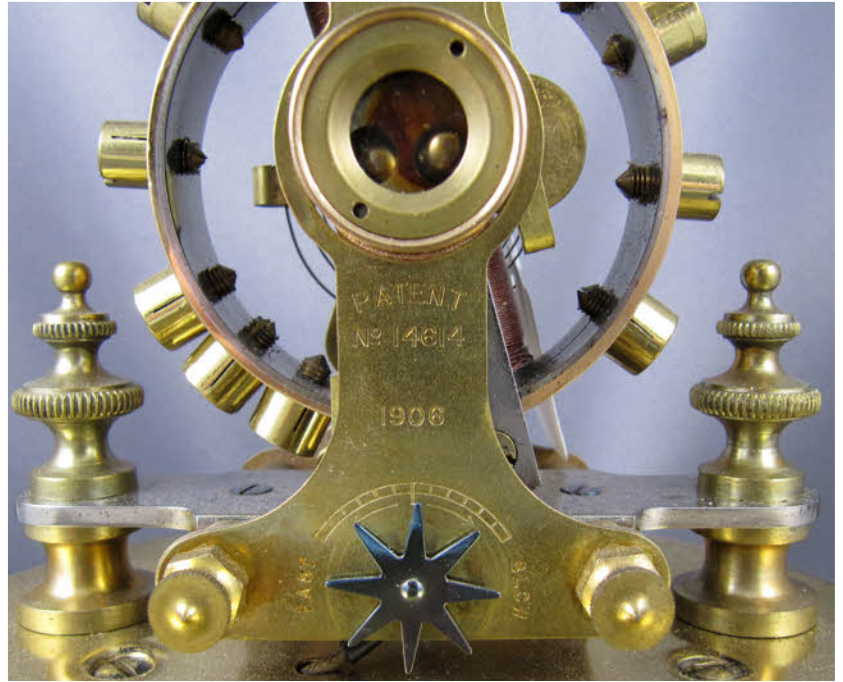
These views show that the clock is in a generally good condition but the front identification plate has lost its wax filling. This is not an issue and new wax will be applied after polishing. The rear of the dial shows a clean and tidy dial pan with two of the dial pins showing through.. The owner decided not to have the base cleaned and polished as some of the original gilding was still present and polishing would not have been in keeping with the rest of the clock.

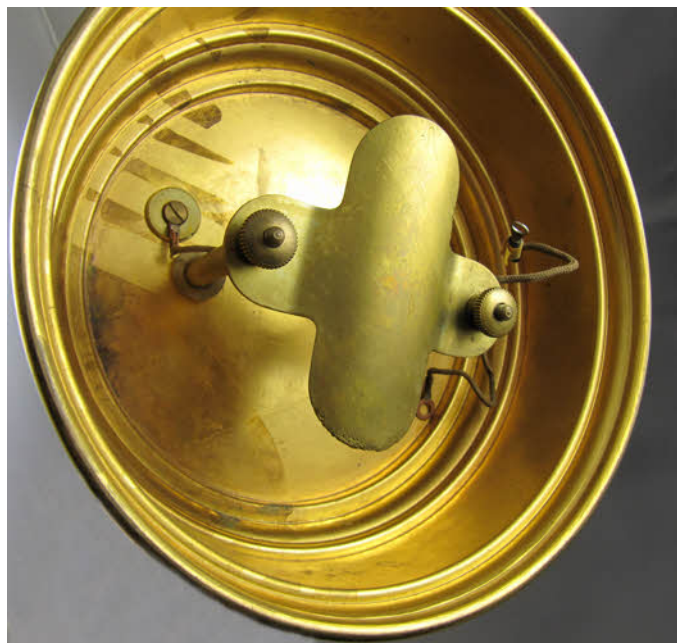
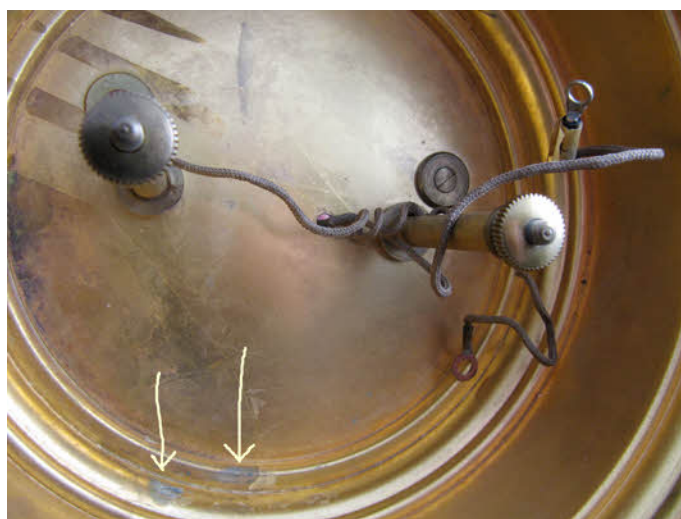
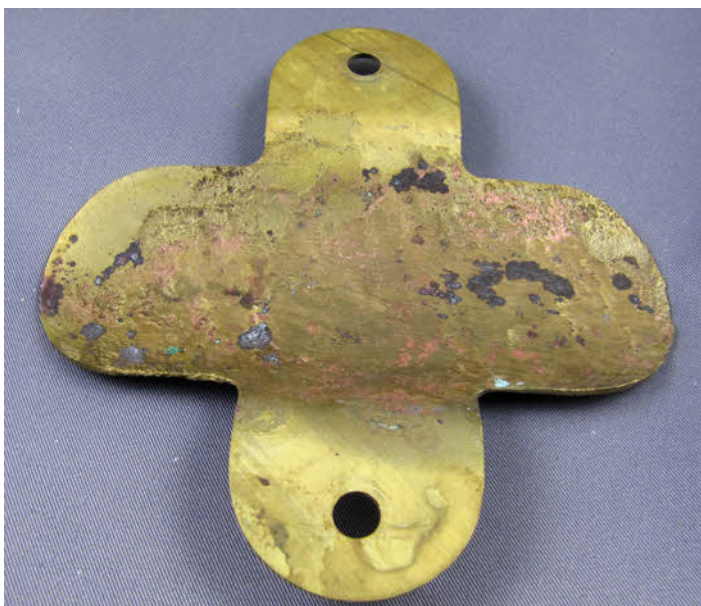
The photos above show the underside of the base with just a couple of acid corrosion marks. These will be cleaned up. But the condition of the battery cover gives some cause for concern as can be seen in the photo at left. It has been heavily corroded and cleaned at some point leaving large pits and ragged edges. I will clean and remove the corrosion but I am a little worried that the metal may be too thin in places and the whole cover will break up.

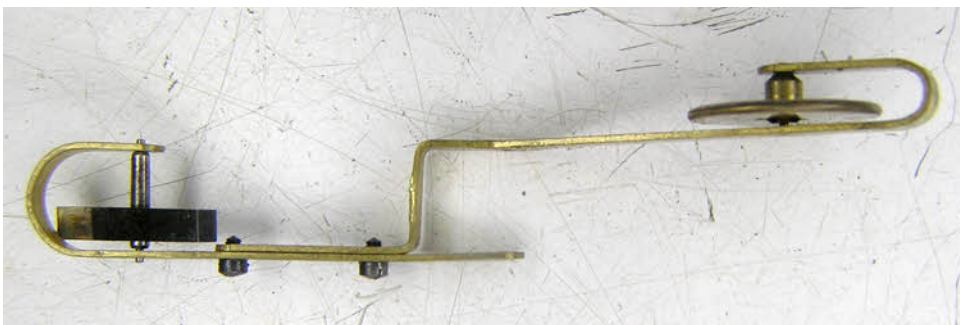
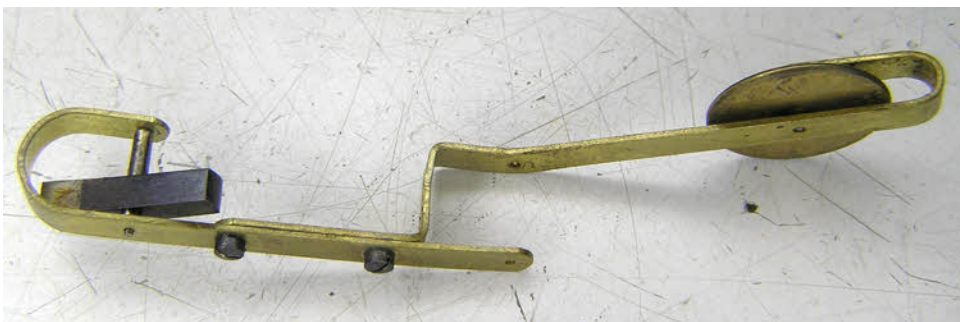
The impulse arm on Eureka clocks is one of two type. In this case it is made from two flat brass parts bent and then screwed together. The other type is bent to shape from one single sheet of brass.

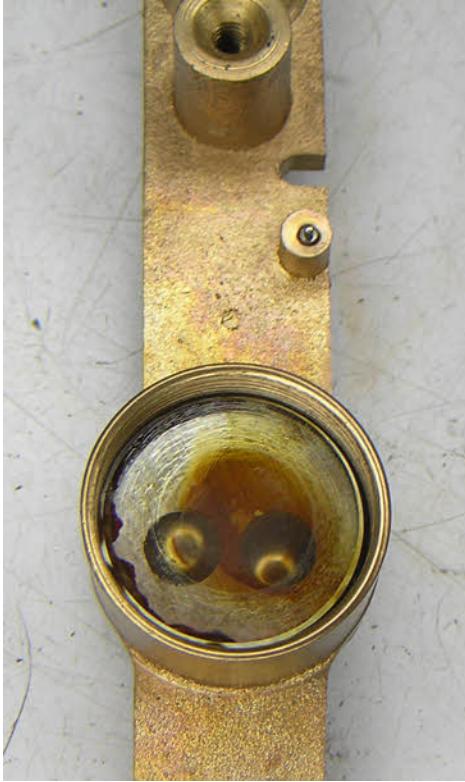
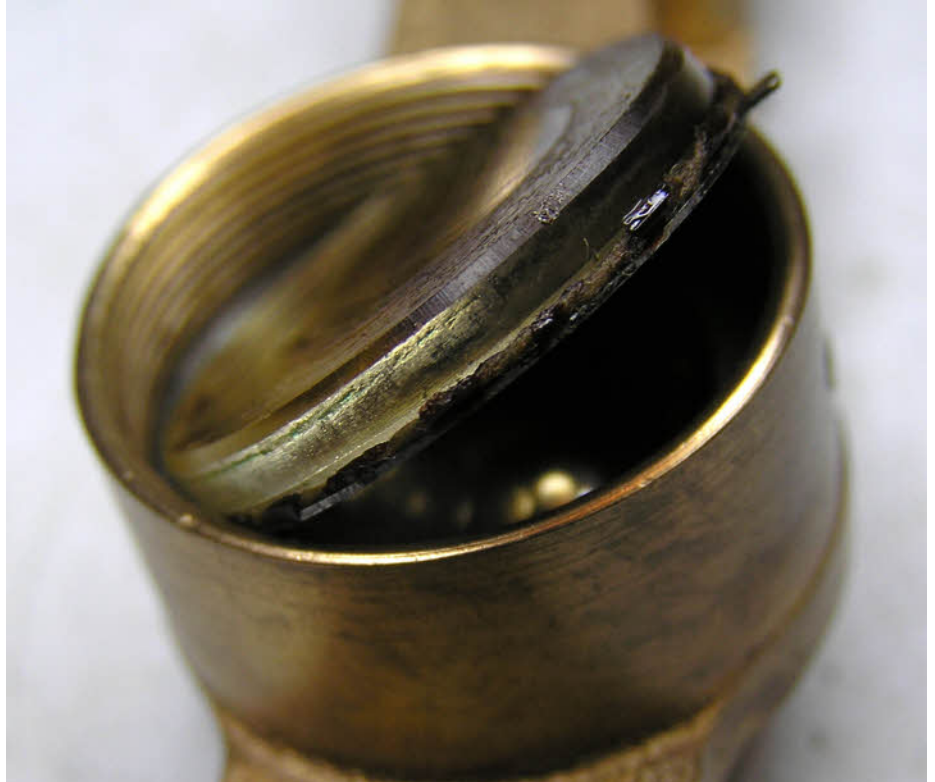
This group of photo shows the extent of the oil build up on the bearings and the the pivots. It is easily removed although the staining may be more difficult to remove on the steel plate and glass. I use acetone and cotton buds. Although the last picture seems to indicate a groove in the pivot it is in fact just a build up of oil gum and the pivot is in very good condition with no scoring. But there is some sort of residue on the brass and steelwork as shown by the arrows.

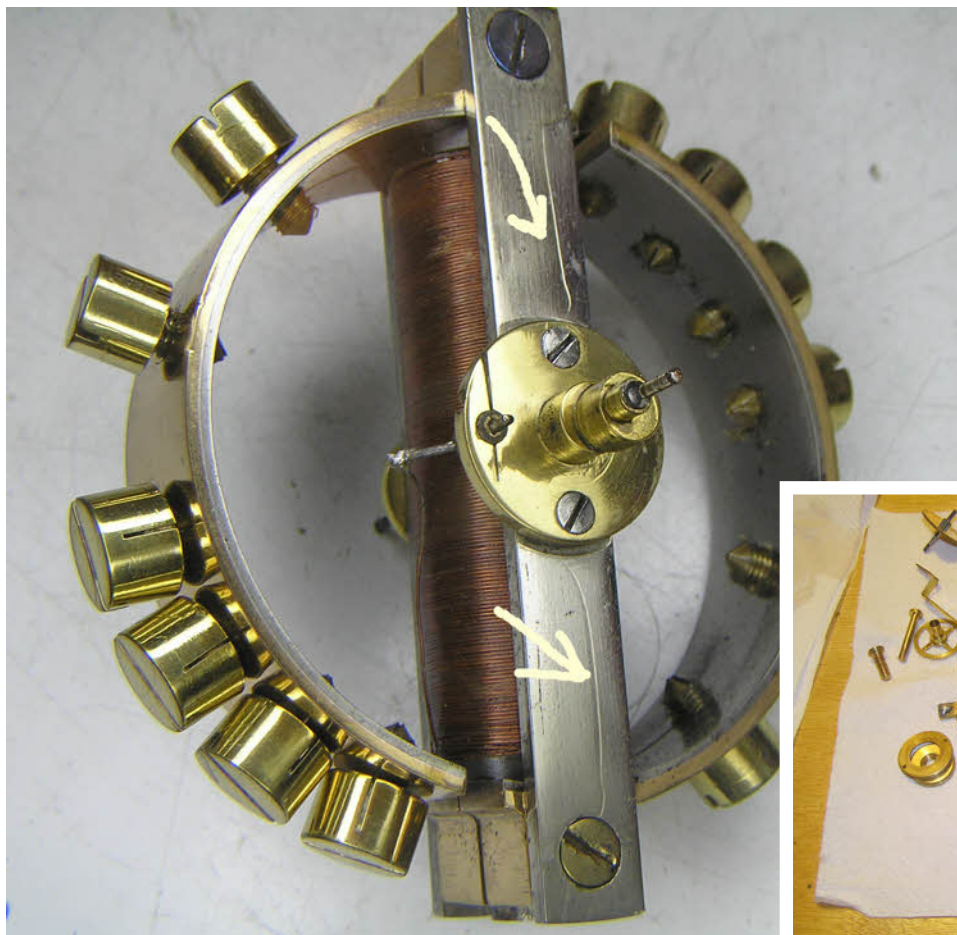
On closer examination it was discovered that the the whole clock was coated in a thick layer of lacquer which must of been slapped on with a trowel. The arrows indicate where it is thickest. It was everywhere and proved quite difficult to remove. I had to resort to two sessions in the ultrasonic tank before it would even start to lift.

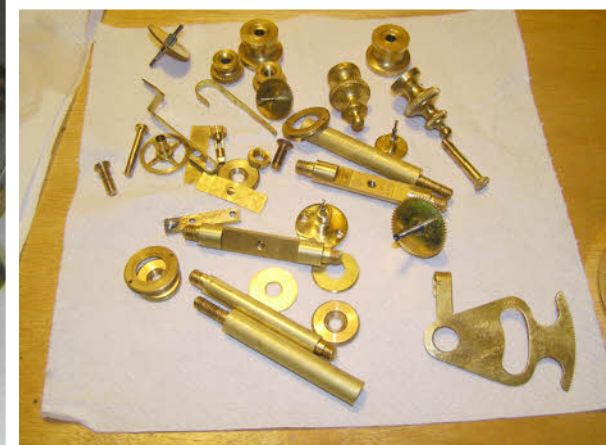
Some of the parts after their second ultrasonic bath. I had to resort to extra cleaning with acetone before I could start polishing. If the old lacquer is not removed completely then trying to polish the brass would just result in black smudges of lacquer everywhere.

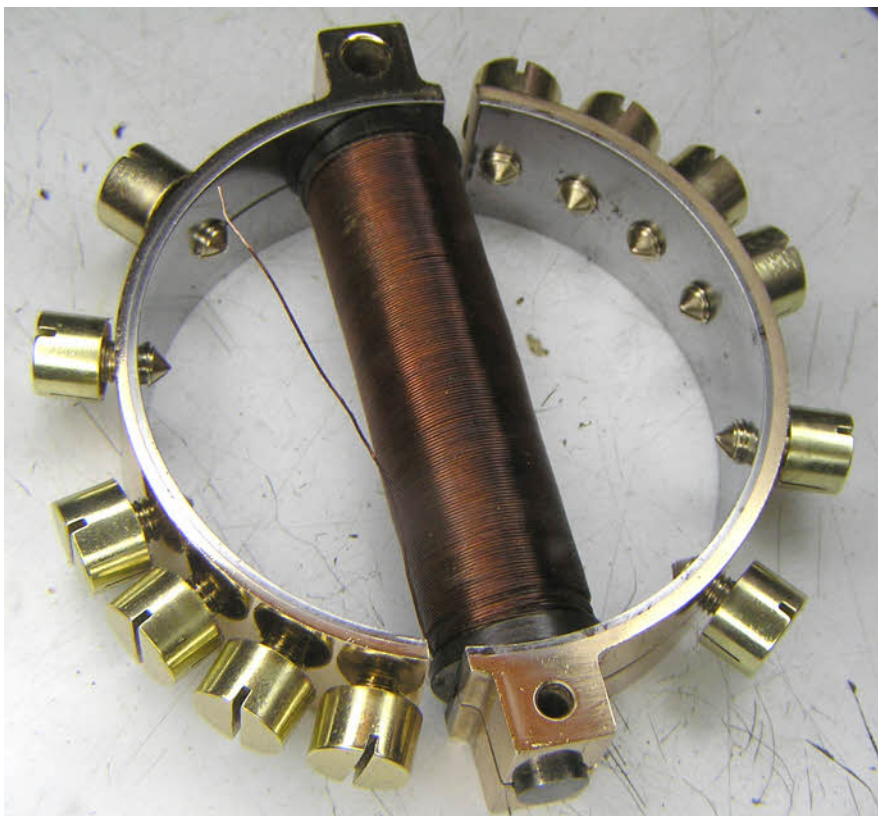
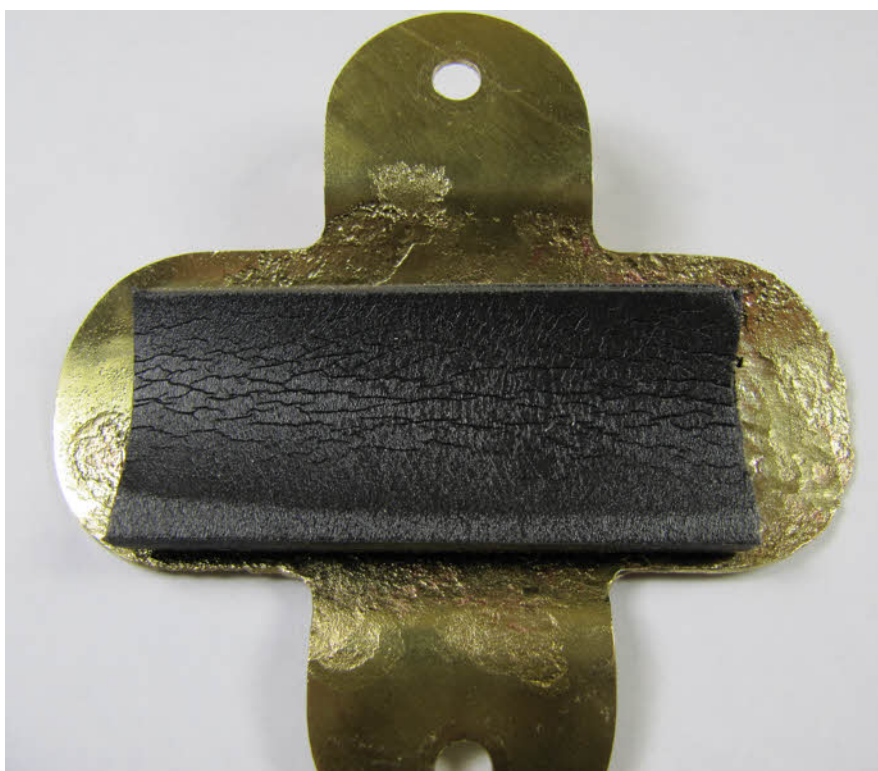
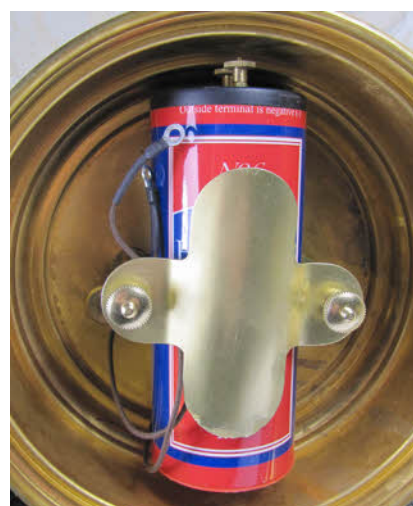
The balance wheel partially assembled. Each of the screws is weighed so the best way to remember where they come from is to note the weight of each screw as if it was on the face of a twelve hour clock. I use a small electronic scales accurate to 1/10th of a gram. These are then noted with the clocks serial number in a file so that they are easily replaced in the correct position when reassembled. The steel armature has been cleaned and polished to make sure of a good contact in the brass wheel rim. The whole assembly is then checked for continuity and correct 20 Ohm resistance reading before final assembly. The contact pin is yet to be attached. Below are a couple of photos of the battery cover and underside of the base. The cover was still good and solid after the removal of corrosion and was given extra protection with lacquer. The sticky back foam was attached to cushion the battery and provide enough pressure to secure the battery without it sliding around. These batteries have two protruding terminals which should not be allowed to touch the brass base.

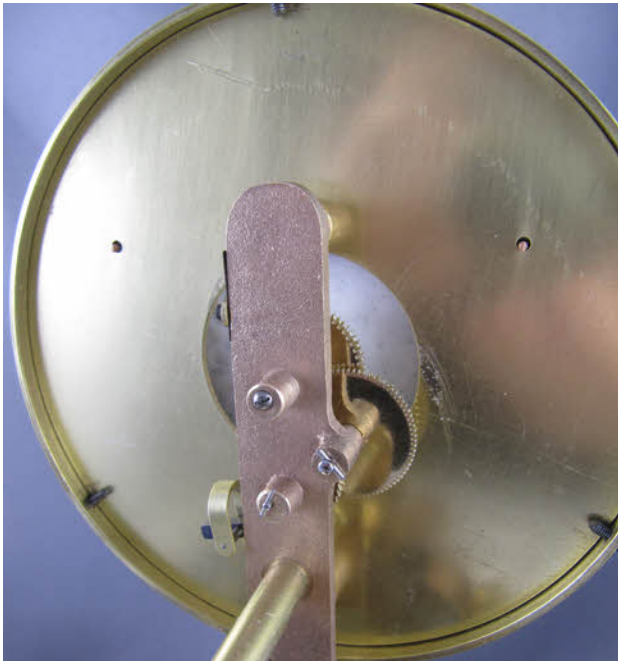
Some shots of the reassembled movement. Note the new contact pin and flag assembly. Also the newly waxed id plate which is not perfect as the two arrows show. The engraving is very shallow at those points and would not take the wax to the depth required.
