**Eureka Clock Serial Number 7617**

*Restoration of Eureka  
Clock Serial Number 7617*

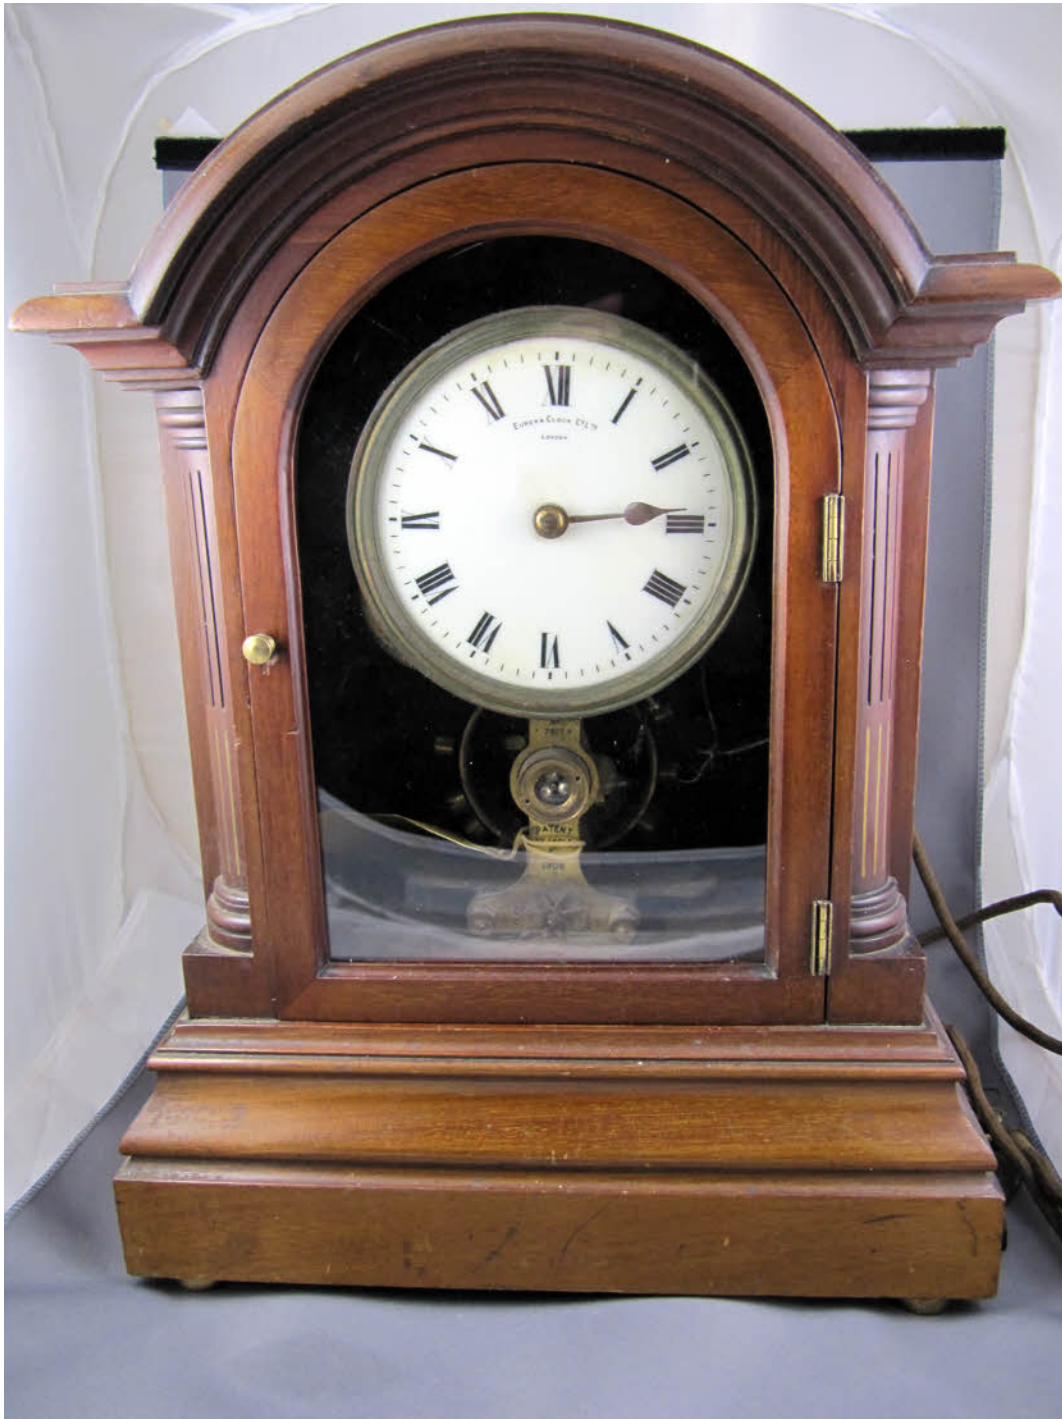
*A tall clock in a mahogany break arch “Early English” case with moulded quarter pillars. Enamel dial “Eureka Clock Co Ltd, London”. Three ball movement without second hand. The case has provision for a full flag cell battery at the rear. Initially the clock looks OK with just the minute hand missing. But what are those wires at the back?*

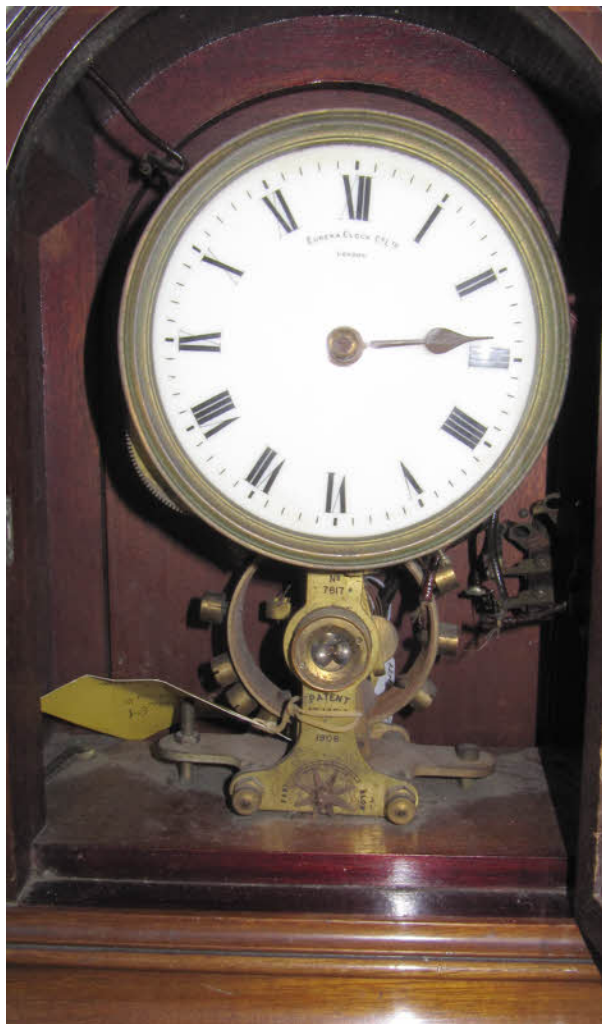
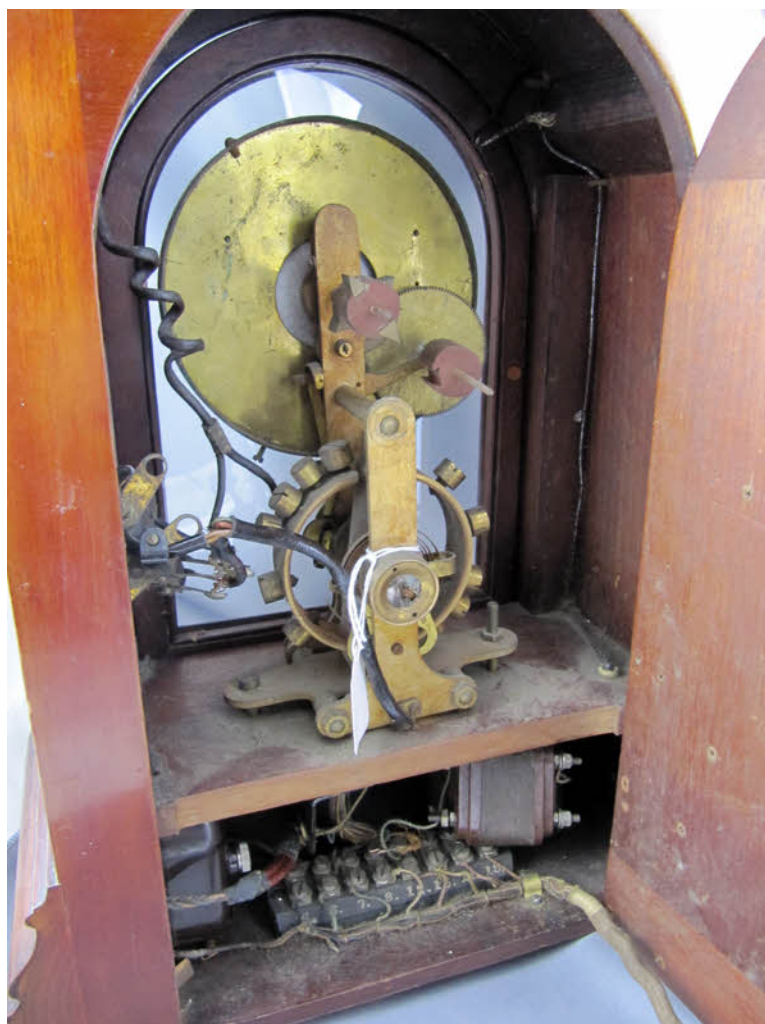
*On opening the case it's obvious that this clock has had some major changes made. But it also seems to have parts missing. Note the missing feet and decorative finials that support and embellish the movement. But its the second photo that shows the really interesting alterations. In place of the battery there appears to be some sort on transformer, screw terminals and perhaps a solenoid. From here lead various wires that terminate in some mechanical contacts that are now disconnected from the movement. These were obviously connected to the extra wheelwork seen at the rear of the clock. From what I can make out the insulated material with the triangular brass protrusions were connected in such a way as to provide impulses at the quarter hours and hours. It naturally follows that this system provided a chiming and striking method that, rather than being mechanical on the clock, was in fact led away from the clock as electrical impulses to drive some other remote device. All of this extra work looks to be from the 1920's or 30's and done to a professional standard which suggests that the clock was changed after purchase at some cost.*

*All of these additions have been photographed in situ before being removed and the clock returned to it's original condition.*

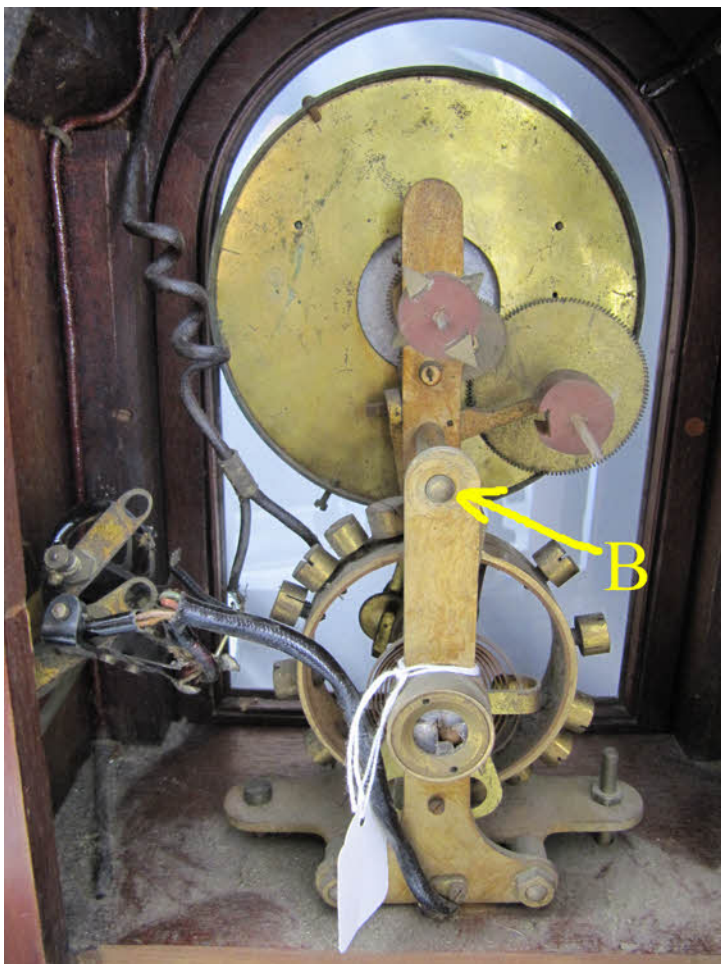
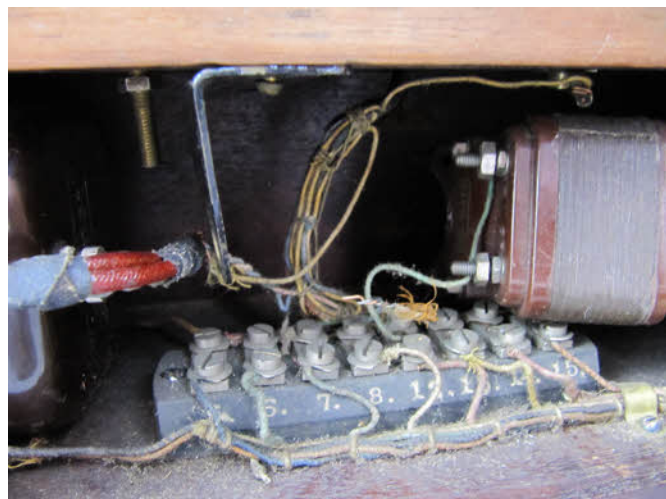
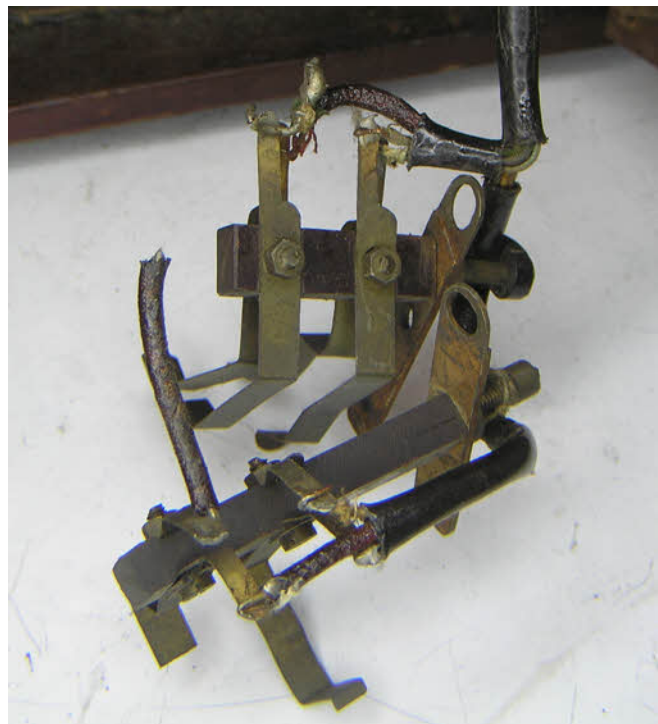
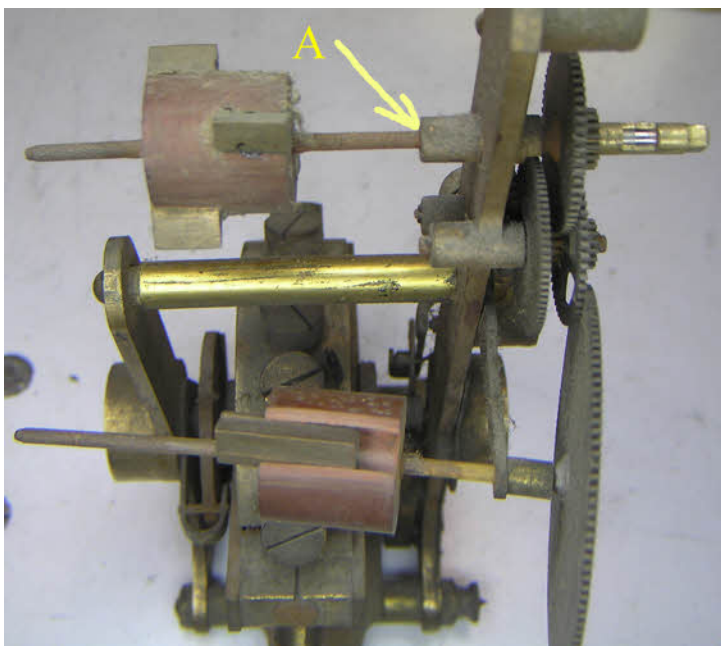
*Note that the arbour carrying the four triangular blocks has been screwed directly to the rear of the minute hand arbour (A). The other arbour is driven from the motion work. Surprisingly, considering the additions, there is no damage evident to the clock itself. All the additions have been placed using existing holes or screws. Note that the nut is missing from the frame plates at (B).*

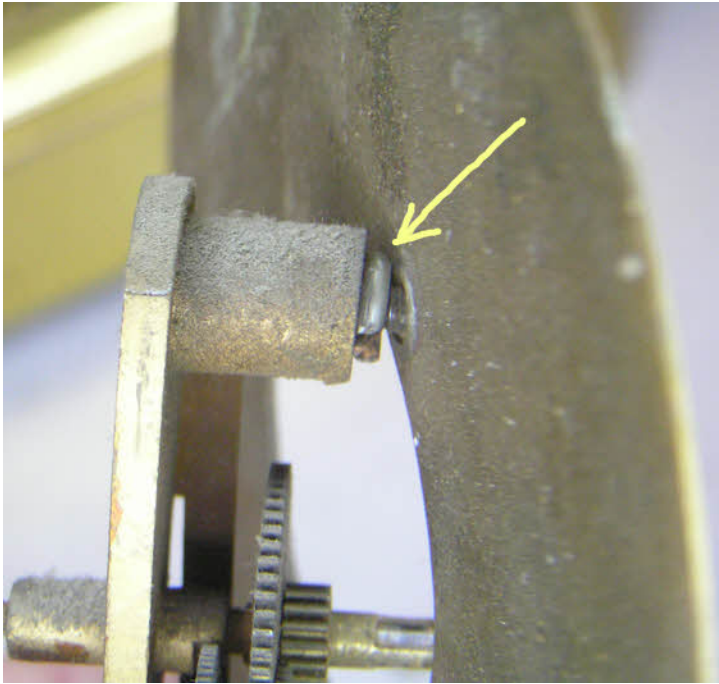
These "spacers" were found behind the dial pan. Why?

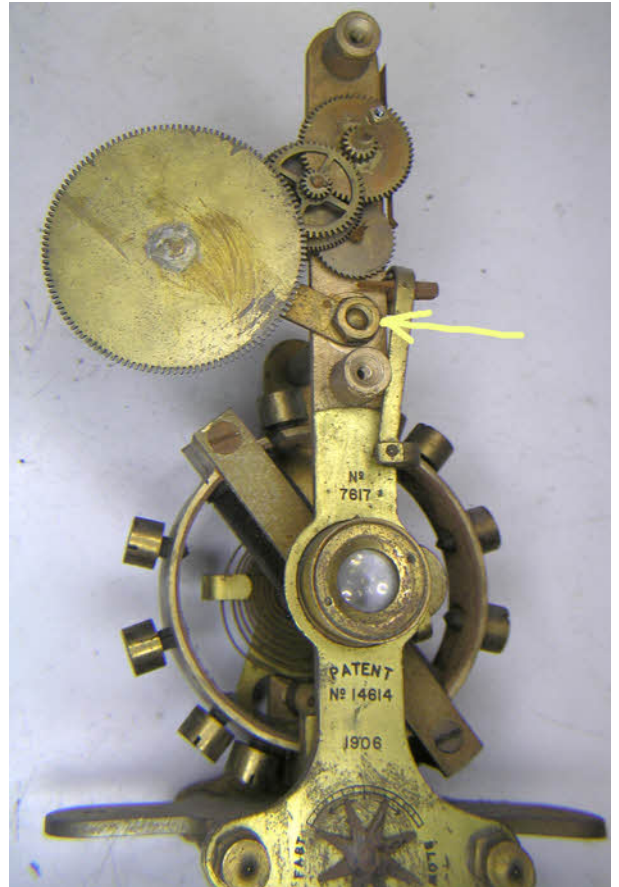
The extra wheel work is attached to the clock using the existing frame nuts.

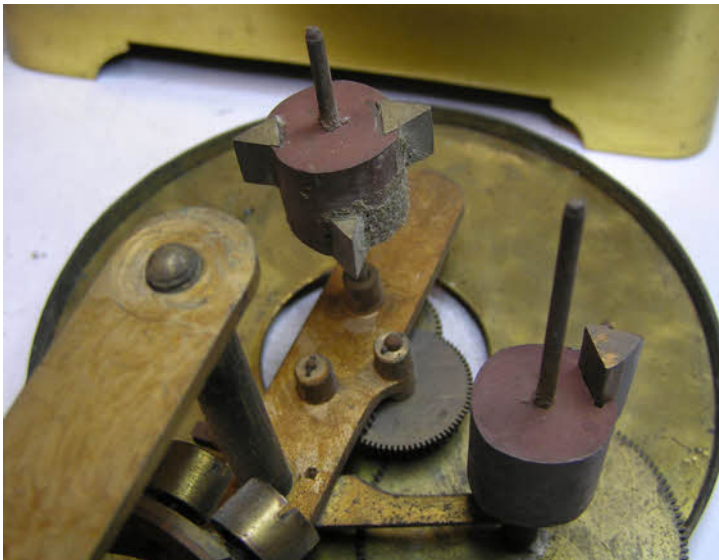
Note the one triangular brass insert in the arbour driven by the motion work.

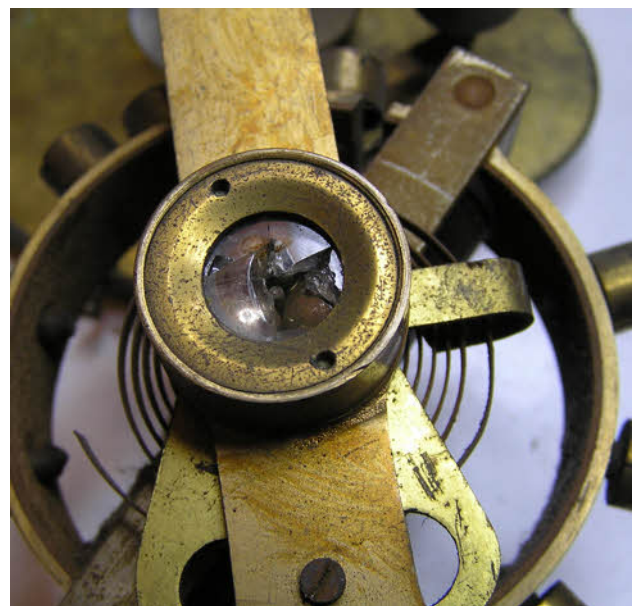
The photo on the right shows the badly damaged rear bearing. Besides the broken glass, which looks as though it has been shattered by shock, all the steel work is badly rusted.

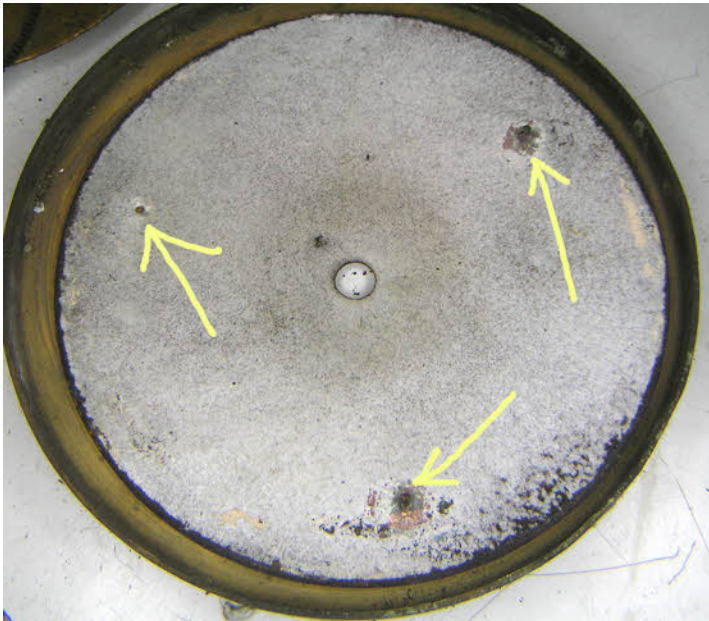
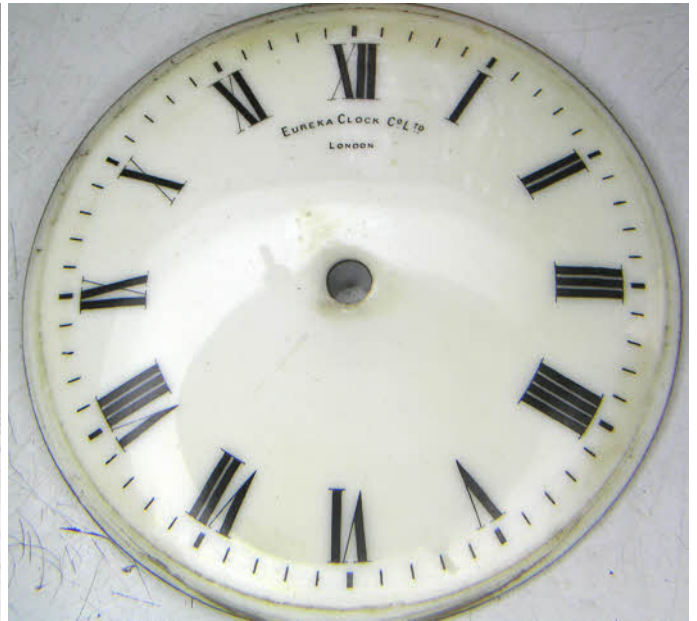
*All of the pins at the rear of the dial look as though they have been under stress with one of them actually broken off. But the front of the dial is unmarked bar all the dirt which will easily wash off. Given the state of the rest of the clock I am surprised the dial survived intact.*

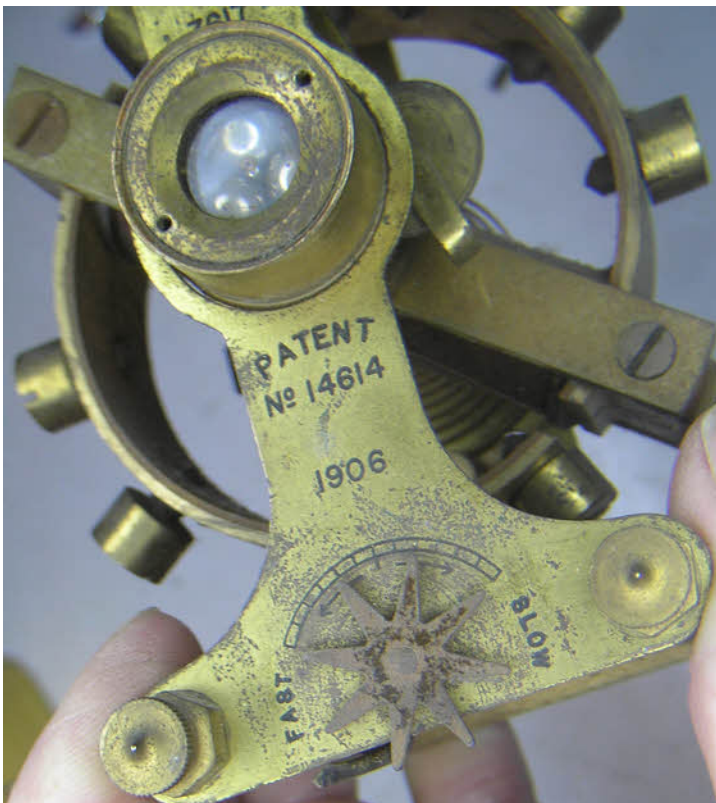
*The front bearing and registration plate.*

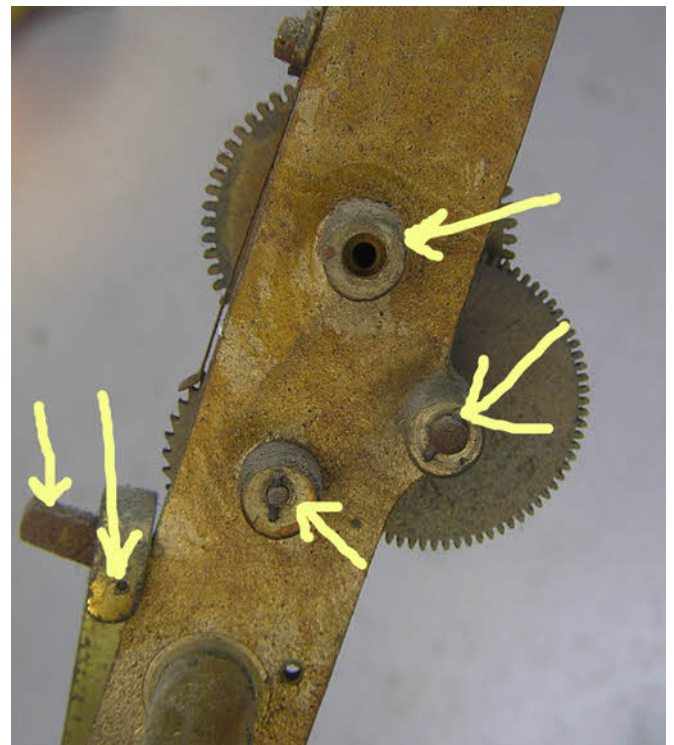
*All of the arbours and steel work are badly rusted and hard to remove.*

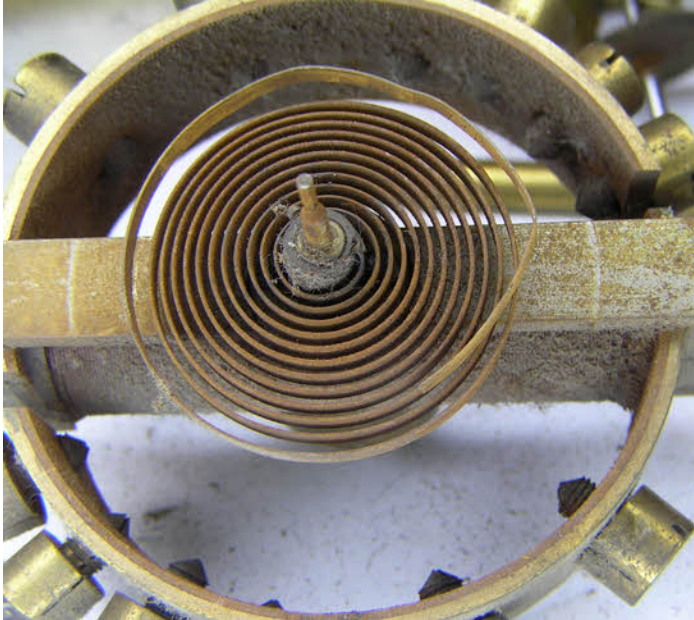
*The balance spring heavily rusted. This will take some cleaning. The rear pivot is also rusted.*

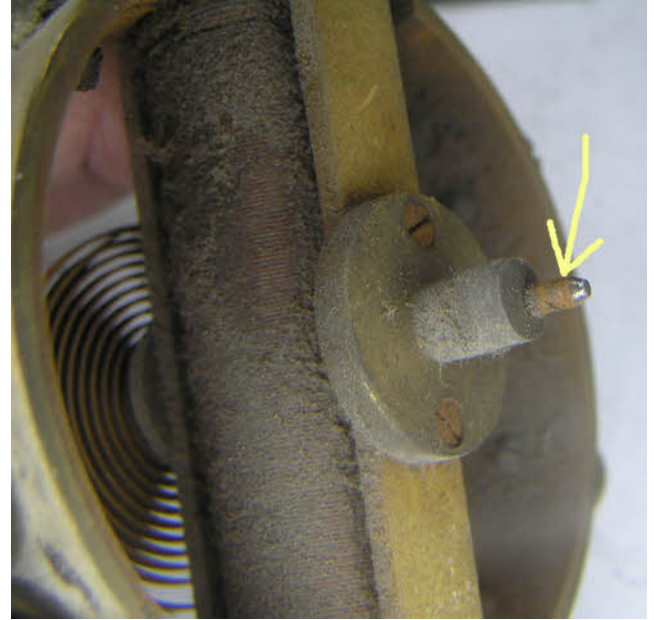
*The front pivot has been snapped off. It's a wonder the glass was still intact.*

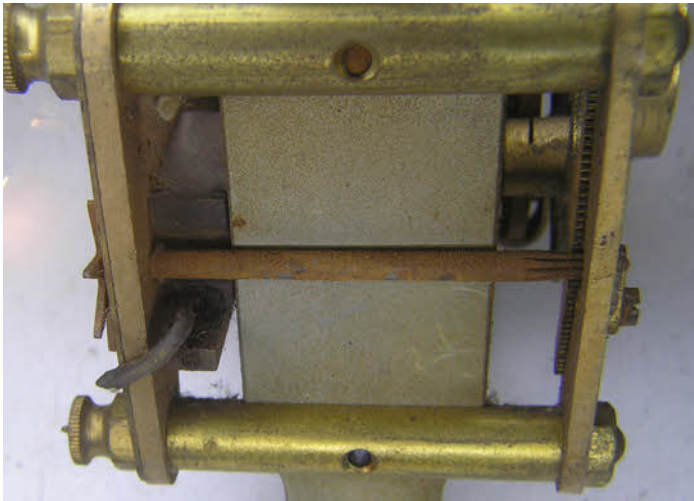
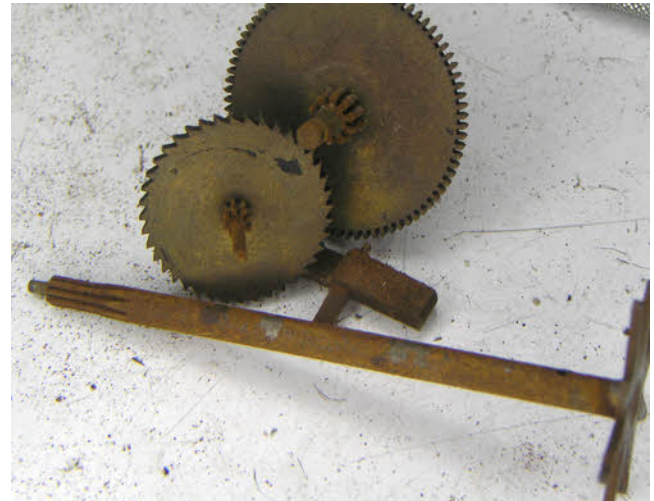
*The arbour carrying the star adjusting wheel also shows heavy rust. When I'd removed all the wheel work the extent of the damage was evident. Every piece of exposed steel was heavily rusted. All of the pivots and pinion teeth will need to be cleaned and re-polished. All of the screws will need the same treatment as well as bluing. If you take into consideration all the missing and damaged parts then this clock will require more work than I have put into any Eureka or Bulle clock in the last ten years. But I have to say that is also the most interesting!*

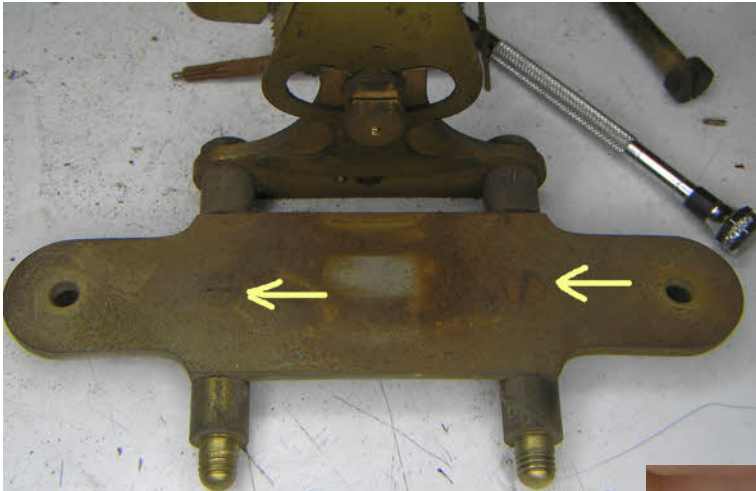
The two base plate screws were hidden in the rust.

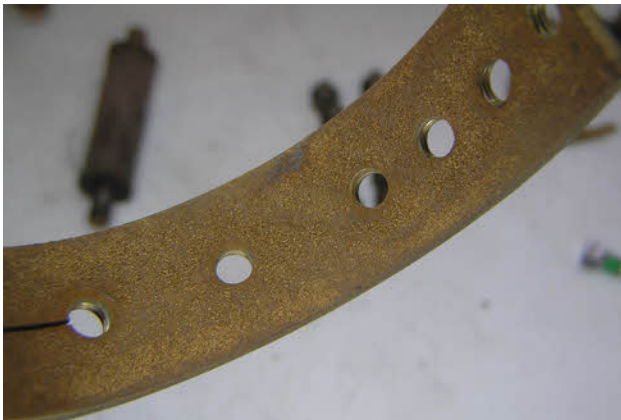
The steel of the bi-metal balance wheel did not escape the rust. It was so bad that deep pits showed up when the rust was removed. The steel was originally polished and then nickel plated but all of that nickel was now gone. There is not a lot one can do when steel gets in this condition other than to clean it as best one can and secure it from further damage with a coat of lacquer..

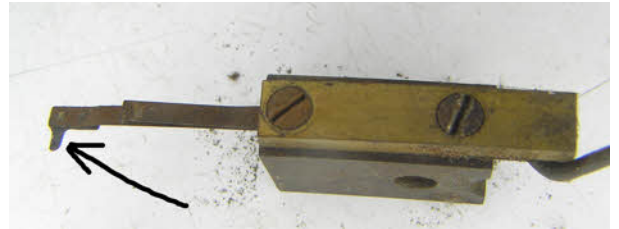
The contact pin had been worn down to a small point.

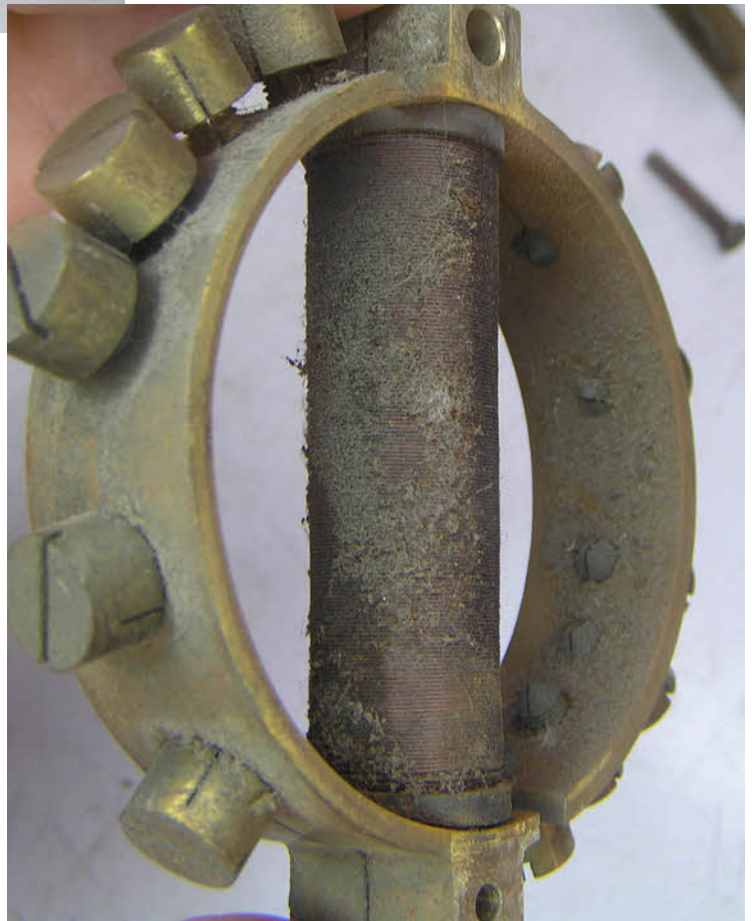
Although covered in dirt the coil proved to sound and reading a good 20 Ohms. When cleaned I took the opportunity to give it a coat of clear lacquer too.

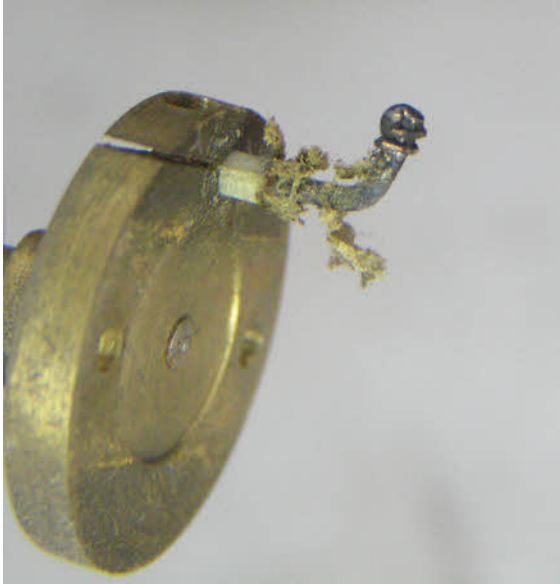
*The contact pin assembly had started to disintegrate.*

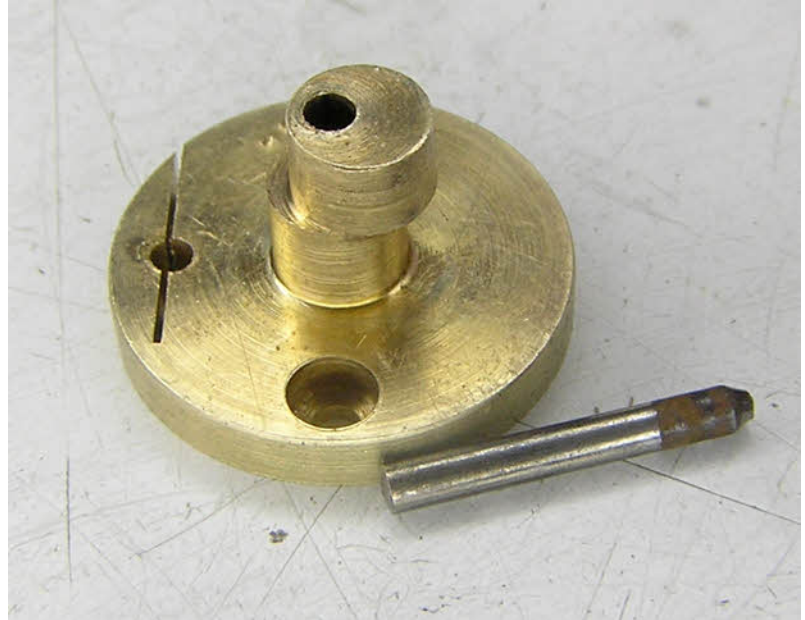
*The front pivot removed ready for replacement.*

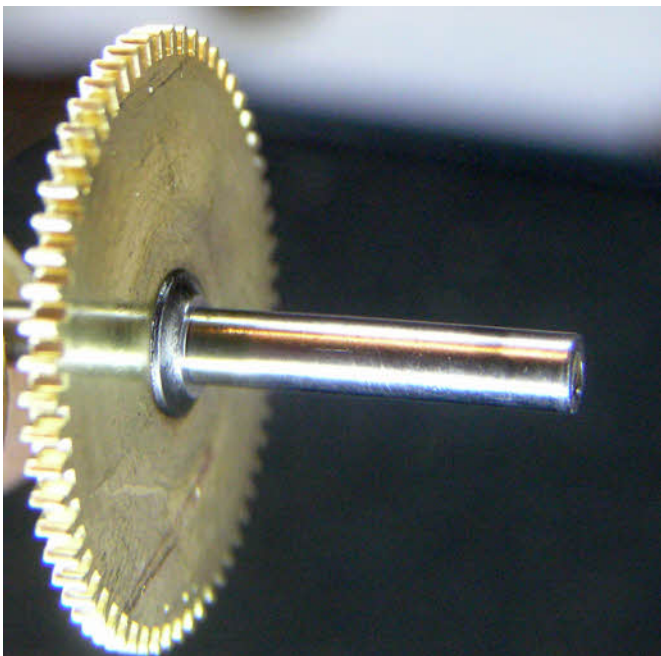
*Arbours cleaned and polished.*

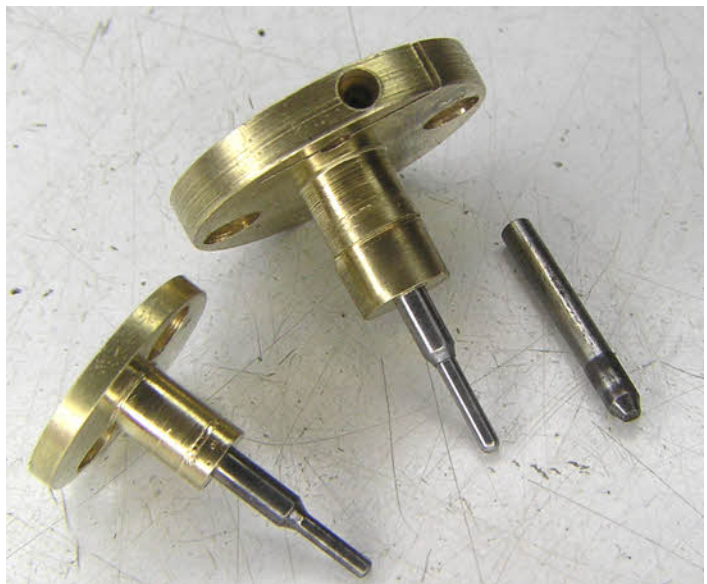
*New front pivot polished and in place.*

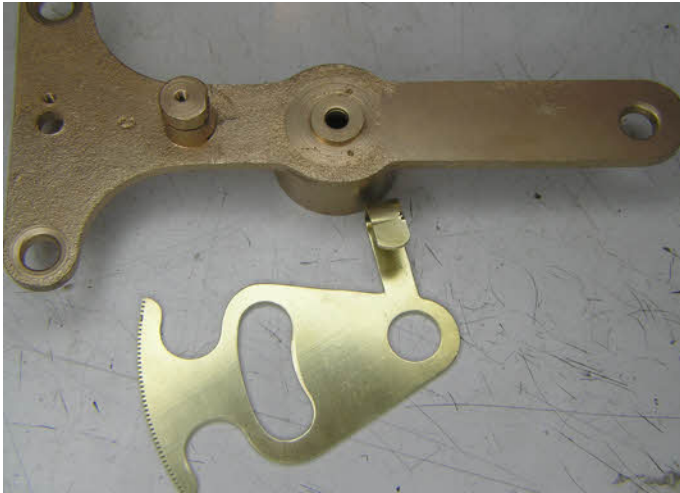
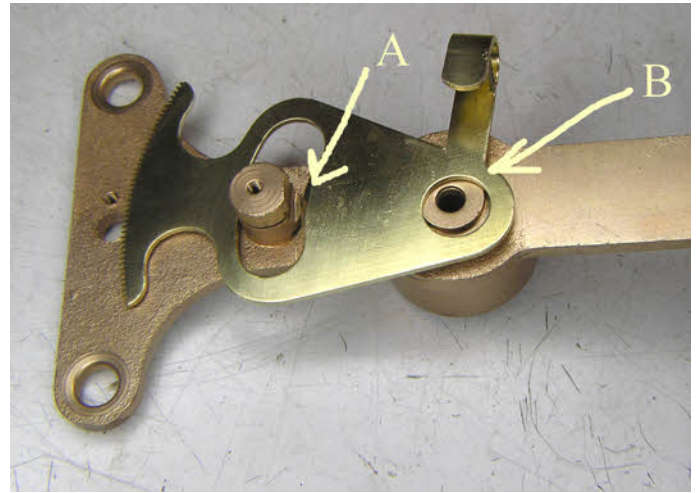
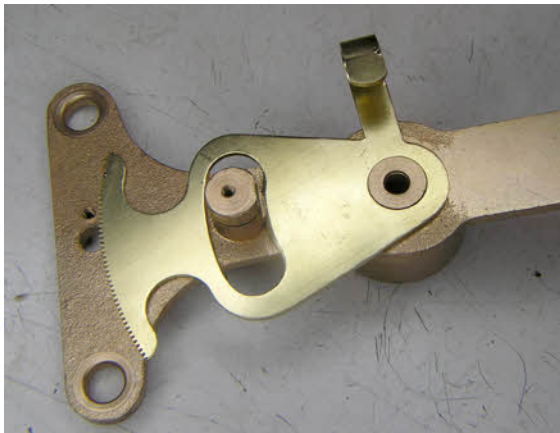
These two photos show how the regulator segment is secured to the frame. It is first roughly set in position with the hole at (B) ready to be slipped over the protrusion at the rear of the bearing. But it will be found that it cannot slip directly over the protrusion until the slot at (A) is pushed down and into the slot cut into the side of the round pillar that holds the spring securing screw. The photo below left shows the segment in position. It should be a snug fit with an easy sliding action.

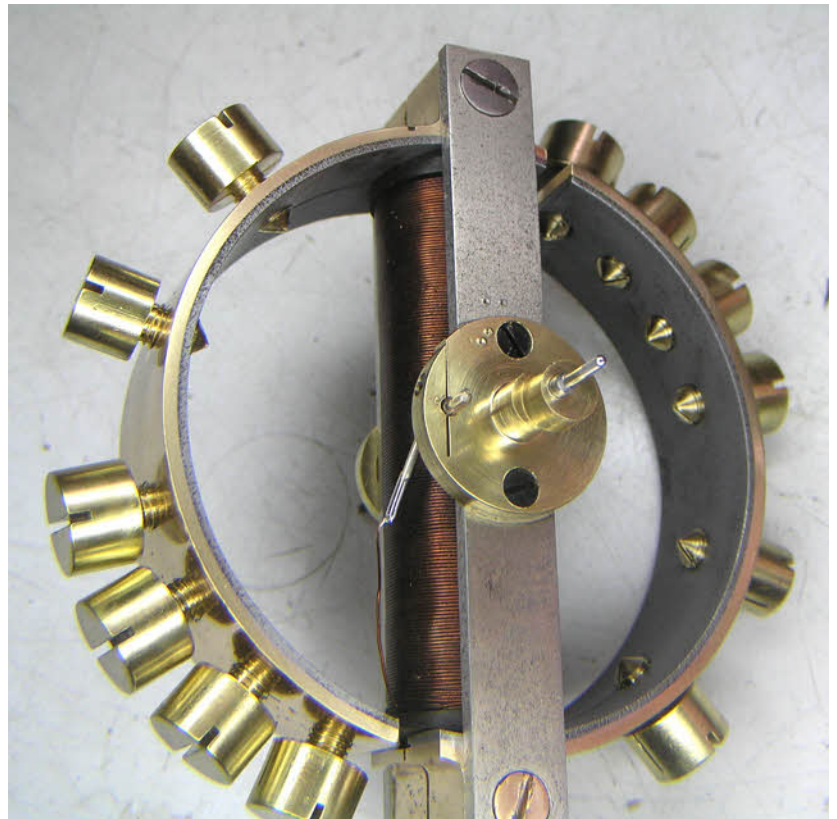
The photo on the right shows the restored balance wheel with steel of the balance cleaned and lacquered. The pivot has been polished and the screws blued.

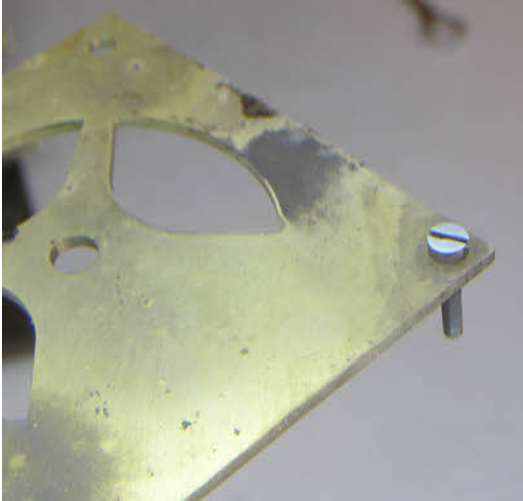
*I use a scrap of old brass to hold cleaned and polished screws. A heat source such as a heat gun is then played on the brass near the screw until the screw starts to turn the required shade of blue.*

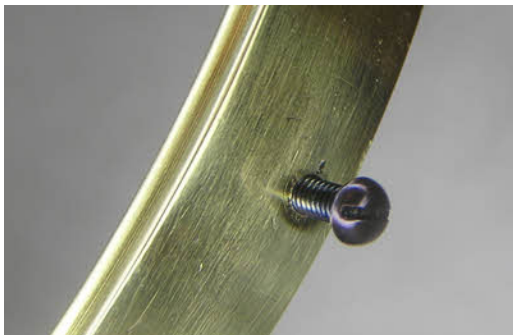
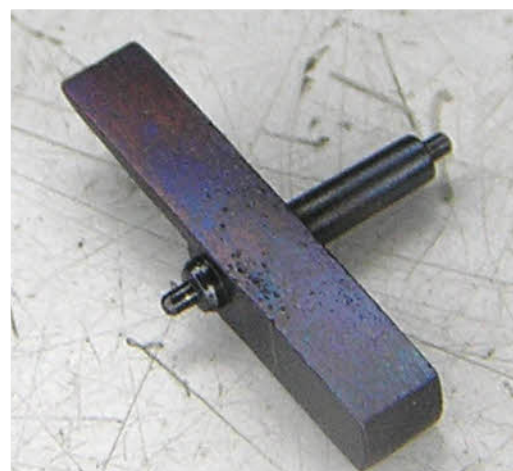
*Above can be seen the motion work back in place with the new count wheel click spring which replaces the original which was rusted and holed through. It is made from 0.004" spring steel. The photo above and left shows one of the dial retaining screws which had to be polished and blued.*

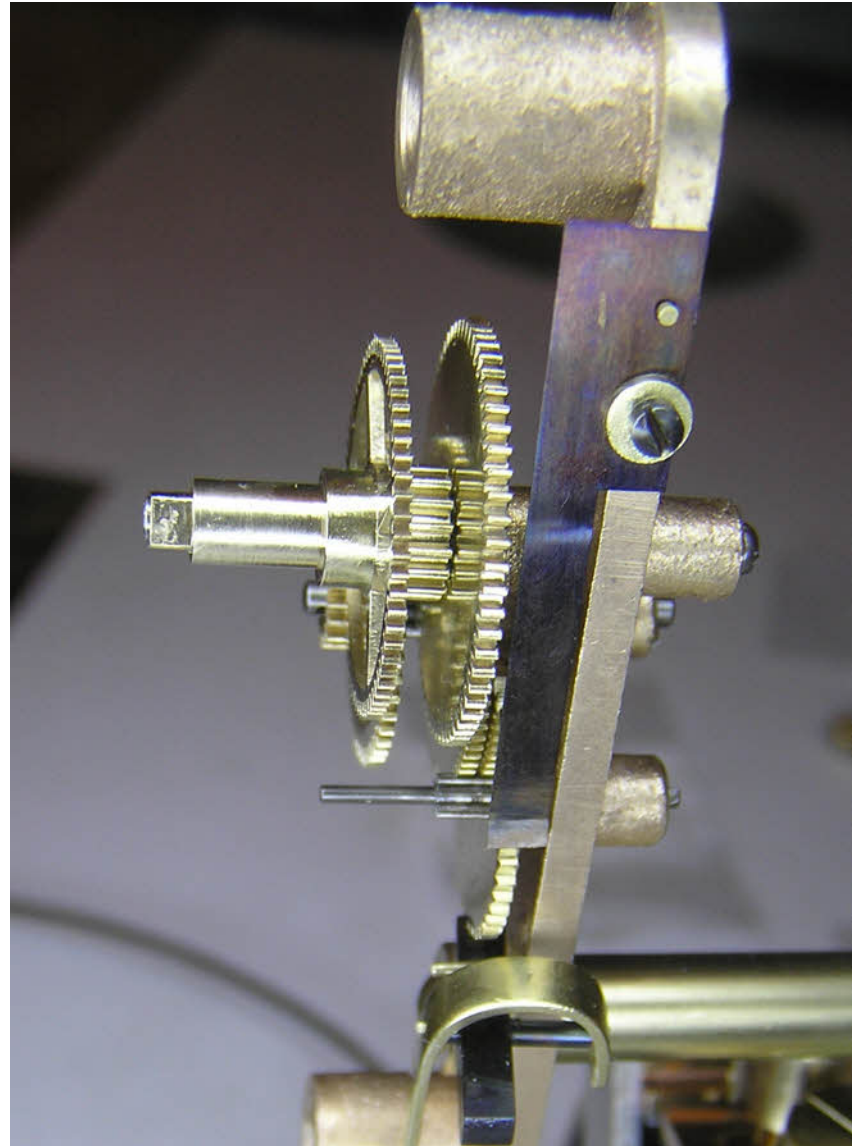
*The final photo is the hardened steel gathering pallet. Although the actual gathering face has been polished to remove pitting, the body of the pallet has only been cleaned and blued leaving the pits in situ. To polish them out would have left the pallet much thinner and too light for its purpose.*

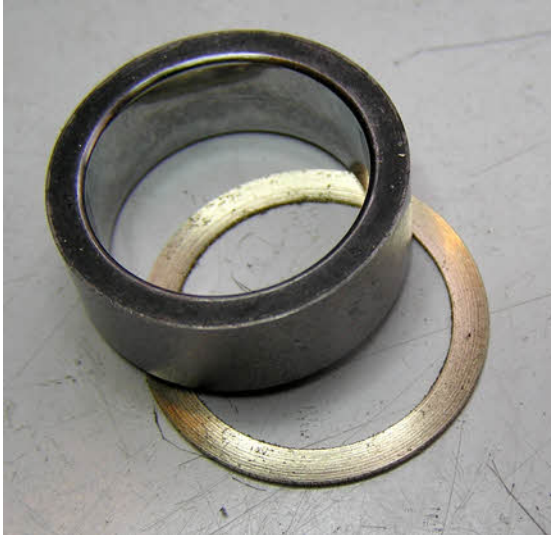
On re-assembly it was found that on one side, the ball bearings stood proud of the bearing sleeve (ballrace) and fouled the glass. I've never seen this before. But I had to polish the balls to get rid of the rust, so it may be that they are that much smaller. So I turned a thin brass washer about 0.2mm thick and placed this in the housing before the sleeve. This was enough to give the balls room to roll even when the lock washer was turned down tight. There are paper washers in the assembly but these are placed between the lock washer and glass.

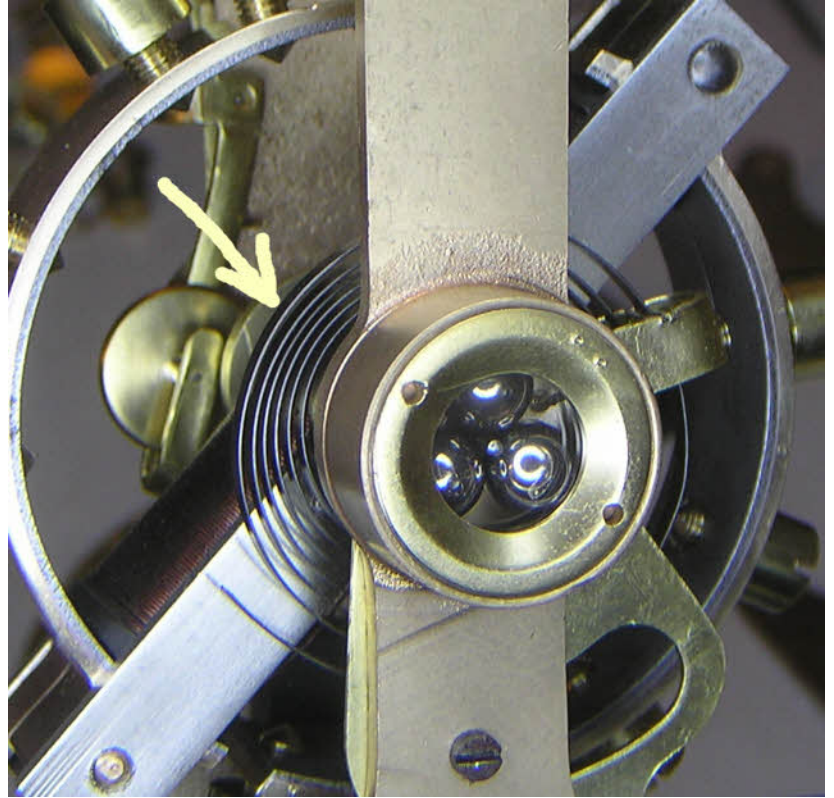
A photo showing the rear bearing housing with polished balls and new glass. It also shows the cleaned and polished balance spring. This spring took many hours to straighten, clean and polish. But it still remains very pitted and slightly misshaped. It must have been put under a lot of stress.

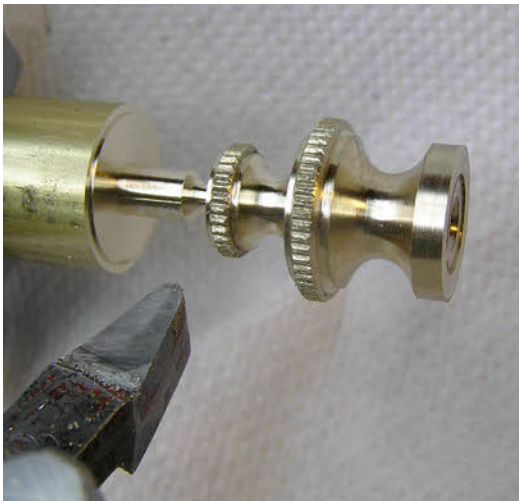
The photo at left shows the final stage in machining one of the two decorative finials that act as nuts to the screws holding the frame to the case. I also machined the two supporting pillars as can be seen on the following pages.

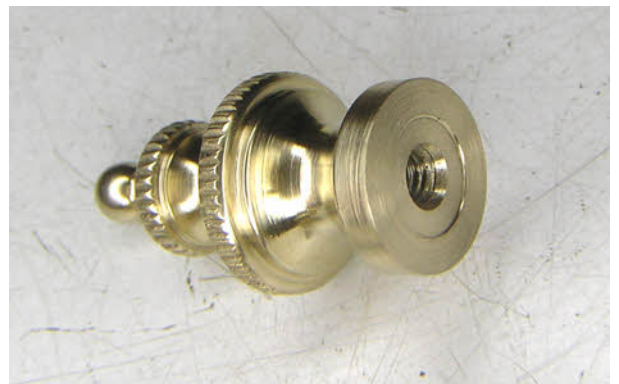
A finished finial. The base is undercut to make sure it sits straight. It is threaded 2BA to accept the original screws.

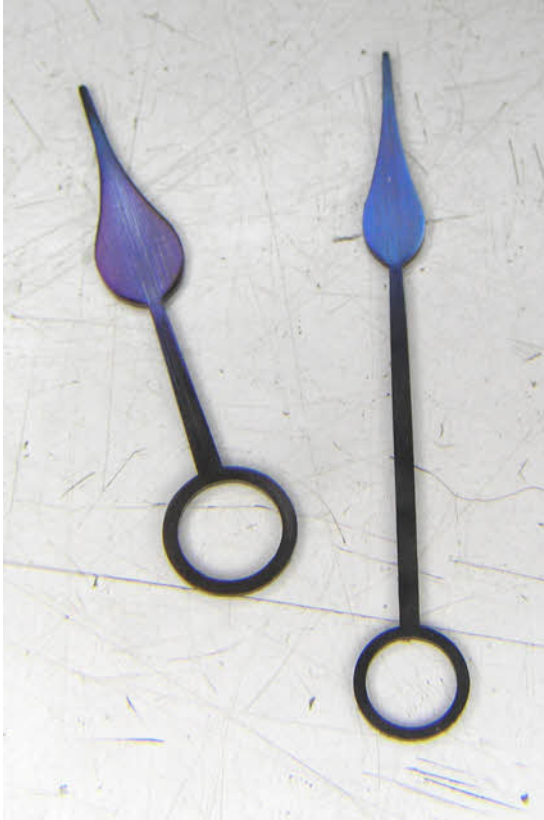
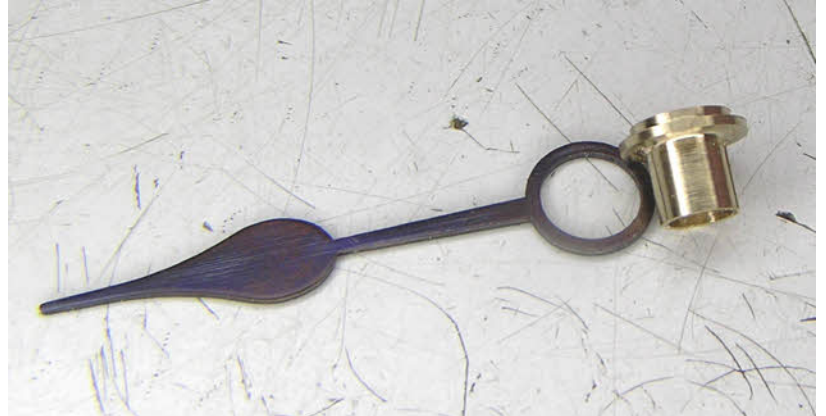
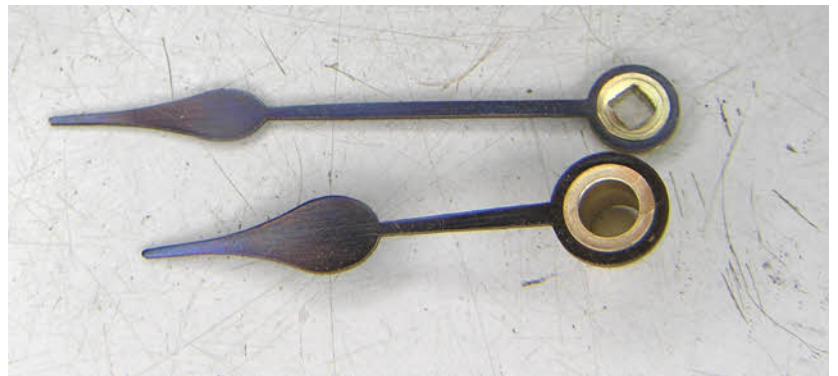
*The only hand left on the clock was the hour hand which again was badly pitted with rust. So I made a new pair from spring steel to the original design and then made a new set of collets to match the existing wheel work. The hands were blued before securing to the collets.*

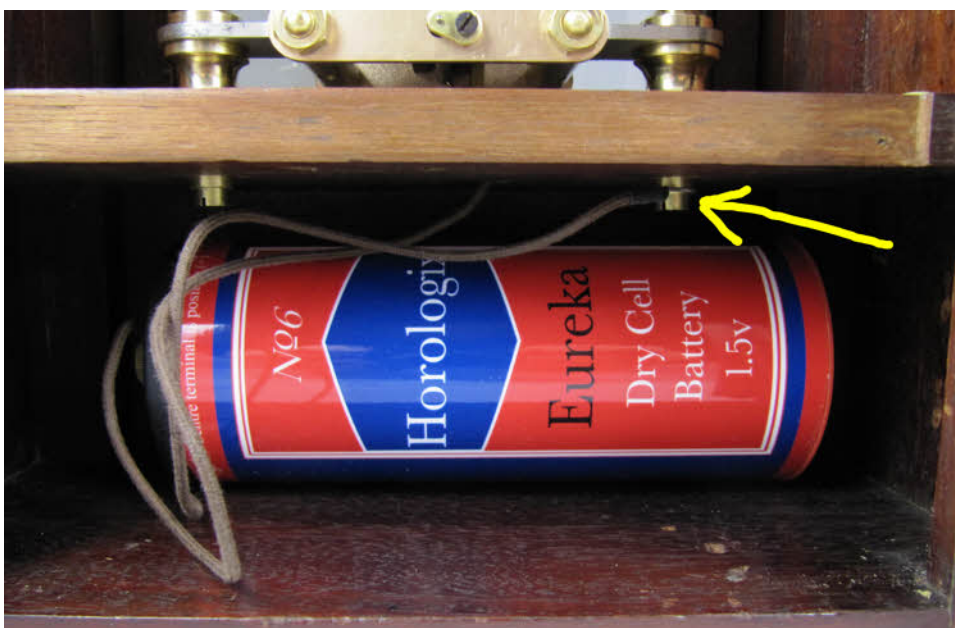
*Here we see the 1.5v flag cell battery case (EU005) in place in the special compartment underneath the movement. The negative side of the battery is connected to the frame via the screw arrowed.*

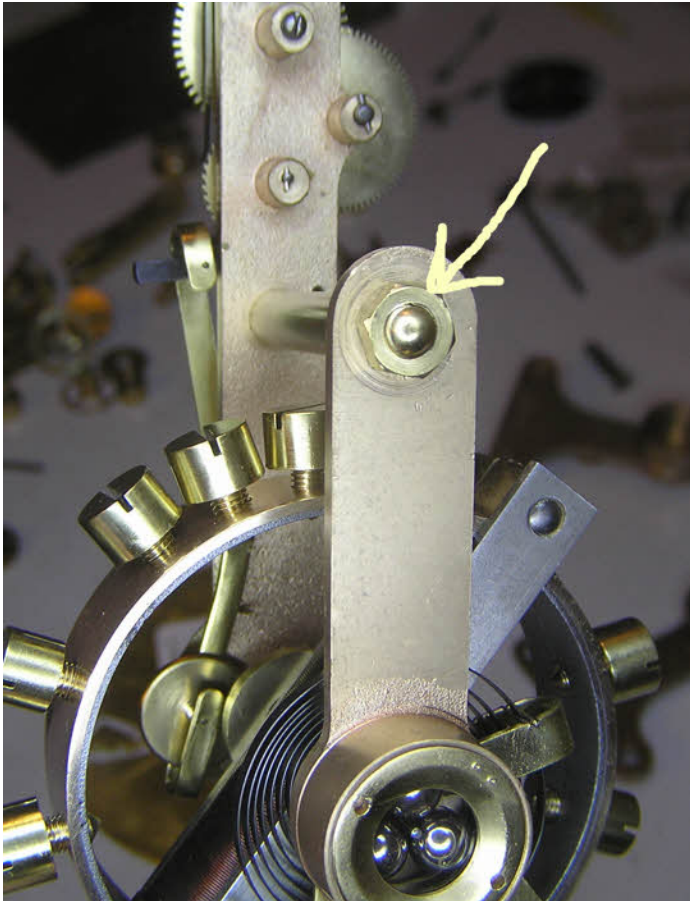
*The final missing part was the frame nut which has now been replaced.*

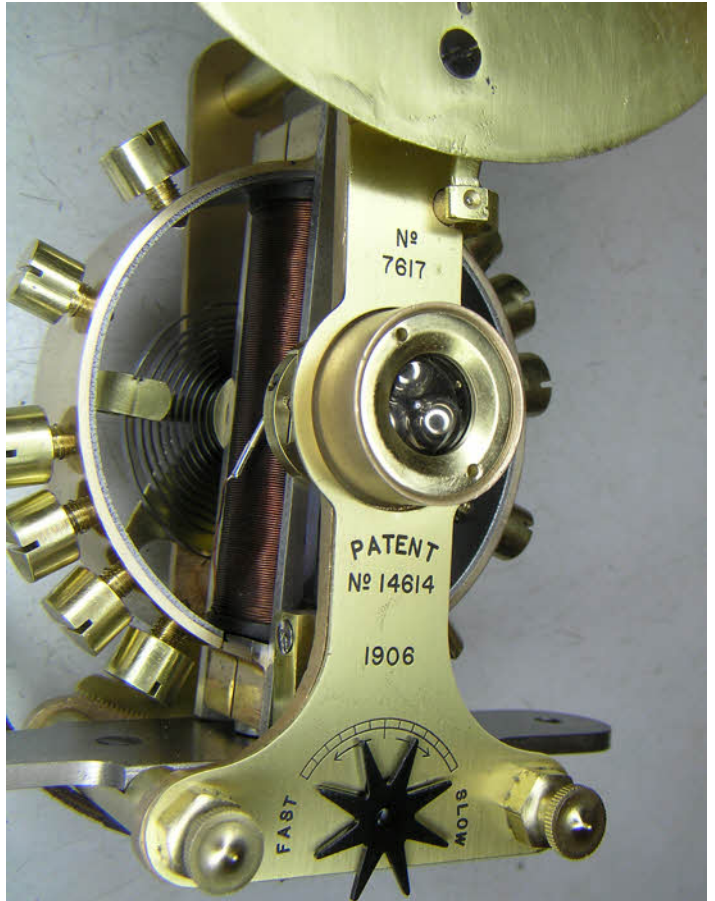
*The front of the restored clock showing the registration plate which has been cleaned with the engraving re-filled with wax and the whole then lacquered.*
