**Eureka Clock Serial Number 7617**

*Restoration of Eureka  
Clock Serial Number 7617*

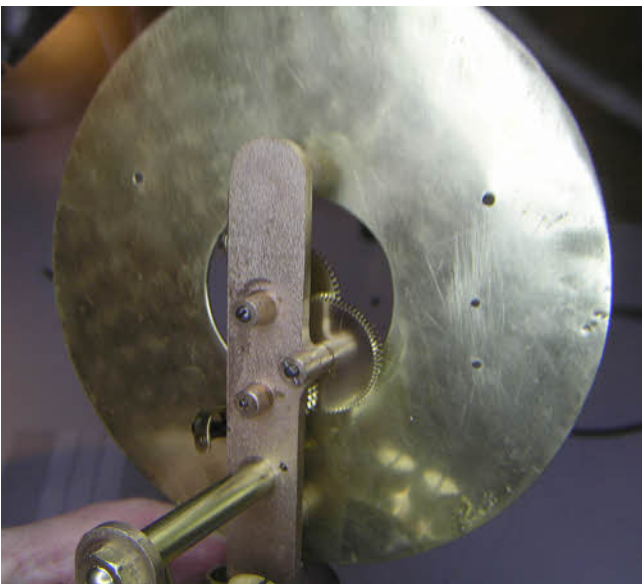
*The front of the restored clock showing the registration plate which has been cleaned with the engraving re-filled with wax and the whole then lacquered.*

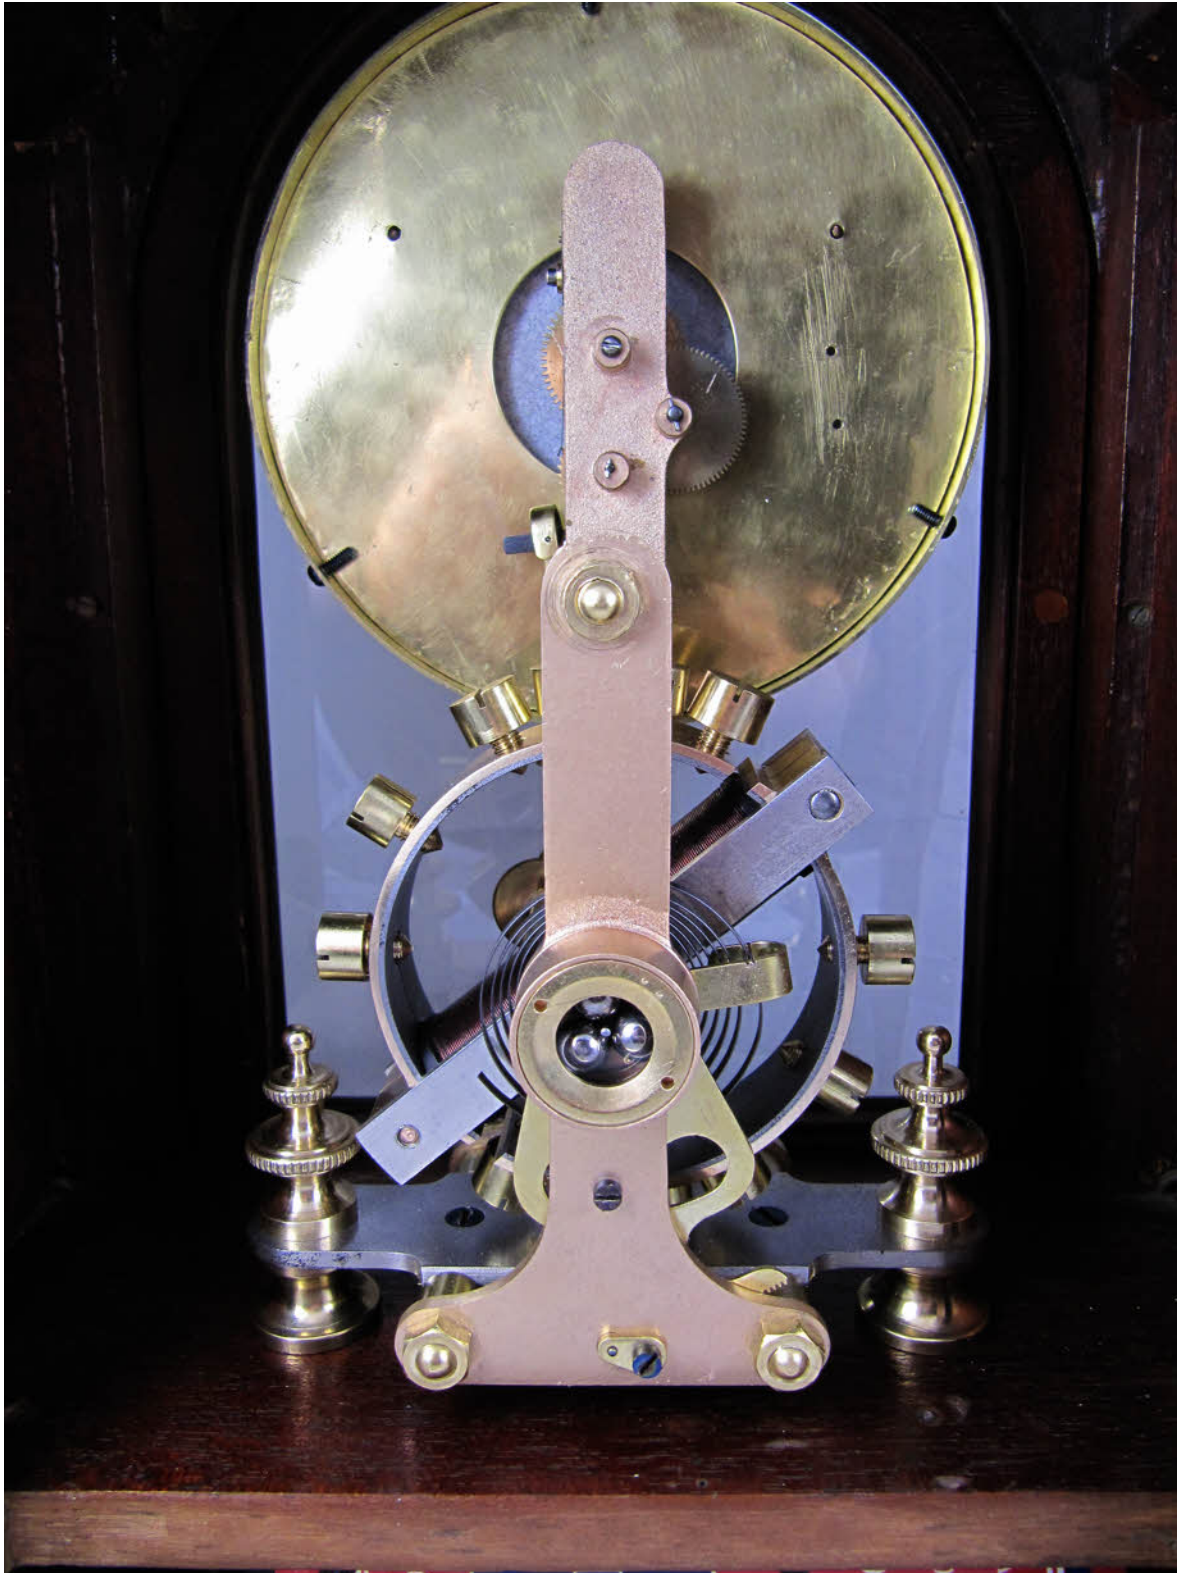
*The rear of the finished clock with the new pillars and finials. Hopefully these would not be distinguishable from the originals.*

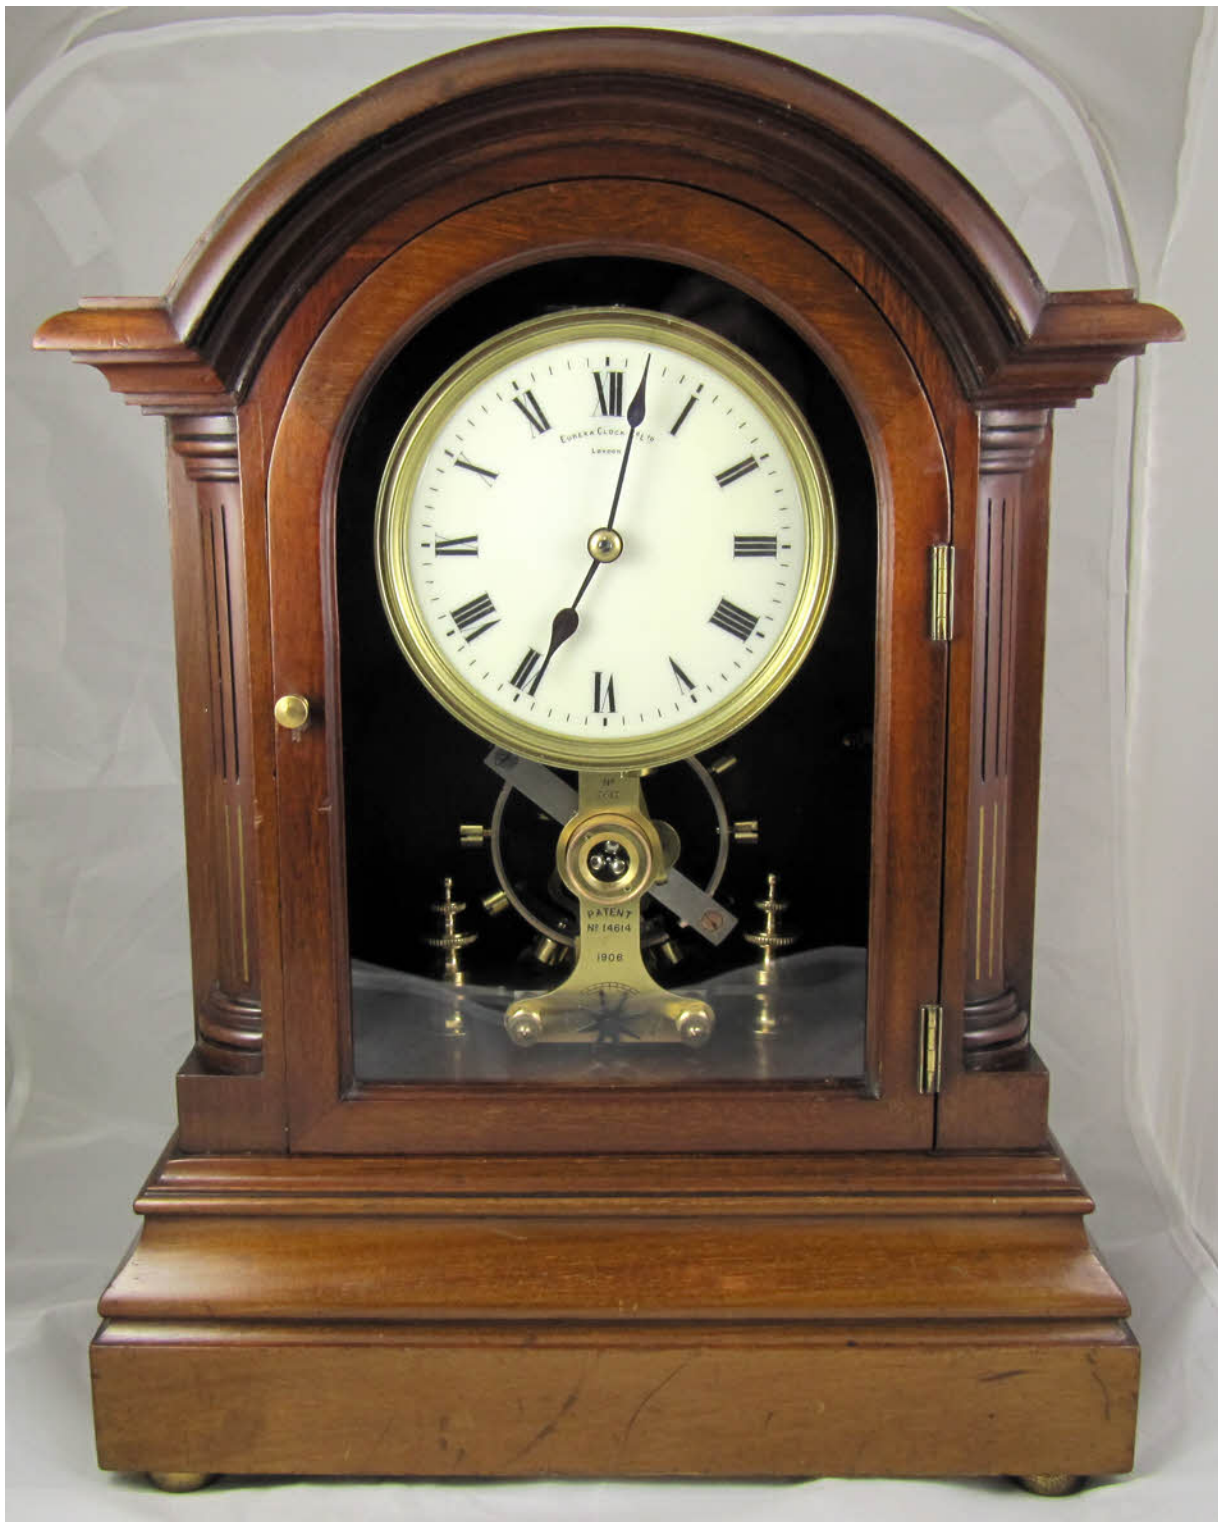
*The finished clock.*
