**Eureka Clock Serial Number 8256.**

## Eureka Clock Serial Number 8256.

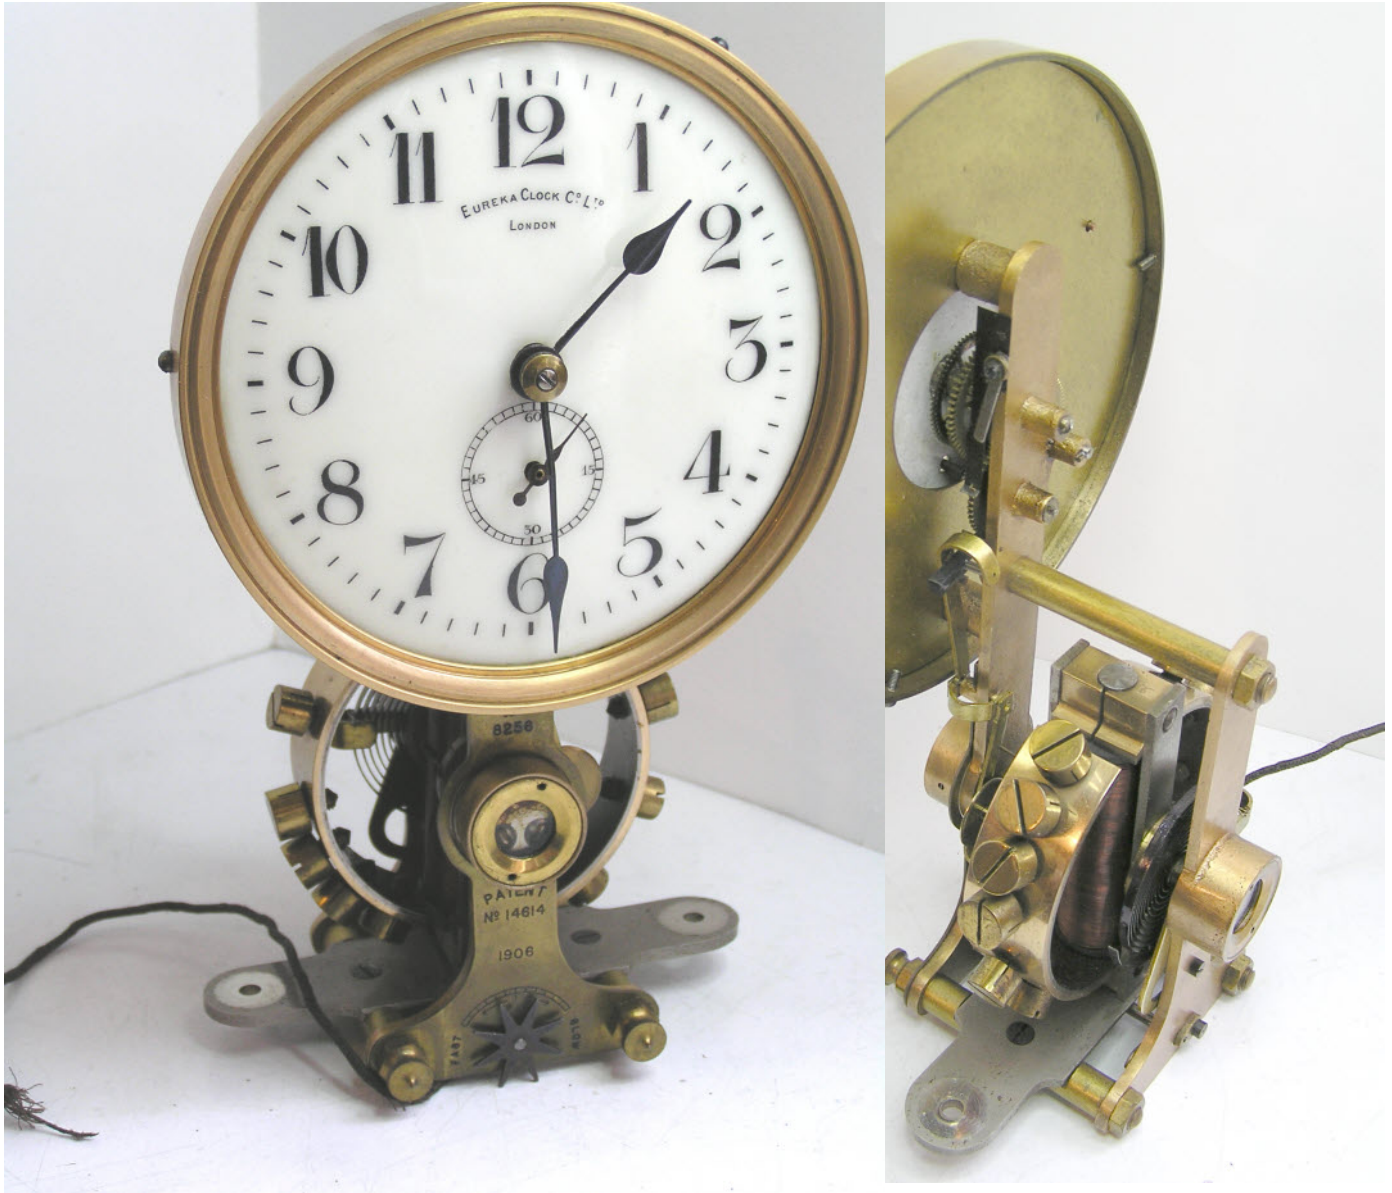
*The movement as delivered without case. This tall movement seems to be in excellent all round condition with any wear limited to the contact set and return spring. It is a two ball movement with a second hand. The bezel though was very loose because the retaining screws were not catching the back of the dial plate with sufficient friction. This may be a replacement bezel. But either way it is simple enough to correct by adjusting the dial to sit further out from the dial plate and closer to the bezel..*

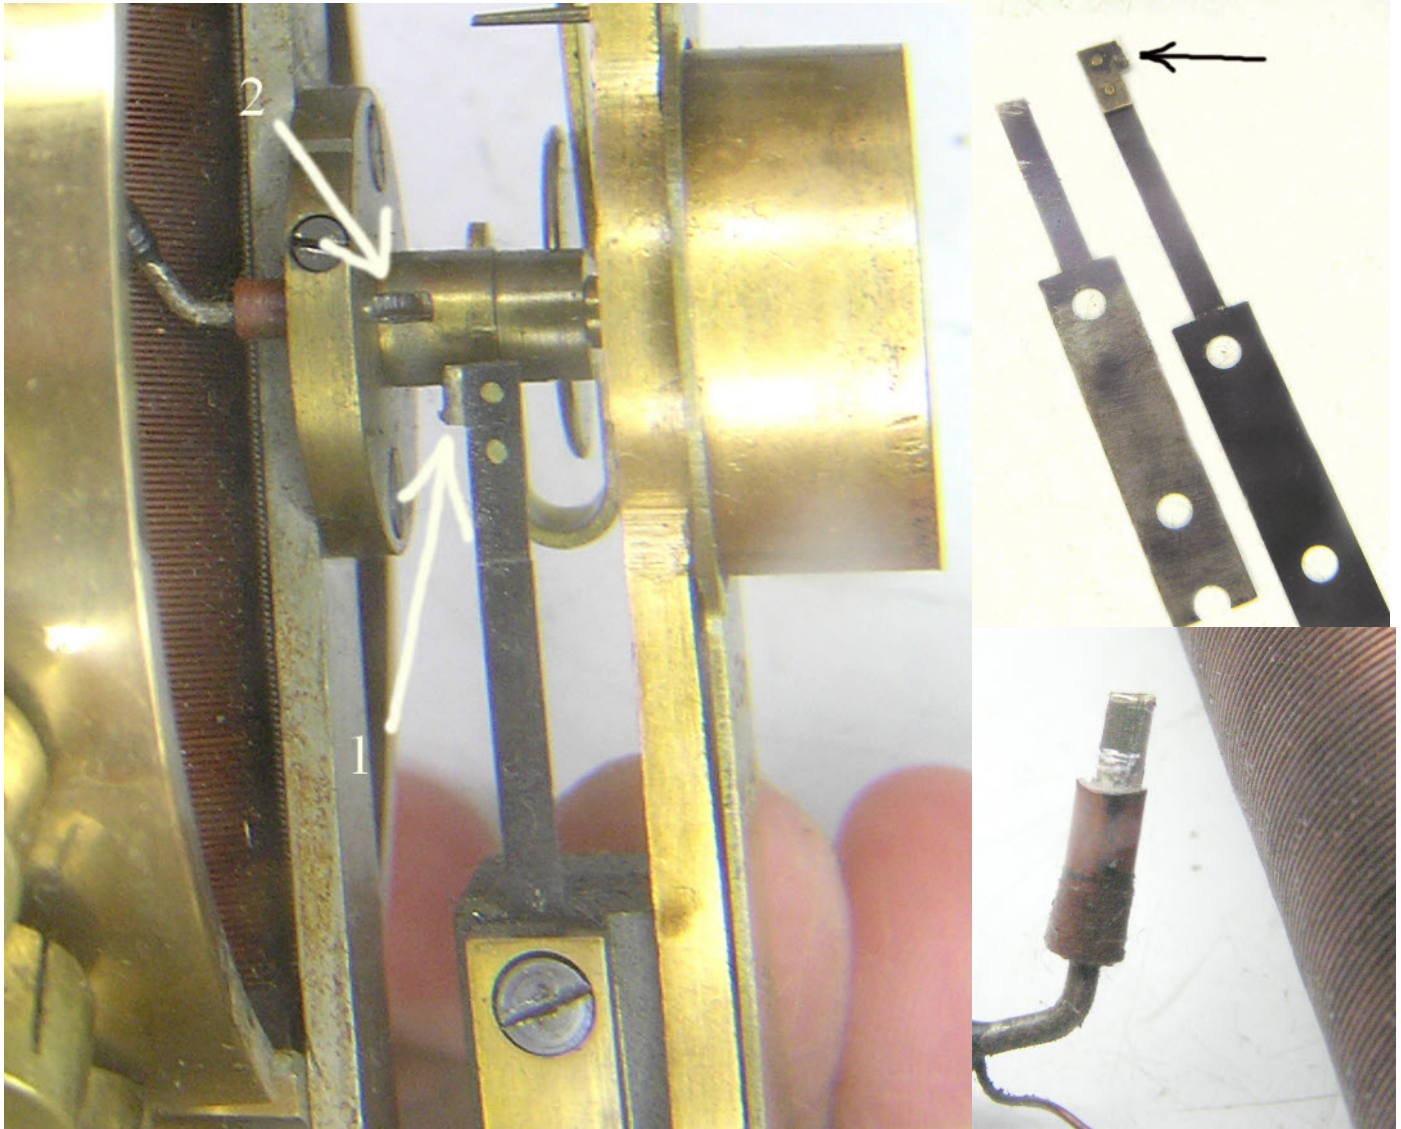
*As can be seen here, there is catastrophic wear to the contact flag. In fact it is completely worn away. The contact pin (2) has not fared much better and will need to be replaced. The flag is a small piece of silver riveted to a 0.004" piece of spring steel. It is reinforced on the one side by the addition of a buffer spring in the same material. This spring increases the pressure the silver side of the flag exerts on the pin when the wheel is revolving in a the clock wise direction.. There should be approx 3mm of flag protruding to make contact with the pin..*

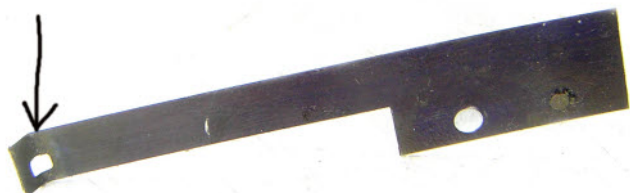
*This photo at left shows the wear in the count wheel return spring. It's function is simply to capture the count wheel once it has been impulsed one tooth forward by the gathering pawl. It has worn clear through and will be replaced from one cut from 0.004" spring steel. It only takes a sharp pair of scissors and hole punch.*

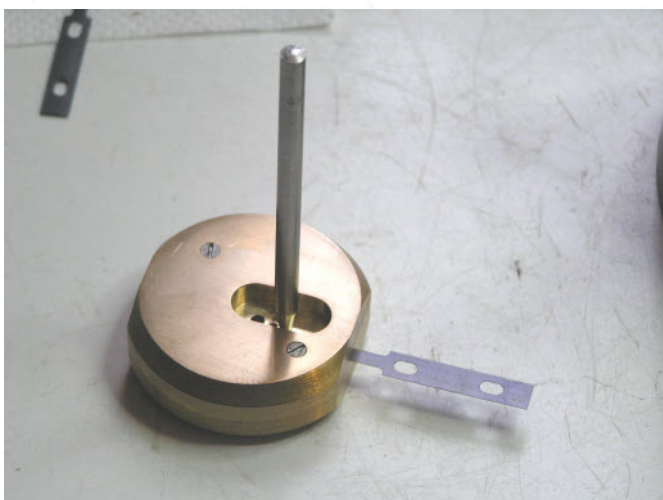
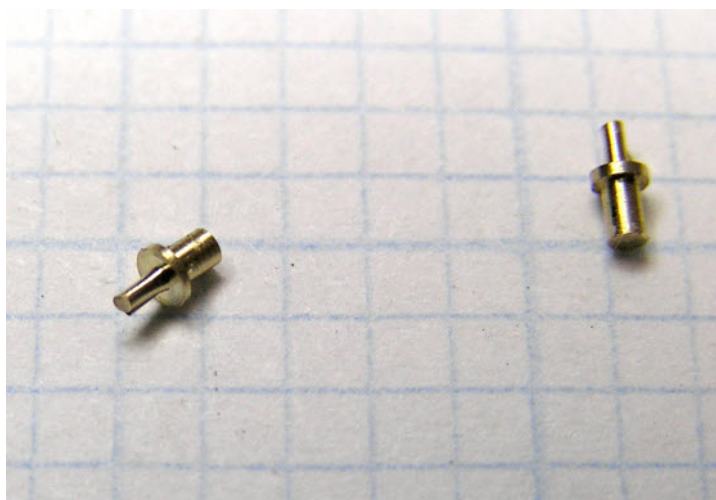
*The two photos above and below show the jig I use to punch the contact spring ready to accept the rivets and silver flag.*

*Above are embryo rivets after turning on the lathe. The heads are 1.6 mm diameter while the body is 1.00 mm. The stub left by the parting tool needs to be filed away. The photo below shows the rivets held in a pin vice ready for filing..*

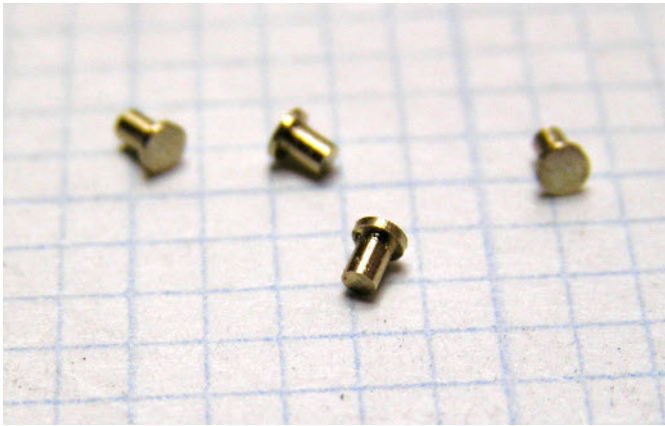
*The rivets after filing. They are now ready to be fitted.*

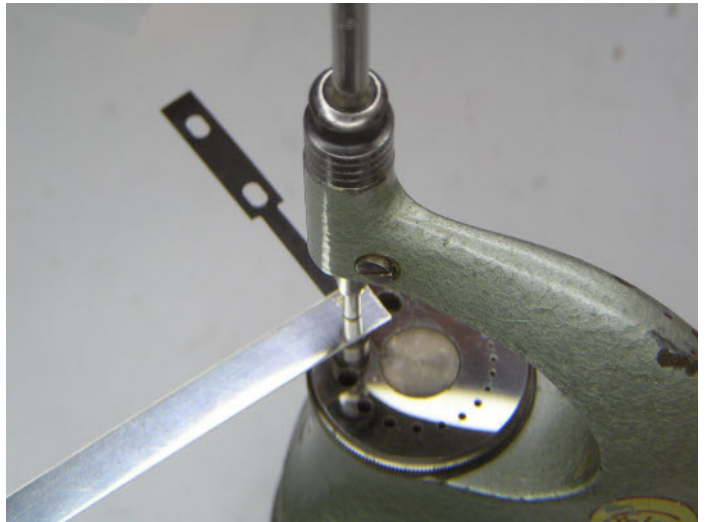
*The Parts being riveted together in the stake. The photo below shows the flag spring immediately after riveting The second flag shows the situation after being roughly trimmed to shape ready for chamfering the edges with a needle file.*

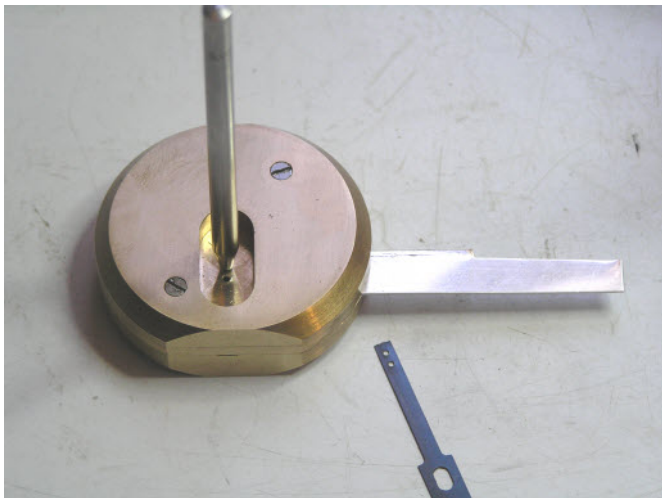
*The silver strip in the same jig ready to have the holes punched through for the rivets. I made the jig so that both spring and silver would be in perfect alignment for the rivets.*

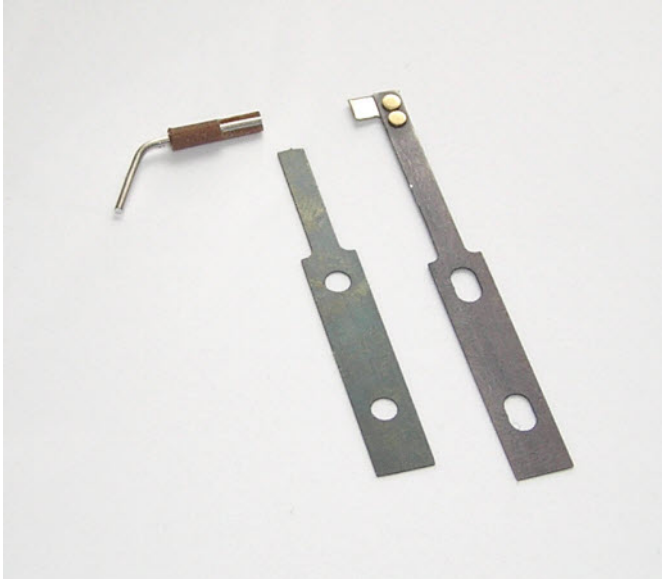
The photo above shows the completed contact set. The Tufnol sleeve of the contact pin can be turned to suite the hole in the Eureka plate. This varies in diameter from 2.00mm (shown) to 3.00 mm. Half the diameter of Tufnol is filed away to leave the silver pin exposed on one side.

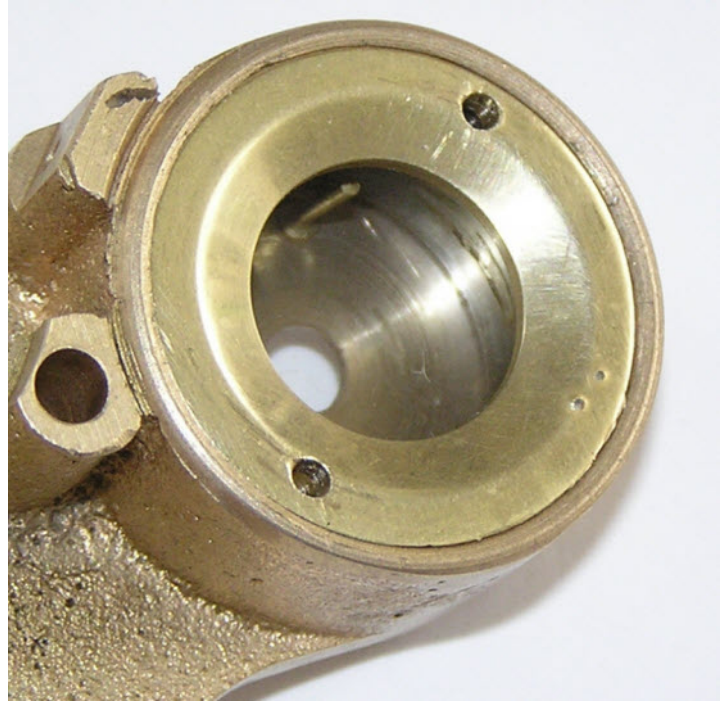
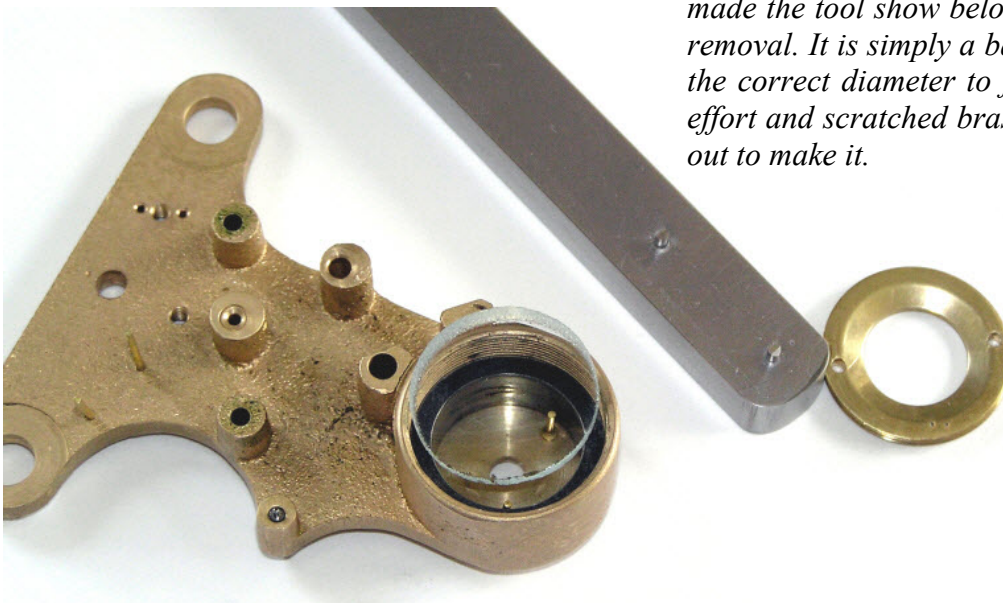
The threaded retaining ring that secures the bearings and glass can be a bit of a b\*\*\*er to remove so I have made the tool show below which greatly facilitates its removal. It is simply a bar with two chamfered pins at the correct diameter to fit the holes. It saves a lot of effort and scratched brass. Well worth taking the time out to make it.

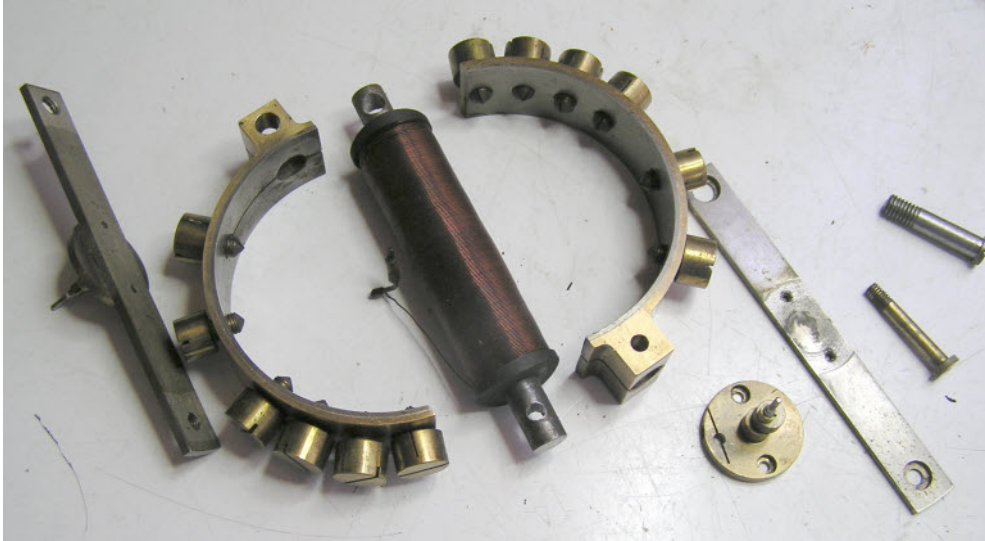
The components of the balance wheel ready for removing and numbering the poise screws. These screws can be very different in their weight and must be replaced exactly the same position.. You will find the inside of the screw will be relieved to varying levels. Check the coil at this stage and make sure that it reads 20 ohms give or take 2 ohms.

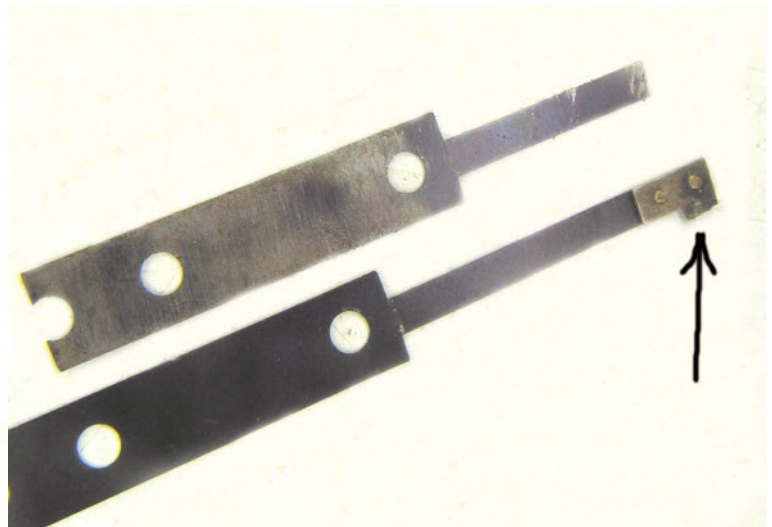
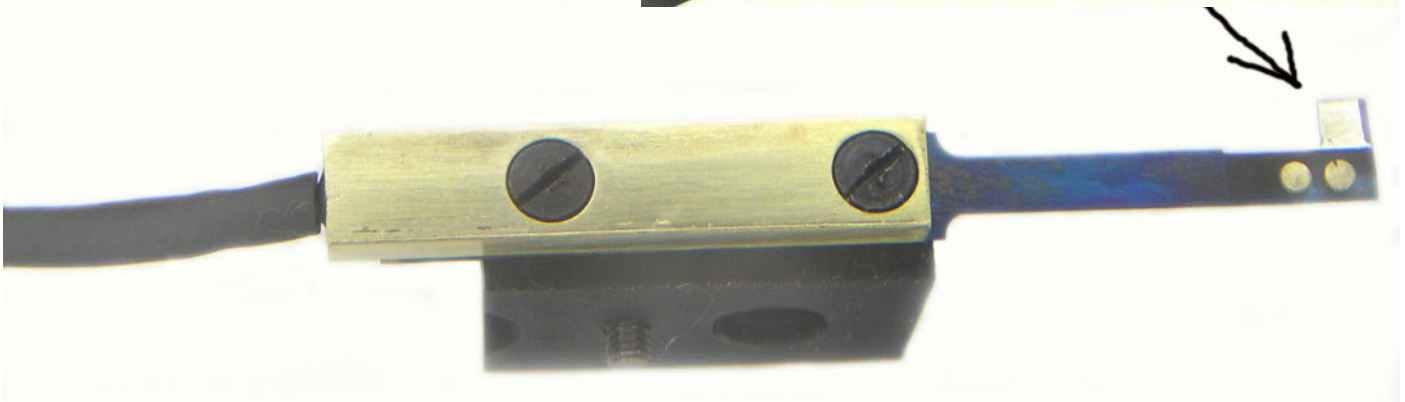
The photos at right and below show the worn flag and the new replacement. The flag has two chamfers which facilitate the pin sliding past the silver pin on the clockwise swing and the Tufnol insulator on the anti-clockwise swing.

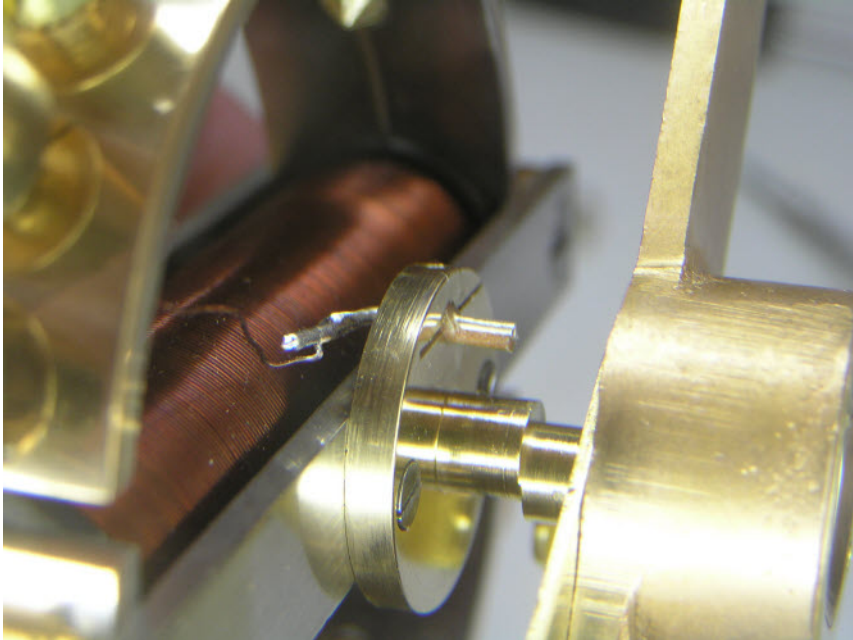
*The contact pin in position on the balance wheel. It must be positioned such that it present the silver contact pin to the flag on the clockwise swing and the Tufnol insulator on the reverse swing. The chamfers on the contact flag will*

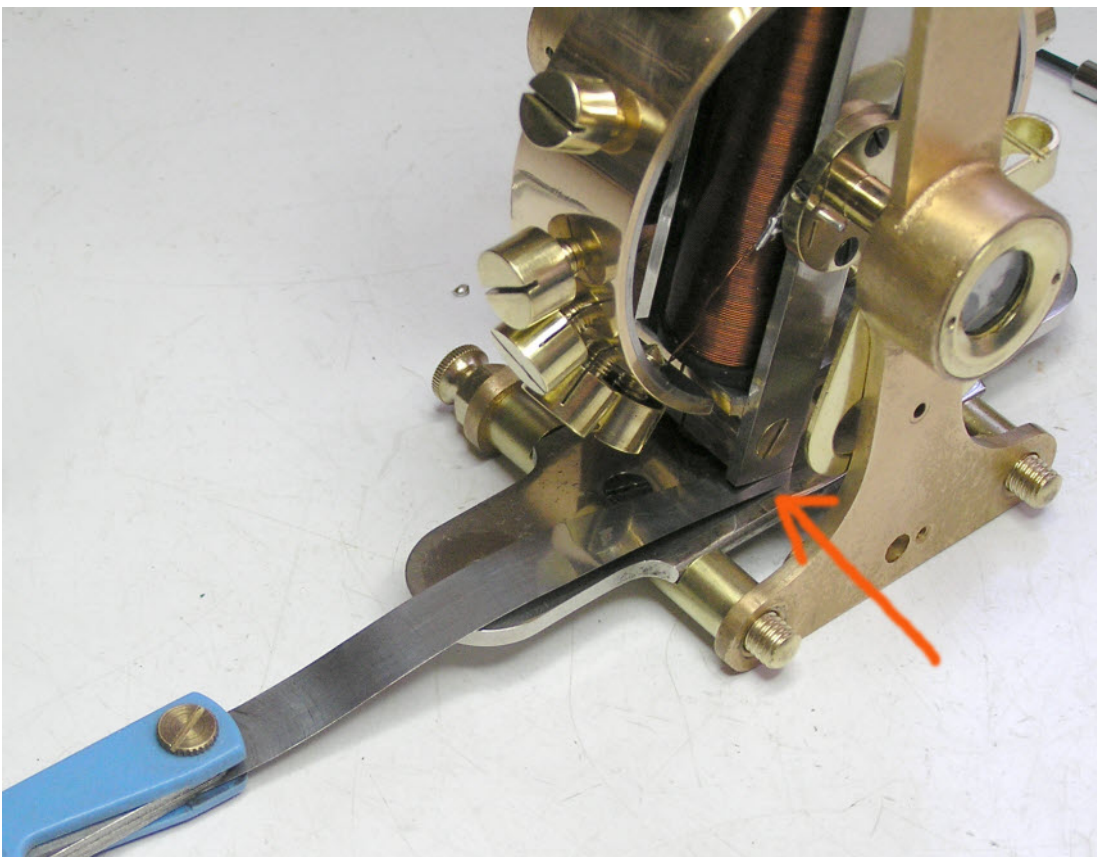
*The solenoid within the balance wheel must have a minimal gap between it and the steel base plate when in the vertical position. To help get this gap correct a number of shims can be positioned under the plate to lift it towards the solenoid. Use a feeler gauge to estimate the shim size required..*

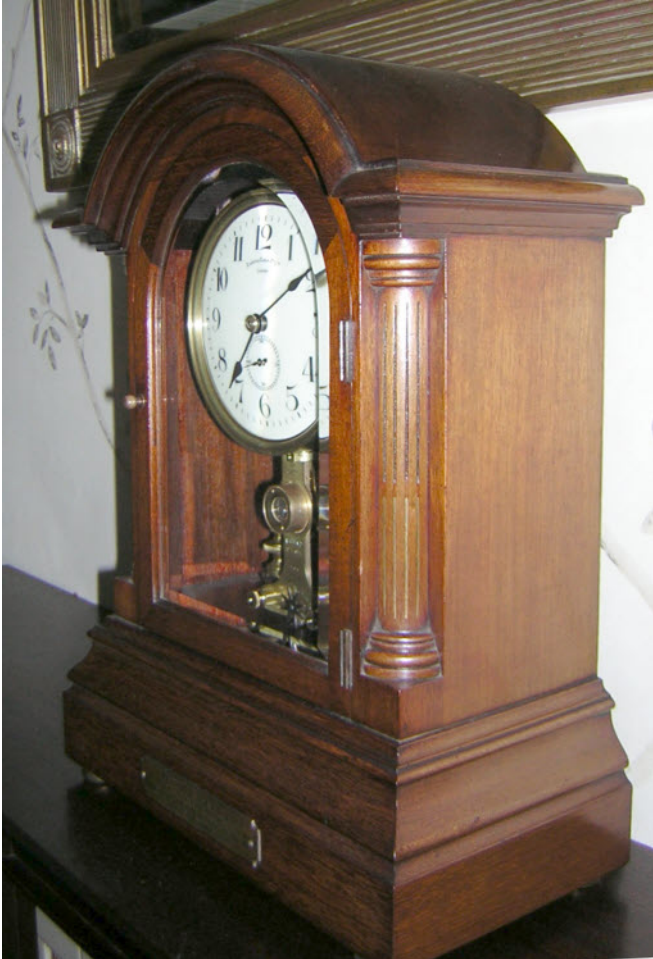
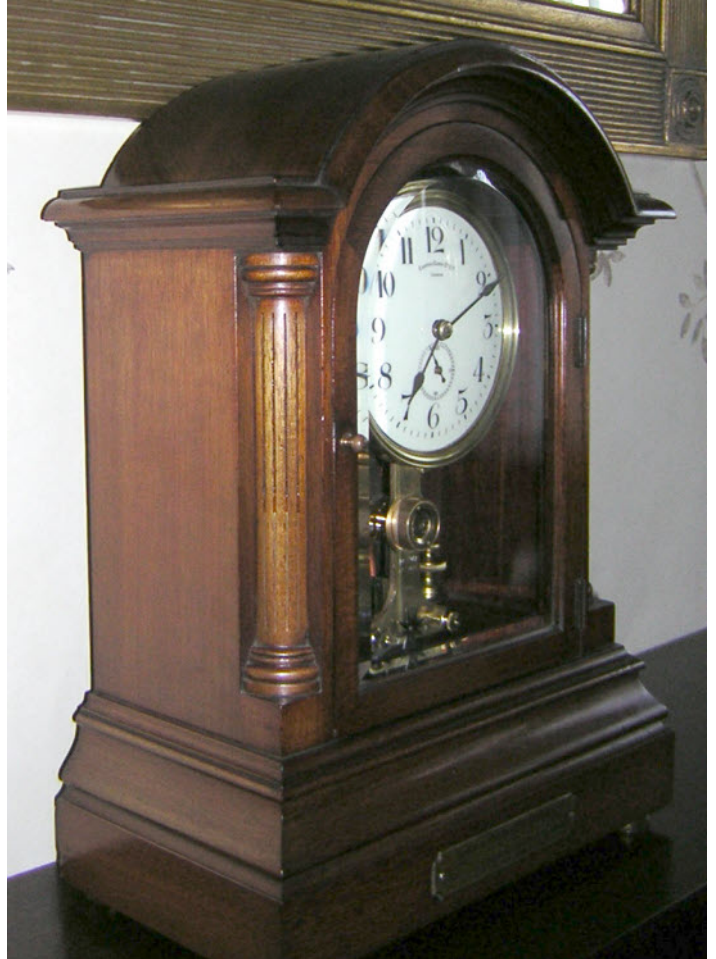
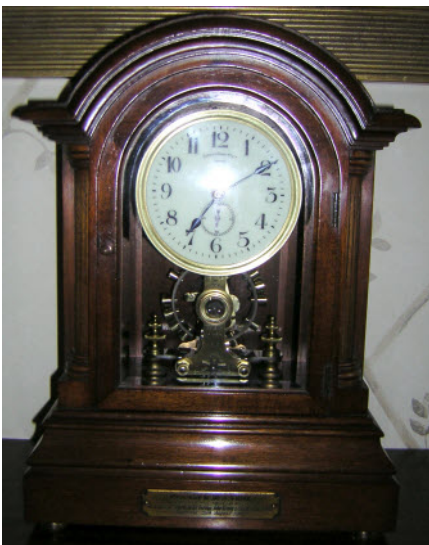
***The finished clock.***

*Photos supplied by the client. The movement has been fitted back into the restored case and these photos supplied by the client show the finished clock. The presentation plaque is a good dating aid and reads:-*
