Eureka Clock Serial Number 8419

*Restoration of Eureka
Clock Serial Number 8419*

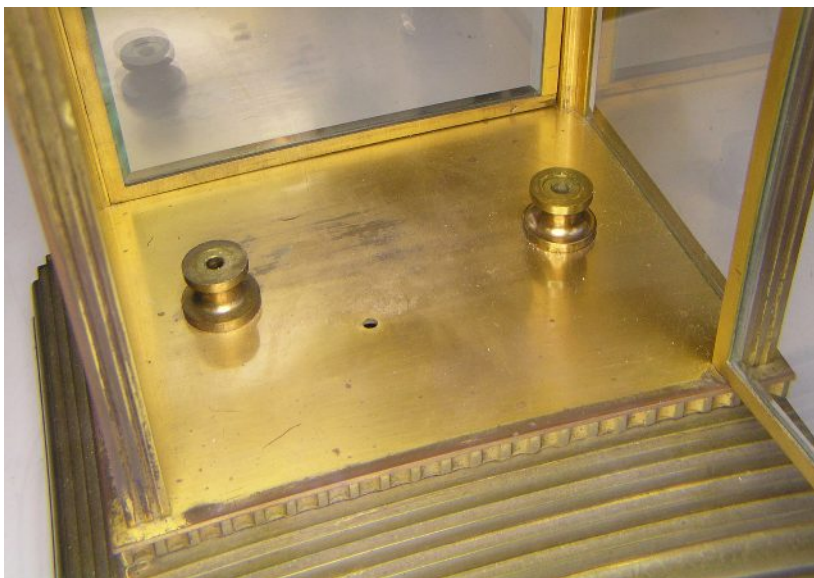
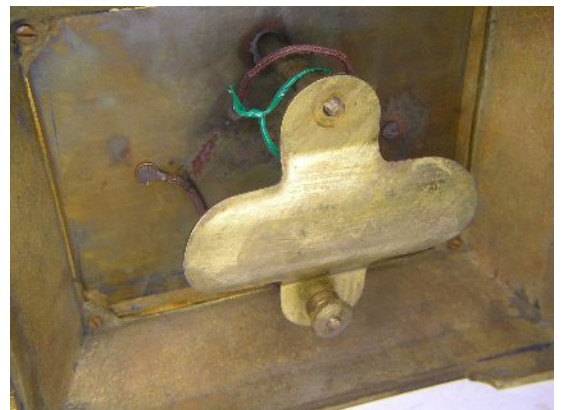
Because the wiring for the movement comes up from below and is easily disconnected, the whole movement can be removed from the case making life much simpler for assembly and testing (unlike the Bulle four glass which is a real pain to assemble and test).

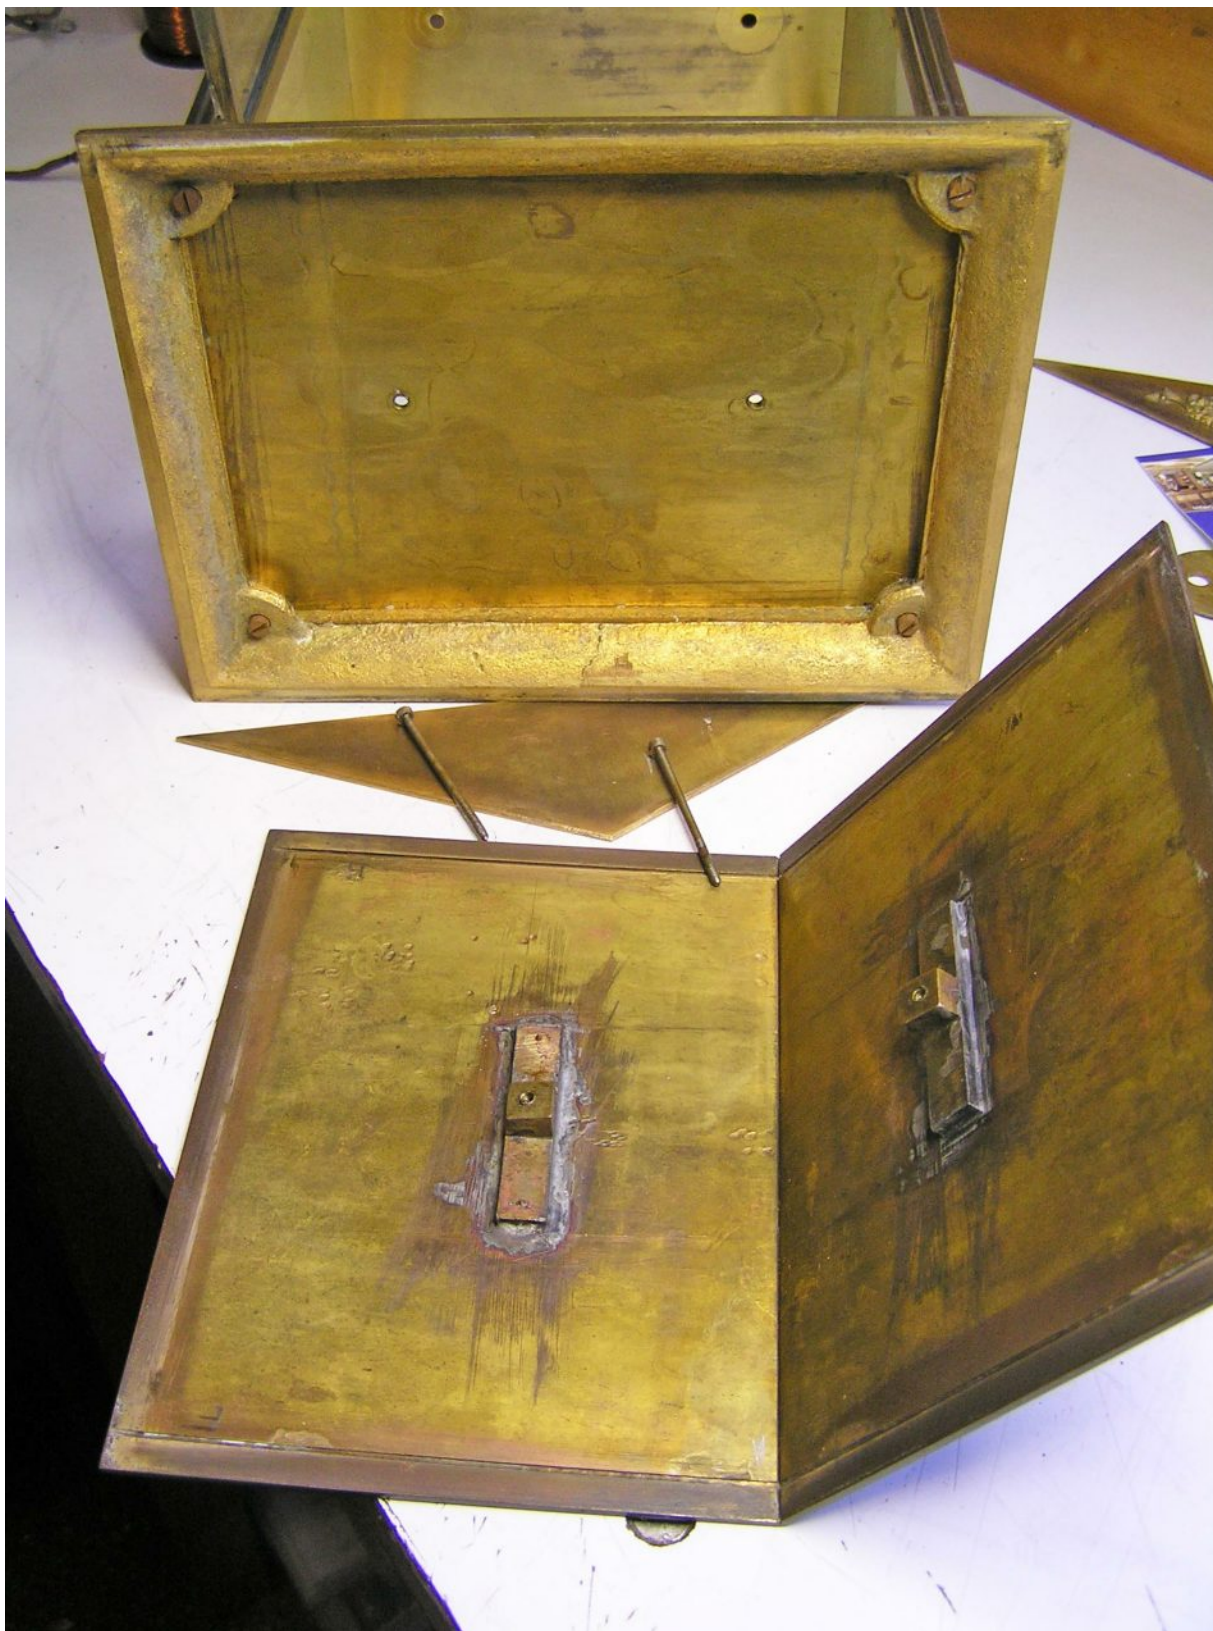
Note the groove in the roof and threaded inserts for the two screws.

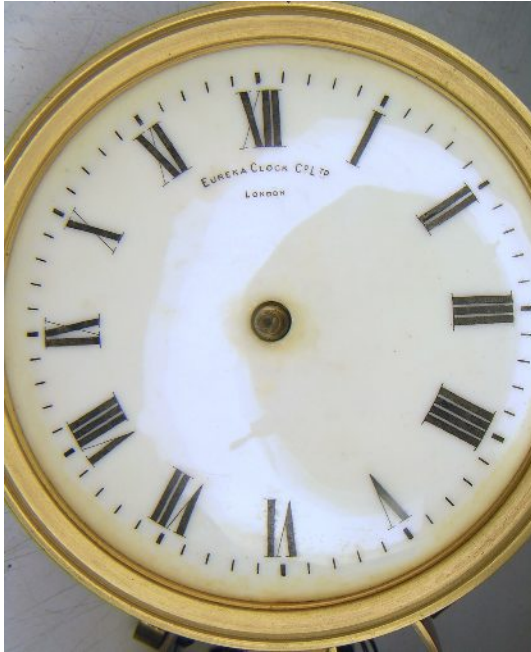
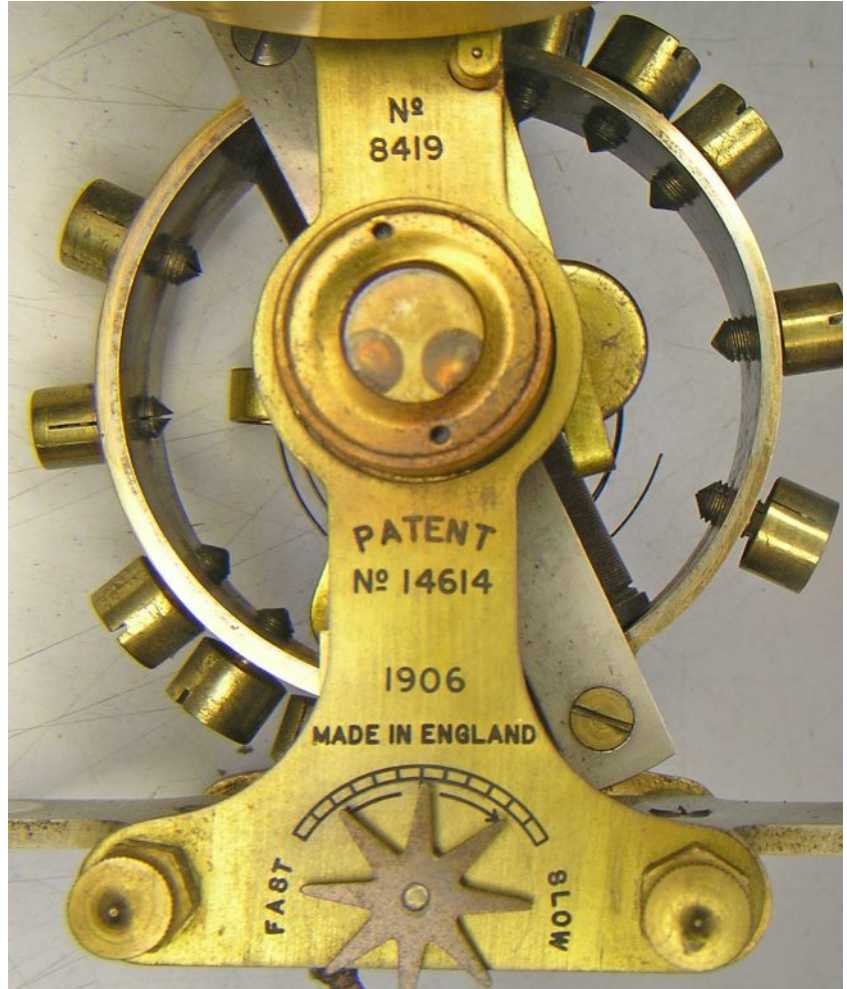
Other than years of dirt and grime first impressions are that the whole clock looks to be in a complete and original condition; other than the normal wear of the contact flag.

The dial has typical yellow staining probably caused by smoke either from a domestic fire or smoking.

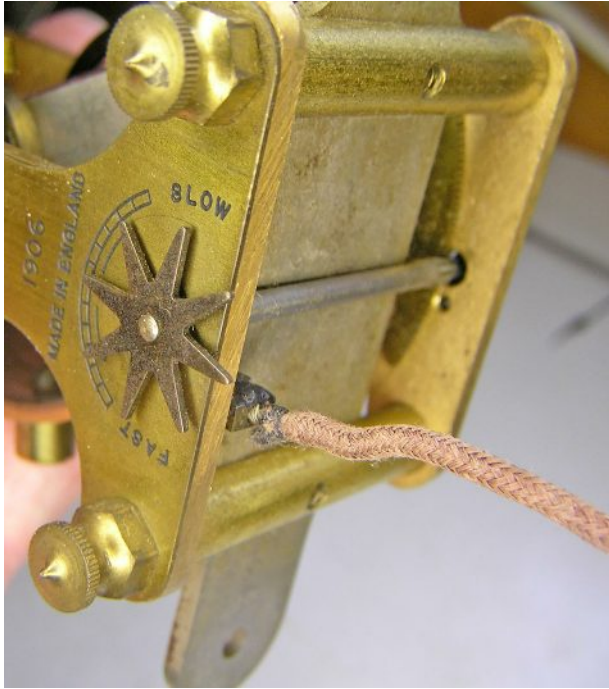
These photos show that the the wheel train is complete and in good order. Even the count wheel click spring is fine with hardly any wear.

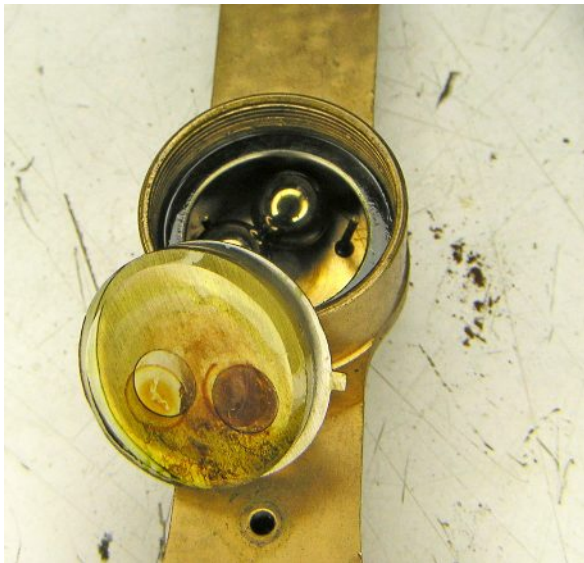
The bearings are a little caked with congealed oil, but this is easily cleaned off and is far better than being coated in rust.

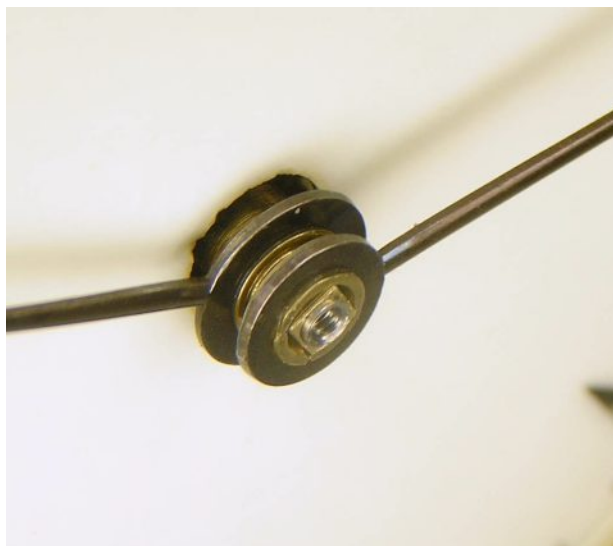
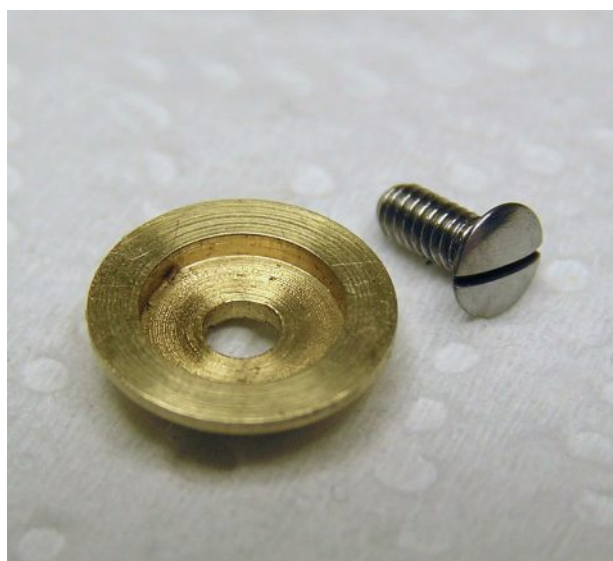
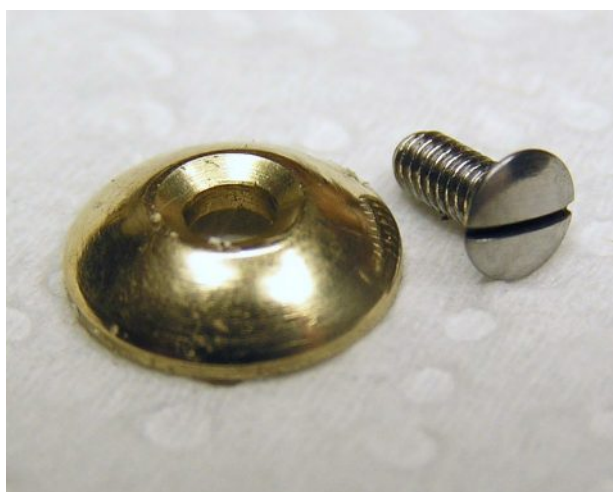
The clock came without the hand collet and retaining screw but these are easily made. One issue though was that the canon pinion square protruded through the minute hand and I had to turn the décolleté with a shallow relief to cater for it, otherwise The collet would not pull up tight against the minute hand.

Note that the collet is countersunk to accept the matching screw. The screw itself is also slightly domed. It will be polished and blued.

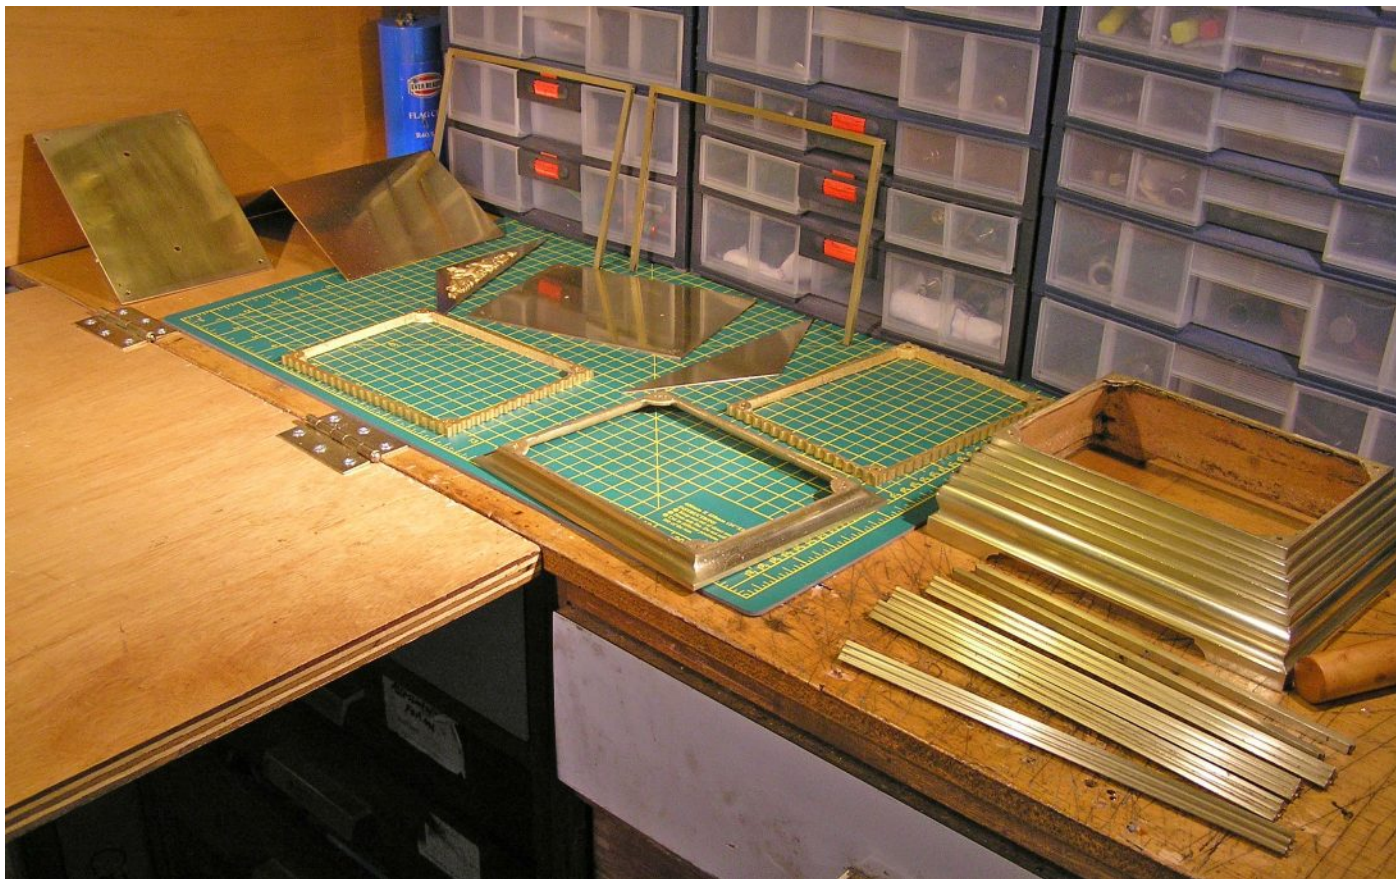
The component parts of the case after cleaning and lacquering. There are still some traces of gilding on the case but the majority and long been polished away. This leads to some difficulty in matching up the different types of brass used in making the clock. There are some cast parts as well as plate. Another issue is that the top of the roof which has been exposed to the open air has had some leaching of the zinc in the brass which has left the copper prevalent. I have polished out as much as I can but there are tinges of red left showing through. After all the parts were gently cleaned I had to polish some parts while leaving others untouched to try and get an even colour match. Of course it is possible to have all the parts re-gilded but I wonder whether the effort and cost would be worth it?

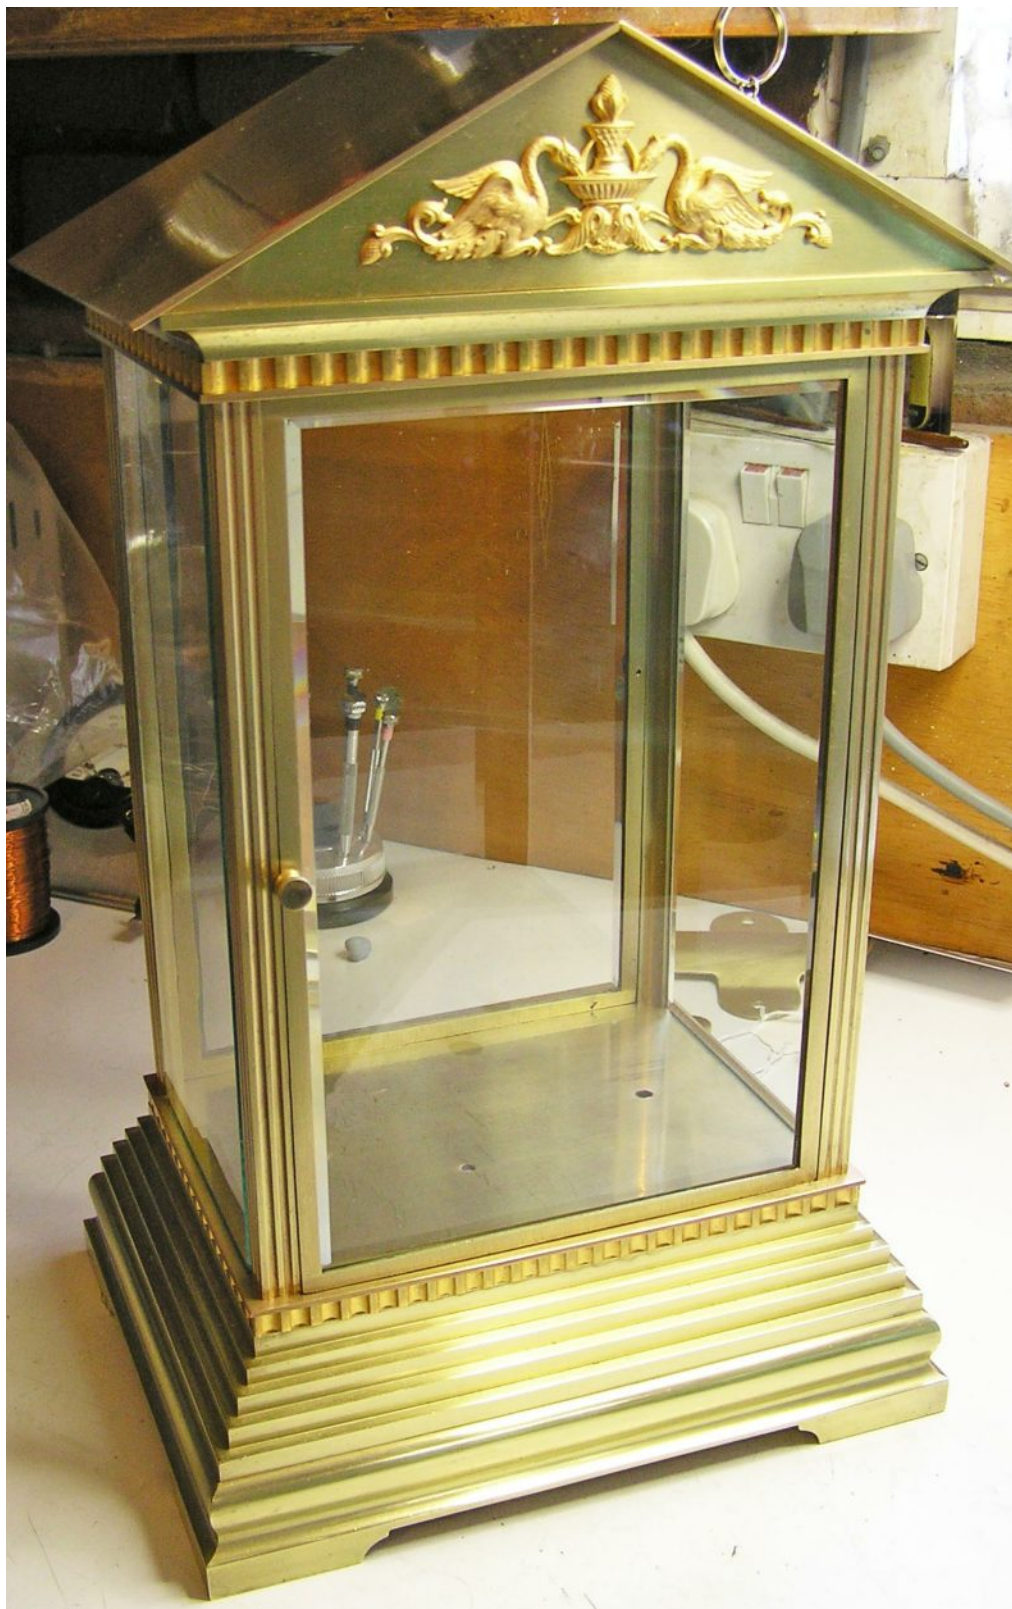
*The case re-assembled.
Ready to receive the move-
ment.*

*As previously noted the
Madeleine case can be
completely rebuilt separate
from the movement be-
cause of the way the move-
ment is mounted in the
case, This makes it a
dream to test the move-
ment at any time and re-
place in the case. Unlike
the Bulled equivalent in
which the movement is al-
most an integral part of the
case with the top of the
movement secured through
the top of the case and the
wiring being fed through
the top and down the inside
of the case. A real pain.*

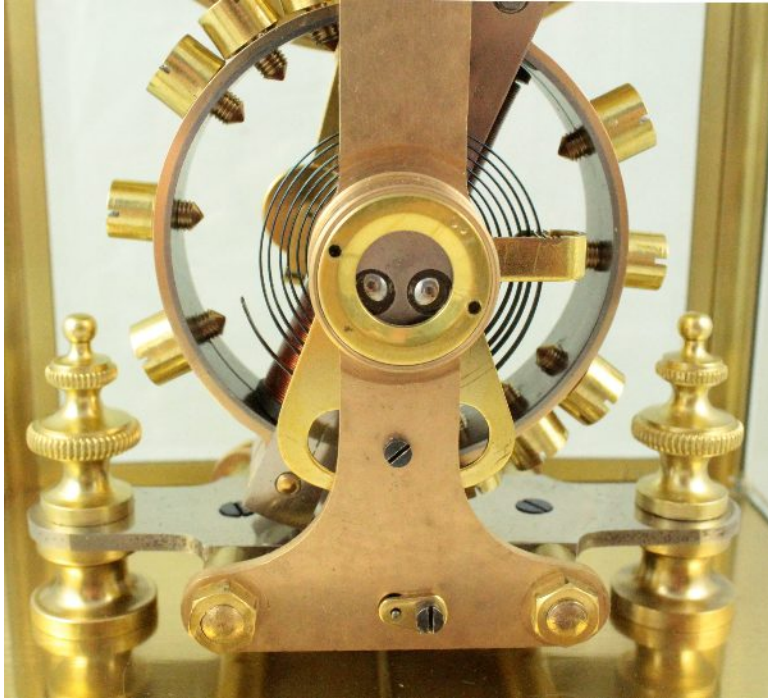
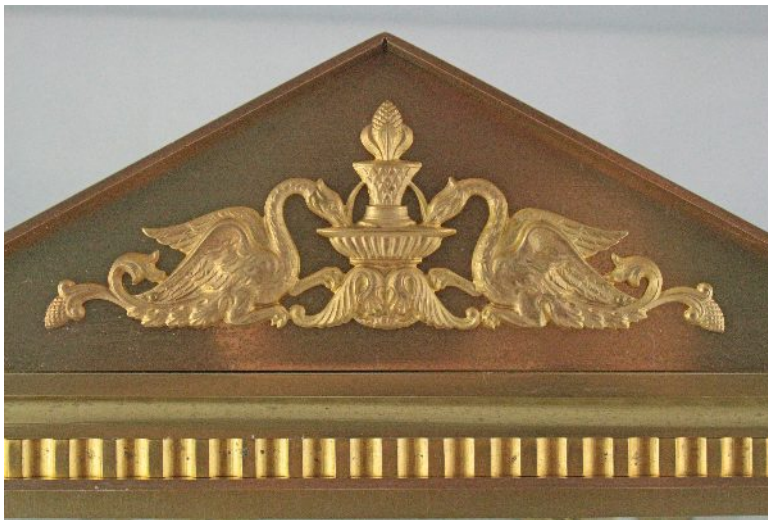
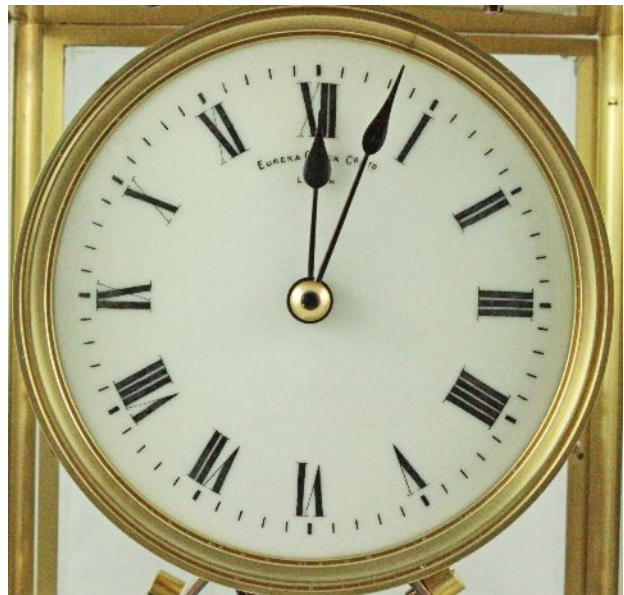
Some shots of the finished clock. Note the straightened balance spring, hand collet and blued screw, The dial has cleaned up very well with just a little warm water and soap.

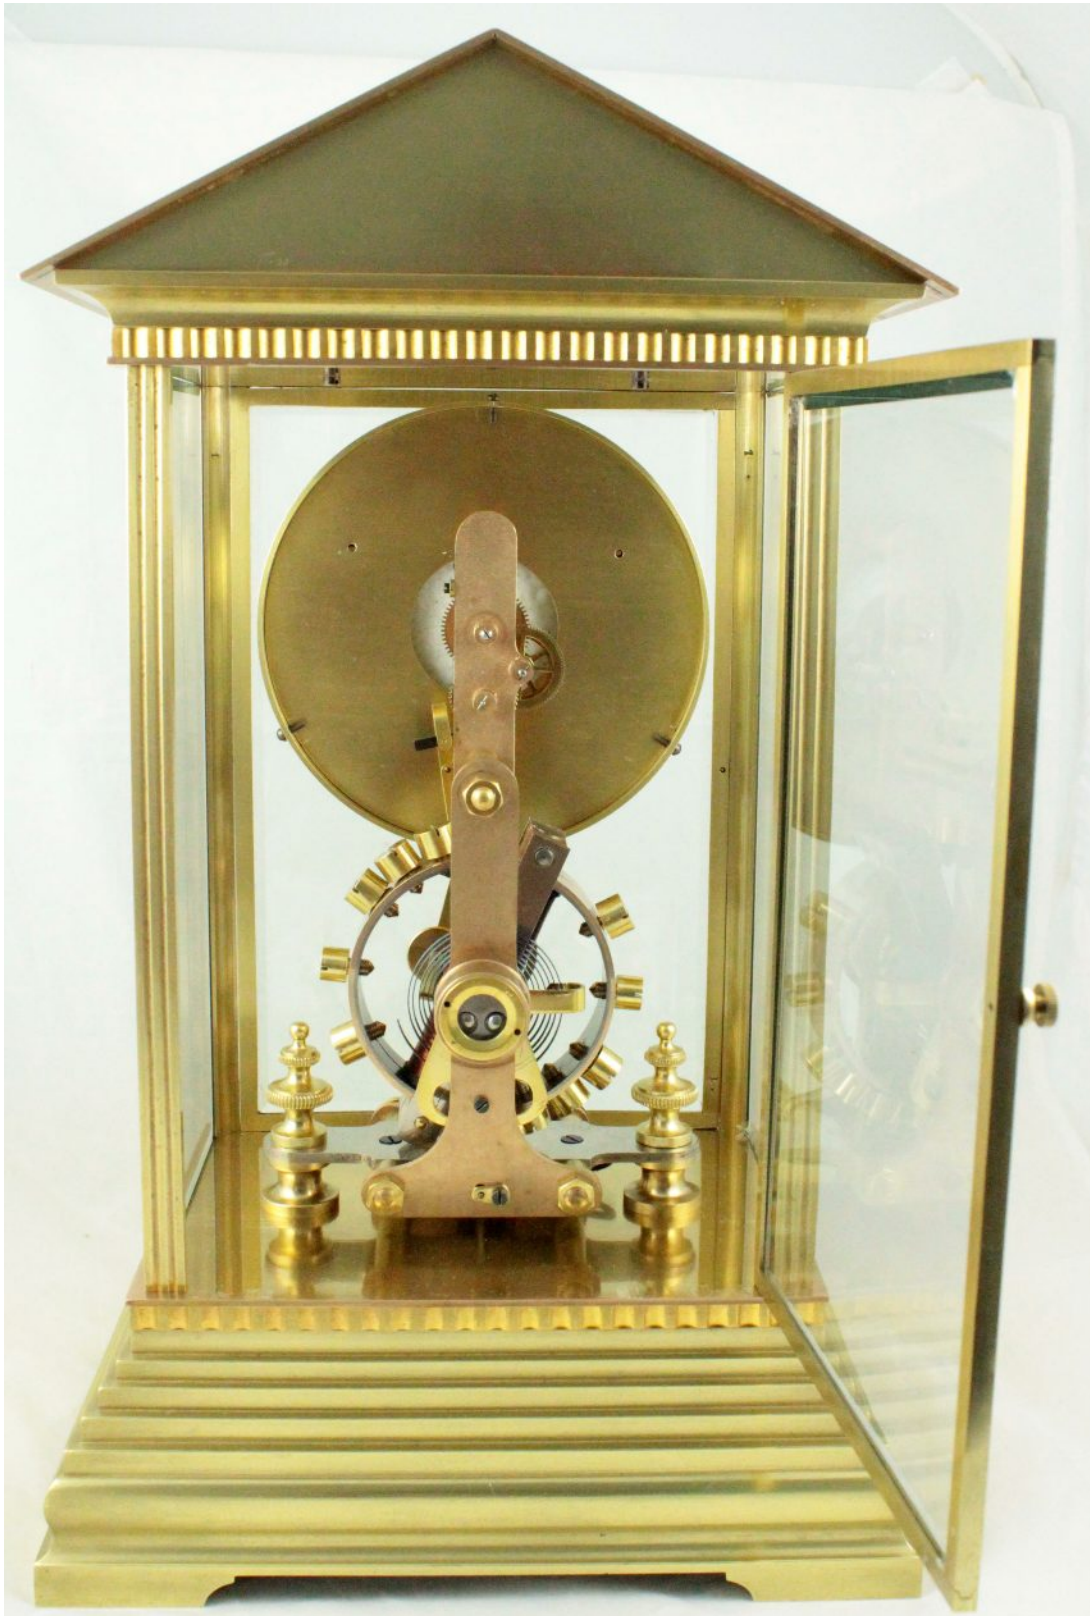
The rear of the finished clock.

The owner expressed a wish to replace one of the side panel glass which had a small shelling of the corner. A new panel was cut and bevelled by Gary Long of Class Glass.
