**Eureka Clock Serial Number 9082**

## *Restoration of Eureka Clock Serial Number 9082*

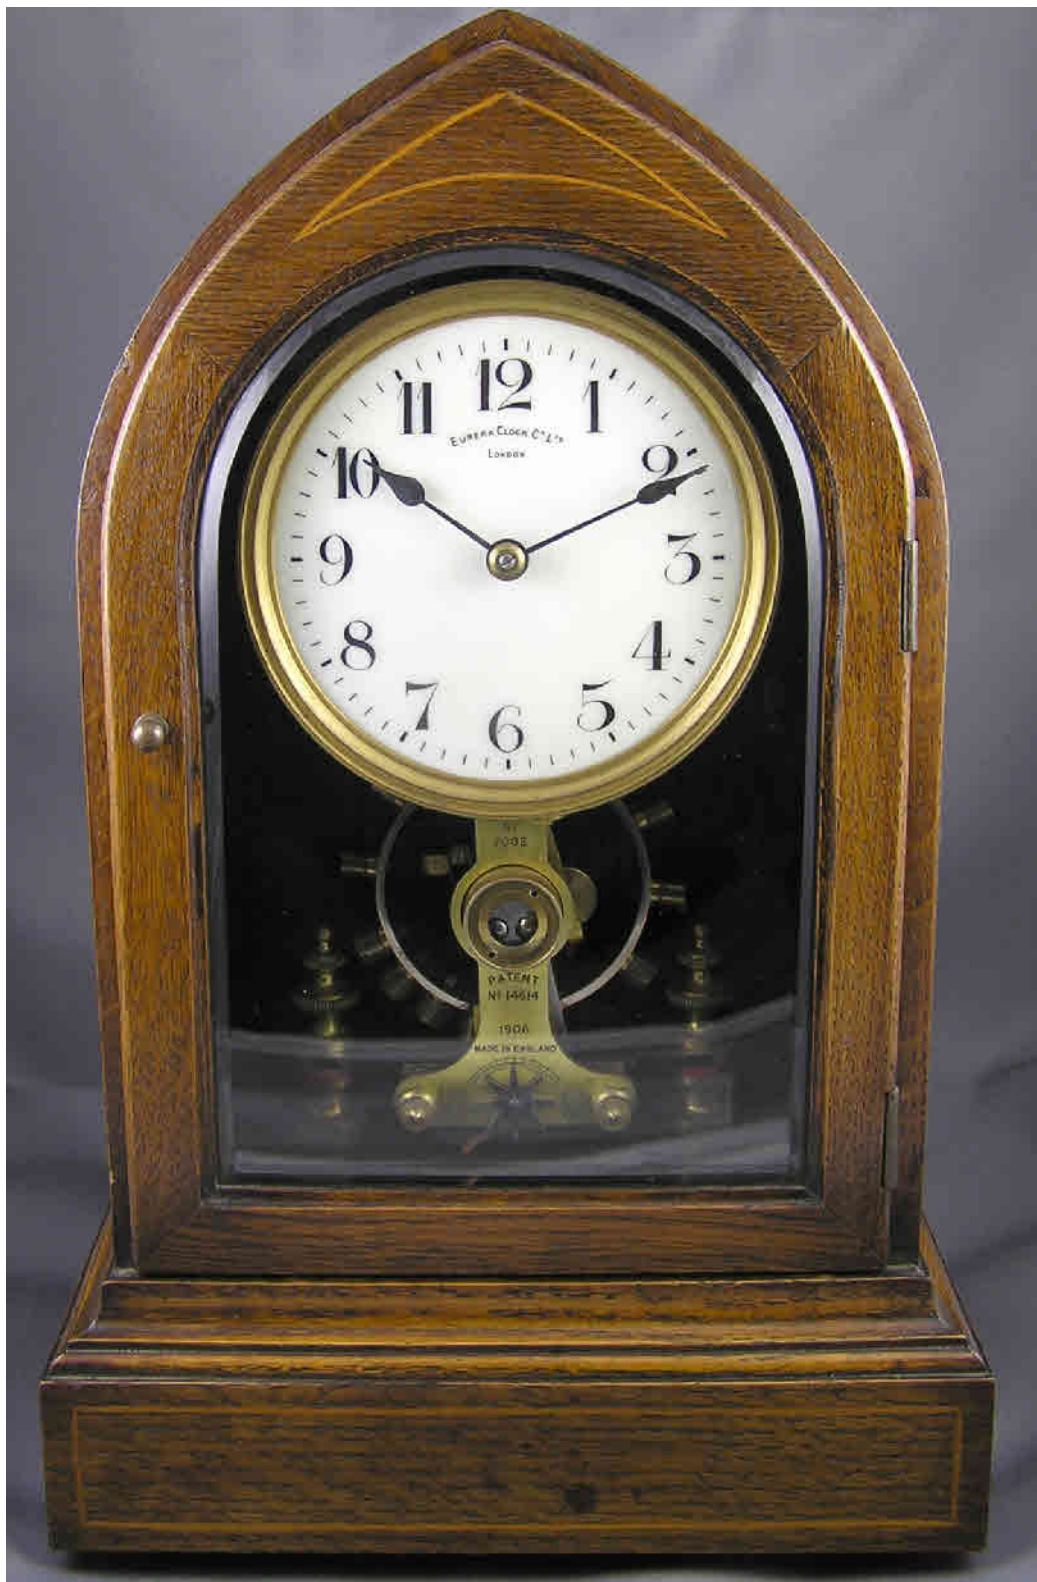
*The clock as delivered*

*The clock has a tall  
movement with two ball  
bearing and steel shim  
protector. The dial is the  
usual ceramic with no  
seconds subsidiary. The  
movement is housed in  
very nice oak lancet style  
case with bevelled glass  
front door. Everything  
looks fine and complete.*

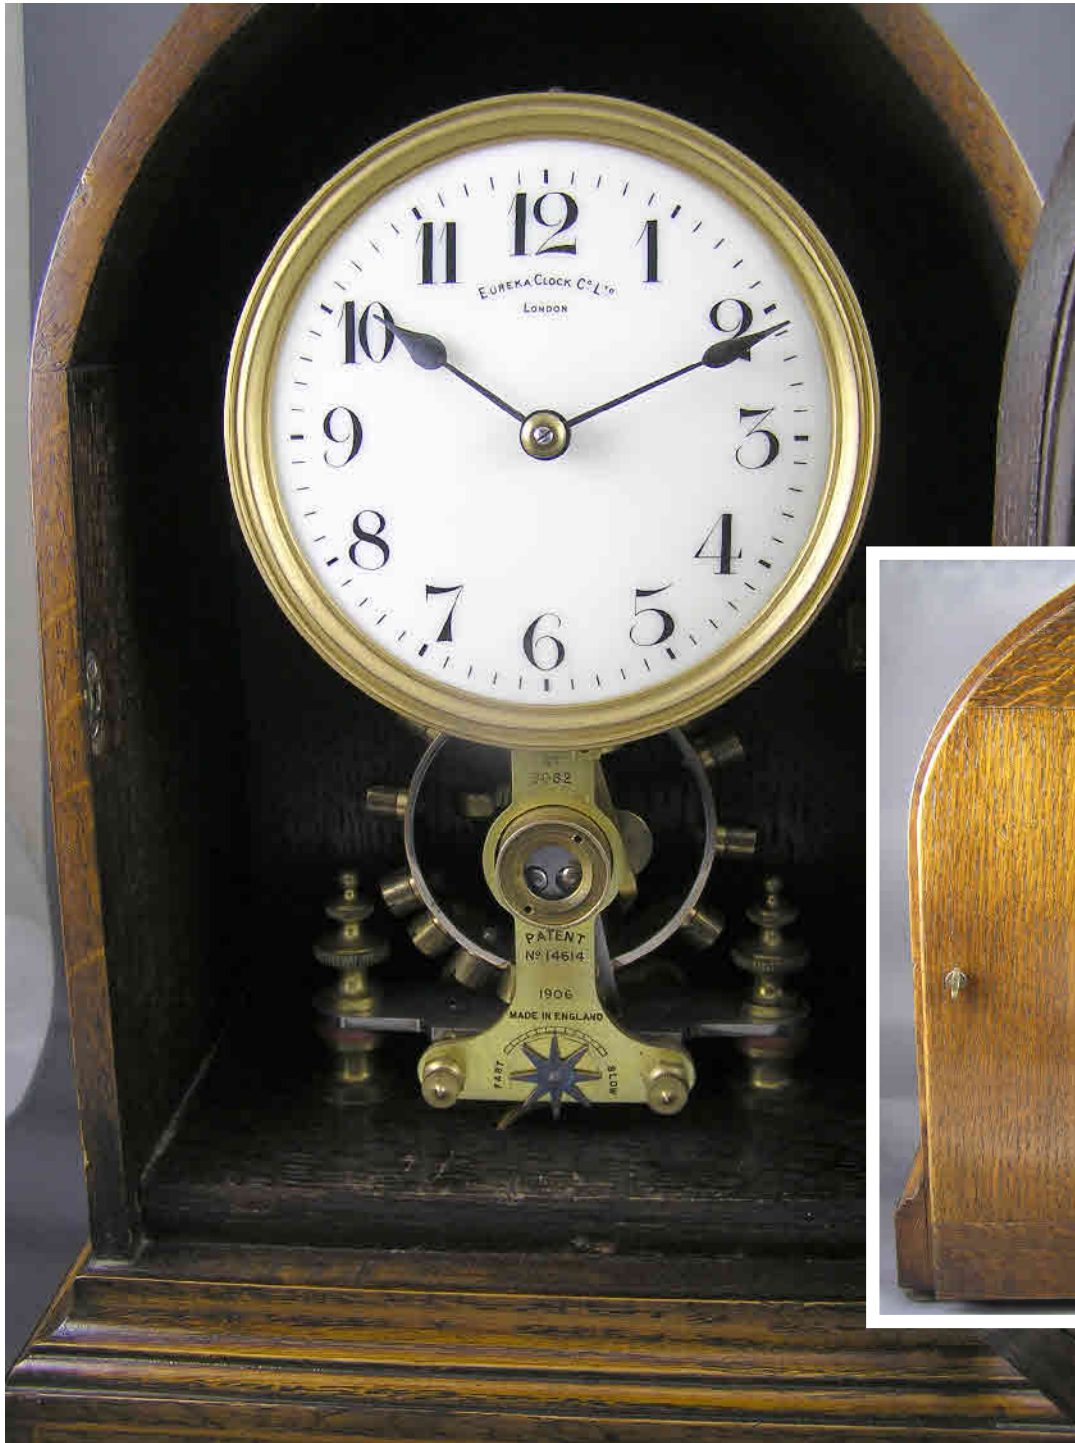
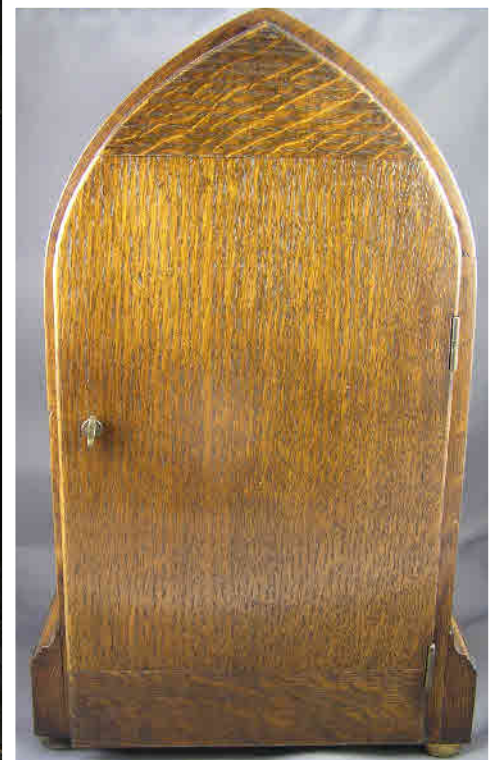
*The rear of the case has a full length oak door made of three pieces. The second photo shows the front door open revealing the complete movement.*

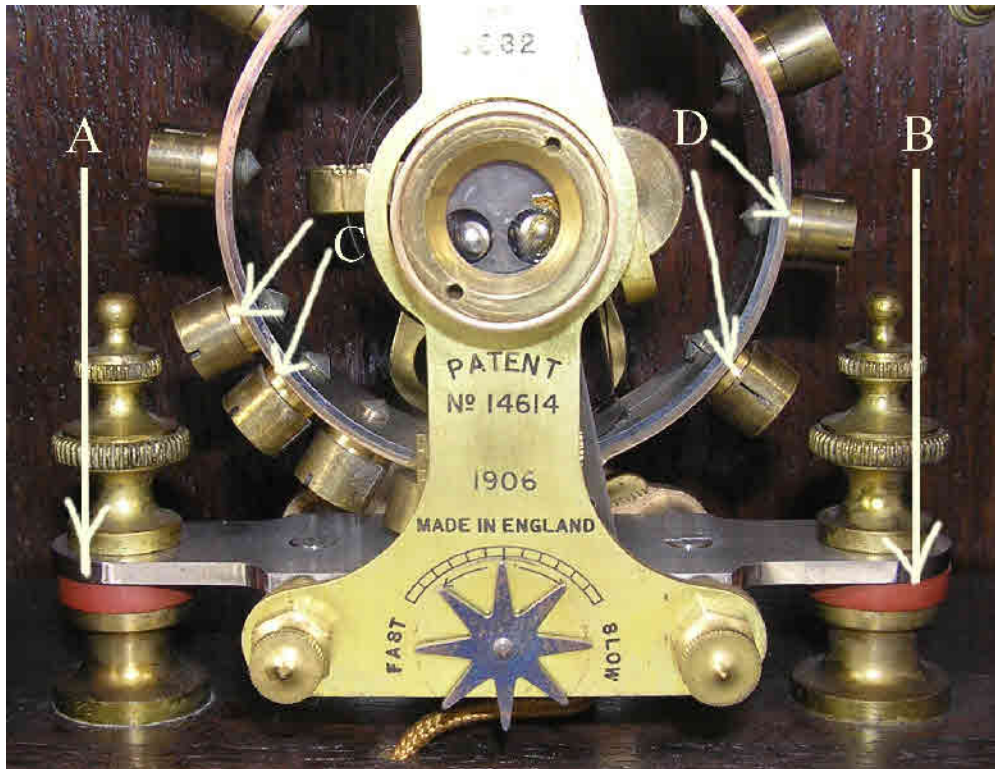
*This is rather odd. Note that at A and B there are what looks like two rubber washers. Why are these here. They provide no function other than to lift the movement higher in the case or to prevent the long case screws from bottoming in the knurled caps. Either way, they are not original.*

*At C and D notice the extra brass washers on each of the screws. These can only be to increase the weight of the wheel which immediately suggest that the clock is not running well to time. Further investigation shows that the balance spring is only 11.5 turns in length. When they are normally 12.5. This means that the clock would run fast and therefore the extra weights were added in an attempt to slow it down. We cannot add coils to the spring so we will balance the spring, wheel and power using the Horologix battery to try and regulate the clock for reasonable wheel amplitude and time keeping. All these things together suggest that the movement may not have started off with this case.*

*The rubber washers have been replaced with newly turned and relieved brass of the same dimensions.*

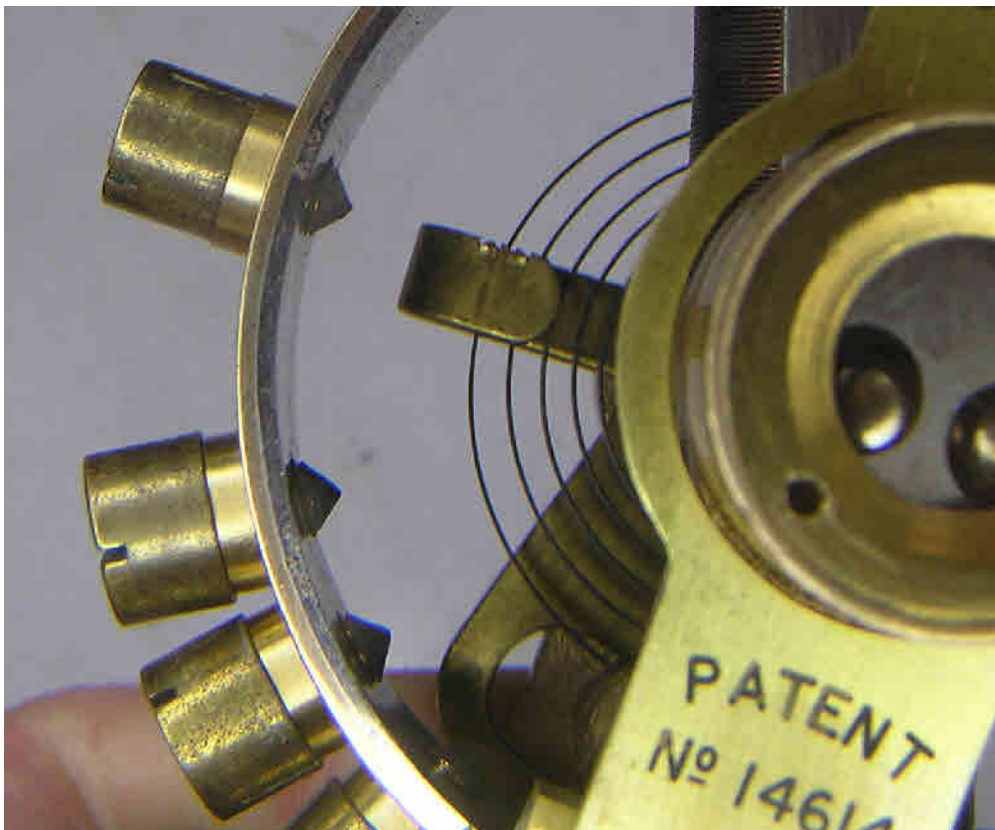
*This photo shows the washer weights in more detail.*

*The movement completed and back in the case for testing. Note that the washer weights have all been removed.*

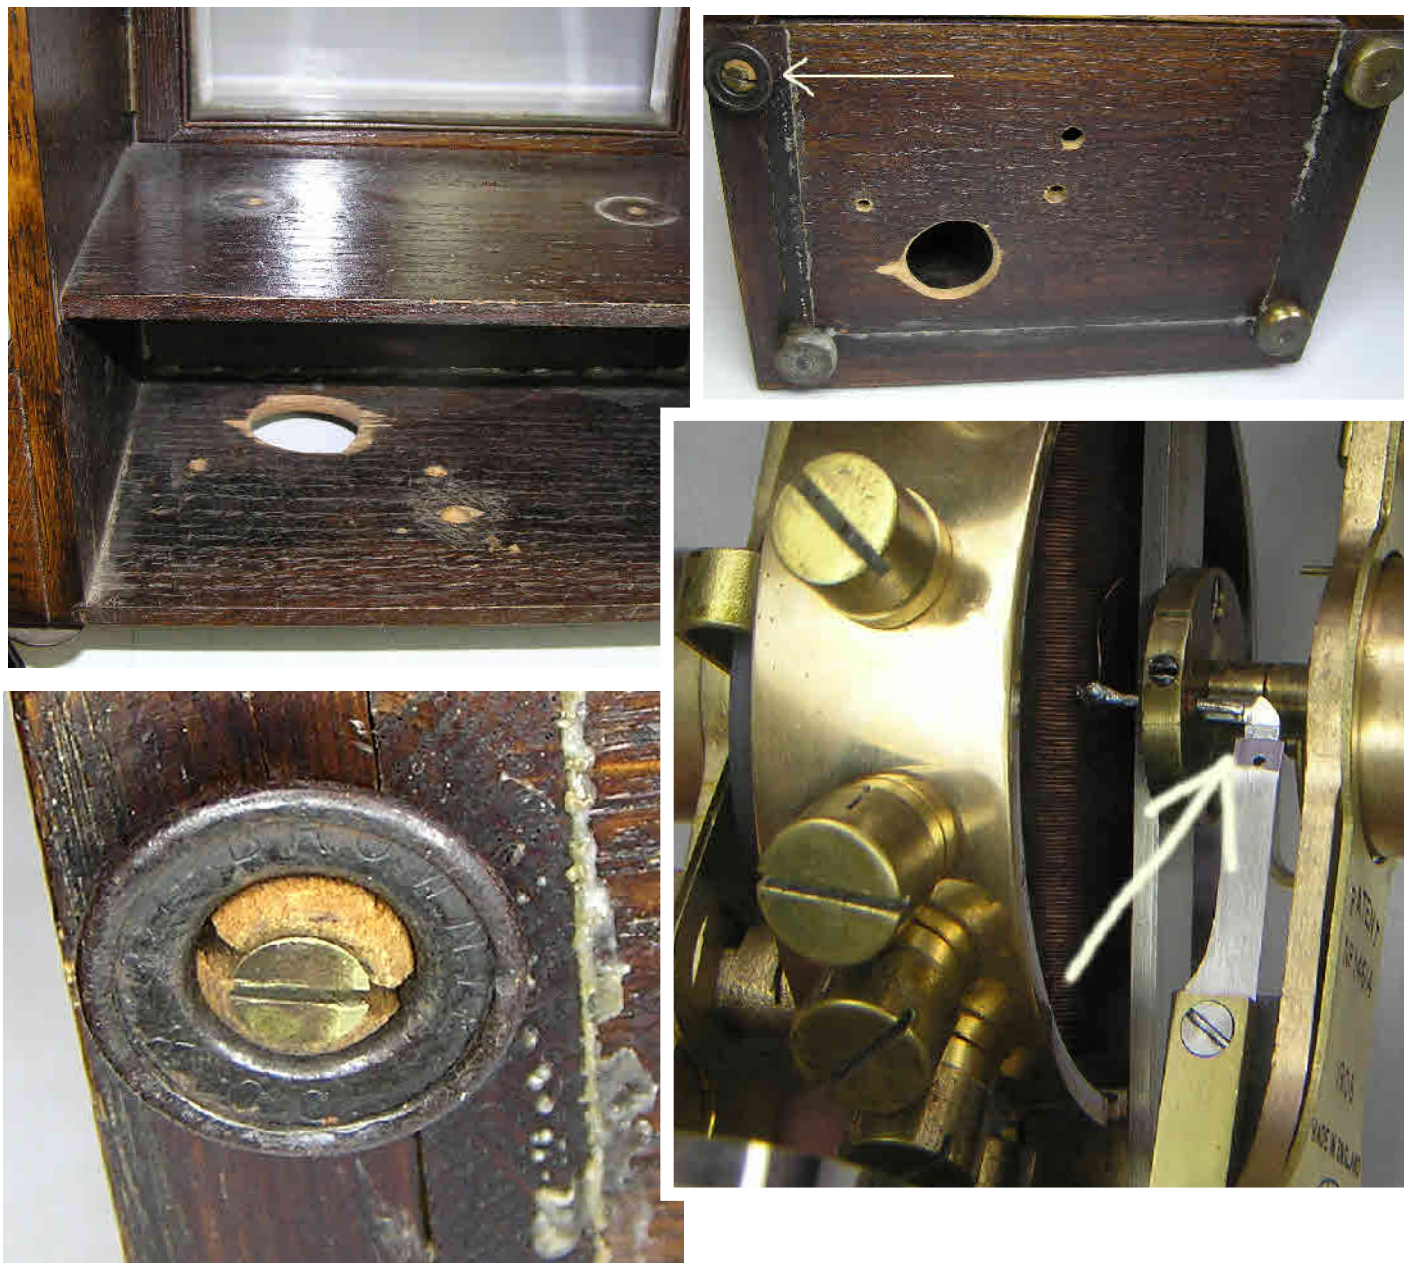
*The first three photos show the extra holes in the case and the missing bun foot. These holes are a mystery and the only thing I can think of is that someone has perhaps tried to fit a light to brighten the interior of the case to aid viewing the movement. Or maybe they were to allow wiring to a transformer of some sort.*

*The last photo shows the substantial home made contact flag. It is well made, if a little beefy.*

*The missing bun foot will need to be turned on the lathe.*

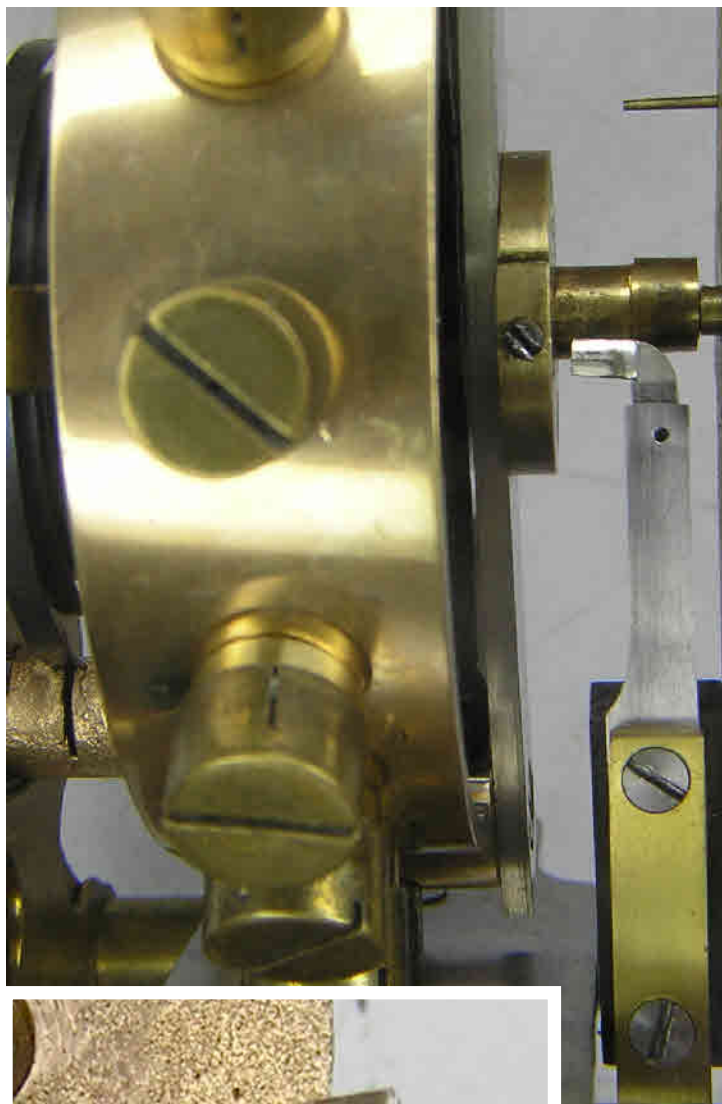
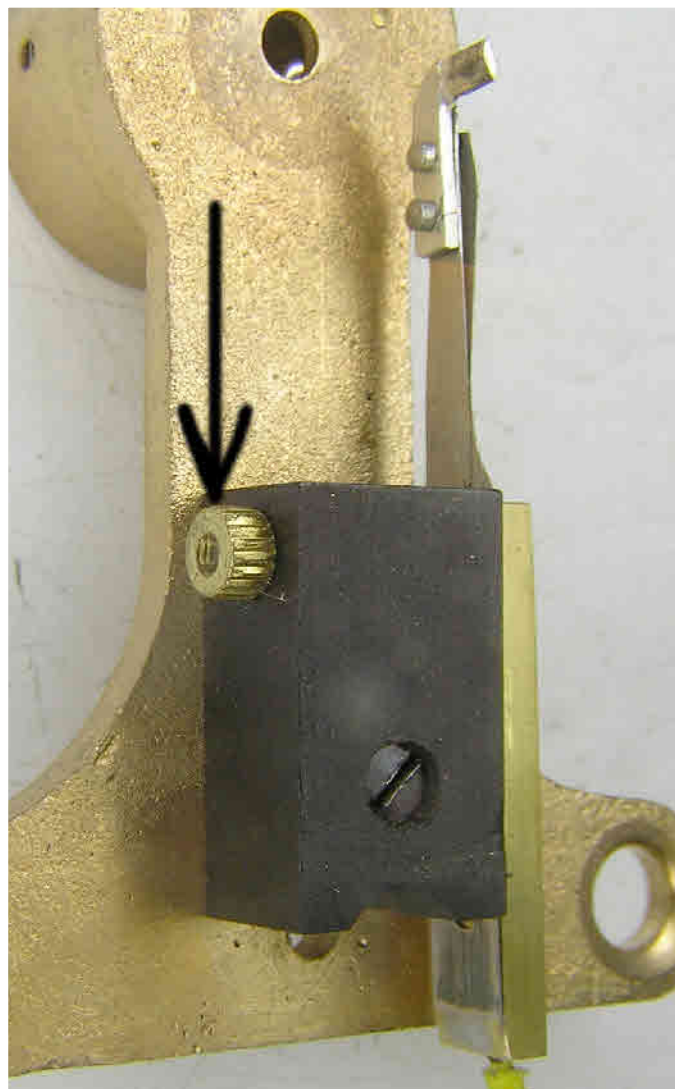
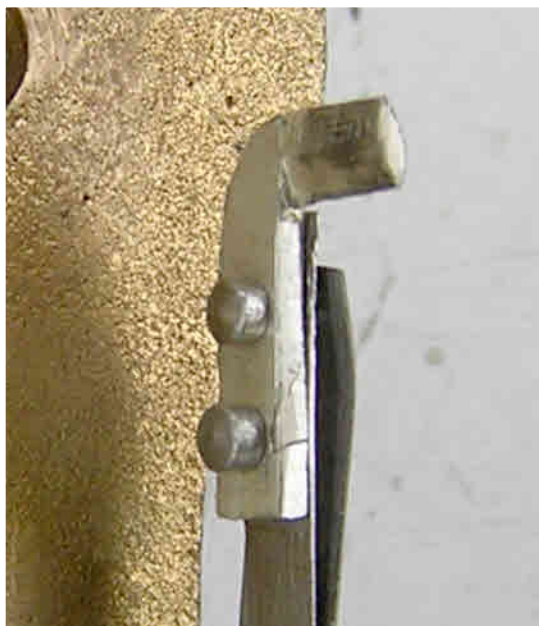
*This group of photos show the contact flag and terminal assembly. Although the flag is rather large it has probably worked OK. The knurled nut on the fibre terminal block is there because the thread in the fibre has been stripped and will no longer allow the screw to pull the contact tightly against the flags. The block will need to be replaced.*

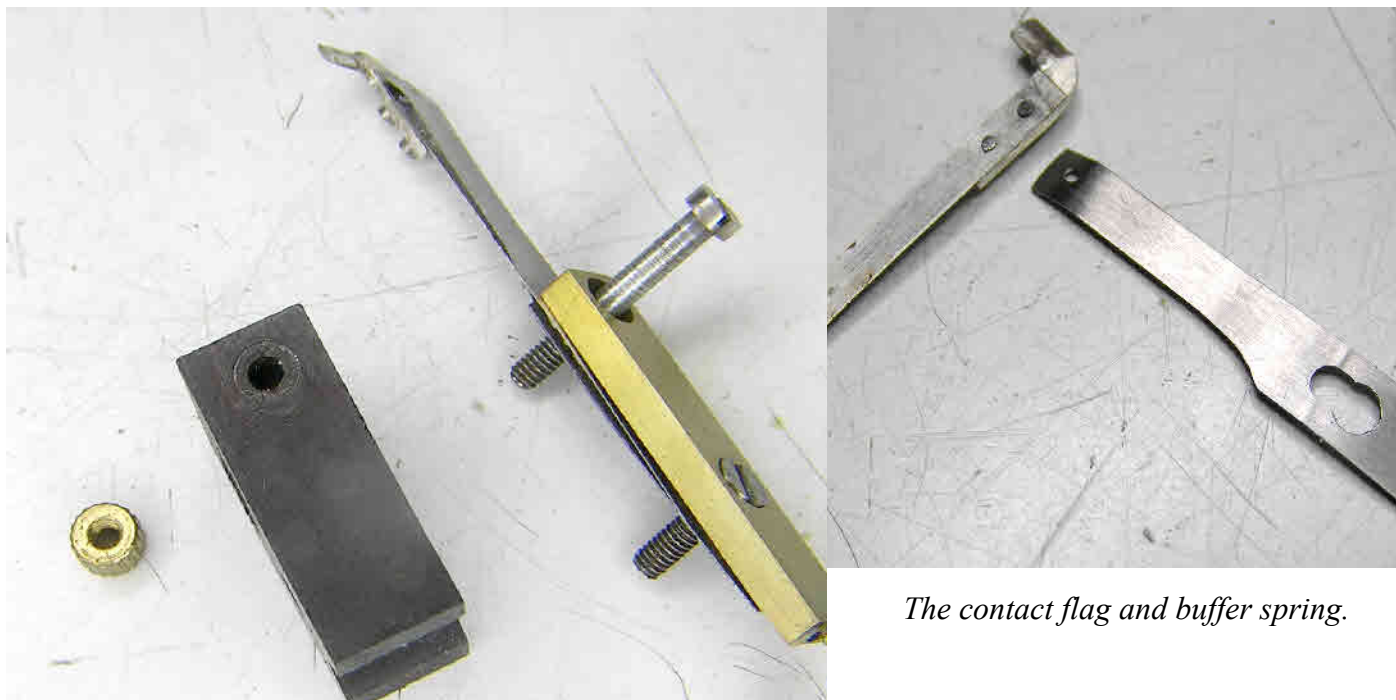
*The contact flag and buffer spring.*

*The terminal block disassembled showing the extra long screw that replaced the original. and the hole in the fibre block to house it.*

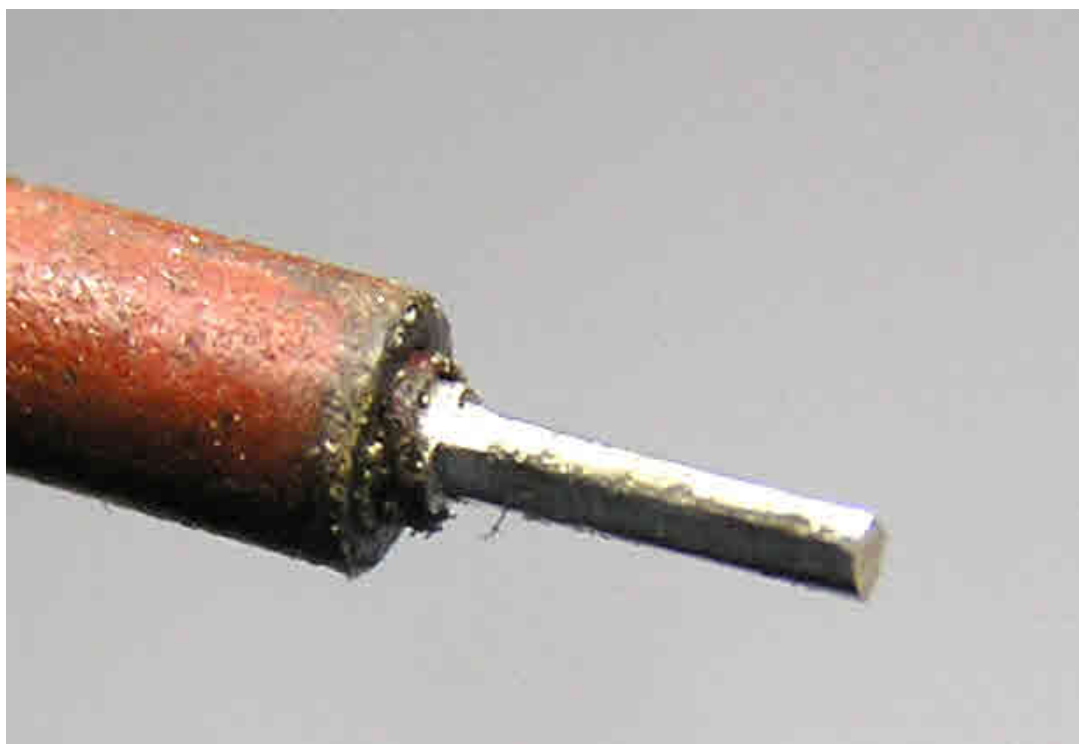
*The contact pin itself has been worn oval. The outer bronze casing and insulation have been worn away. A whole new assembly will have to be made.*

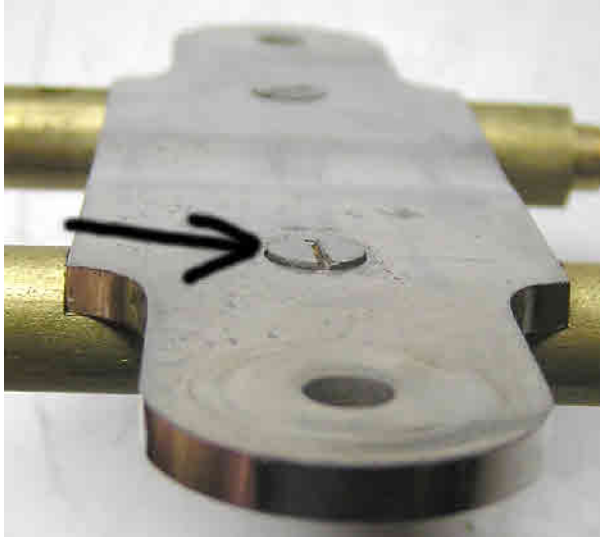
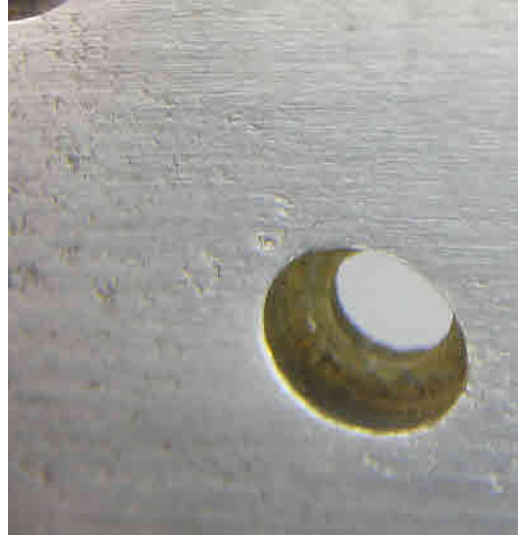
The base plate screws seem to be sitting a little proud which may impede the wheel. On removal it can be seen that there is a layer of rust which prevents the screws from bedding down correctly. This will be cleaned out and the screws re-blued.

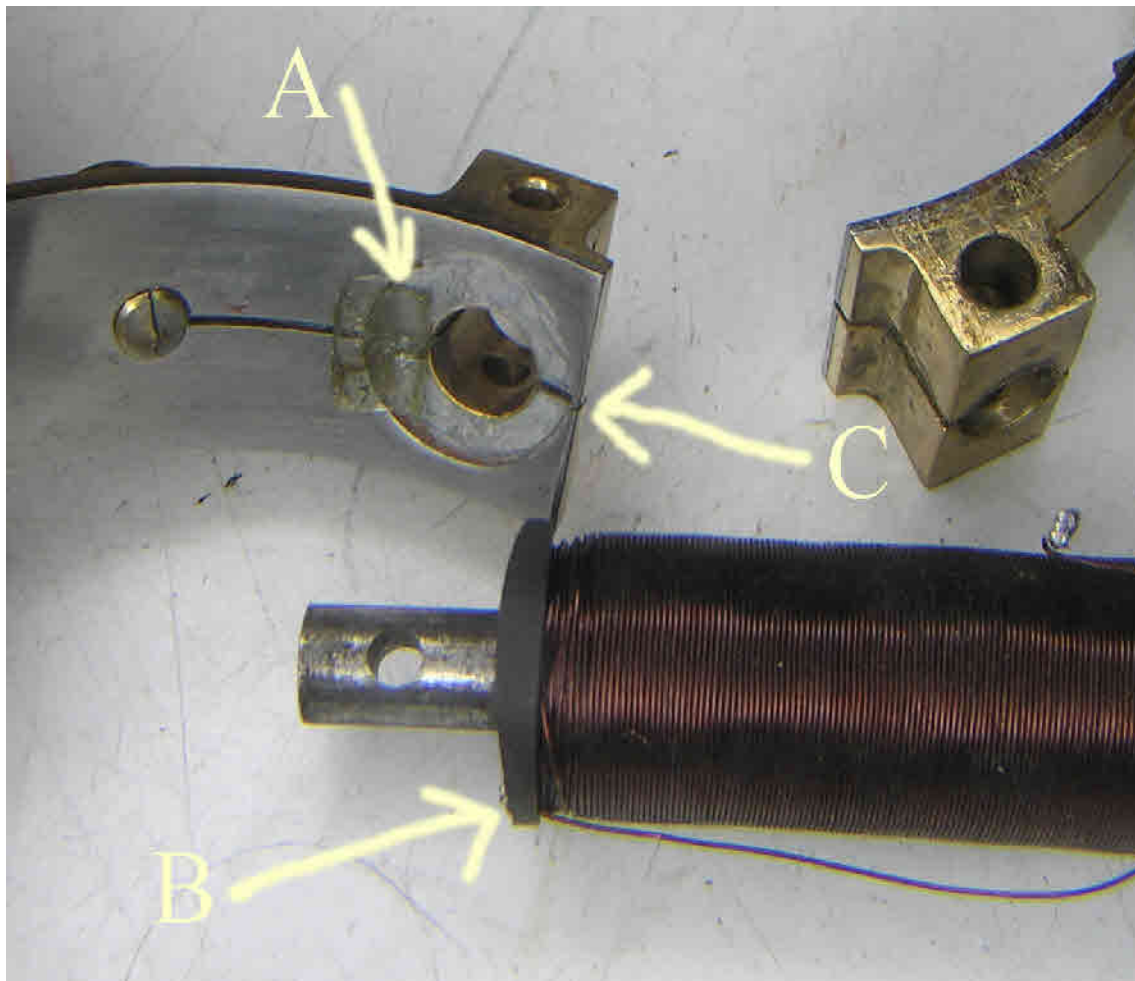
Note the cellotape at A where a previous restorer has tried to insulate the coil wire at B from contacting and possibly shorting the armature. The problem has come about because the armature has been accidentally turned 180 degrees from where it is intended to sit. The coil wire is looped in the fibre at B and should sit in the balance wheel housing so that it faces the gap at C thereby negating the need of any extra insulation.

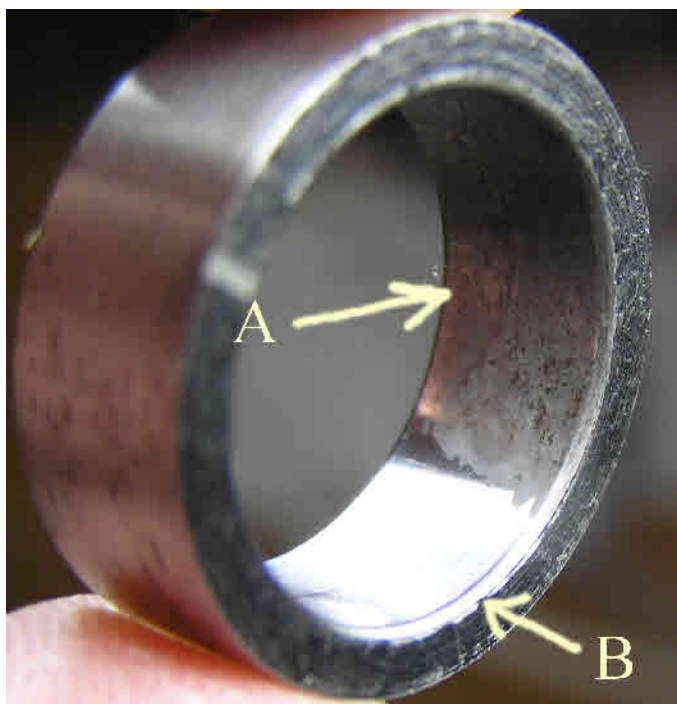
The ball bearing housings on both front and rear bearings has been badly scored as can be seen at "A". Luckily the housing can be turned through 180 degrees to present a fresh clean surface at "B". If the movement was a three ball type then this would have not been possible and the bearing would need to be re polished.

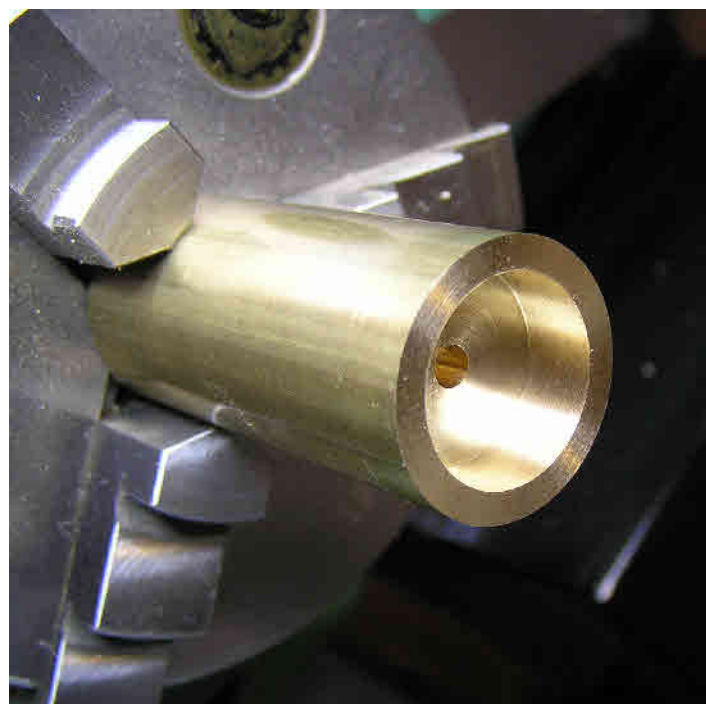
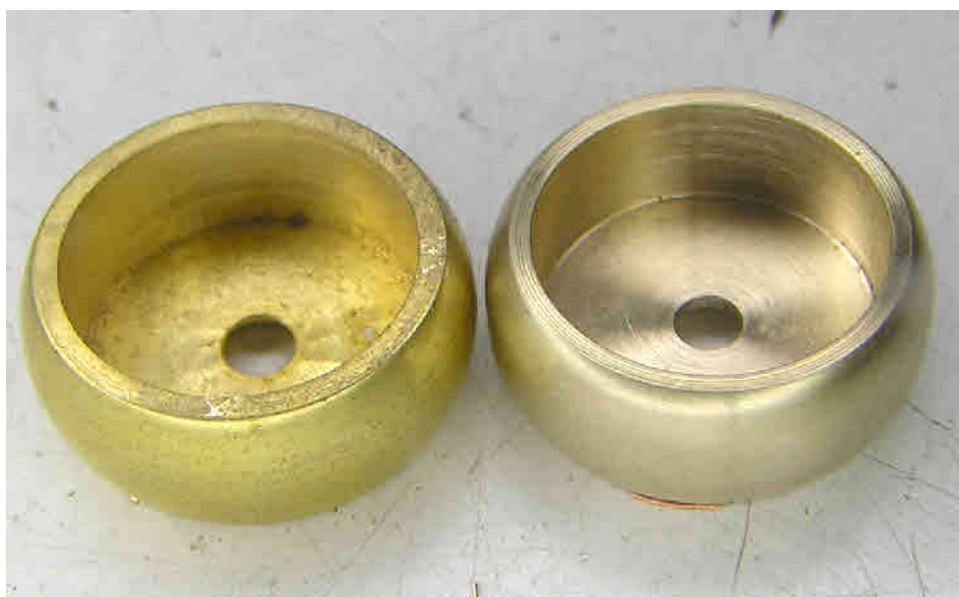
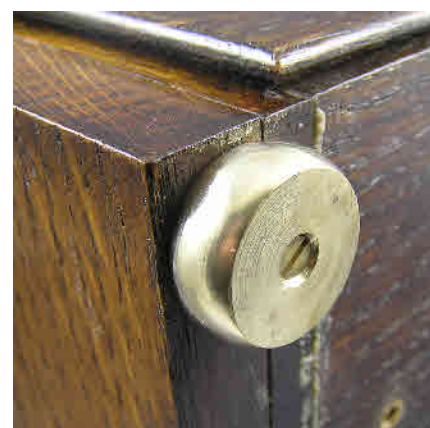
Above we can see the new bun foot being turned in the lathe with the finished foot shown below left. The final photo shows it in position on the case.

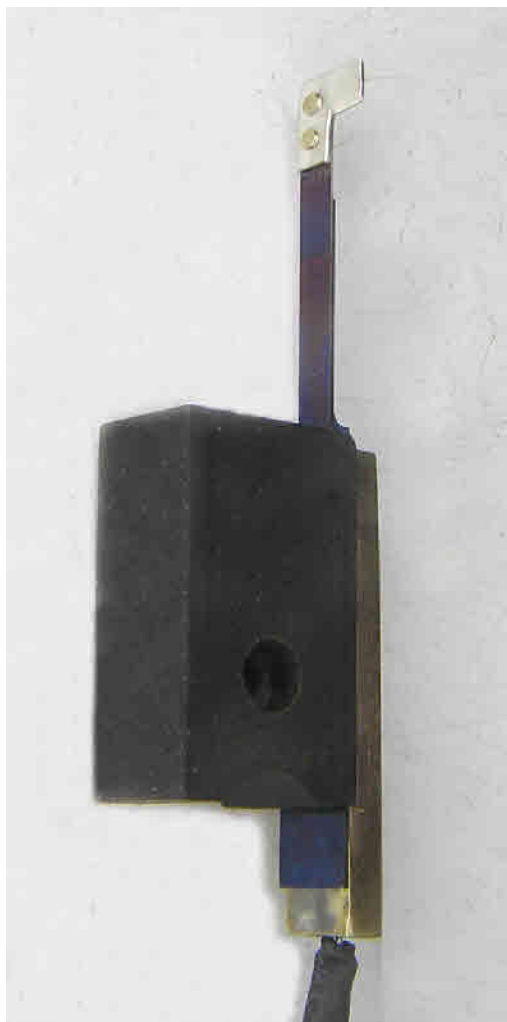
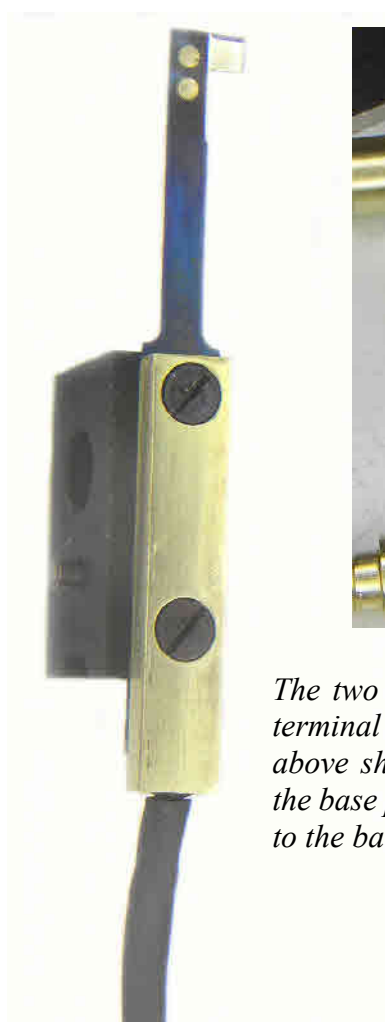
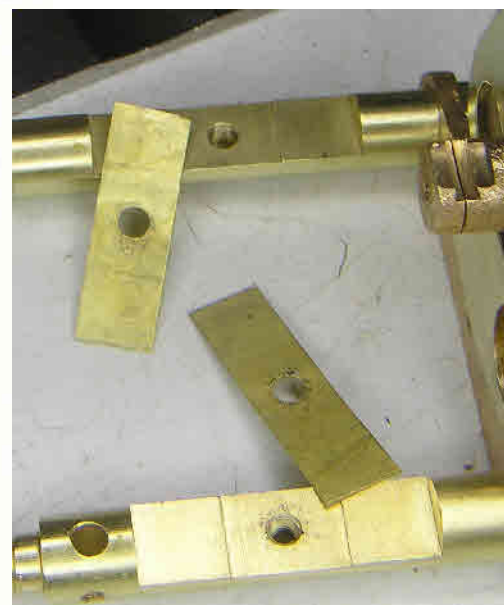
*The two photos at left show the new fibre terminal block and contact flag. The photo above shows the shims necessary to bring the base plate armature as close as possible to the balance wheel armature.*

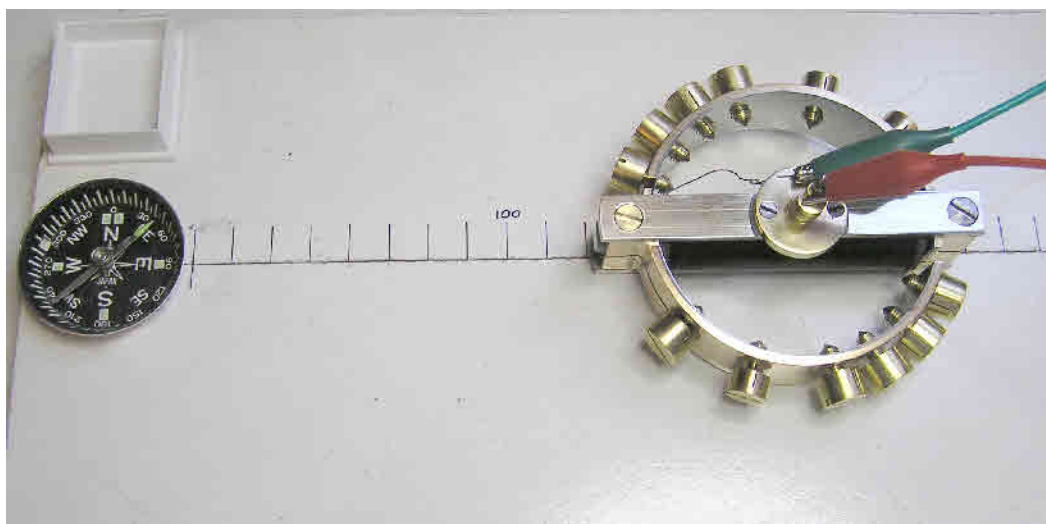
*Testing the strength of the armature using the magnetometer. For Eureka clocks the needle should be deflected from North to 45 degrees (NE) by presenting the energised armature at 120mm on the scale.*

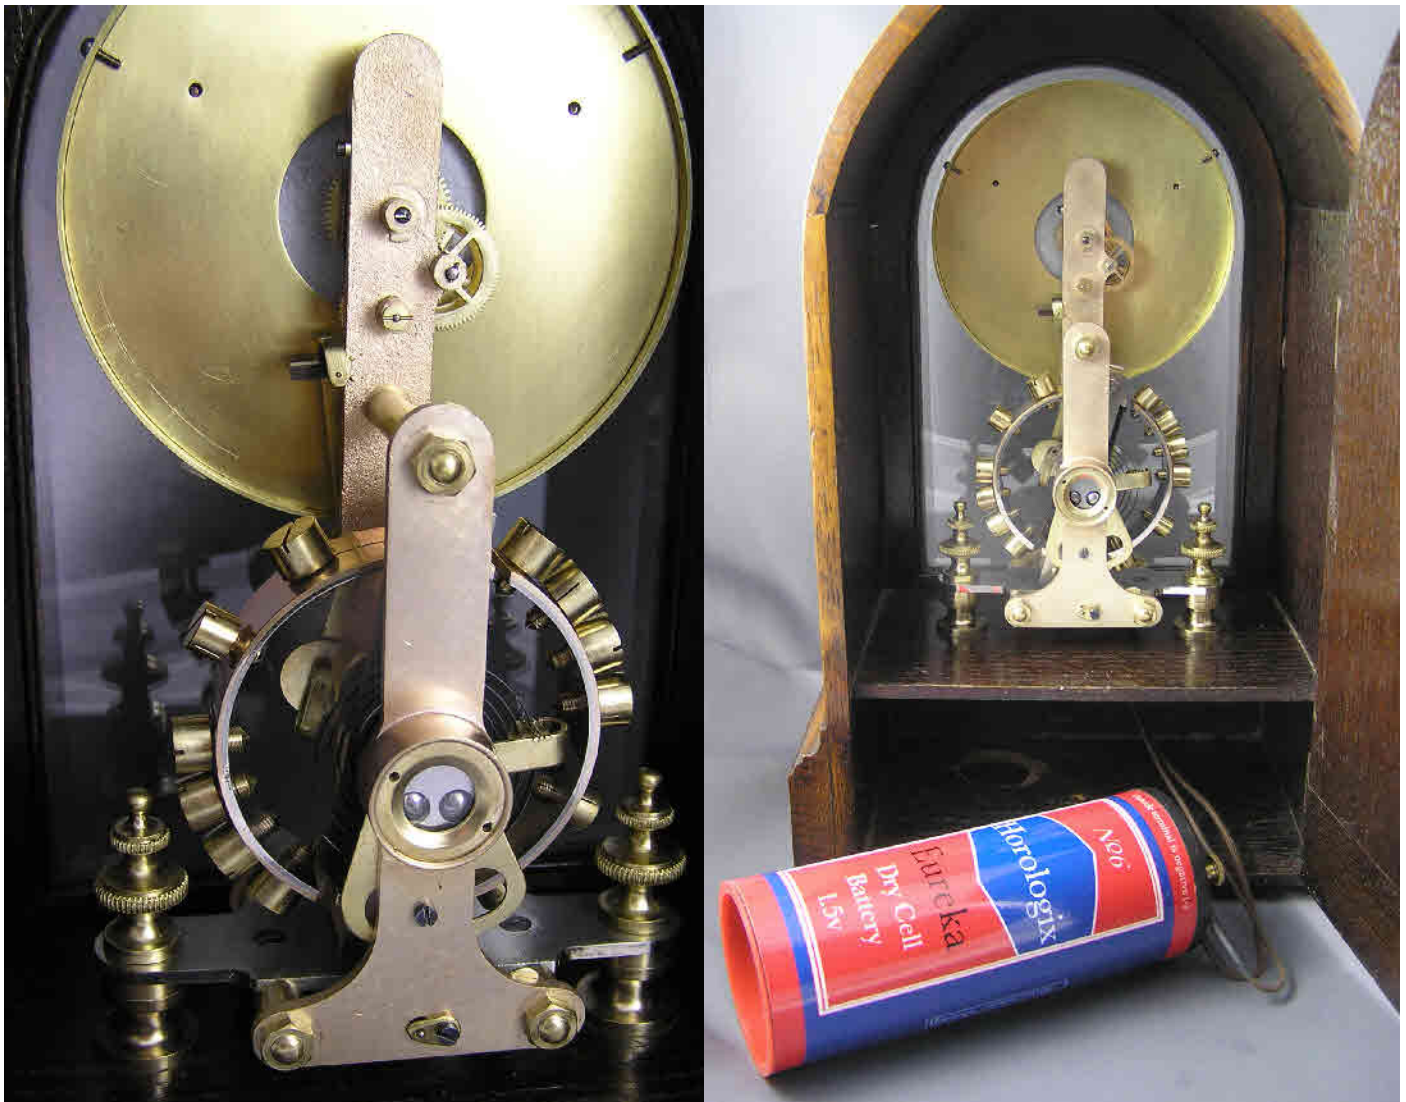
*The rear of the restored movement and the replacement “Horologix” regulated battery power supply.*

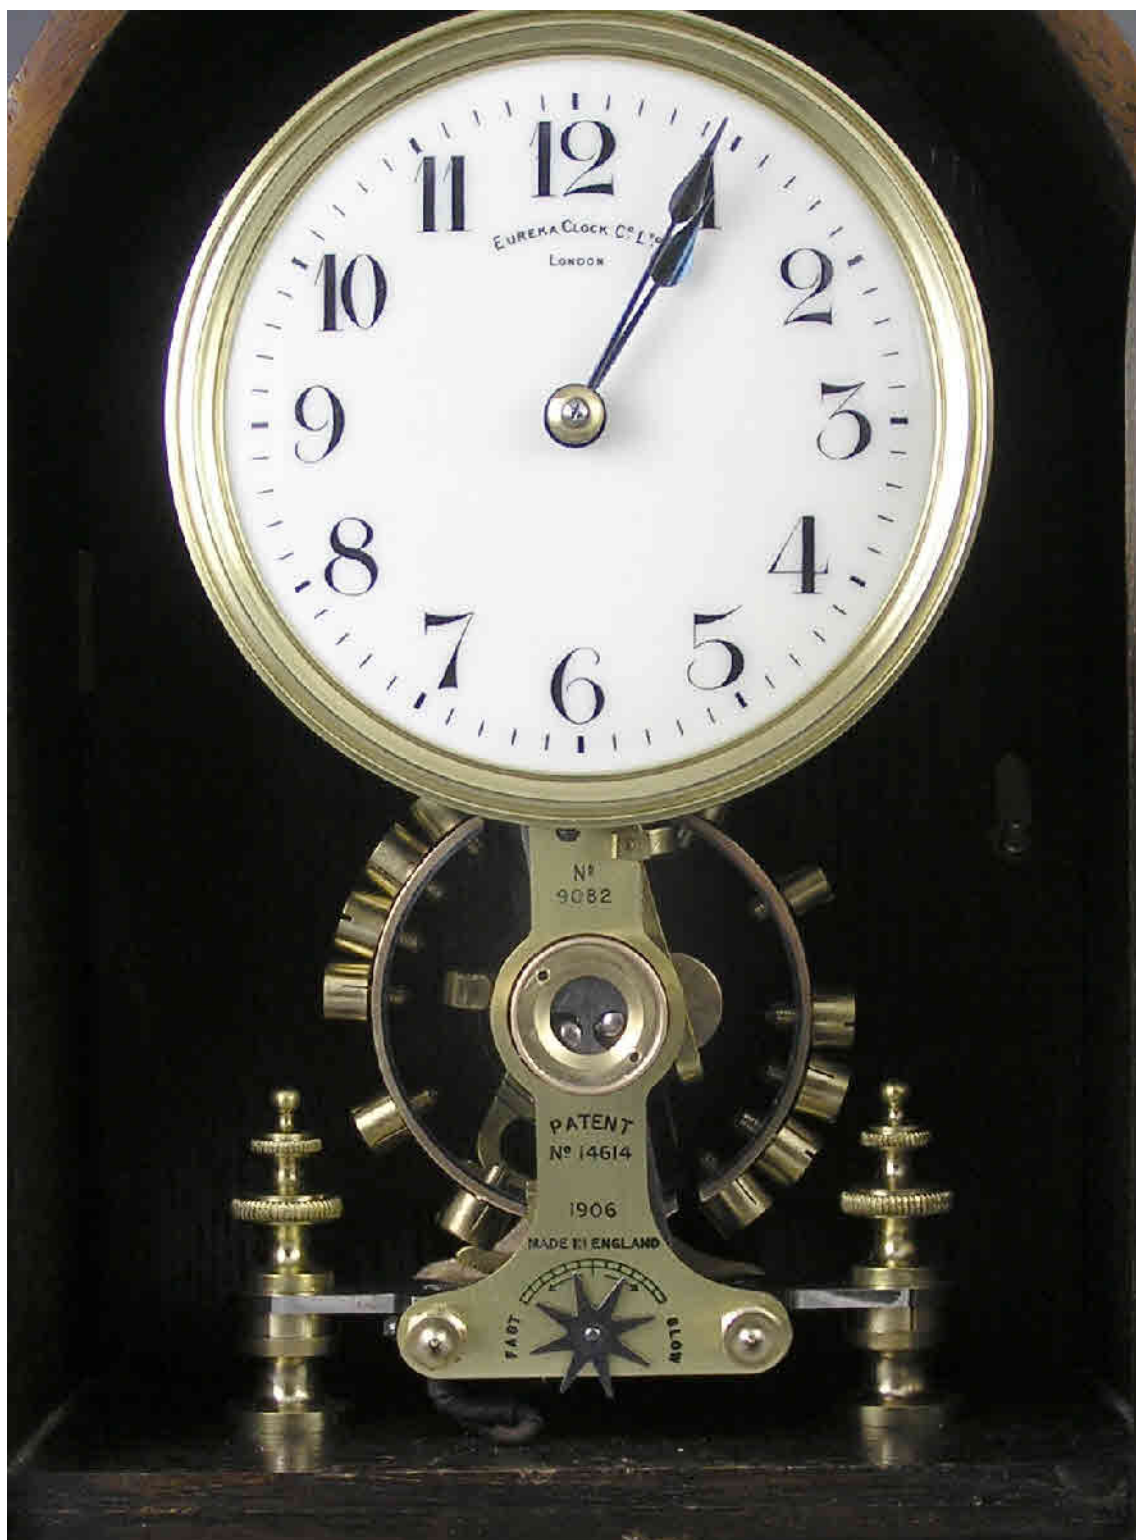
**The completed  
movement.**

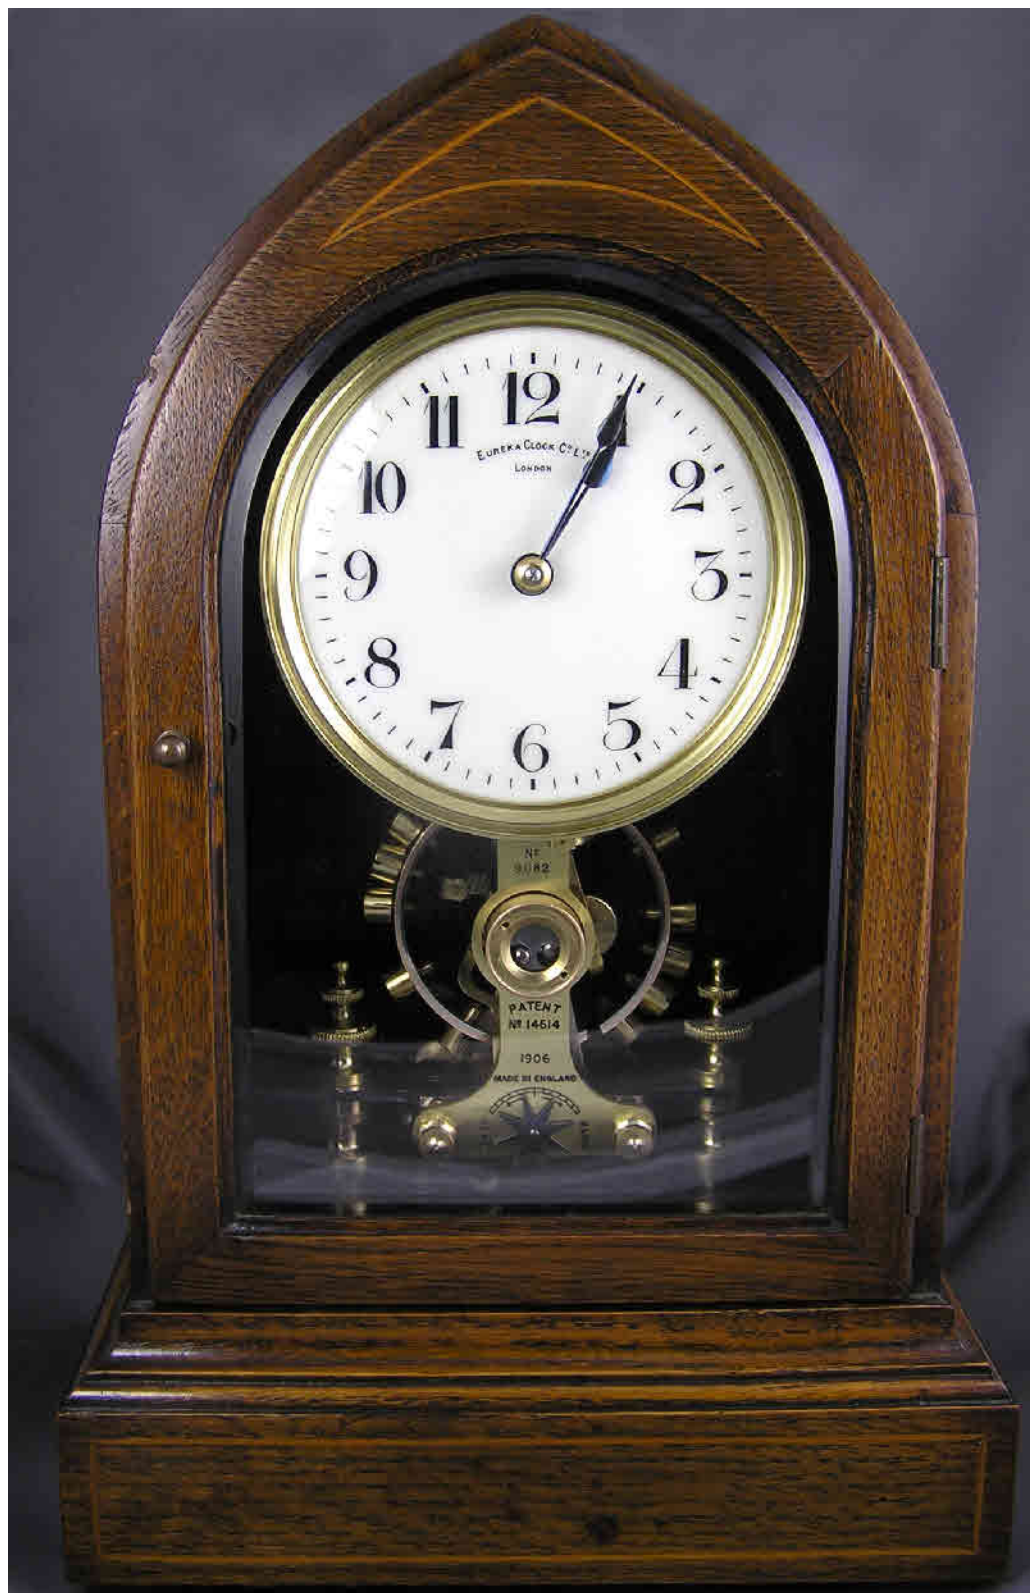
The completed clock.
