Restoration of Eureka Clock Serial Number 9247

Eureka Clock Serial Number 9247

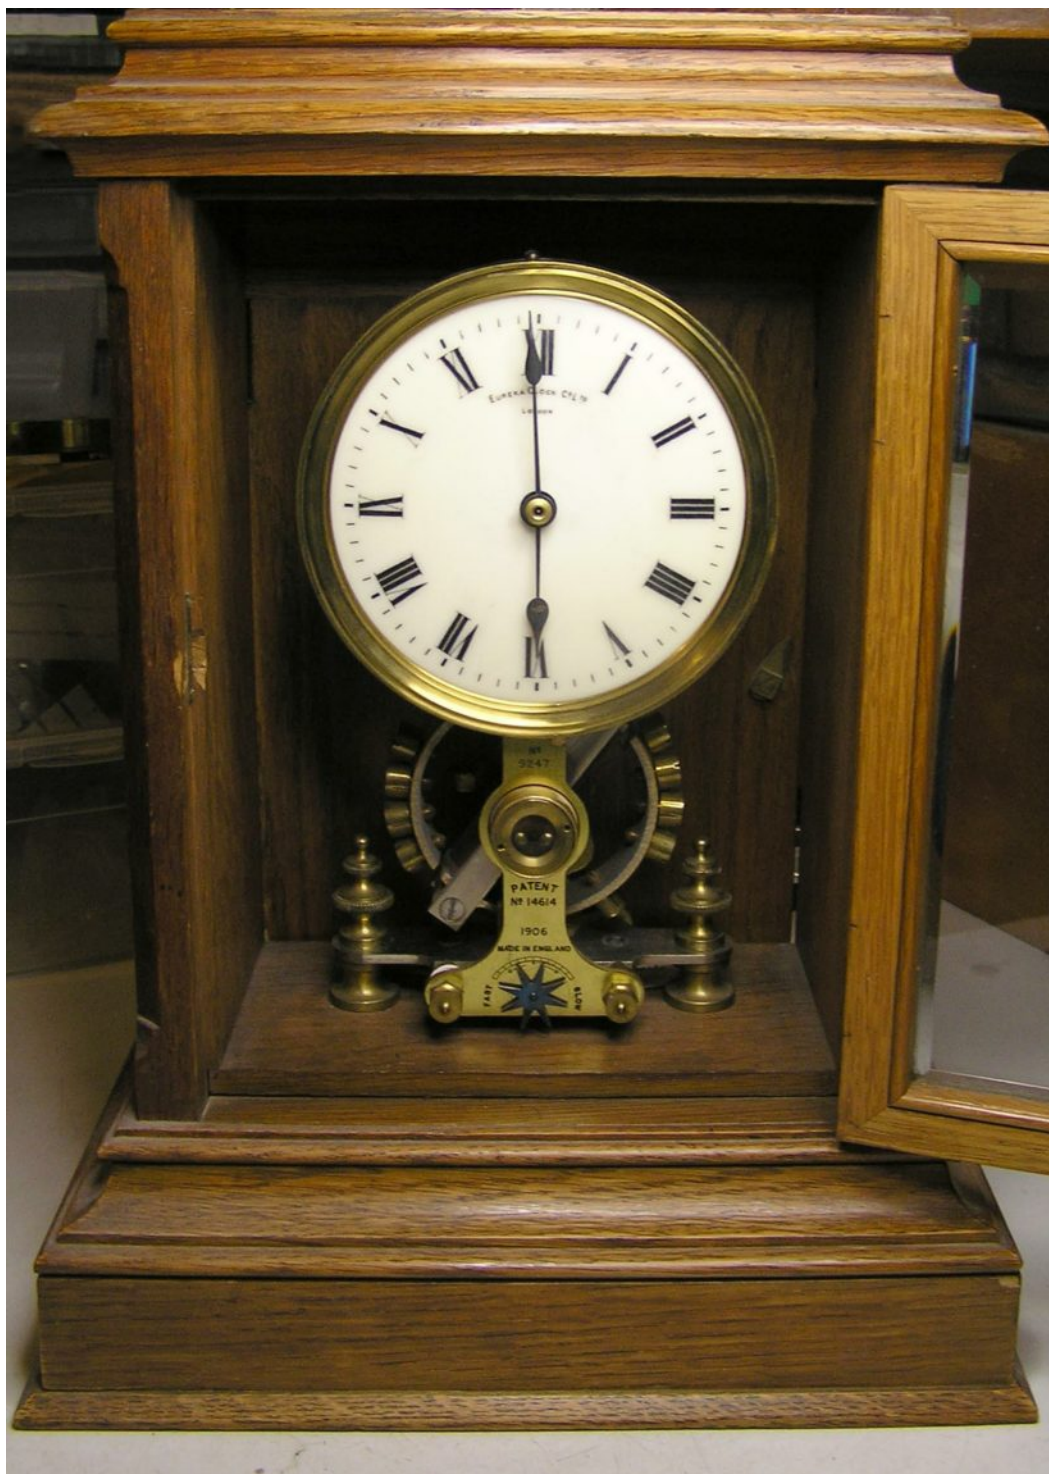
This tall movement Eureka in an oak case I saved till last as I thought it would be the most challenging clock to restore. As it turns out, it was! You will see why shortly. But first impressions are that it is a complete movement with a nice clean ceramic dial and two bearing balance wheel. Nothing out of the ordinary so far.

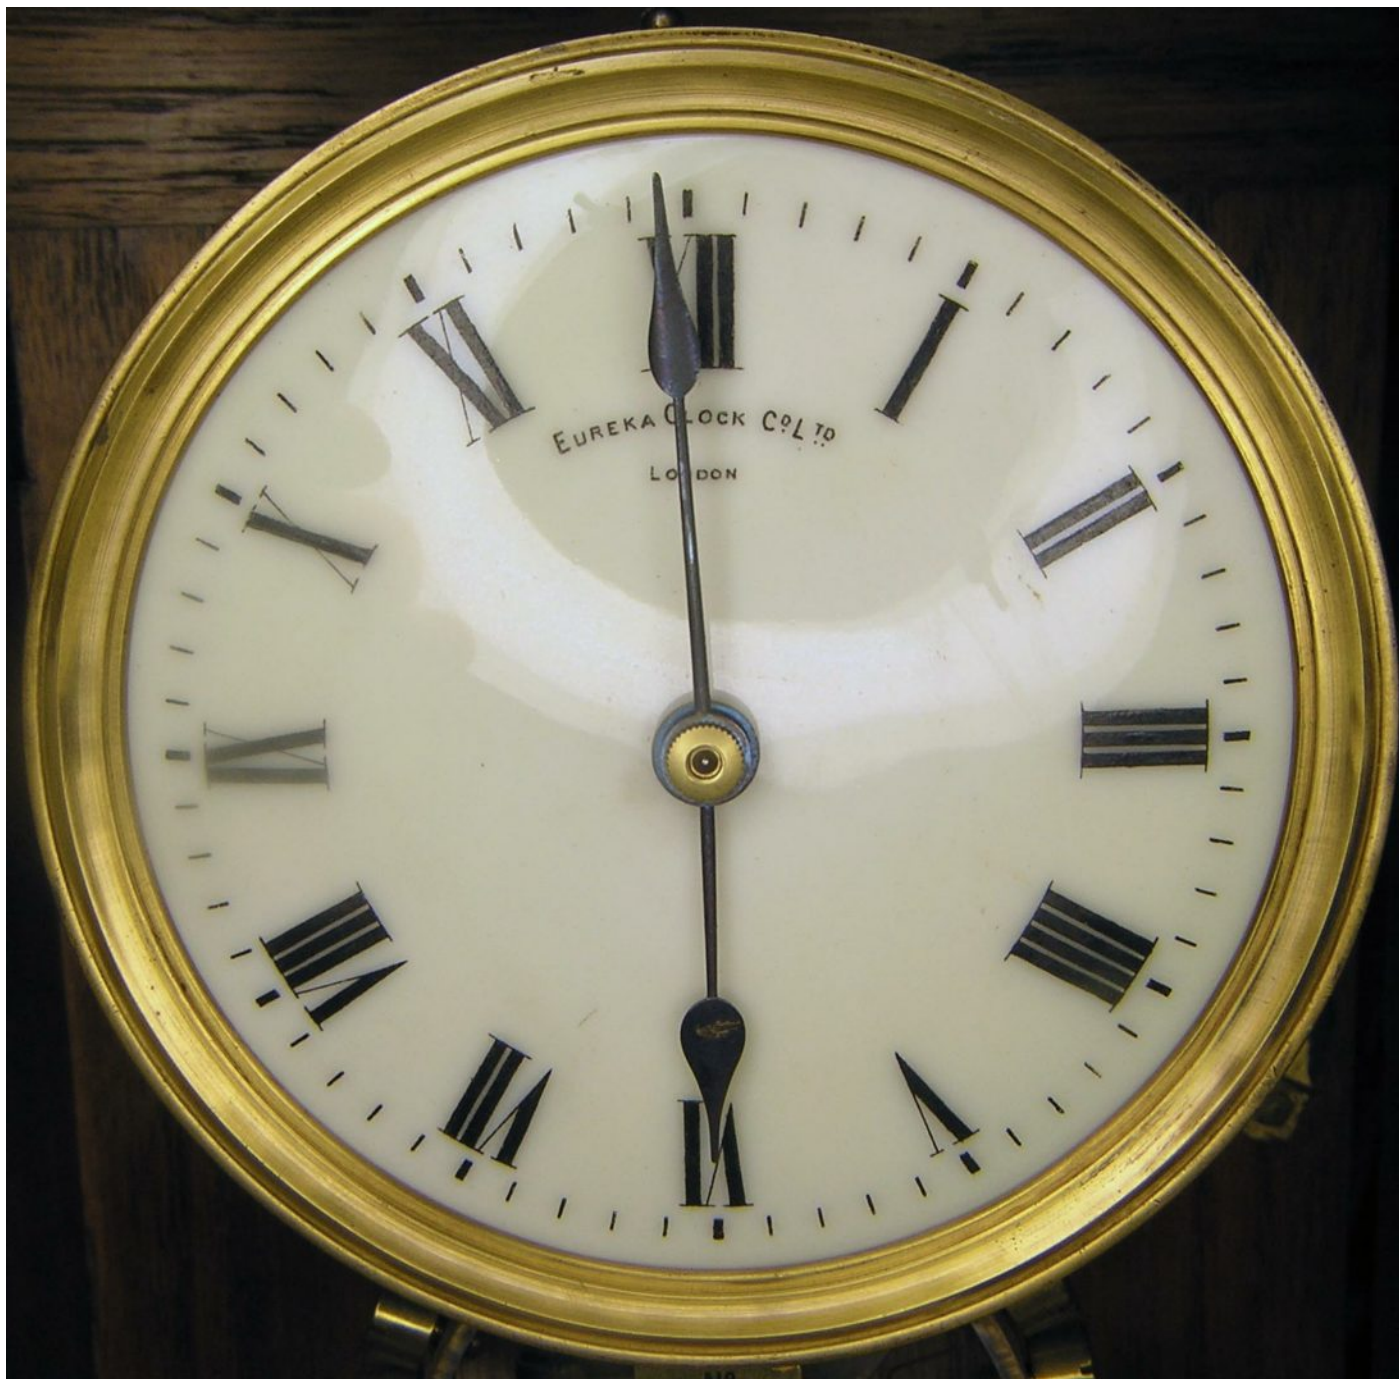
This photo of the dial should have given the game away but I didn't spot it. Can you see a problem?

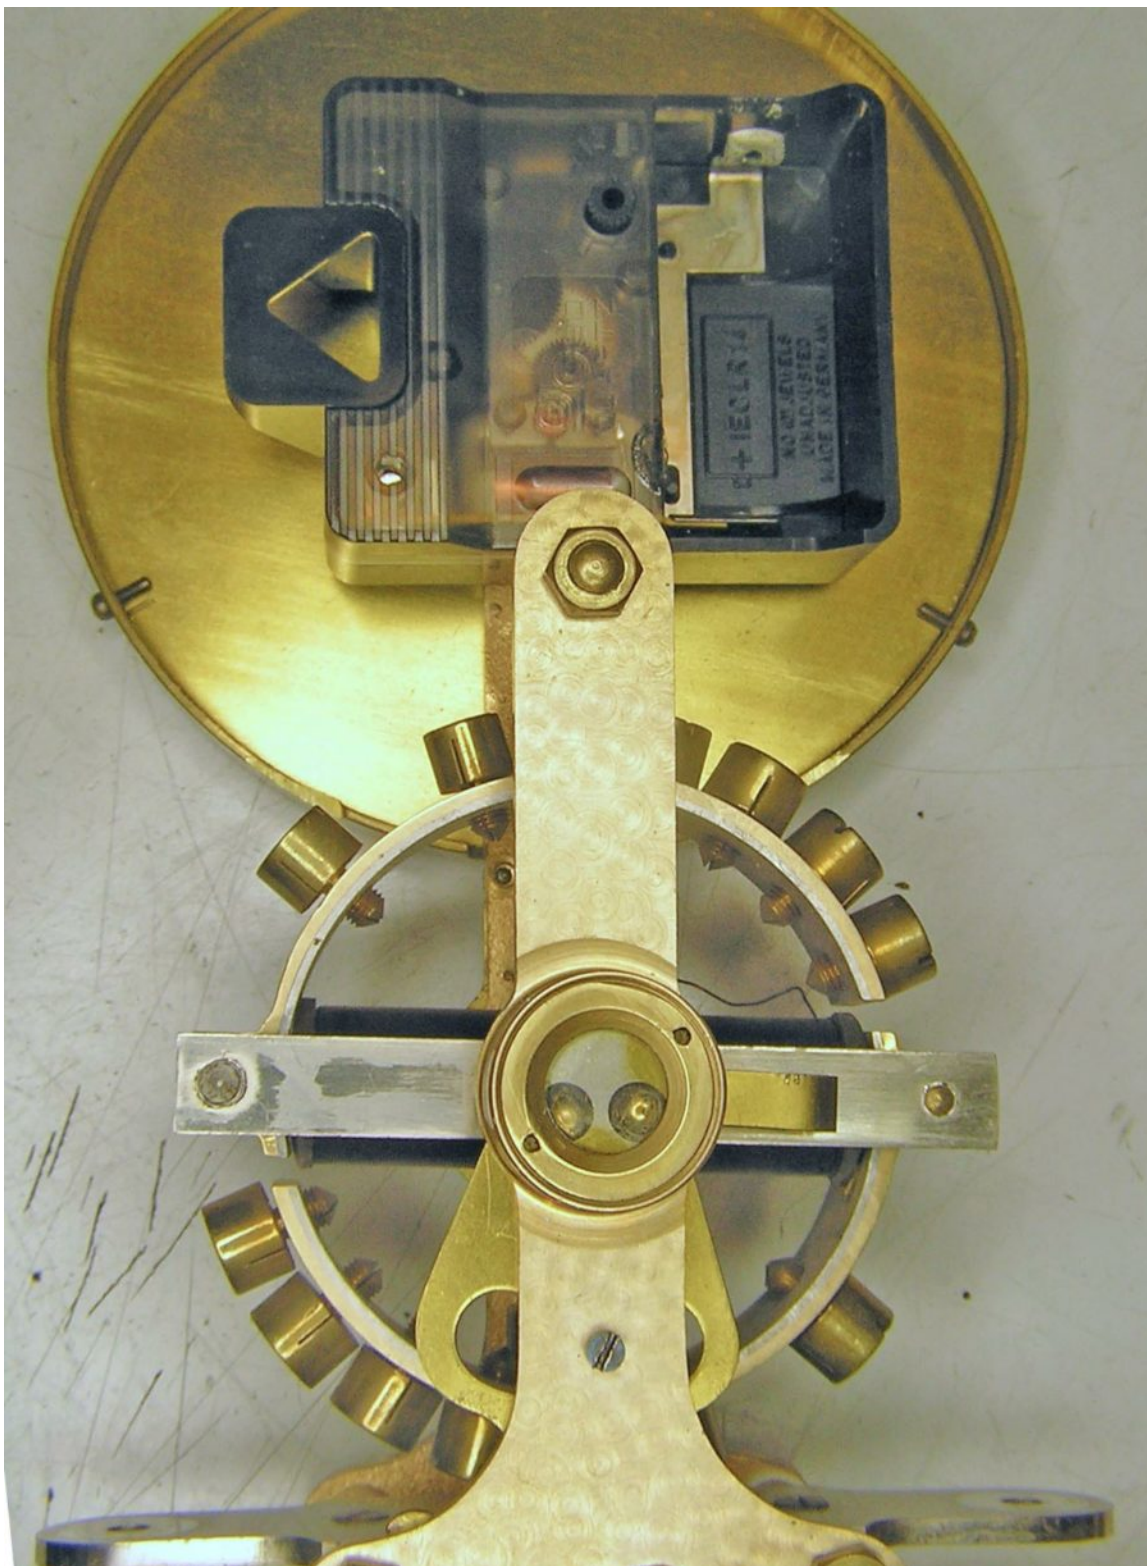
As I said, it is not obvious from the front but is pretty blatant from the rear! A quartz movement has been inserted but using the original hands which had the collets filed to fit the movement. But there was worse to come!

Meanwhile it seems that the balance wheel and contacts were untouched.

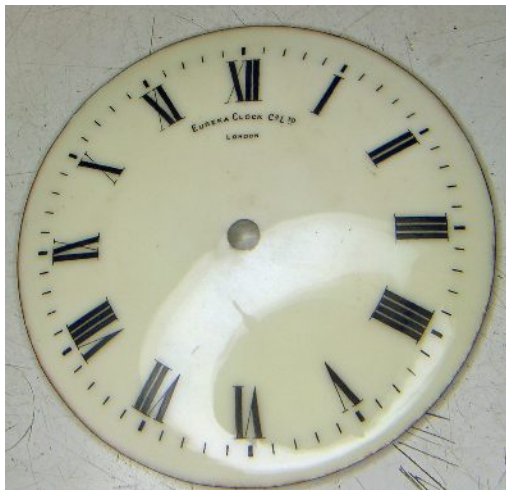
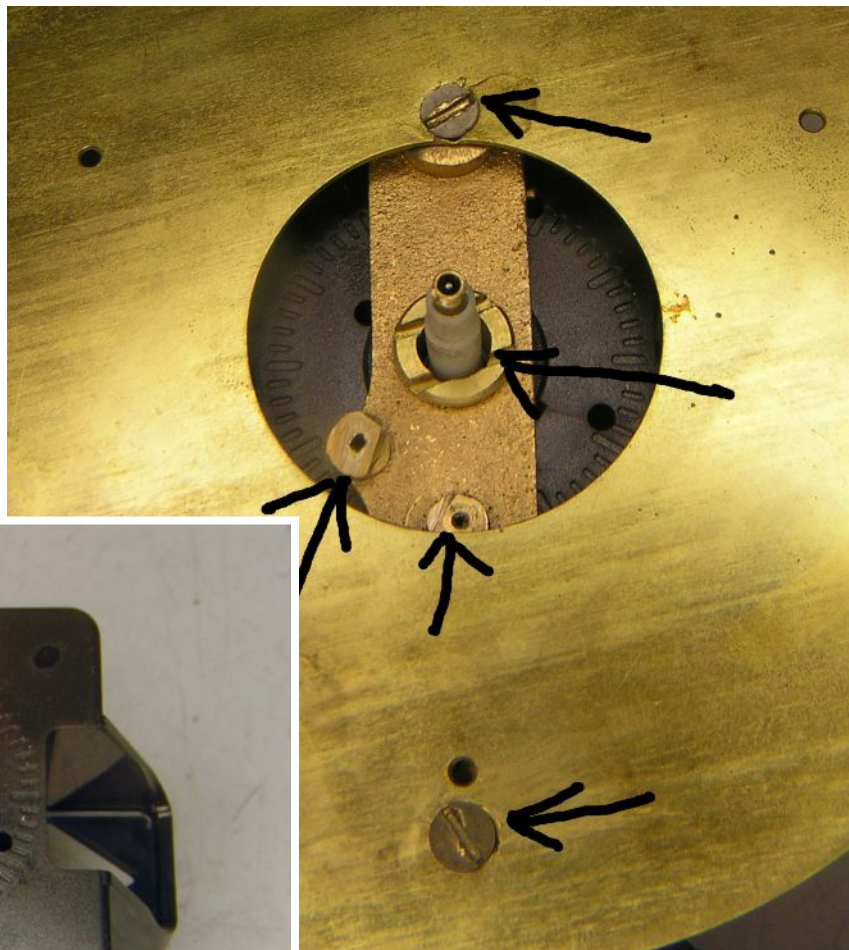
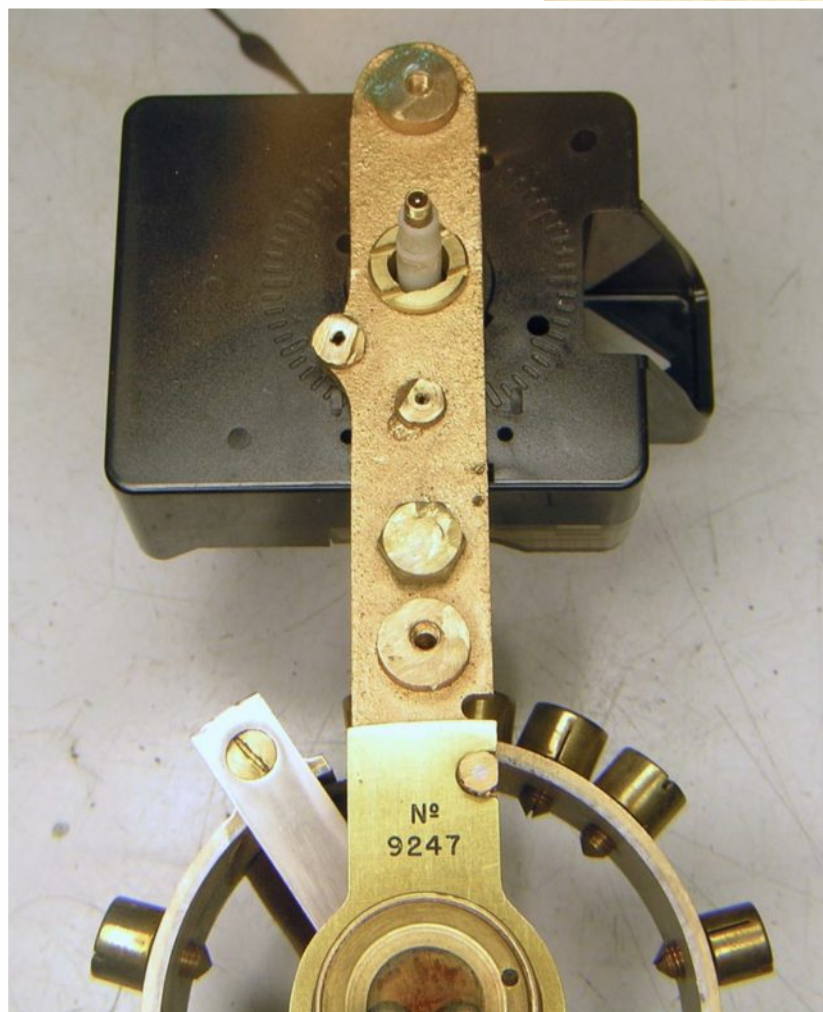
With the dial removed we can start to see the extent of the problem. Note the arrows that show that whoever fitted the quartz movement decided to completely destroy not only the wheelwork which is completely missing, but also file down all the pillars and collars that held the dial pan and wheels.

The dial itself escaped any mishandling.

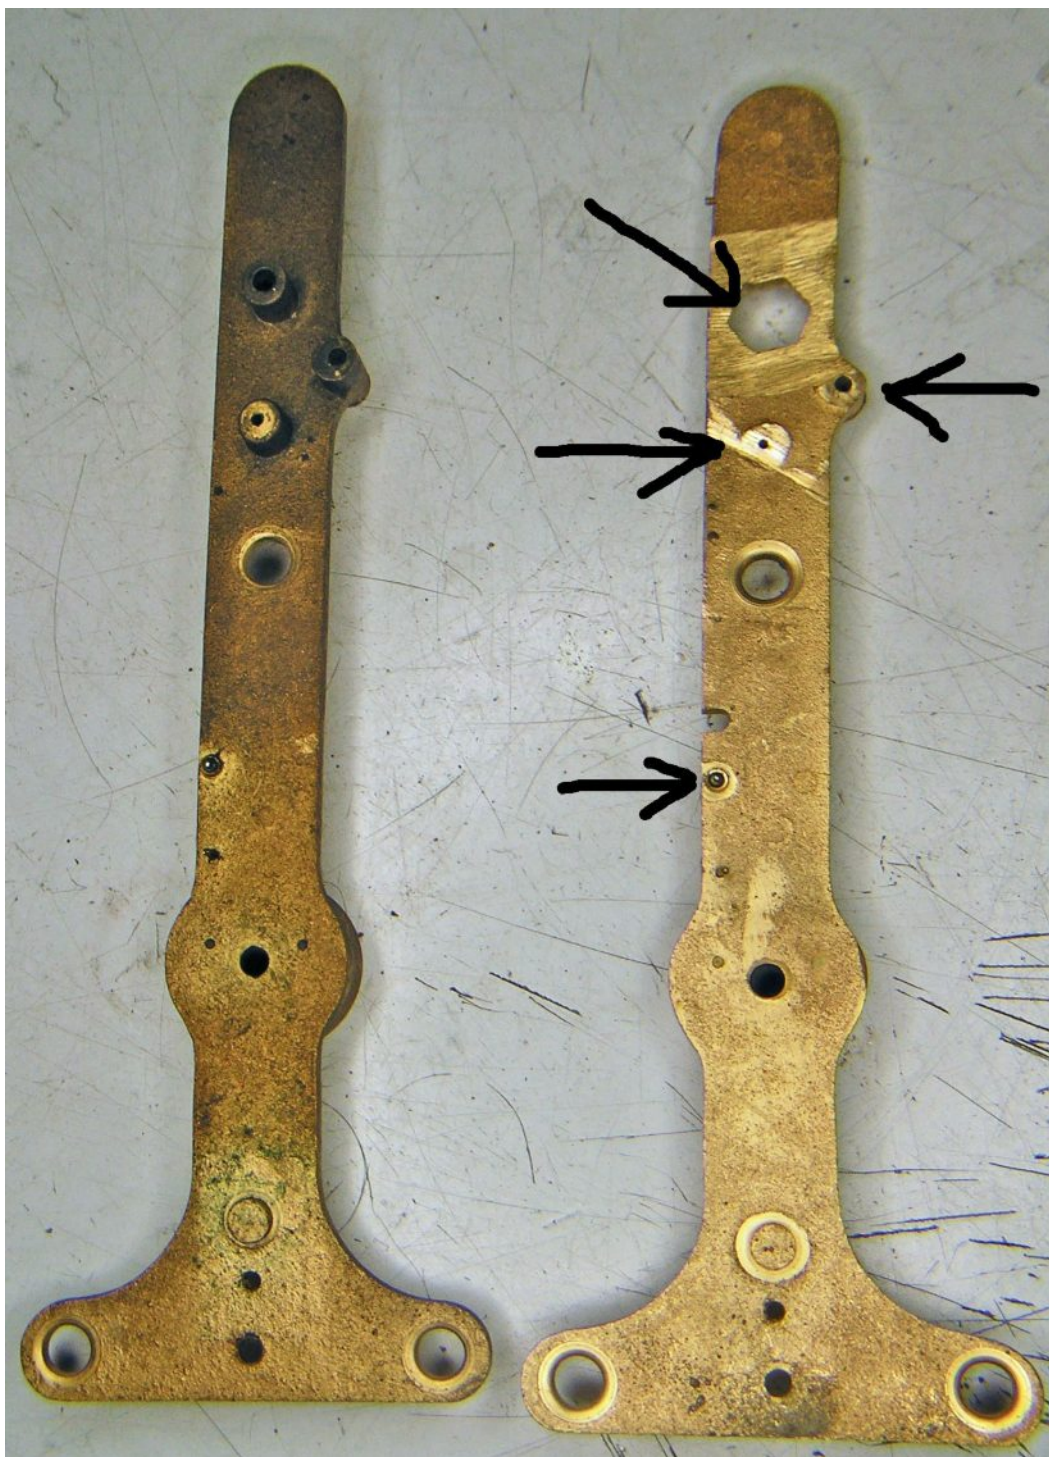
The plate on the left is an original which is untouched. The plate on the right is our modified plate from the inside. Note the large hexagonal hole (probably done with a broach) which held the quartz movement via the centre boss. This will have to be made round before trying to fit bushes. Note also the ground down pillars and hardened steel arbour of the impulse arm which is completely missing along with the wheel work.

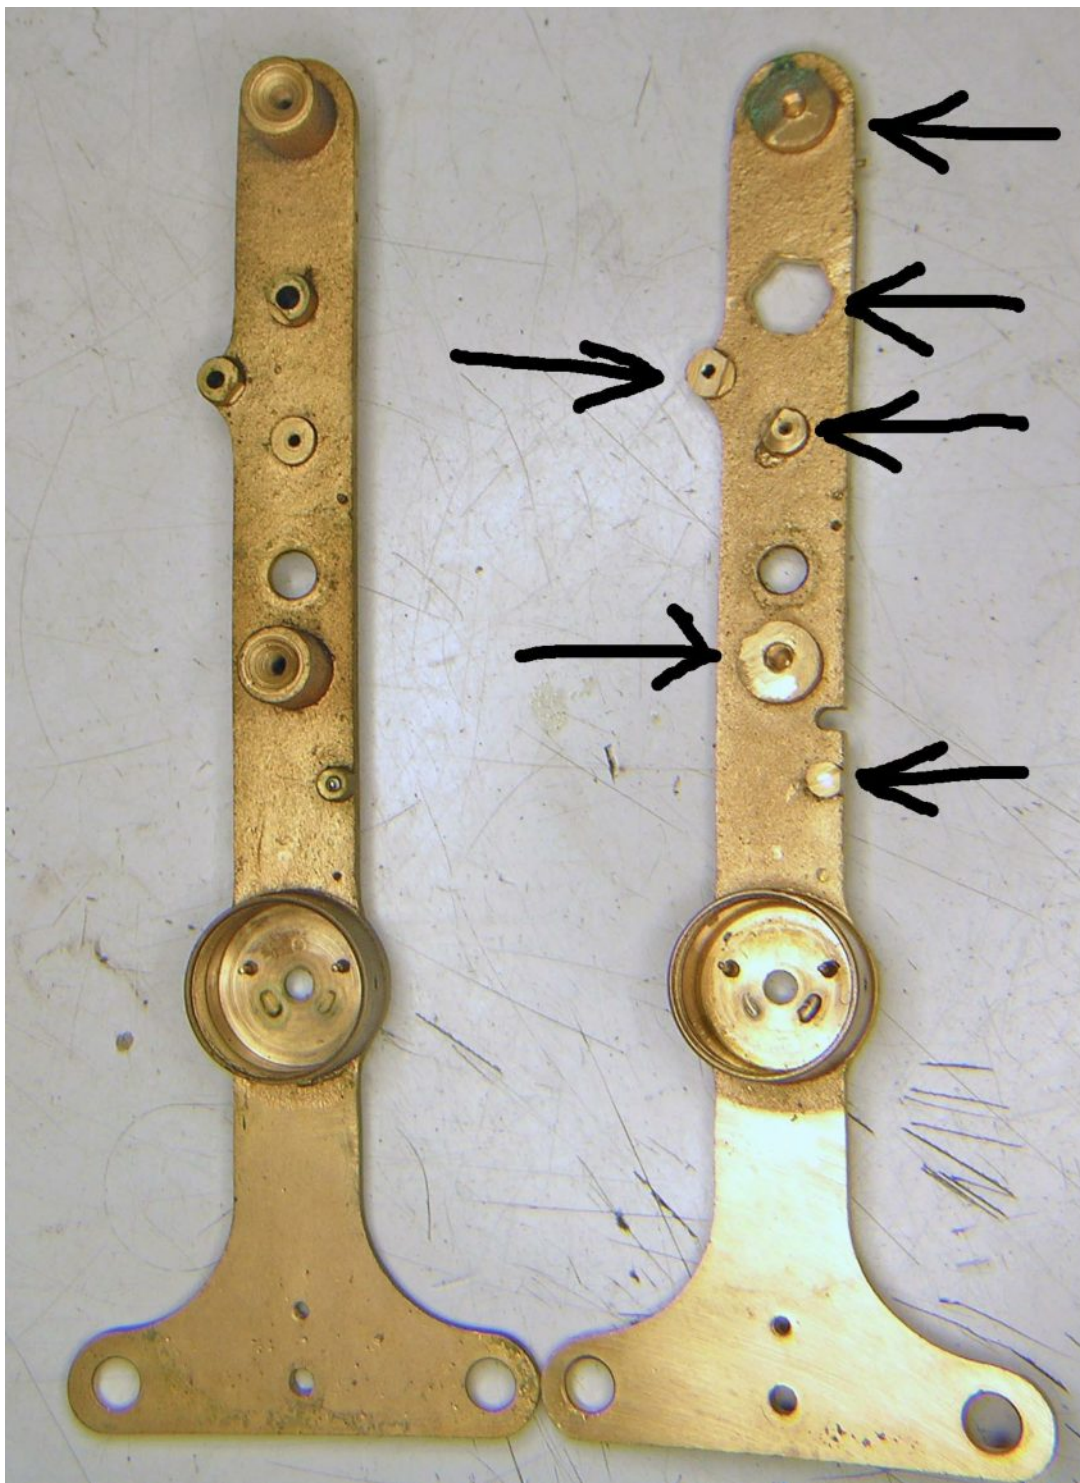
This photo again shows an original plate on the left and outside of our modified plate. All the points arrowed have been ground down. Lots of work to do. My plan of action was to straighten and level up the ground down pillars and round off the large hole. Over to the milling machine.

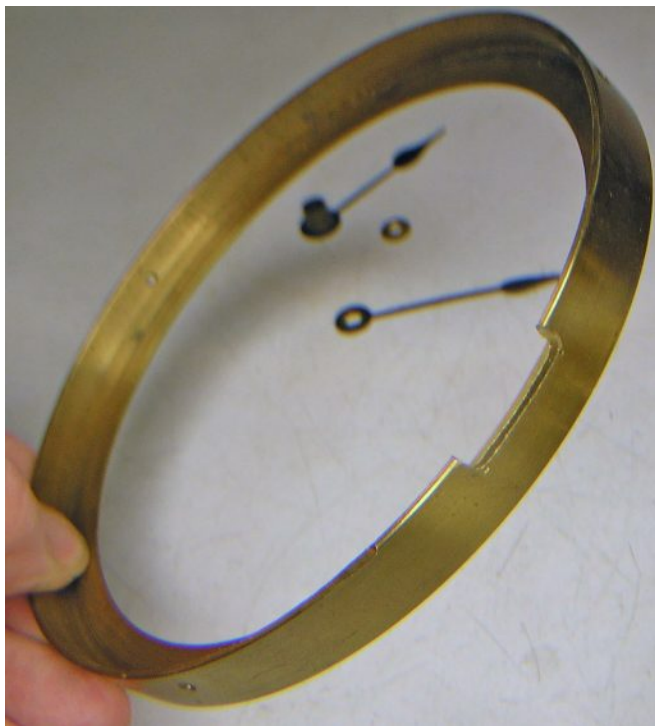
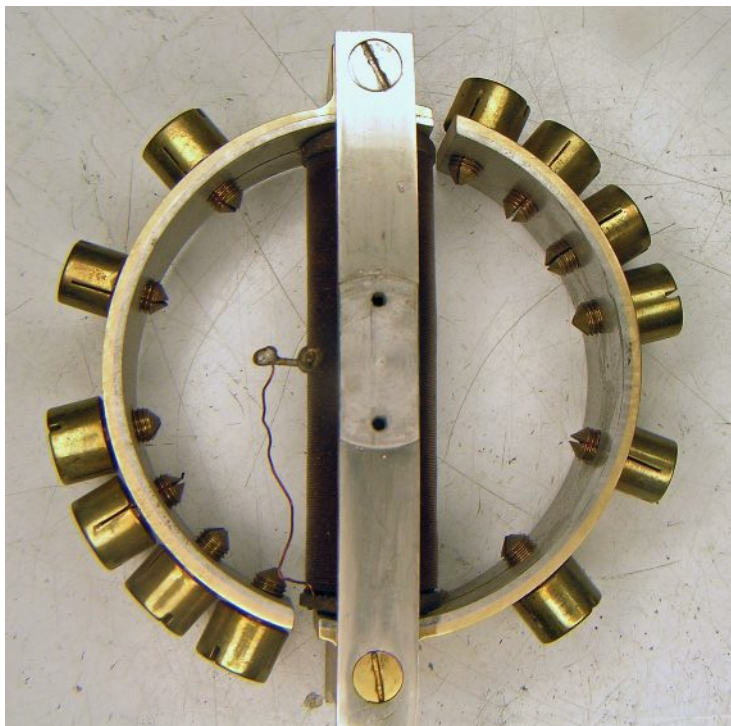
Meanwhile it seems the bezel didn't escape the onslaught of the file or grinder with a rectangle taken out of the rim. Luckily this is below the dial and to the rear so it won't be seen at all.

The balance wheel was in good untouched condition with a resistance of 20 Ohms.

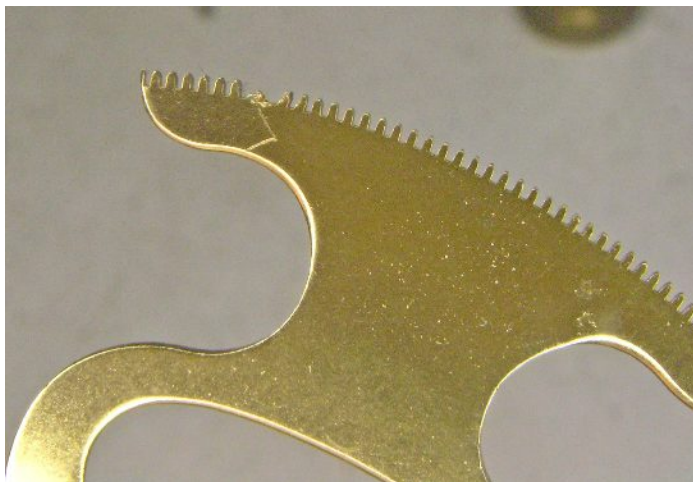
The regulator segment seems to have a few teeth missing, probably from the butcher with the grinder

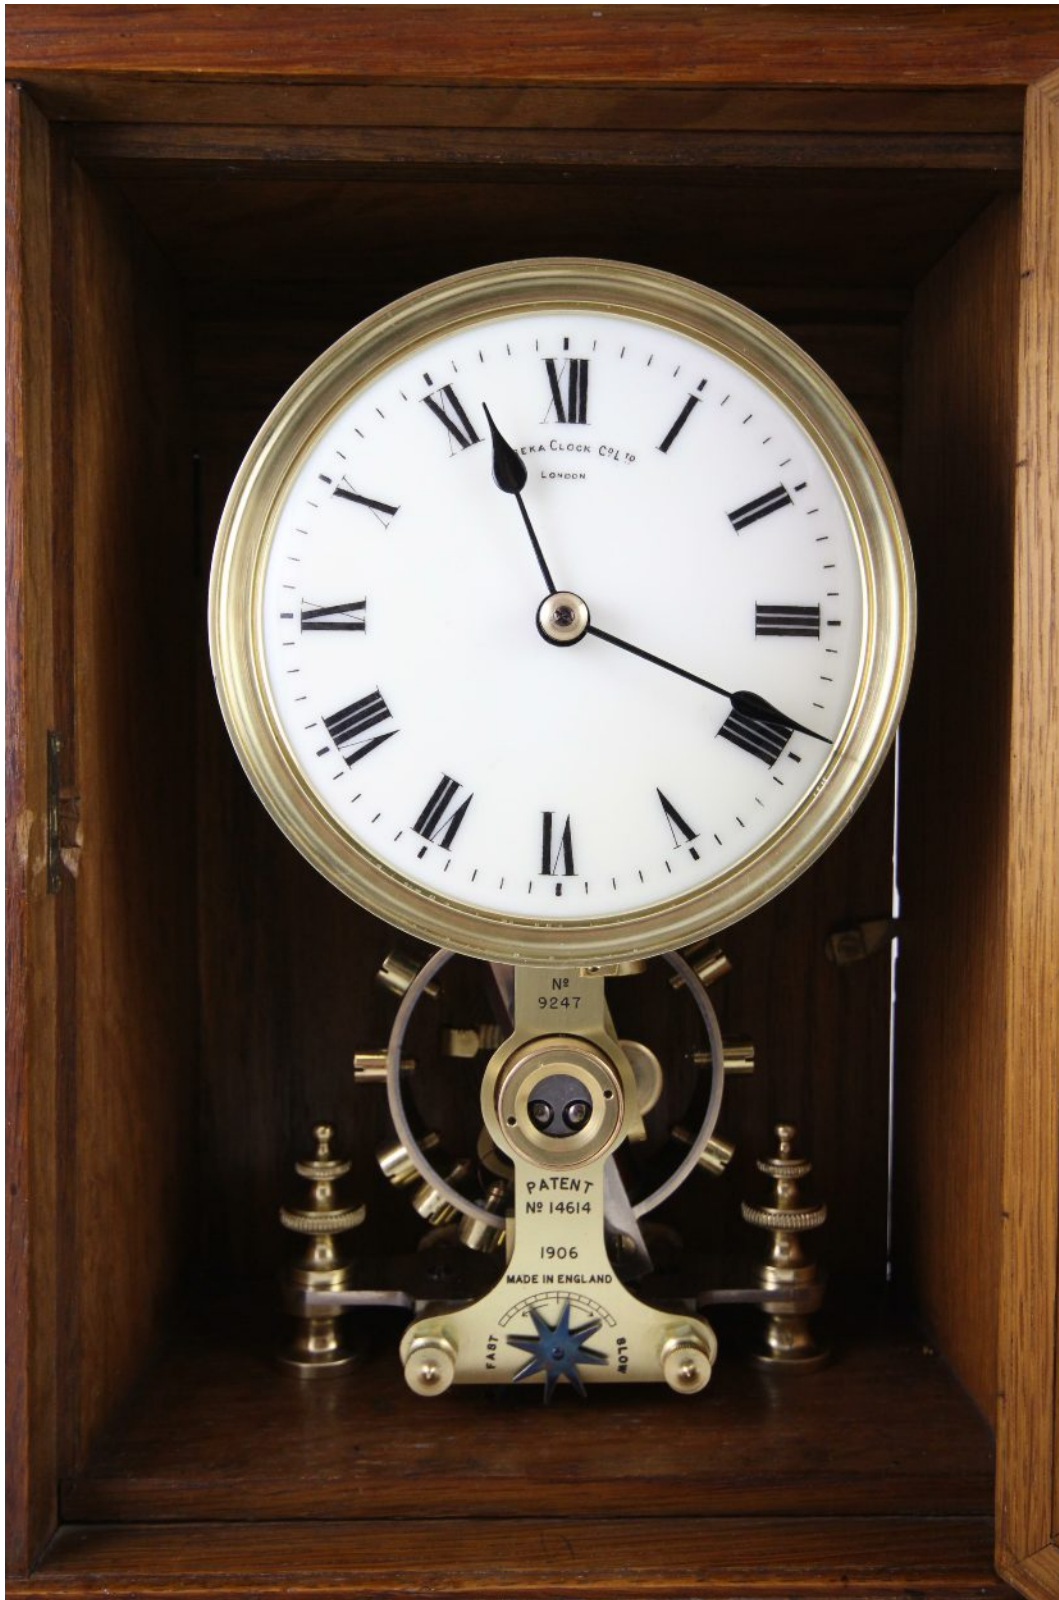
The case itself was in quite good condition and only required the application of some good wax polish.

Back in the case.
