Restoration of Bulle Clock Serial Number 11536.

This restoration by courtesy of the owner.

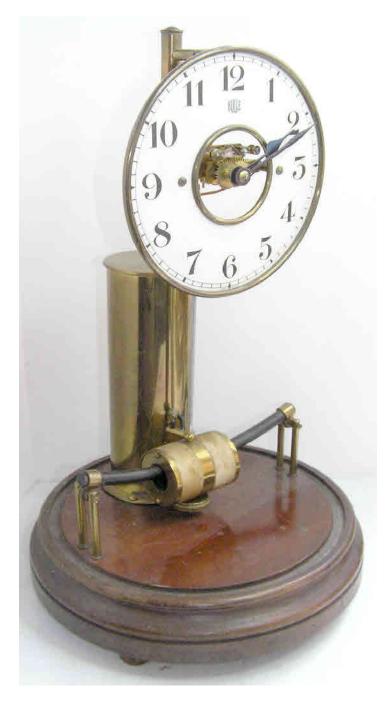
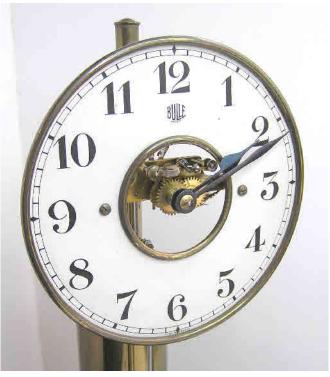
This clock is a tall movement from about the second year of recorded production. Not much has changed although the hands are of the fine spade type instead of the moon style. They look to be original with the clock. The rest of the clock looks to be pretty standard with no modifications or add ons that we can tell at first glance. The dial is certainly in fine condition with no major marks or stains.

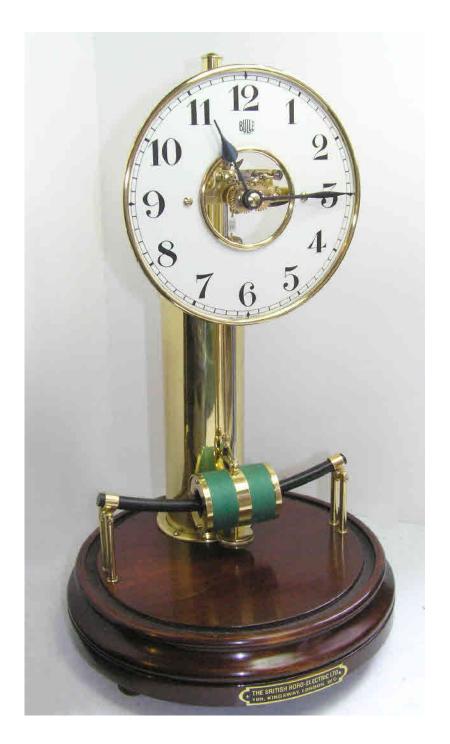
The finished clock.
