# Restoration of Bulle Clock Serial Number 12199.

Bulle Clock Serial Number 12199. (By kind permission of the owner)

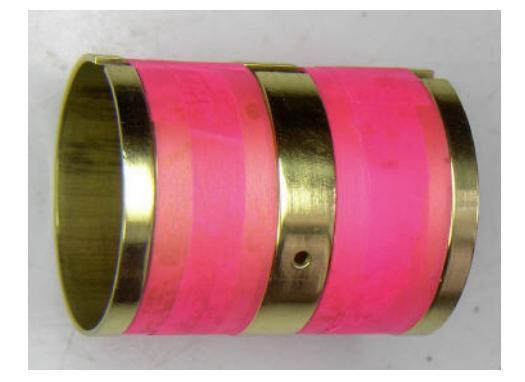
The photo also shows some damage to the brass coil casing which will need to be polished out.

There is always a conflict of interest when presented with a coil that has much of the cord intact (especially when it is in reasonable condition such as here) yet the brass cover needs repairing or cleaning.. To really get at the brass it is preferable to remove the cord so as to effect a good job. But it is then impossible to rewind the cord without it twisting and presenting a Zebra pattern when finished. Besides, the cord is usually so fragile after 80 years that it falls apart at the slightest touch..

In these cases I wrap some light duty masking tape around the cord only and try and clean the brass with 0000 grade wire wool. The tape I use is not as sticky as the normal white variety and does not tug so hard on the cord when it is removed.. I admit you still have to be very careful and it does take much longer but you are preserving a s much as possible of the original clock. There may also be some discolouration of the outside coil of the cord due to dirt migrating under the masking tape when cleaning. But it should be hardly noticeable if you're careful.

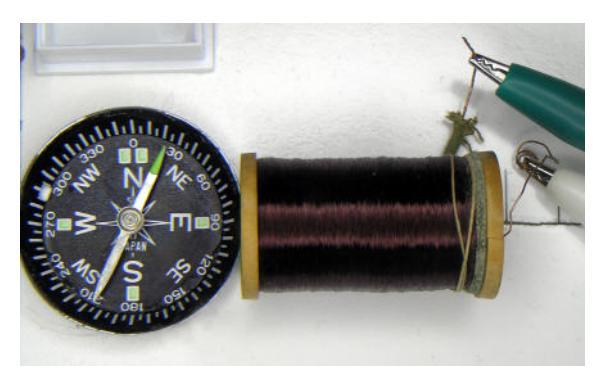
This sequence of photos shows another way of testing the coil. Well, OK, it's just me playing with Electromagnetism. But it does show the principles involved in Electromagnetism and the strength of the field introduced by the Bulle Coil. The first photo shows the effect on the compass of 1.5 volts

The first photo shows the effect on the compass of 1.5 volts being passed through the coil. The magnetic field induced is quite weak and is just enough to deflect the compass 20 degrees if it is pushed right up against it.

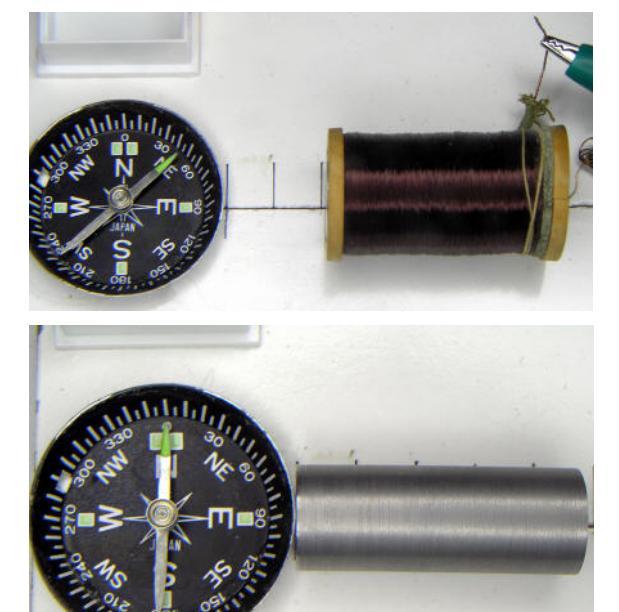
This photo shows the effect on the compass with the soft iron bar introduced into the core of the coil. The magnetic flux was so strong that it pulled the compass needle to horizontal (East) so I moved the coil 20mm down the scale to get a 45 degree reading.

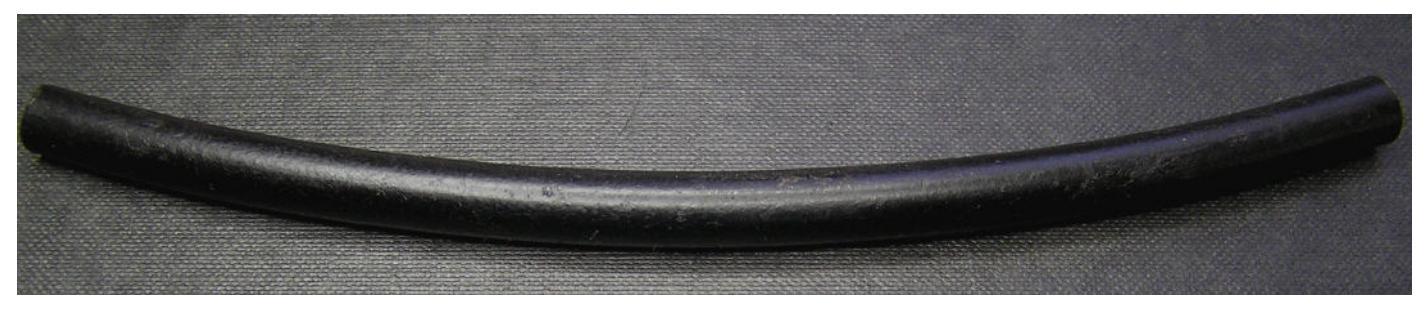
The bar magnet after regenerating and buffing with Grate Black.

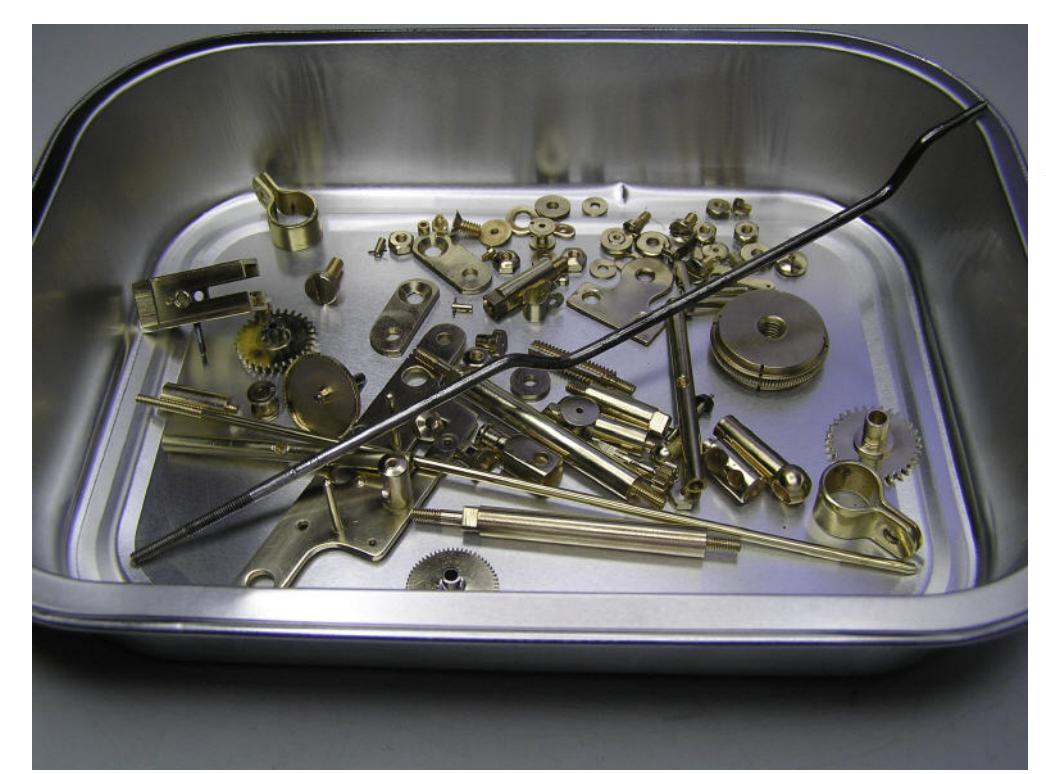
All the parts cleaned and ready for reassembly. Only the frame, magnet retaining parts and the pendulum bob casing parts are lacquered. Everything else is left clean to ensure good electrical contact.

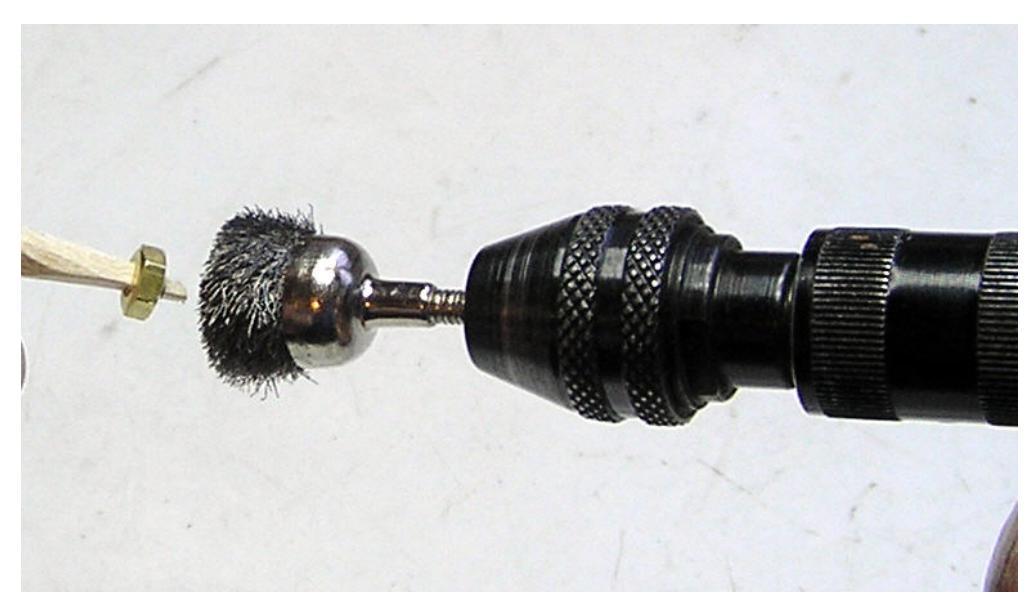
Even though the parts have been cleaned in an ultrasonic tank the parts are quite dull and need to be polished. So each individual part right down to the smallest nut and screw are given the once over with a soft iron rotating brush in the Dremel. This imparts a nice polish to the brass.

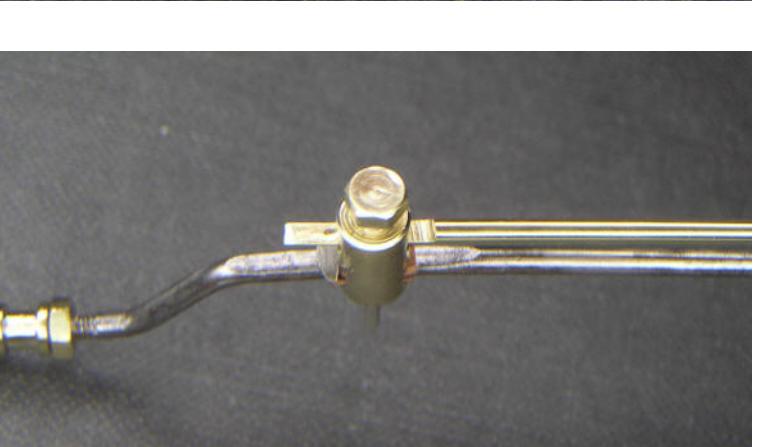
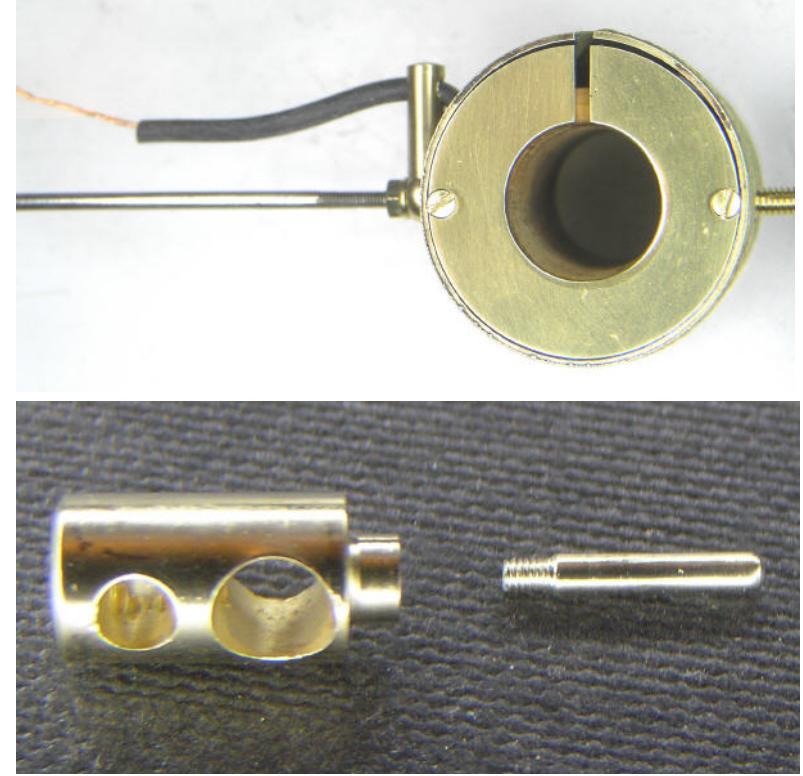
The coil back in the bob with the caps in place. Note the insulated end of the coil in place ready for trimming and fitting to the brass pendulum rod.

The silver contact pin cleaned and ready to be screwed back into the brass housing...

The contact pin assembly with the new steel "T" piece back in place. The "T" piece was cut from mild steel strip 0.5mm thick. I held it in a small hand vice while cutting and shaping..

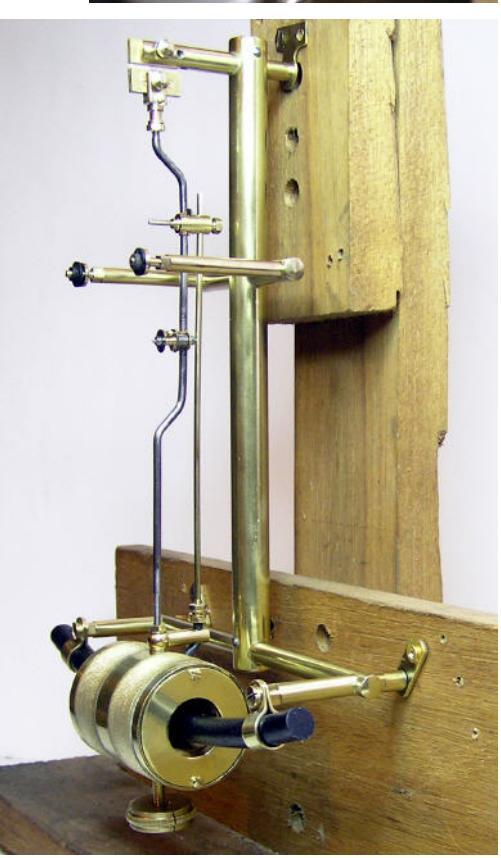
The finished pendulum assembly in place on the test frame.

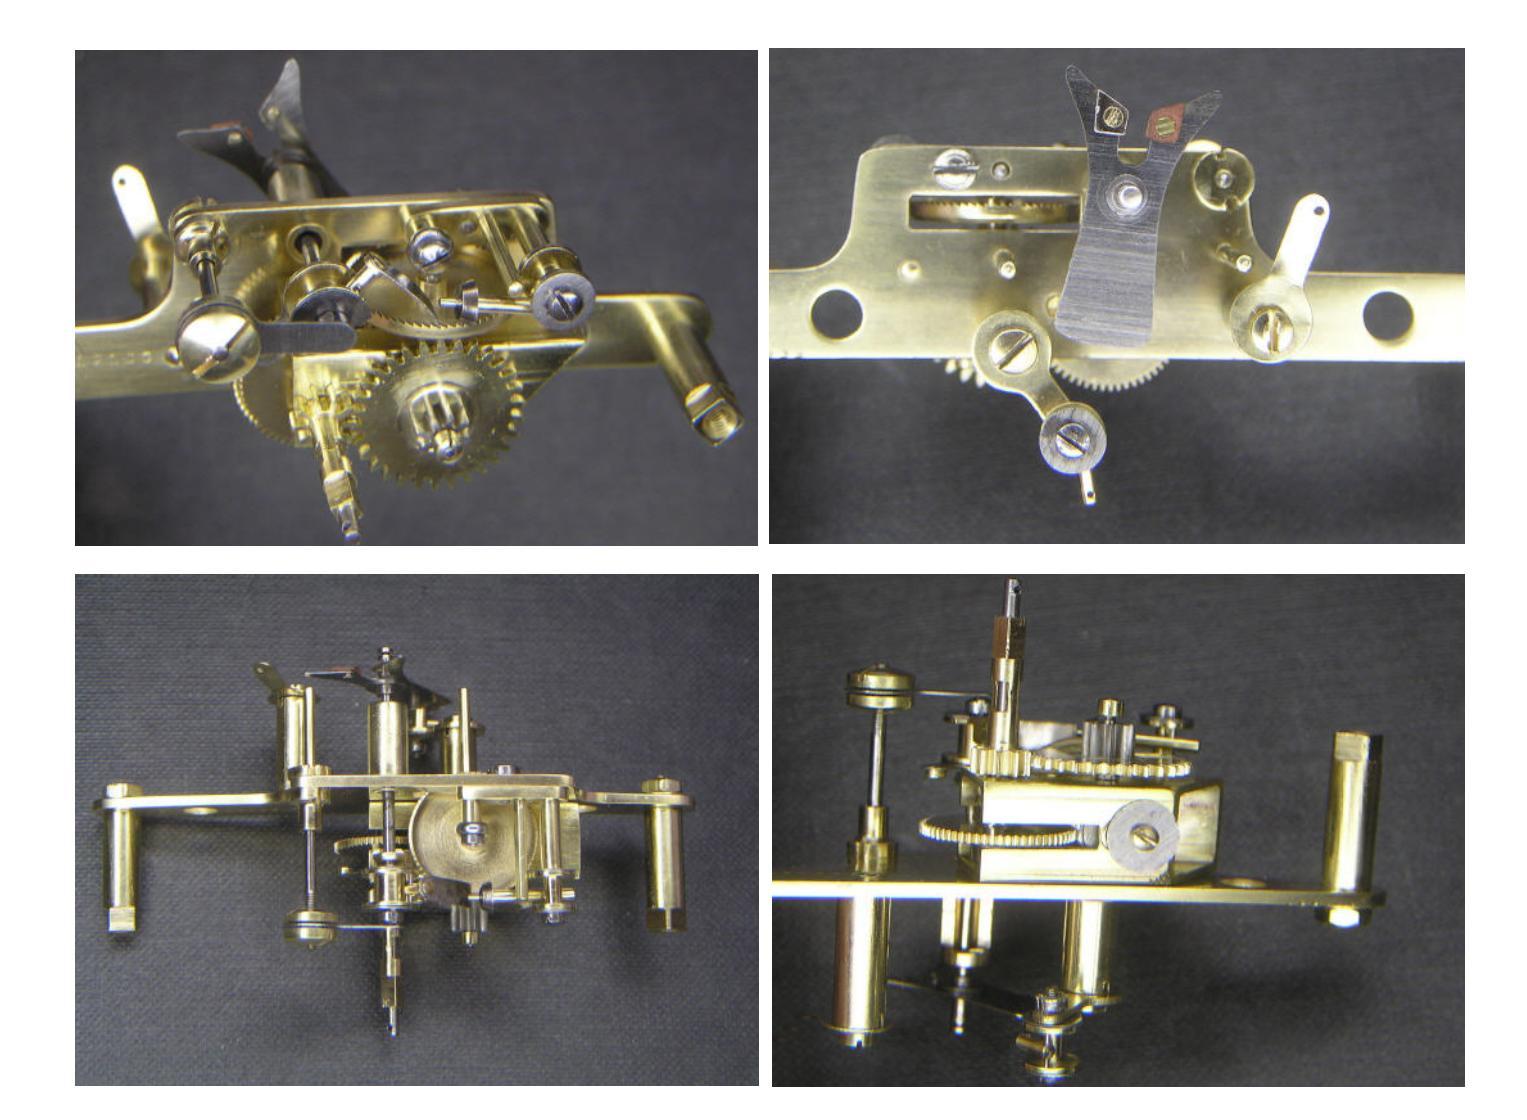
The movement assembled and finished. The silver contact spring will now be fitted and the the assembly mounted on the frame with the pendulum. Note that on this movement there is no provision for a damper assembly. The arbour is still there but only supports the stop assembly for the fork arbour.

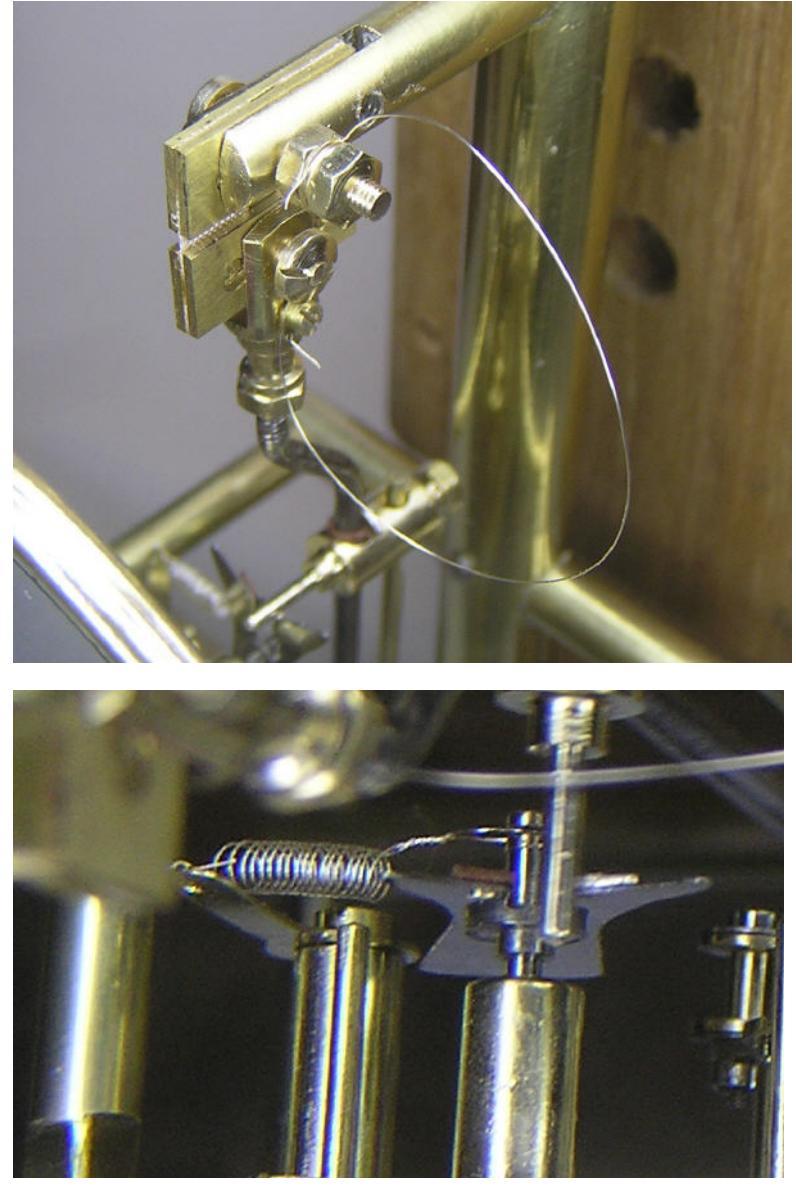
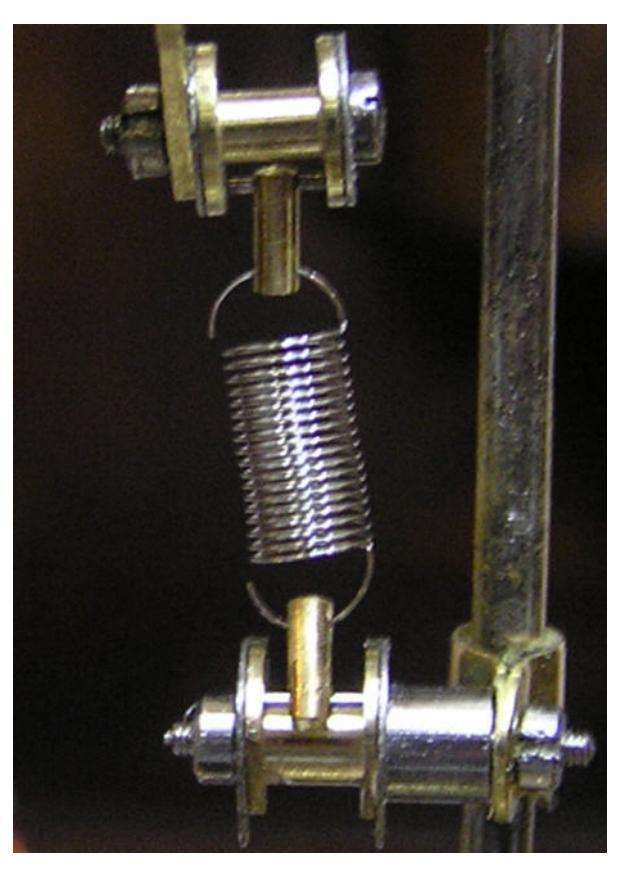
The photo top left shows the Silver contact wire that jumps the gap created by the silk suspension. It must have a large loop so that it is not stressed into breaking by the continuous rocking of the pendulum. The photo above shows the Isochron spring in postion. It should be under no tension when at rest. In fact for the first test run it should not e

be under any tension even when at full amplitude. This will then allow the rating nut to be tested to check that the clock will run slow when fully lowered. Only then should it be brought under tension with the rating nut set at the midway point. The final photo shows the Silver Contact spring in place rolling in the silver groove at the back of the fork arbour, under just enough tension to keep it there.

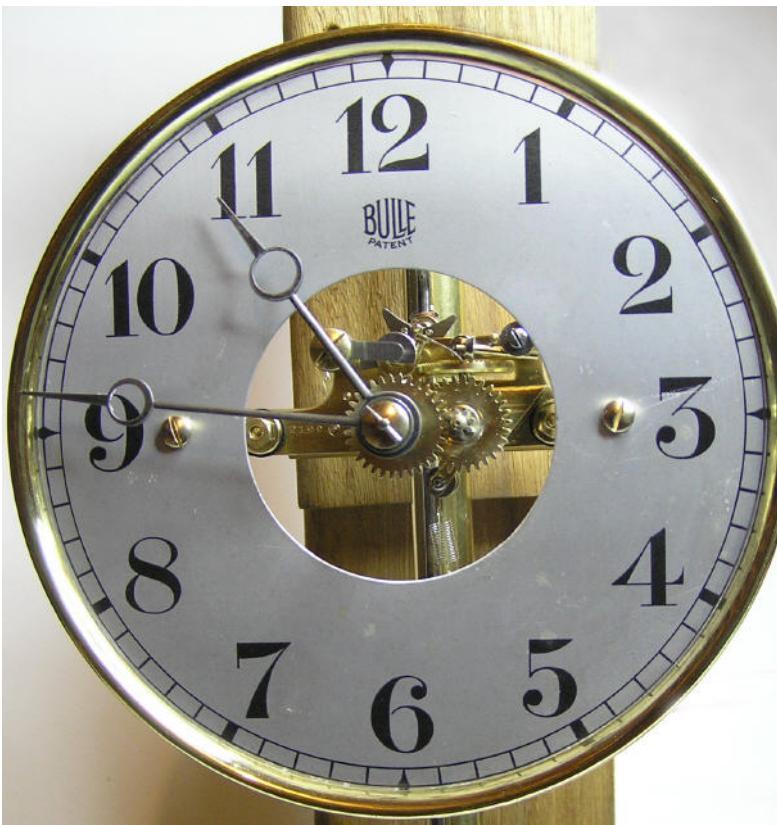
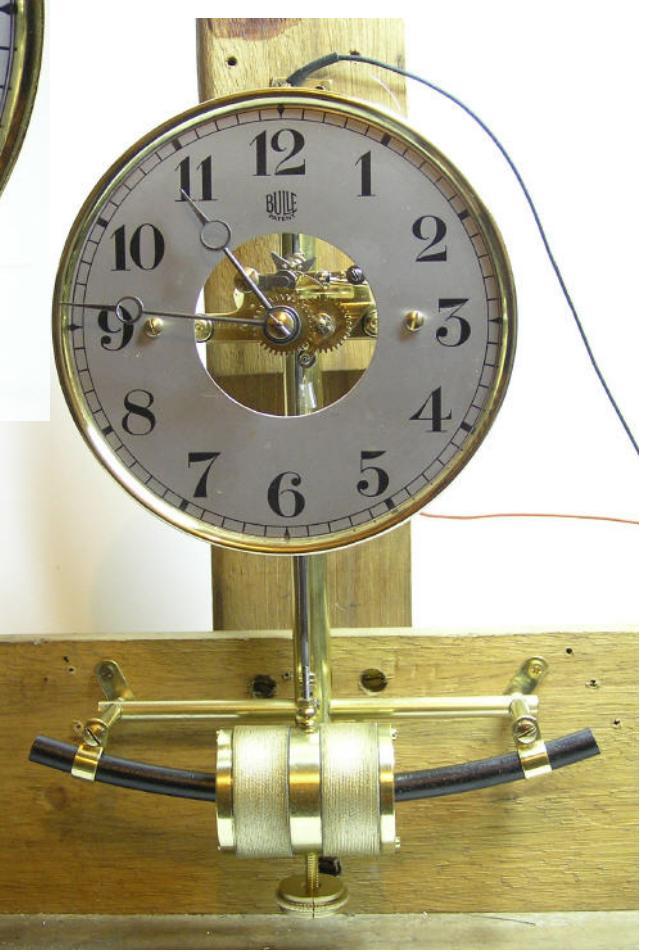
The photo at right shows the finished clock in place on the test stand. There now follows a week of testing. making sure that the pendulum has enough amplitude to drive the count wheel and checking that the pawls are not gathering more than one tooth at a time. Loss or gain in 24 hours should only be of the order of minutes. If it gains an hour or more then it is gathering two teeth at each swing. This is normally attributed to the contact pin being set too deep in the fork. The face was cleaned with just soap and water whilst the brass surround was polished with '0000' gauge wire wool. Great care needs to be taken with this process as one slip and the dial is marked for good. I use two pieces of thin brass sheet; one cut to the outside diameter and once cut to the inside. This allows me to cover the face whilst working on the brass.

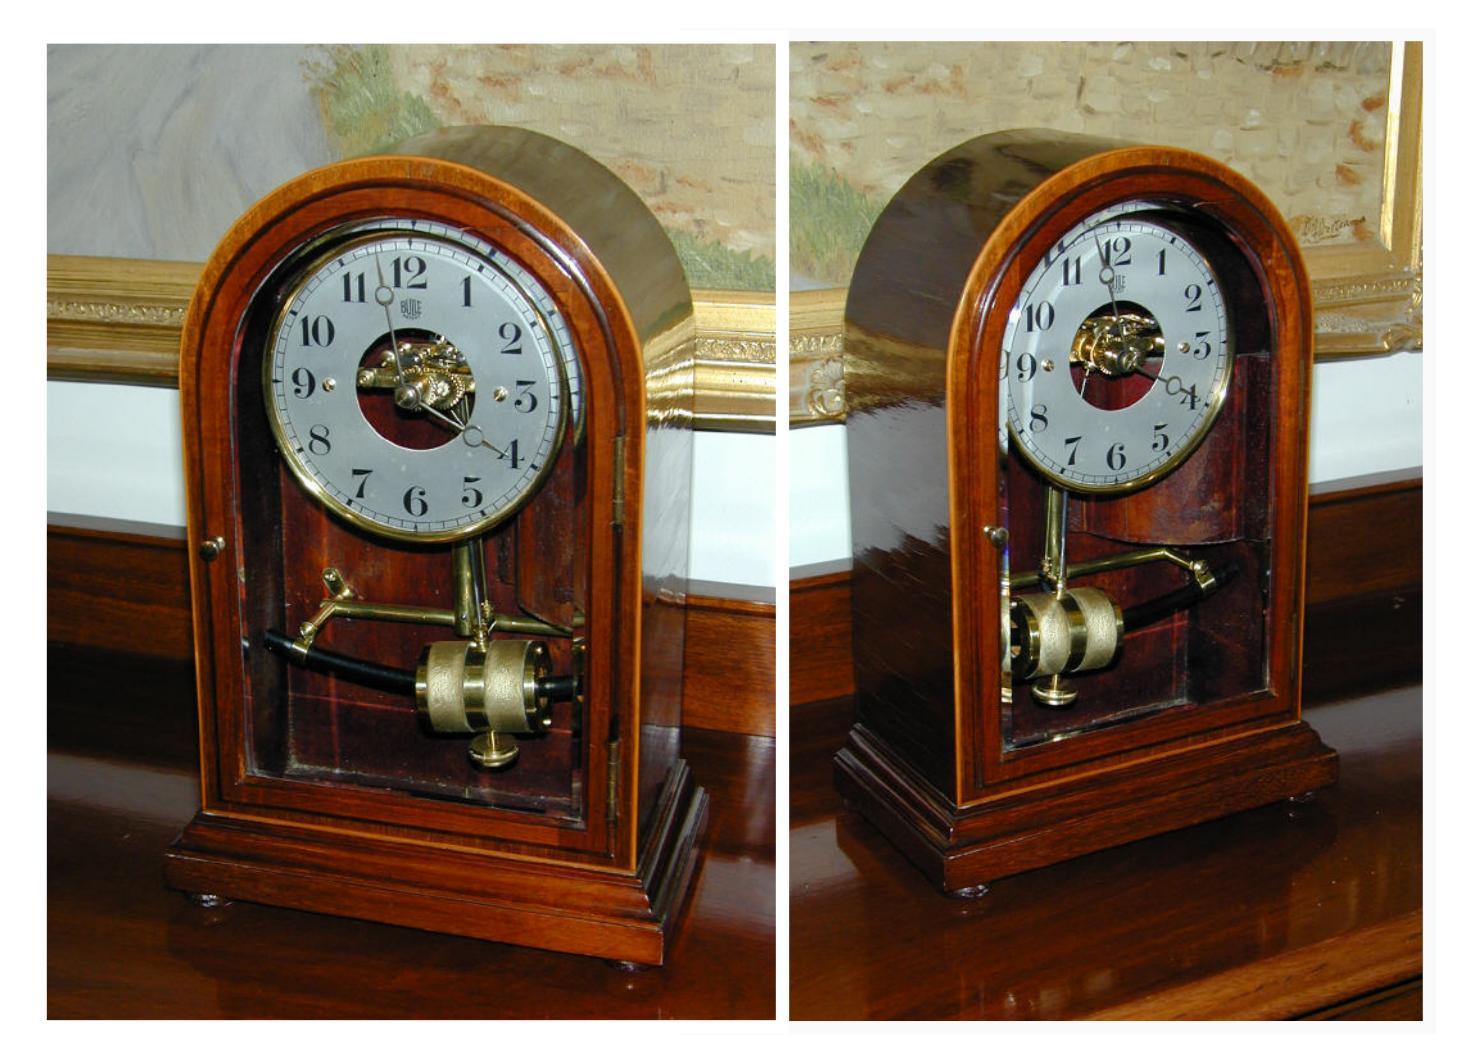
The finished clock reunited with the case and door. Photos kindly supplied by the owner.
