Restoration of Bulle Clock Serial Number 125374.

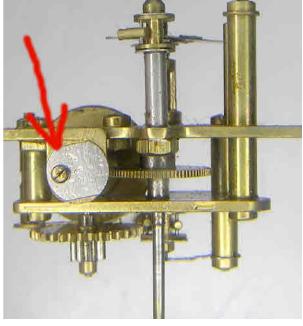
The top left photo shows the general state of the movement. Very heavily contaminated with old gummy oil. Under the movement (above) is a hardened steel plate which acts as an end stop the the vertical count wheel arbour. The style on this clock is wrong as it is normally of a smaller thicker steel with two screw holes. We'll soon find out when we removed it..

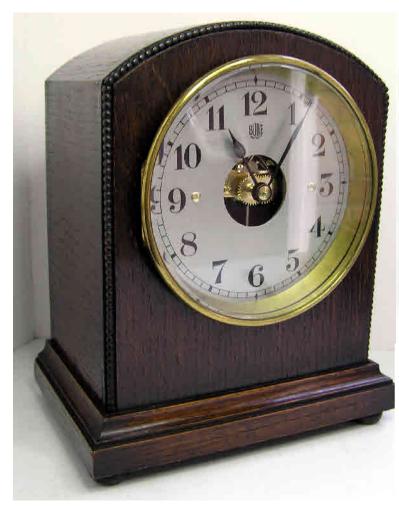
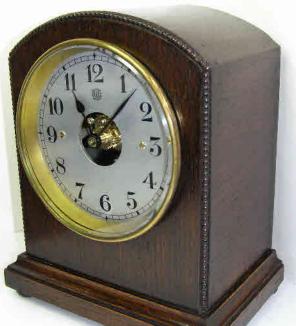
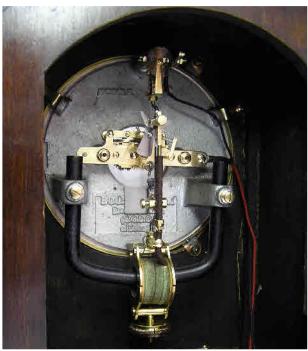
The completed clock.
