Restoration of Bulle Clock Serial Number 180859.

Horologix

—Early Battery Clock Parts & Restoration

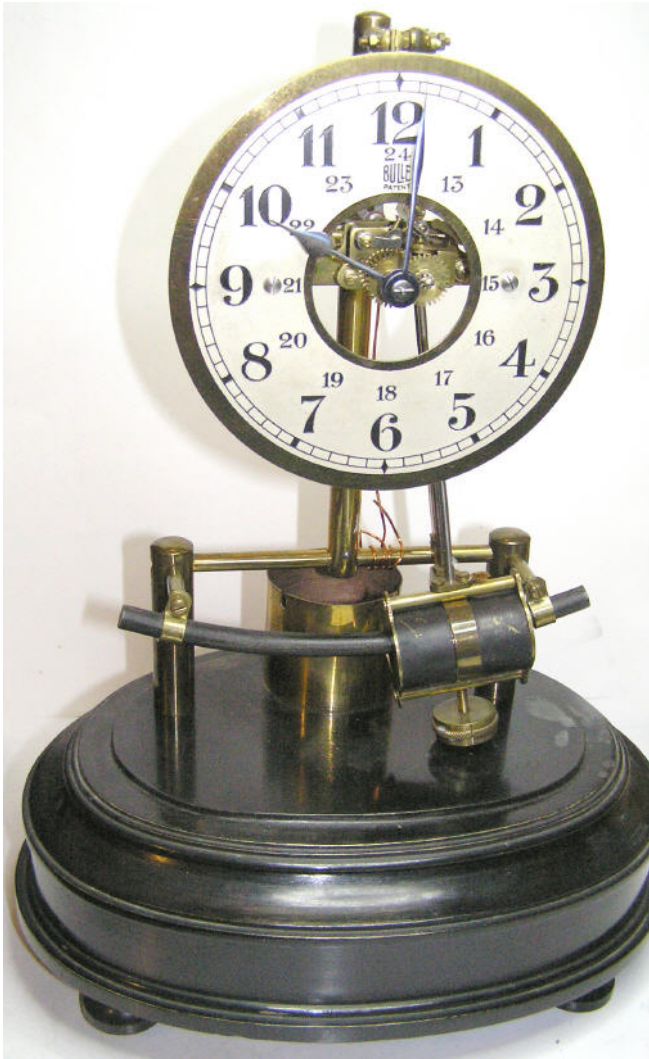
This clock is of the tall type on an ebonised wood base. It sits under a Crystal Glass dome which has not been supplied. The restoration is shown on this web site with kind permission of the owner.

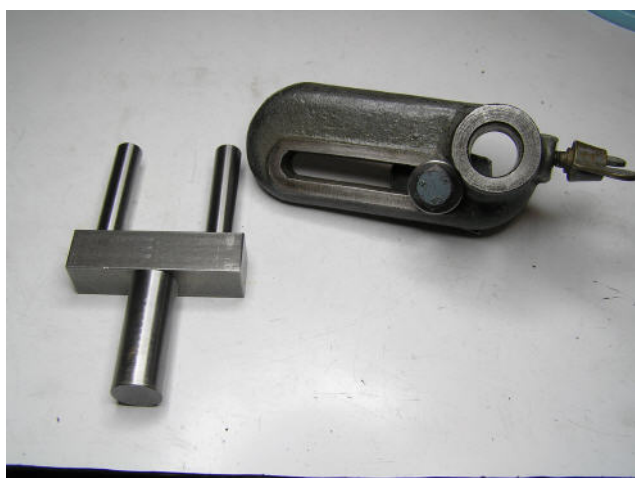
This photo shows the T rest with vertical levering bars. I already had a standard Myford T rest so I used the base of this as the starting point. All I needed to do was turn up a bar of steel to 19.00mm to fit into it. To this I added a cross piece of 3/4" mild steel to act as the tool rest with 1/2" silver steel uprights.

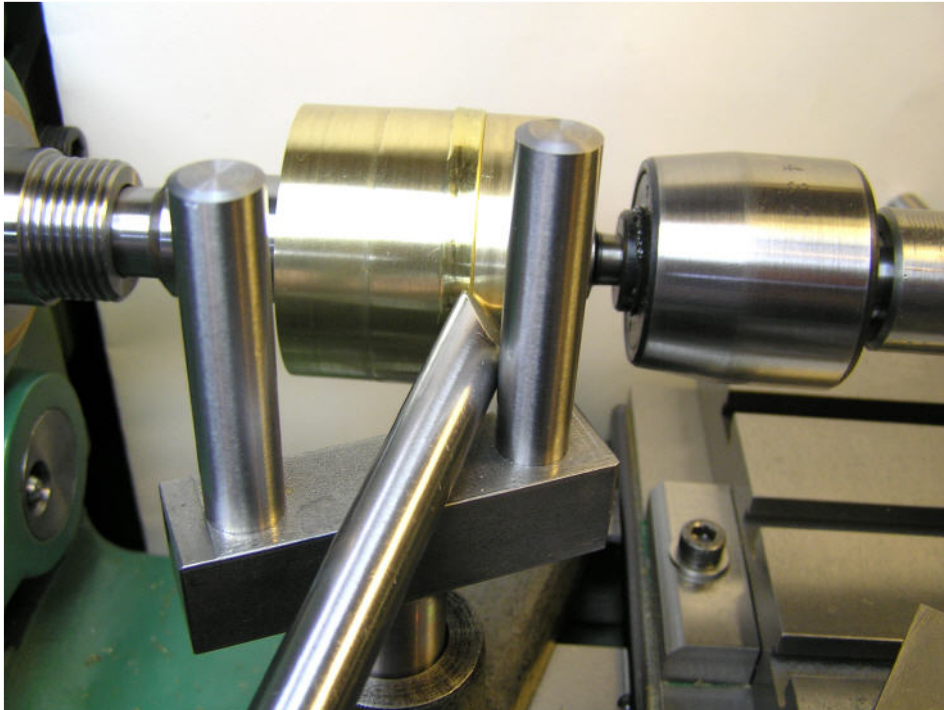
The forming tool I shaped from a 1/2" piece of Silver steel. The end was shaped and polished before fitting it to a wooden handle. The tool can be seen working the brass in this photo. It is being levered against the post while easing the brass into shape on the pattern..

The pattern I turned up from brass and secured it to a two morse taper arbour so that it may be fitted directly to the Myford head stock spindle. This ensured that no chuck jaws got in my way while manoeuvring the tool.. The traditional material used for patterns is wood. But I just happened to have a good bit of brass the right size in my scrap bin..

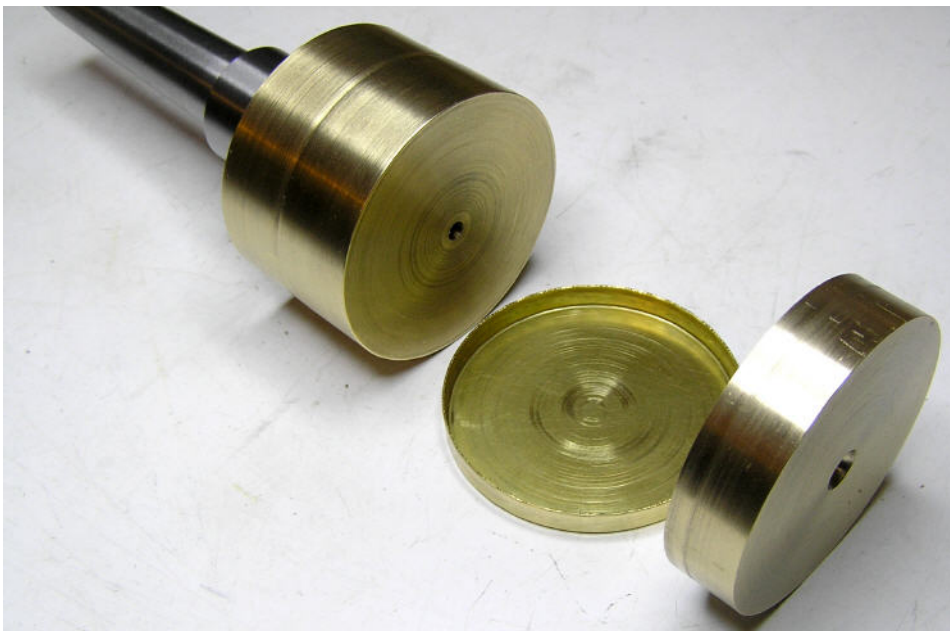
The follower is again formed from brass and sandwiches the cover between it and the pattern. The follower has an angled centre cut hole that accepts the nose of the revolving centre. The work is then nicely trapped for turning to size before shaping.

After forming, the cover was reversed in the setup for trimming .

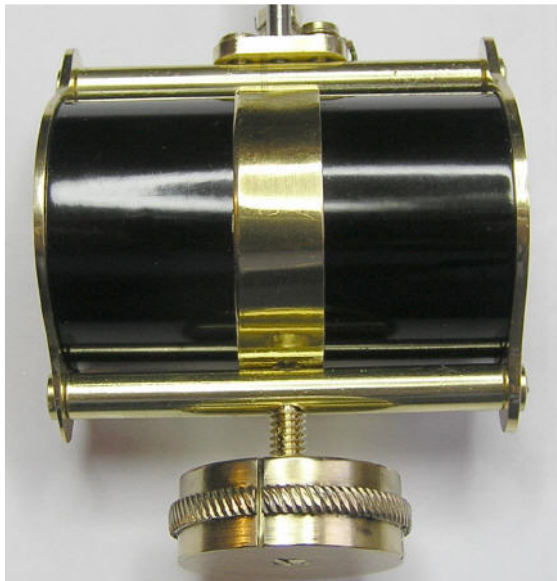
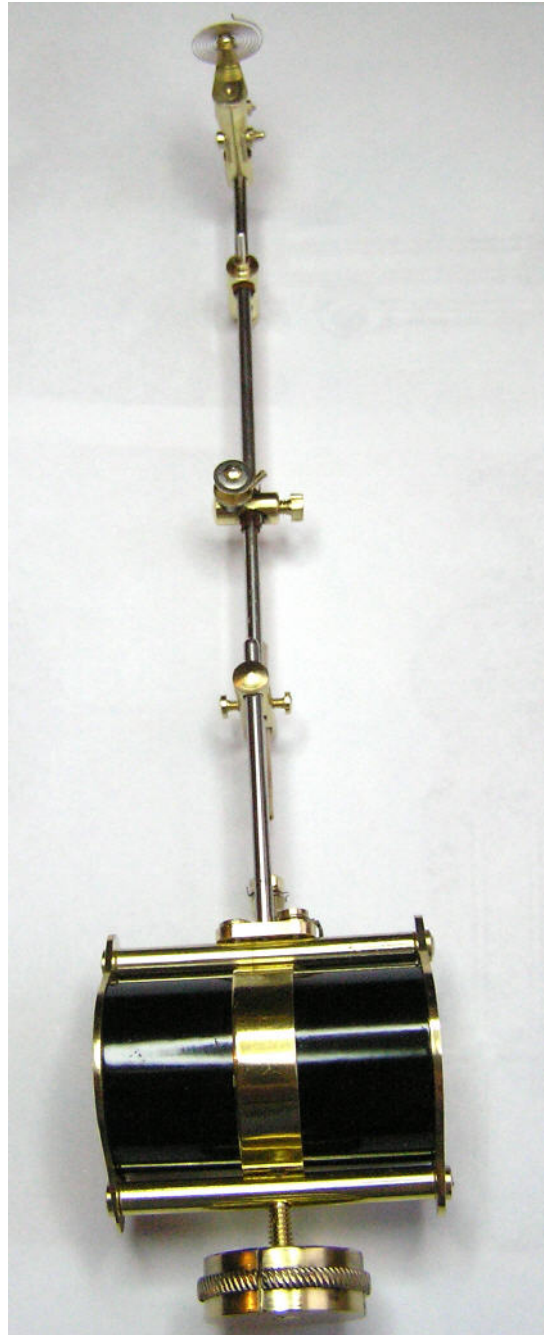
The pendulum assembly before and after.

The bob was dismantled completely and the coil checked. It was still in good condition and showed 1190 Ohms.

The bob shell was in need of some attention as can be seen at the top left. It was cleaned and sprayed black. Only the brass parts of the pendulum bob itself were lacquered. .

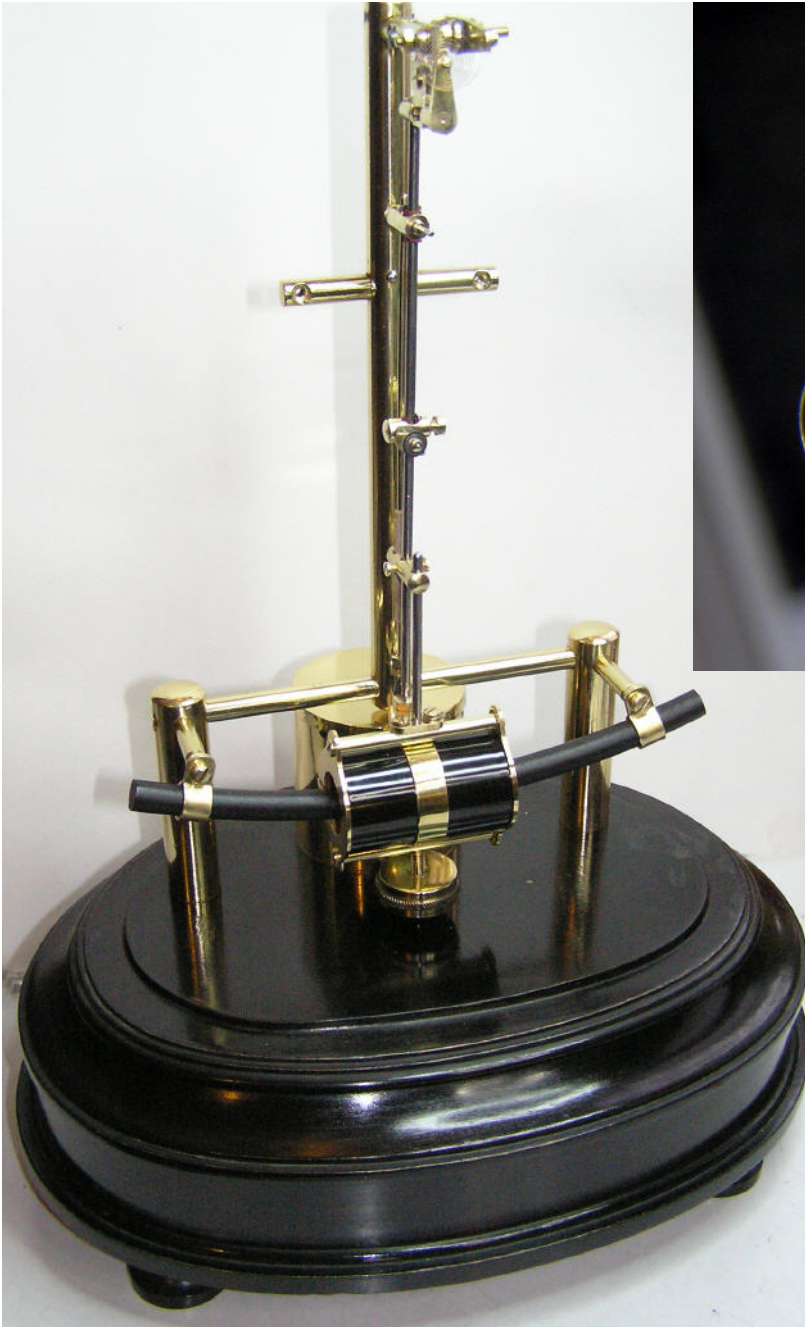
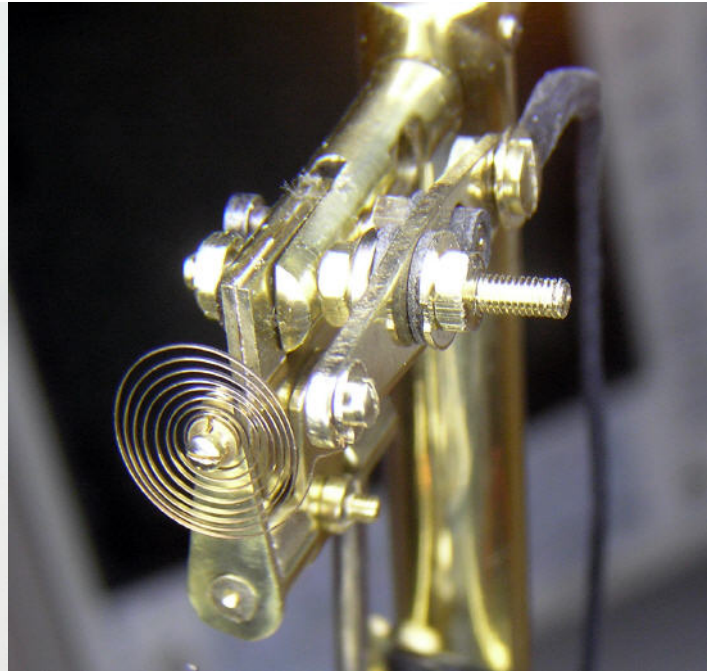
The Hairspring and Negative contact assembly complete and in position.

The base, Column and pendulum assembly re-united and waiting for movement, dial and hands.

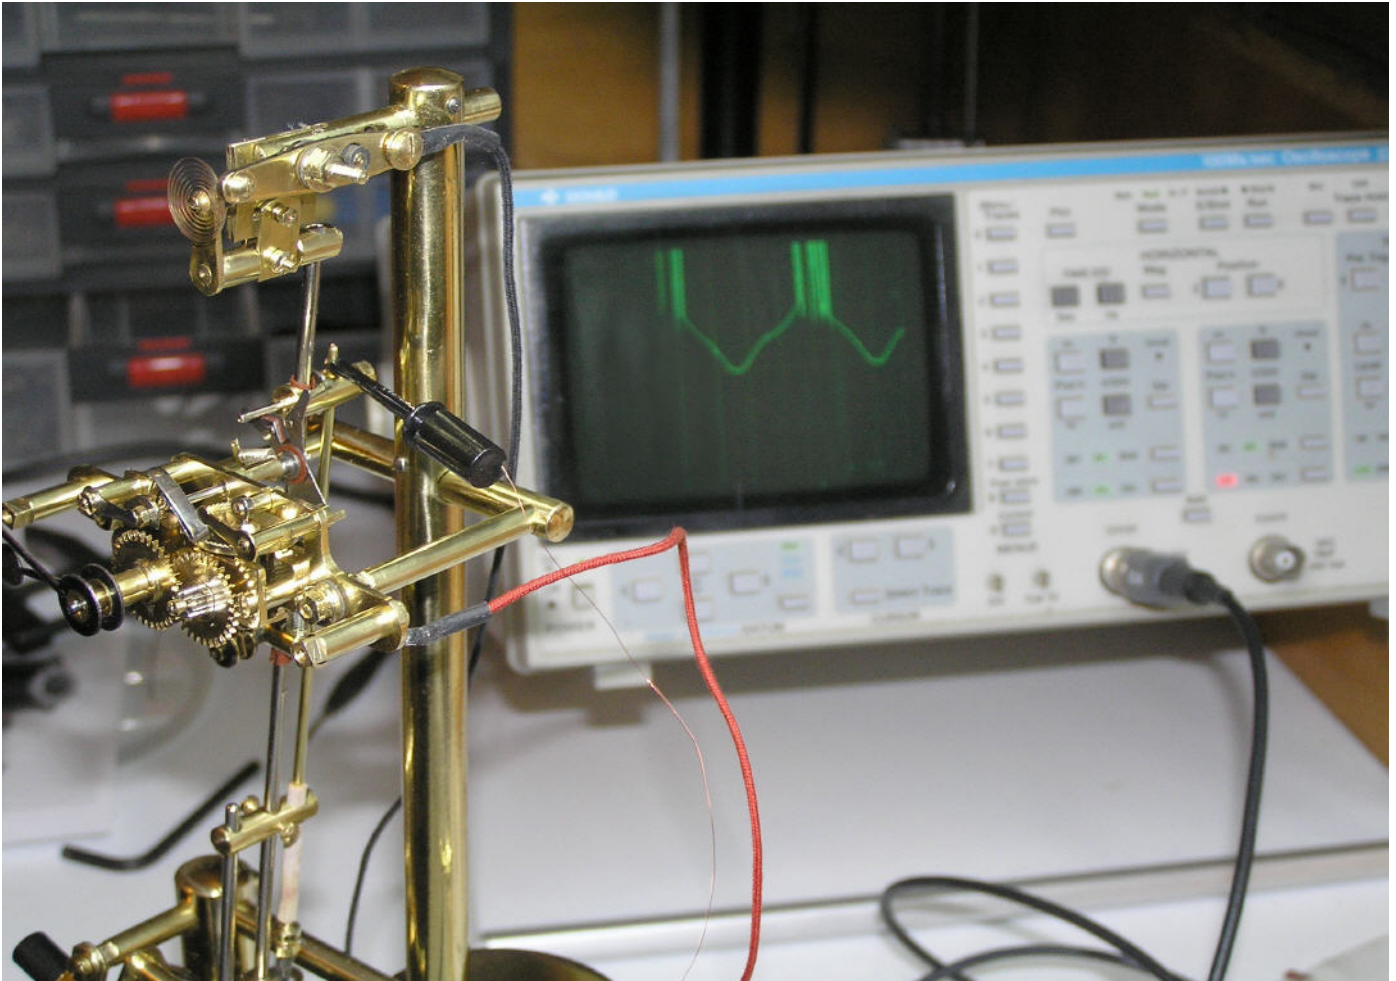
Testing the Bulle for timing , continuity and cleanliness.

I use an oscilloscope to show me the what's going on with each swing. It needs to be connected in the right places. One point is directly behind the contact pin. But this is on the pendulum which is swinging away so it's no good trying to touch it with a probe. I use a lightweight plastic gripping probe with 42swg enamelled wire attached which being extremely light does not influence the pendulum at all. It's the same wire used to wind the core of the coil. When connected at this point the oscilloscope not only shows the reliability of the contact, it also shows the voltage induced by the coil moving over the magnet when the pin is not in contact with the conducting side of the fork. You can just see this "wave" on the screen. This is another way of checking the effectiveness of the magnet.

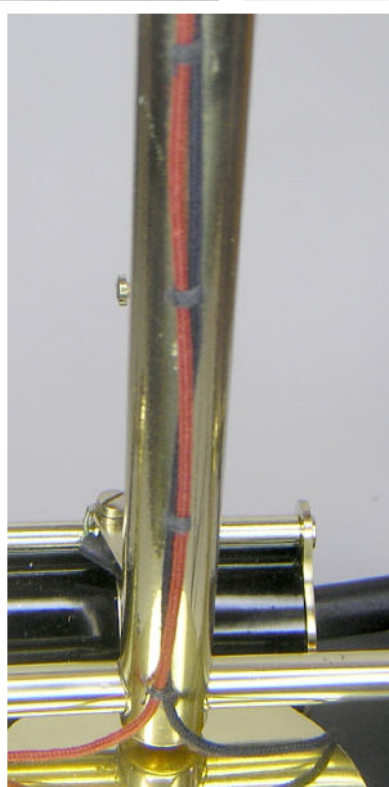
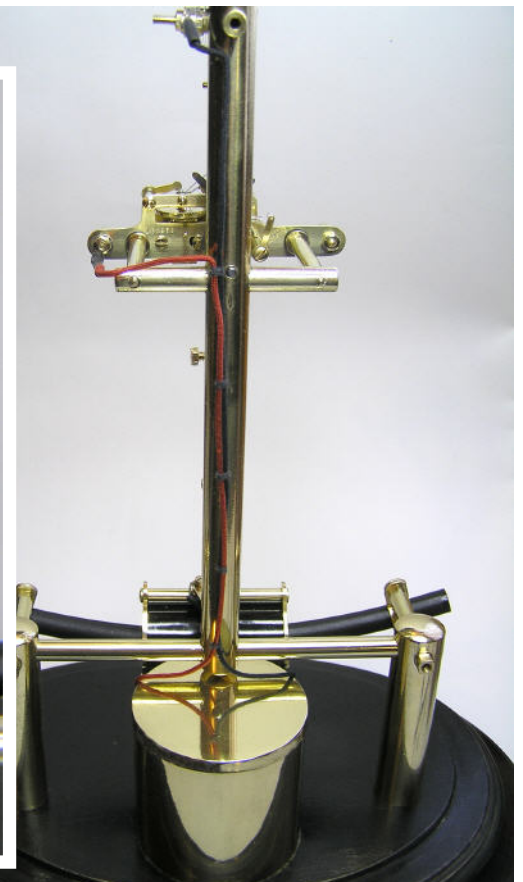
The steel battery cover has been cleaned of all rust and sprayed black. The cover is heavily pitted but still usable. The new threaded tube can be seen in place with matching dome head screw. You may just notice that sometime in the past a couple of pieces of brass shim have been forced between the battery tube and the wood. This was probably to stop the tube from falling out of the wood base. The tubes are only held by friction and so must be a good tight fit in the hole. There was also some fracturing of the end of the tube.

The wiring at the back of the clock has been bound with black cotton to try and lead and keep it behind the column so it won't be seen from the front. These later column clocks had nowhere for a "Run" of wire. The tall earlier clocks at least had the hollow tube and column that hid the wiring from the base to three quarters up the height of the clock only to emerge at the height of the movement support arms.

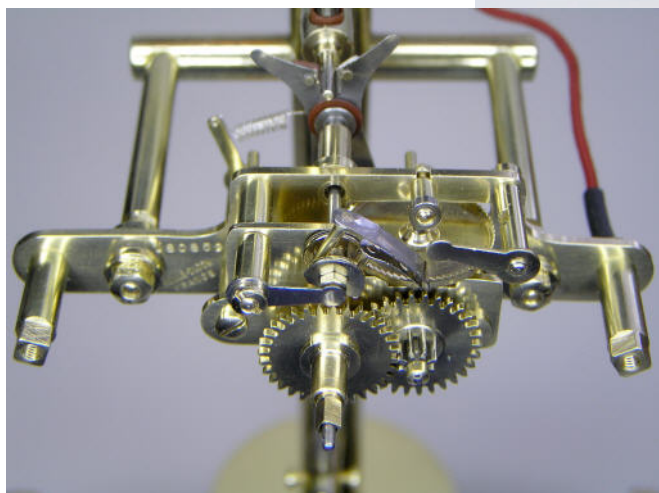
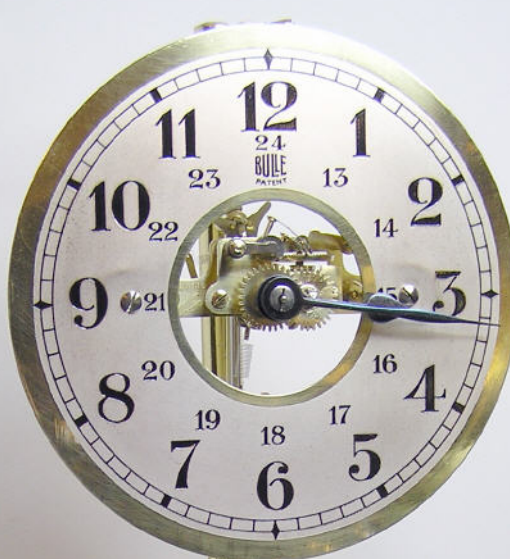
These photos show the movement fitted to the clock and the finished clock with dial. The dial on this type of clock is one of the better types as the numbers and lettering are engraved and filled. The silvered chapter ring is matted and sits slightly lower than the surrounding brass. This one is in good condition and only needed a polish to the brass surround..

The clock is now on test and has so far kept good time to within a minute a week. This will no doubt be improved upon when settled back home with the owner.
