Restoration of Bulle Clock Serial Number 201191.

Horologix Early Battery Clock Parts & Restoration

Bulle Clock Serial Number 201191. (By kind permission of the owner)

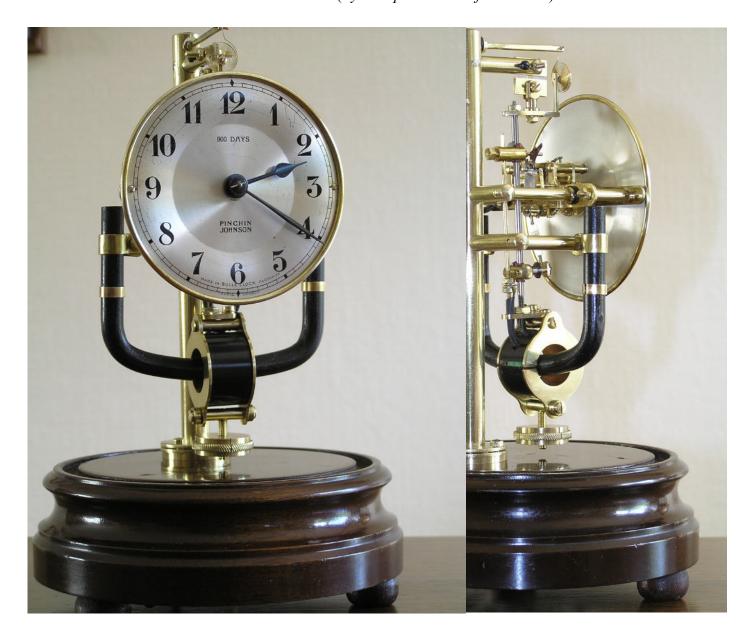
The clock, finished. The next two pages show the completed clock. It is now keeping good time. This photo shows the repaired fork and contacts, once again performing good service as they were originally designed to do. The silver pin shows a score mark which was probably caused by the sharp edge of the fork when it was left to start its cutting action after the silver contact on the fork was partially worn away. The contact assembly was re-assembled with the clean un-worn side of the pin at the bottom.
