Restoration of Bulle Clock Serial Number 313749.

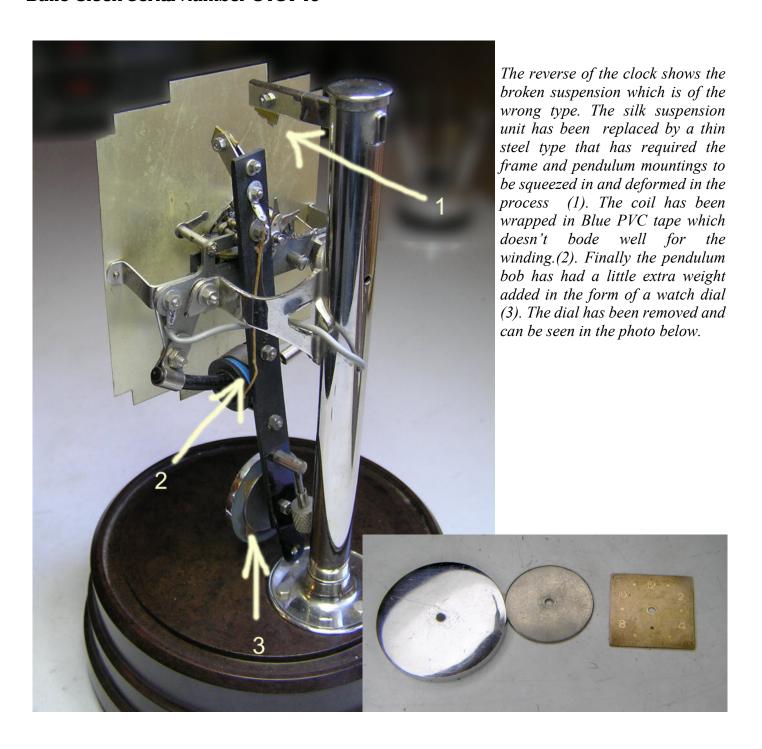
An interesting find on this clock was a small piece of brass hidden behind the chrome pendulum bob. The only reason it could have been there was a extra weight to slow the rate down. So a previous repairer must have had a problem trying to adjust the rate and resorted to one of the old tricks of adding weight to the pendulum.

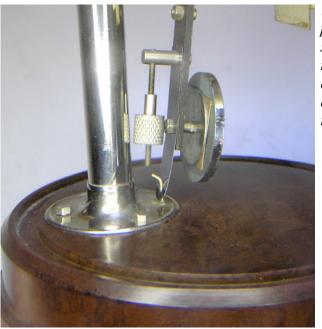
This photo shows the tidy little method of securing the pendulum rod during transport. A strip of blued spring steel is secured to the wood rod by the bolts holding the rating nut and pendulum bob. The lower end of this spring extends down past the end of the rod and has a hole in the end. The spring steel is then bent backward to secure it to the small hook attached to the column base.

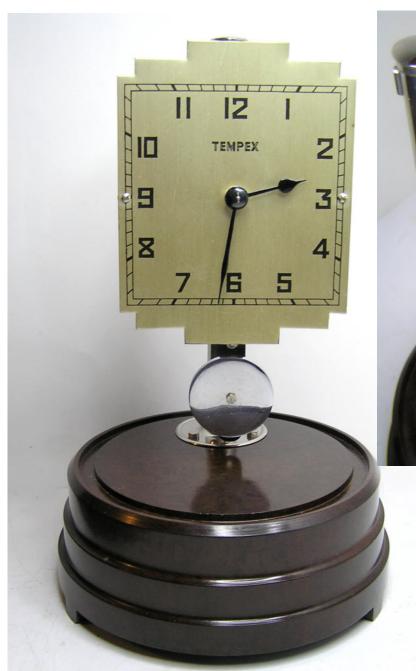
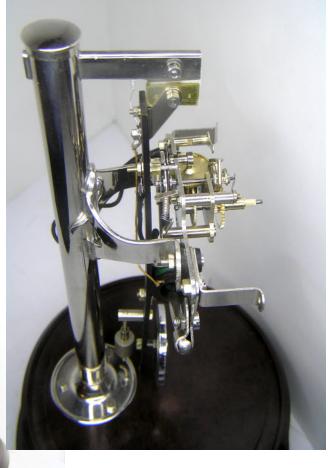
The finished clock

It is currently on test and keeping time to about one minute a week.
