# Restoration of Bulle Clock Serial Number 5962.

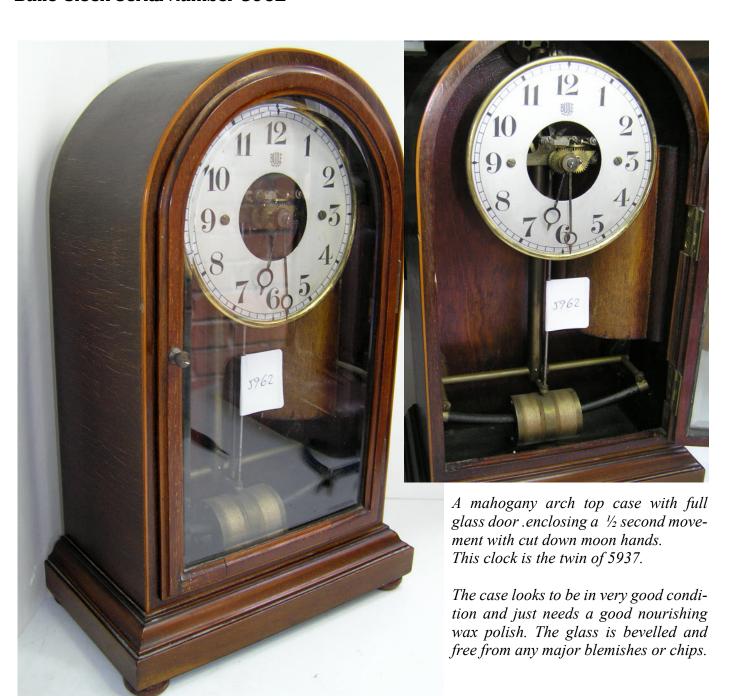
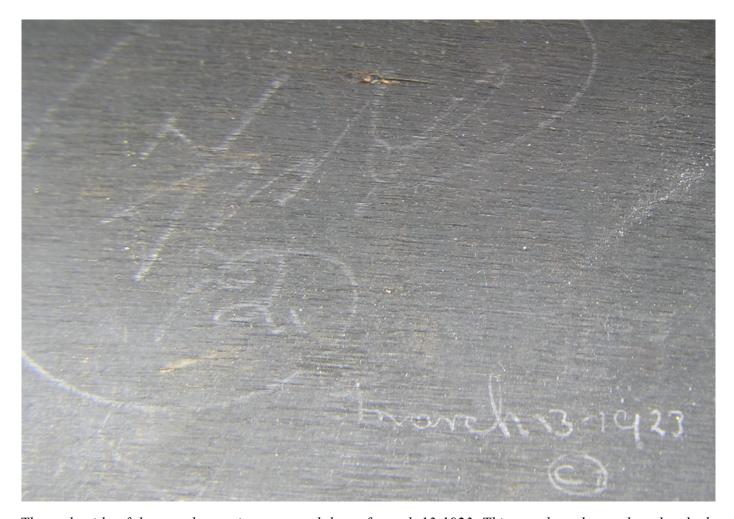
The underside of the case has a signature and date of march 13 1923. This may have been when the clock was taken into stock at the retailers as it seems to be formatted as an English date. The signature unfortunately unreadable to me. It's interesting though that there is some form of either copyright or circa sign under the date. I wonder what that meant. The date doesn't tie up very well though with the published date range for the serial number. Perhaps the clock was in stock at the factory for while before casing and distribution to the retailer in the UK.
