# Restoration of Bulle Clock Serial Number 7894.

The full restoration of this Bulle with kind permission of the owner.

This Bulle is of the tall A type movement and frame but in a four glass case. The serial number 7894 puts it with the first two years of production.

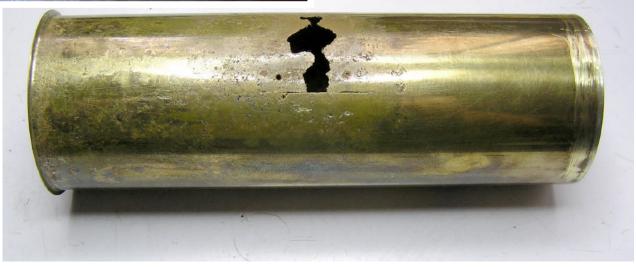
This photo shows the extent of the damage from the inside. The whole area is very thin and weak. The seam has been opened up by the acid attack.

Meanwhile I have separated the tube from the rest of the stem( as seen below) and have replaced it with one from a clock that I have had for a while that has a damaged column but the tube is in a reasonable state. There are a few marks in it from acid burning but nothing in comparison to this one. Besides, we don't want it too look new and therefore stand out like a sore thumb. So with a good clean up I should be able to set up u jig to hold the parts together whilst soldering the parts.

I will keep this tube and perhaps experiment with ways to effect some form of repair that would hopefully not be too obvious from the outside.

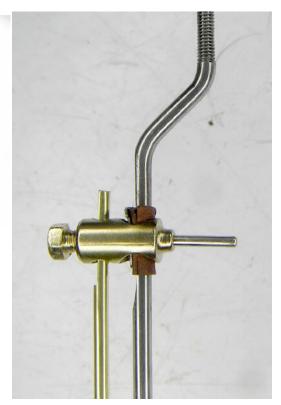
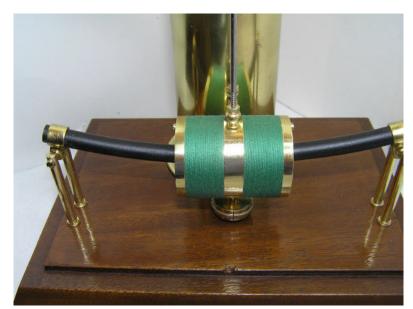
These two photos show the finished base of the clock and the pendulum bob after re-assembly and binding with new cord.

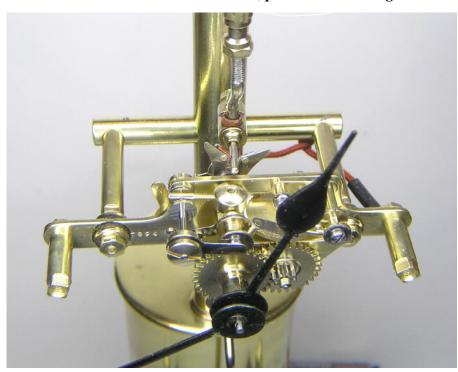
The base, pendulum and magnet re-assembled.

The movement now back in position with the column and on test with the hand attached temporarily while rough timing trials are conducted. This is the time when the action of the new fork contacts are tested as well as the length of the pendulum. If all goes well then the dial and hands can be finished and attached. The clock then goes on test for about a week for fine tuning.

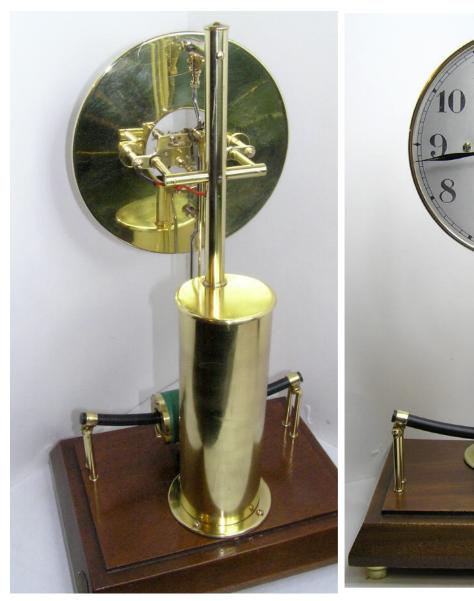
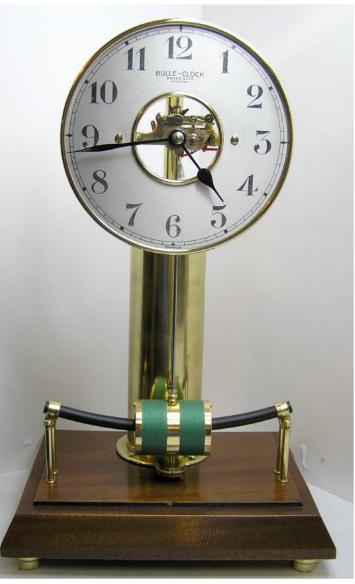
Rear and front views of the finished clock. No holes anywhere!

The rubber mounting between the glass retaining screws and washers was rock hard and disintegrating badly. I needed to replace it with a material that was both strong but very pliable so that it would both retain the glass and yet bend easily to take the shape. I looked around and found the very thing. I sliced up sticks of glue that are used withe Hot Glue guns. This has proved very effective with the added advantage of being reasonably clear and therefore less intrusive when when the clock is viewed from the front.

The glass itself was very quirky in that it has a number of air bubbles and blemished in it that modern glass does not have. I thought it better therefore to keep it with the clock even though one corner is shelled. The problem is that each piece is bowed quite appreciably from top to bottom. This therefore took some time to refit it comfortably without cracking or shelling it further. The glue discs proved their worth here being strong and very pliable easily adapting to the misshaped glass.

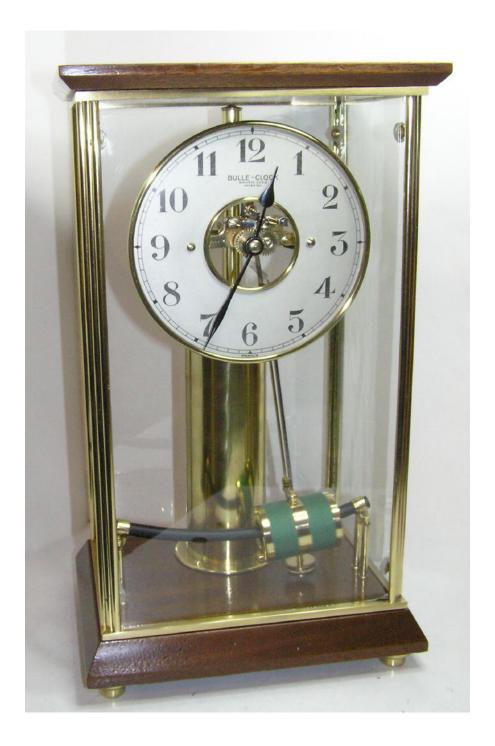
The finished clock.
